# **City of Valdez – Radio Infrastructure Upgrade Audit**

City of Valdez – Site Visit Audit/Report Performed by: Trevor Empey - Program Manager Patrick Goodyear, P.E. - Sr. Electrical Engineer Dale Browning, P. E. - Sr. Civil/Structural Engineer

**Prepared for** The City of Valdez Nathan Duval – Assistant City Manager

December 17, 2021

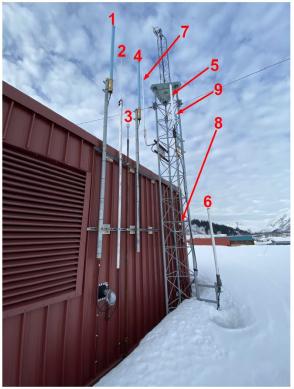
Figure 2 - Existing City Hall Antennas

1)Law Enforcement 2)Tsunami System 3)GPS 4)FIRE 5)Unknown 6)Unknown 7)Unknown (Old Tsunami?) 8)GPS (Not Used?) 9)Monitor Only

The Tsunami warning system operates in the 450 MHz UHF band. So, will not cause problems with the VHF, Fire and Law Enforcement antennas.

The GPS is receive only, and operates above 1,000 MHz; so, it should not cause any interference with the other systems and adversely the other systems should not be impacting the GPS receiver.

We recommend leaving the existing Fire antenna where it is and moving the Law Enforcement antenna to the Northeast corner of the penthouse.

The Monitor antenna could be moved to the top of the tower, or at least the Northwest corner of the penthouse. If the Northwest corner is used the tower could be removed entirely.

All unused or possibly unknown antennas and cabling should be removed.

Prior to the upgraded antenna configuration, the tower will need to be evaluated for structural adequacy. The new loading design will affect the tower and its attachment to the roof and guy anchors. Also, antennas attachments to the penthouse will need structural evaluation and design.

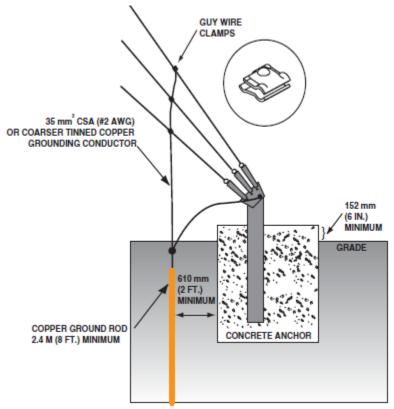
Figure 3 - Grounding Guy Wires and Anchors

The target for resistance to ground for these radios systems is 10 ohms. A proper connection to ground was not observed for either of the penthouse ground bars. Resistance to ground should be measured from the ground bar located on the side of the penthouse. All antenna support steel should be grounded including tower guy wires, pipe mounts, and uni-strut. A measurement of resistance to ground should be made when grounding the penthouse ground bar to the building steel. Paint, galvanizing and other contaminants between the grounding lugs and building steel can increase the system resistance to ground causing unwanted electrical noise in the systems.

Either the external or internal penthouse ground bar should be removed as only one ground bar is required. The more connections there are, the more failure points the system has. There should be one ground bar at the penthouse directly connected to the building ground system (usually located at the utility meter for the building).

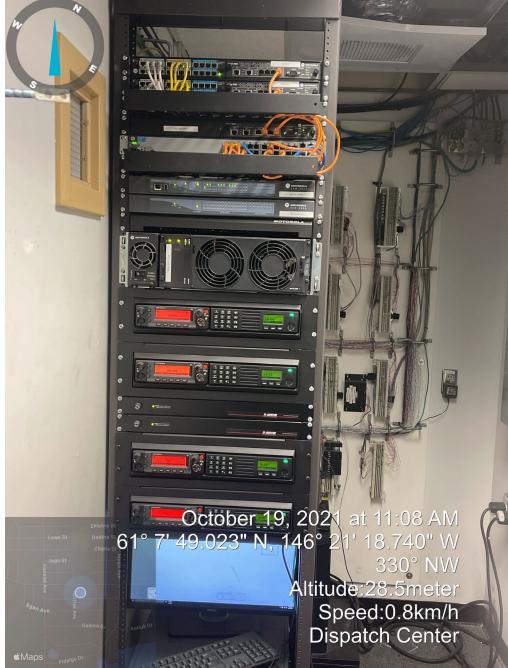
Figure 7 - Dispatch Cetner Motorola System

The Motorola system is being used to record dispatch radio conversations, monitor environmental alarms, and operate the primary Fire and Law Enforcement radios.

This appears to be a trunked radio system, and understanding how the Talkgroups and Trunking is setup is essential when planning future area wide system upgrades. Depending on the wired interface to the radios; it may be possible to move the radios to a remote location by extending the City IP network to the remote location. Motorola makes an interoperability gateway, as do third parties which could support remote location of these radios.

The radios are combined to the antennas using "T" connections. This results in only half of the transmitter power going to the antenna while the other half goes out the opposing branch of the "T" to the other radio. This may not be harming the other radio if the radios have a transmit-receive relay which disconnects the receivers from the antenna while a transmitter is active.

A complete understanding of the Motorola system that is supporting the Dispatch Center needs to be produced by the responsible Motorola Systems entity, detailing the programming, maintenance and repair suggestions to this system.

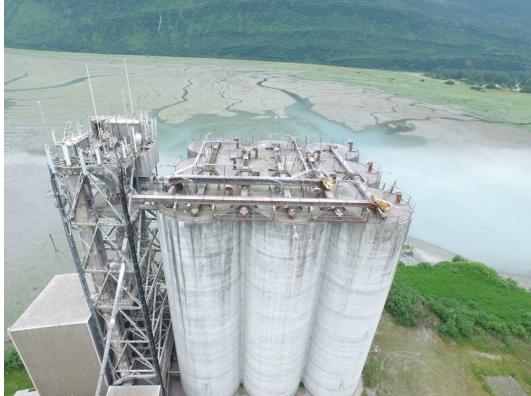
Figure 8 - Valdez Grain Silos

Currently the city is using the Grain Silos for Fire and Law Enforcement repeaters supporting extension of the Fire and Law Enforcement Primary channels.

If new cables and antennas were not installed with the repeater installations, they should be swept with a TDR to determine if they are functional and if the cable and connectors are undamaged.

The ground system should be inspected ensuring the 10 ohms to ground requirement. The antennas cables need to be grounded near the antenna before the bend from horizontal to vertical. The cable should be connected through a VHF surge protector (i.e., Polyphaser) that is connected to the ground bar near the cable entrance to the shelter. Supplemental grounding may be needed to achieve the 10 ohms to ground requirement.

The existing communication antennas that are owned by various carriers are attached to the steel framed structure adjacent to the concrete silos (see Appendix A for current antenna layout). The perimeter of the structure is populated with multiple antennas, but there should be available locations to space the City of Valdez's antennas. The attachment of the antennas to the structure will need to be designed.

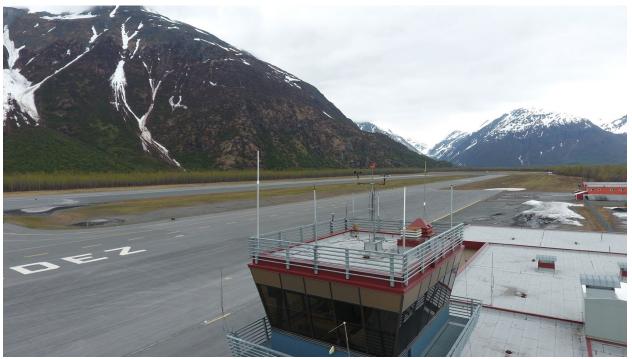
Figure 10 - Airport Tower Cab

With the Airport being a part of the Port of Valdez, the tower cab hosts antennas for the City of Valdez coordination of Port business, maintenance and emergency response at the Airport.

The antennas and cables should be swept with a TDR to determine if any damage is present.

The tower cab has enough area to provide suitable antenna separation. For Maximum separation and optimal performance, antennas operating in the same band (e.g., VHF, UHF, 700/800 MHz) should be mounted in corners diagonally across from each other.

The grounding of all antennas and cabling should be checked to ensure all connections are properly made and connections are tight.

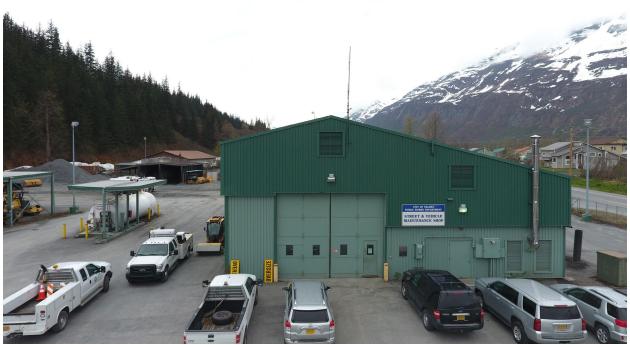
Figure 11 - Public Works Building (VMF)

The Public Works Building is equipped with a two element exposed dipole antenna. This should provide good coverage over the City of Valdez and out to the Grain Silos. If more coverage is needed further from the building, adding a higher gain antenna, or increasing the antenna height would be options.

The antennas and cables should be swept with a TDR to determine if any damage is present.

The antenna and cable grounding should be verified to ensure there is no damage. There should be a ground bar inside where the antenna cable enters/exits the building and the antenna cable should be connected through a VHF RF Surge Suppressor. This ground bar should have a direct connection via a #6 AWG or larger copper conductor to the building entrance grounding system. This is usually located at the utility service meter base.

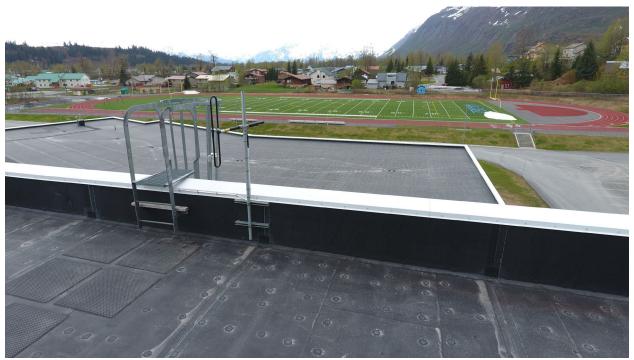
Figure 12- George Gilson Middle School

The Gilson Middle School is equipped with a single element exposed dipole antenna. If the intent for this antenna is to provide coverage in and around the school; we recommend moving the antenna away from the building so the antenna radiation pattern is pointed at the building.

The antennas and cables should be swept with a TDR to determine if any damage is present.

There is a cell tower located at the water tank at the end of Mineral Creek Road that would work for antenna relocation. Alternatively, a directional antenna could be used at the water tank cell tower and directed at the school, increasing signal strength in and around the school.

The antenna and cable grounding should be verified to ensure there is no damage. There should be a ground bar inside where the antenna cable enters/exits the building, and the antenna cable should be connected through a VHF RF Surge Suppressor. This ground bar should have a direct connection via a #6 AWG or larger copper conductor to the building entrance grounding system. This is usually located at the utility service meter base. Building steel can be used as long as proper connections are made and verified.

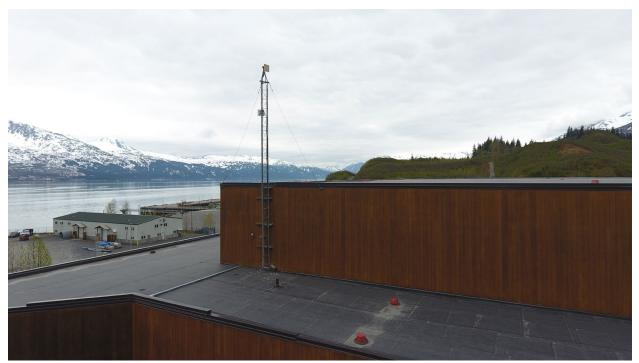
Figure 13 - Civic Center

The Civic Center tower appears to support two WAN panel antennas. If the systems are not experiencing any issues nothing needs to be done. If these WAN connections are experiencing intermittent drop-outs we recommend the cables be verified, and the

grounding system reviewed. These antennas should be grounded to the tower steel, building steel or ground bar. Regardless of grounding used, verification of complete ground continuity to the utility services entrance needs to be verified.

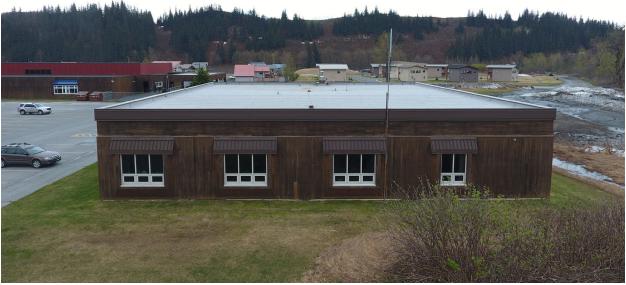
Figure 14 - School District Building

The School District Building is not included in any of the FCC licenses provided by the City. If this location has transmitters or transceivers in operation, proper FCC licensing needs to be performed in order to bring this location into compliance.

As with the other sites; the cables and antenna should be swept with a TDR to ensure there are no damaged elements in the antenna system.

Antenna and site grounding should be reviewed to ensure that the system is properly grounded. There should be a ground bar, outside or inside, where the antenna cable enters/exits the building, and the antenna cable should be connected through a VHF RF Surge Suppressor. This ground bar should have a direct connection via a #6 AWG or larger copper conductor to the building entrance grounding system. This is usually located at the utility service meter base. Building steel can be used as long as proper connections are made and verified.

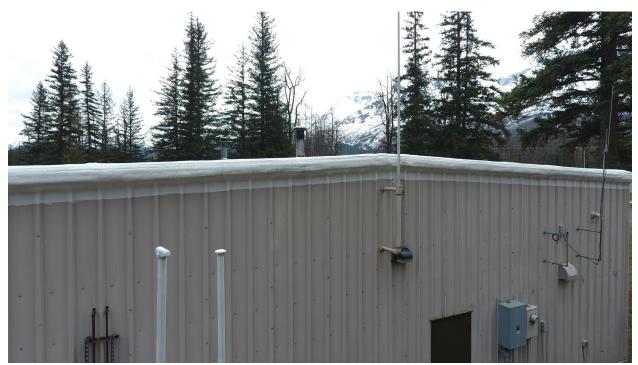
Figure 15 - Fire Station 3

Fire Station 3 is located near the intersection of River Drive and the Richardson Highway. It is equipped with a fiberglass collinear array antenna, similar to the ones used at City Hall, the Airport, and the School District Office.

As with the other sites; the cables and antenna should be swept with a TDR to ensure there are no damaged elements in the antenna system.

Antenna and site grounding should be reviewed to ensure that the system is properly grounded. There should be a ground bar, outside or inside, where the antenna cable enters/exits the building, and the antenna cable should be connected through a VHF RF Surge Suppressor. This ground bar should have a direct connection via a #6 AWG or larger copper conductor to the building entrance grounding system. This is usually located at the utility service meter base. Building steel can be used as long as proper connections are made and verified.

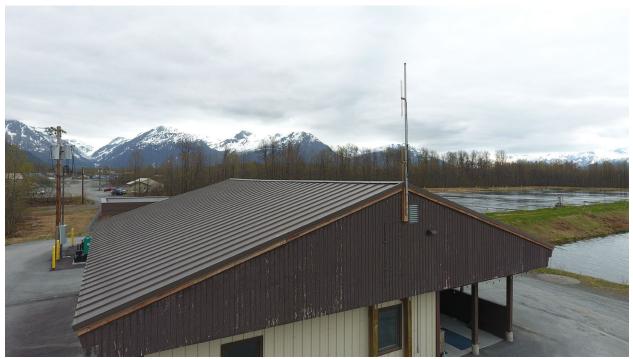
Figure 16 - 800 Sawmill Drive (STP)

The Sawmill site is equipped with a two element exposed dipole antenna, similar to the one at the Public Works (VMF) building.

As with the other sites; the cables and antenna should be swept with a TDR to ensure there are no damaged elements in the antenna system.

Antenna and site grounding should be reviewed to ensure that the system is properly grounded. There should be a ground bar, outside or inside, where the antenna cable enters/exits the building, and the antenna cable should be connected through a VHF RF Surge Suppressor. This ground bar should have a direct connection via a #6 AWG or larger copper conductor to the building entrance grounding system. This is usually located at the utility service meter base. Building steel can be used as long as proper connections are made and verified.

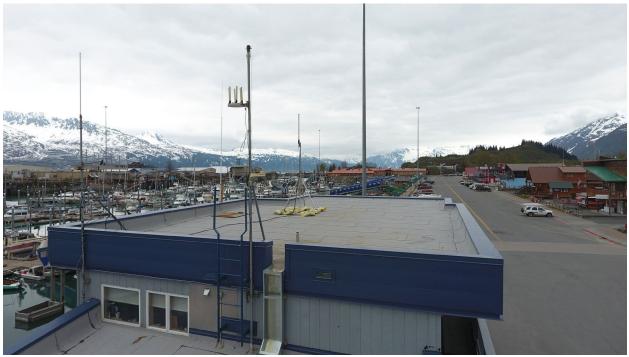
Figure 17 - Harbor Master

The Harbor Master office provides very good coverage of downtown Valdez and the Valdez harbor. There are several antennas at the Harbor Master office, they should all be reviewed and any unused antennas and cables should be removed.

As with the other sites; the cables and antenna should be swept with a TDR to ensure there are no damaged elements in the antenna system.

Antenna and site grounding should be reviewed to ensure that the system is properly grounded. There should be a ground bar, outside or inside, where the antenna cable enters/exits the building, and the antenna cable should be connected through a VHF RF Surge Suppressor. This ground bar should have a direct connection via a #6 AWG or larger copper conductor to the building entrance grounding system. This is usually located at the utility service meter base.

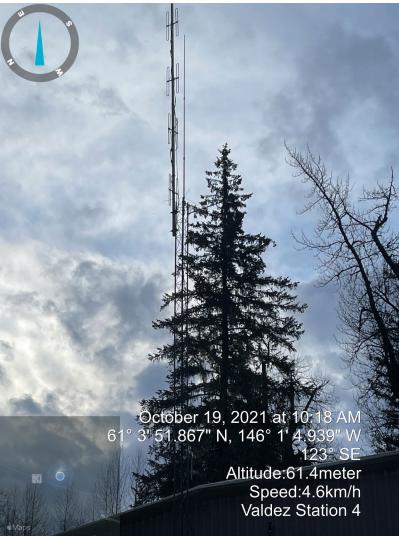
Figure 18 - Fire Station 4

Fire Station 4 is equipped with a dual four element exposed dipole VHF antenna. There is also a ground plane omni-directional VHF (VHF/UHF) antenna and a cellular band yagi antenna. The yagi antenna is most likely attached to the Wilson Cellular in-building amplifier to boost indoor cellular coverage.

As with the other sites; the cables and antenna should be swept with a TDR to ensure there are no damaged elements in the antenna system.

Antenna and site grounding should be reviewed to ensure that the system is properly grounded. There should be a ground bar, outside or inside, where the antenna cable enters/exits the building, and the antenna cable should be connected through a VHF RF Surge Suppressor. This ground bar should have a direct connection via a #6 AWG or larger copper conductor to the building entrance grounding system. This is usually located at the utility service meter base.

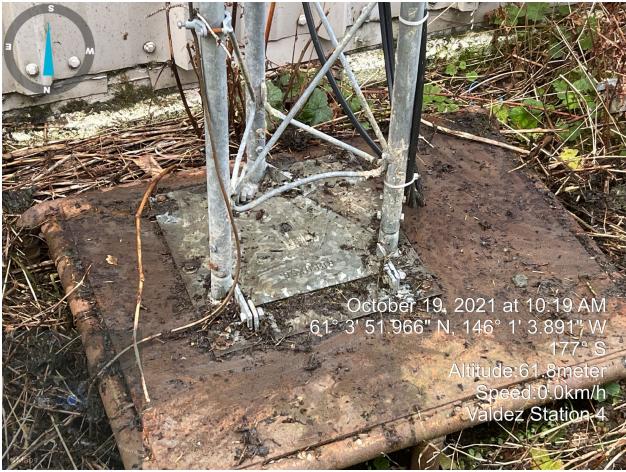
Figure 19 - Fire Station 4 Tower Base

The tower ground at Fire Station 4 indicates the tower is not properly grounded. The above photo depicts the ground connection for the tower. Since the galvanizing was not removed from the tower, or the grounding bracket, this tower is ungrounded.

While it is not possible to install a proper ground ring around the building; a grounding system could be installed on the side of the building where the tower is located. Using several ground rods, and #2 AWG Solid Bare Tinned Copper, a proper ground could be established and then connected to the tower via exothermic weld.
