November 9, 2017
Revised November 17, 2017

City of Valdez – Capital Facilities
PO Box 307
Valdez, AK 99686

**REFERENCE: Valdez Container Terminal & Small Boat Harbor Electrical Upgrades
Electrical Engineering Site Visit Report and Recommendations**

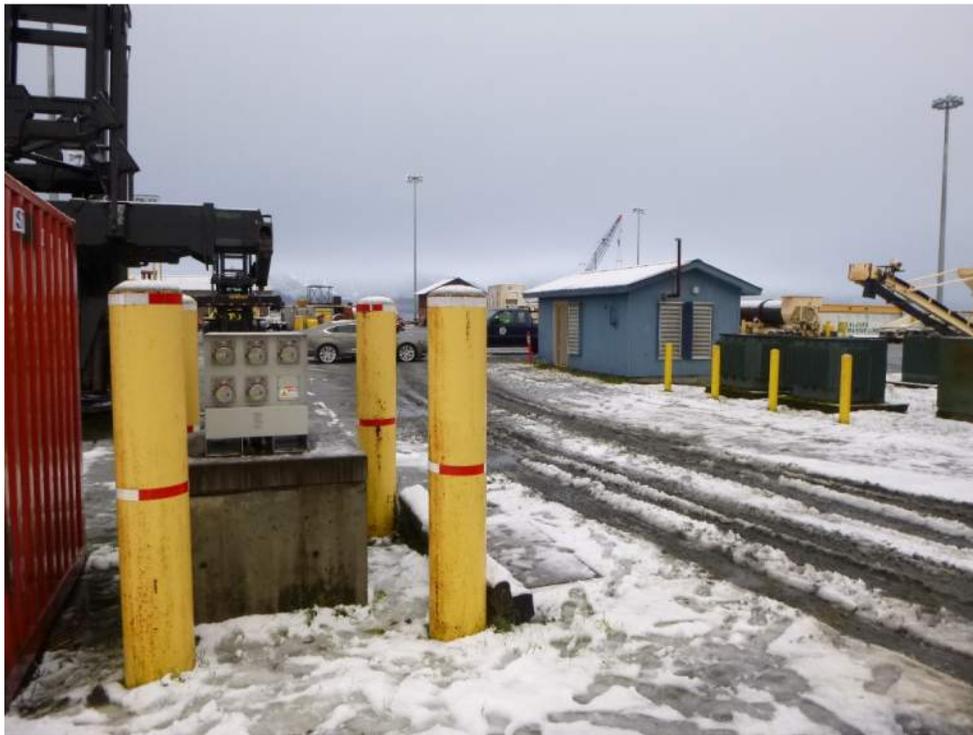
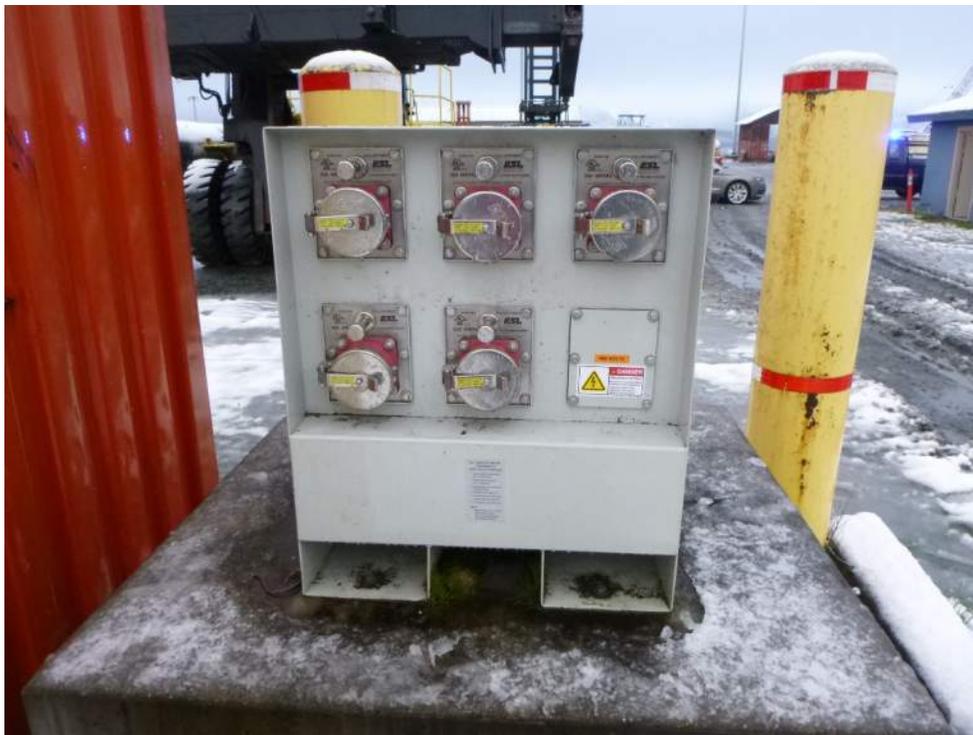
- ii. Existing Conditions – There are currently 18 reefer pedestals on site. Each pedestal contains 10 receptacles each, for a total receptacle count of 180 (Figures 1 and 2). The pedestals, or Power Modules, are manufactured by ESL Power Systems out of Corona, CA. Each pedestal sits on a concrete base and is protected by four bollards surrounding the equipment. Per the as-built drawings of the facility, 17 of the pedestals/receptacles operate at 480V, 3-phase and one pedestal/receptacles operates at 208V, 3-phase (although the breaker feeding the 208V receptacles does not appear to be operating as it was in the off position during the site visit). All pedestals are fed from the main Electrical Building via underground conduits. The electrical distribution equipment that feeds the existing pedestals is described in further detail under Part A.2 below.

Figure 1 – VCT Reefer Receptacle Pedestal

Figure 2 – VCT Reefer Receptacle Pedestal

- iii. Recommendations – RSA recommends that the new 180 receptacles match the configuration of the existing pedestals and receptacles to standardize on equipment and provide ease of maintenance. This includes concrete bases and bollards for protection. All new receptacles will be 480V, 3-Phase unless the COV has a need for additional 208V, 3-Phase receptacles. The new pedestals will be fed from new electrical distribution equipment, which is described in further detail in Part A.2

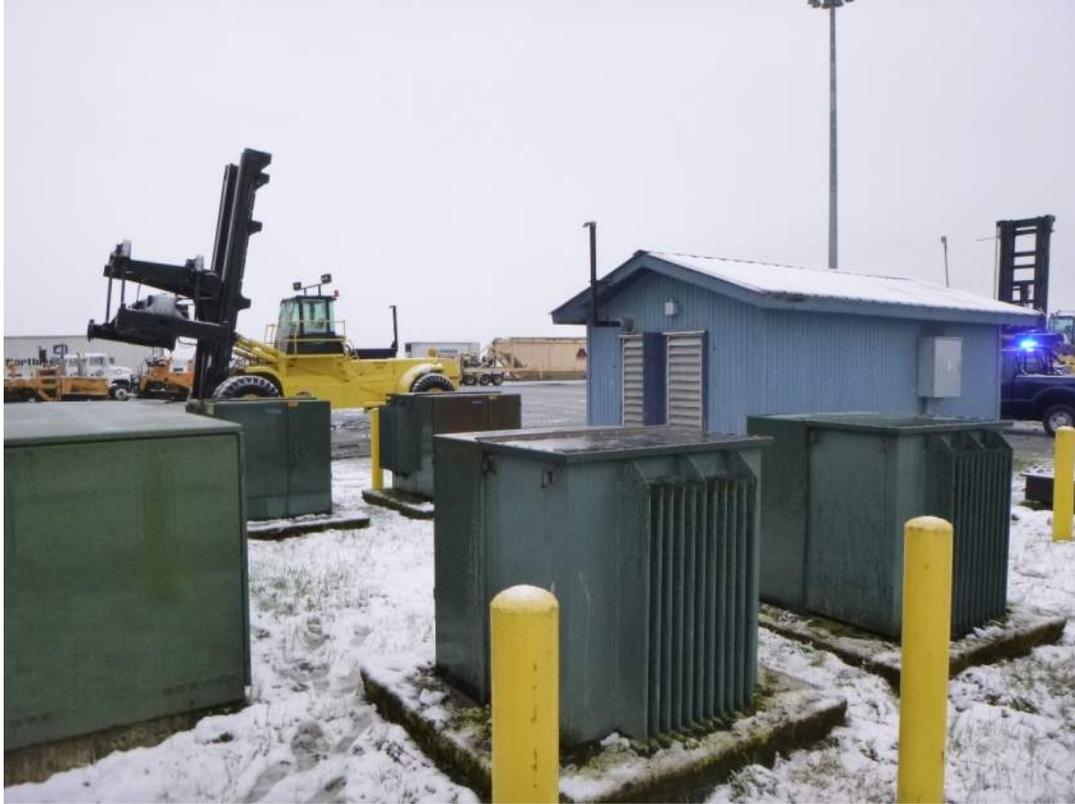
- ii. Existing Conditions – The electrical system for the facility is fed from Copper Valley Electric Association’s (CVEA) medium voltage distribution system, originating out at Mineral Creek Loop Road. The medium voltage system is fed underground to two main exterior switch cabinets located on the west side of the main Electrical Building. These switch cabinets then feed four adjacent exterior padmounted step down transformers, two at 480V, 3-Phase and two at 208V, 3-Phase (Figure 3). The two 480V transformers feed Switchboards ‘1H’ and ‘2H’. The two 208V transformers feed Switchboards ‘1L’ and ‘2L’.

Figure 3 – VCT Padmounted Distribution Transformers & Medium Voltage Switch

RSA also recommends demolishing the four exterior padmount transformers and providing one new pad mount transformer to accommodate the new, larger 480V service. Preliminary calculations require a 2000kVA transformer, which will also be verified during the design phases.

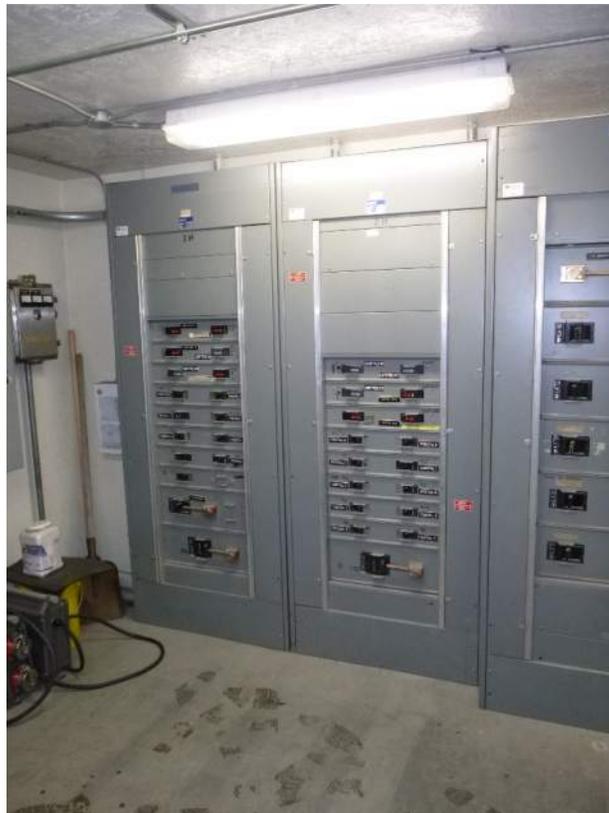
Switchboards ‘1H’ and ‘2H’ are both 900A, 277/480V, 3-Phase, 4-Wire, GTE Sylvania switchboards with 900A main breakers and connected together via a 900A tie breaker (Figure 4). These switchboards feed the majority of the facility loads including the 480V reefer receptacles and high mast lighting. These switchboards are beyond their useful life and replacement breakers are no longer available from local distributors.

Figure 4 – VCT Main 480V Switchboards '1H' & '2H'

- iii. Recommendations – RSA recommends demolishing the 480V switchboards and providing a single 480V main distribution switchboard sized to accommodate the existing and new loads. Based upon the existing peak demand of the facility and the anticipated 180 additional reefer van receptacles, this new switchboard would be rated 2500A, 277/480V, 3-Phase, 4-Wire. The exact size and configuration of the switchboard would be determined during future design phases.

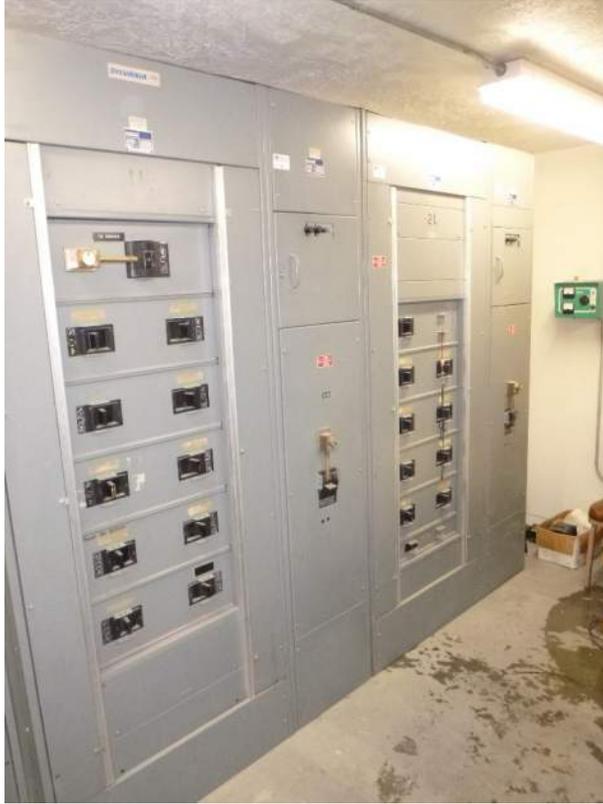
Switchboards ‘1L’ and ‘2L’ are both 1200A, 120/208V, 3-Phase, 4-Wire, GTE Sylvania switchboards with 1200A main breakers and connected together via a 800A tie breaker (Figure 5). In the past, these switchboards fed all of the 208V reefer receptacles, but the majority (if not all) of those have since been removed and all conduit/wire has been abandoned in place underground. The only load that appears to be powered from this 208V system is a 100A, 3-Pole breaker presently labeled “Northstar”. RSA assumes this is the main maintenance building near the dock, however, this was not able to be verified during our site visit. Switchboards ‘1L’ and ‘2L’ are beyond their useful life and replacement breakers are no longer available from local distributors.

Figure 5 – VCT Main 208V Switchboards '1L' & '2L'

Based upon our preliminary site investigation, there does not appear to be a need for the large 208V, 3-Phase switchboards. RSA recommends demolishing those switchboards and not replacing them. Any existing to remain or new 208V loads

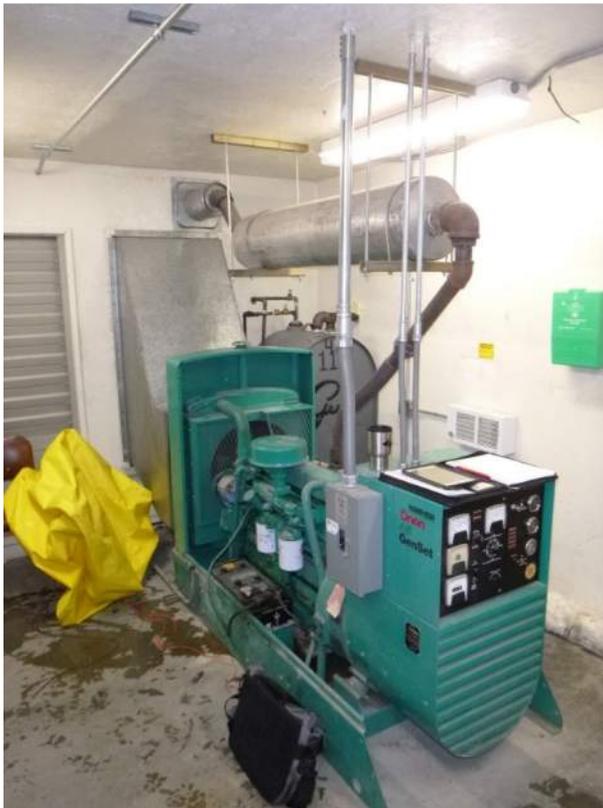
- i. Description of Upgrade - The COV desires a standby diesel generator sized to accommodate half (180) of the reefer receptacles at the facility.
- ii. Existing Conditions – The existing diesel generator is a 45kW, 277/480V, 3-Phase, 4-Wire, McGraw-Edison Onan indoor genset (Figure 6). The generator is connected to back up a small portion of the facility lighting load, generator accessory loads, heat trace and other miscellaneous critical loads. The exact age of the generator was not verified during the site visit; however, it is assumed to be part of the original construction of the facility in the early 1980s and is most likely approaching the end of its useful life.

Figure 6 – VCT Diesel Generator

- iii. Recommendations – RSA recommends demolishing the existing 45kW generator (and all associated appurtenances), and providing a new diesel generator sized to accommodate half of all reefer receptacles, as well as all other remaining loads at the facility. The new diesel generator should be provided within an exterior, weatherproof enclosure and placed adjacent to the Electrical Building. Per COV requests, the packaged generator would be provided with a sub-based fuel tank capable of holding up to 48 hours of fuel at full load. An automatic load bank should be provided and sized to maintain a minimum 50% load on the diesel generator at all times. The new generator would be placed on a new concrete housekeeping pad and protected with bollards. New Automatic Transfer Switches (ATS) will be added to switch the loads on to the generator during utility outages. The ATSs are described in more detail in the next section.

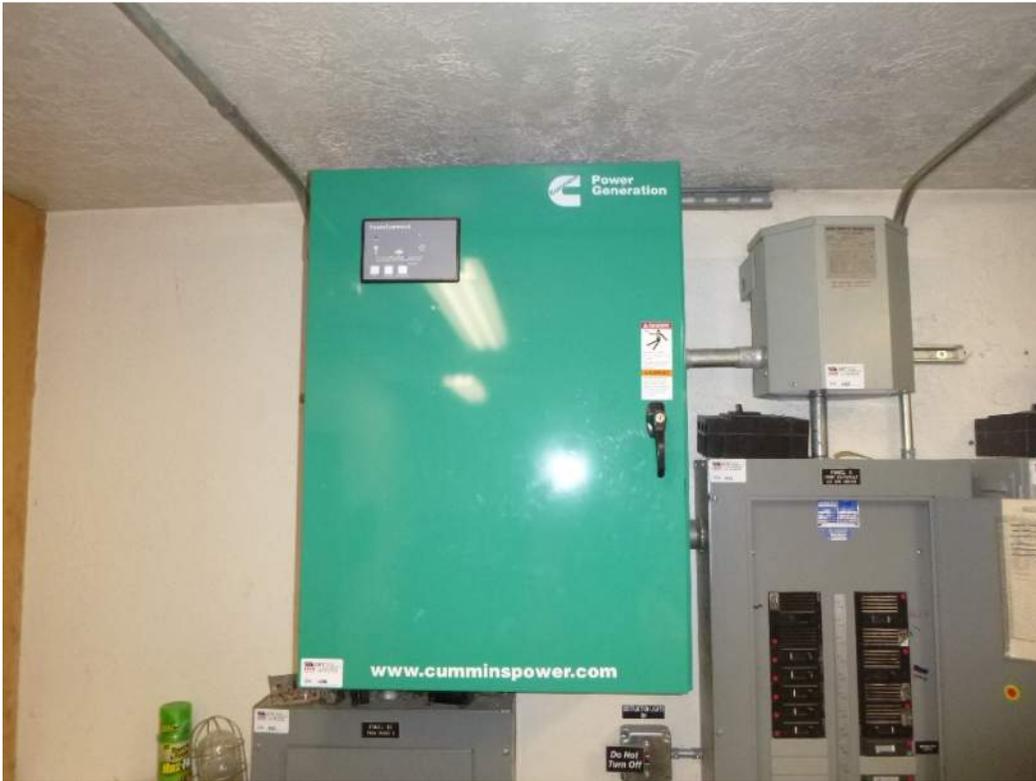
Figure 7 – VCT ATS

- ii. Existing Conditions – There is one existing ATS (Figure 7) that would be demolished if the COV elects to pursue our recommendation within Part A.3.iii above.

- iii. Recommendations – RSA recommends the addition of three ATSs and one load transfer type Manual Transfer Switch (MTS) to accommodate this upgrade. One ATS will cover all non-reefer receptacle loads (high mast lighting, dock, buildings, etc.). The second ATS will be connected to half of the reefer receptacles and the third ATS will connect to the other half of the reefer receptacles. Upstream of the second and third ATSs will be the MTS that allows the operator to select which half of the receptacle load will be powered at any given time. In this scheme, when the utility loses power, the generator will start and automatically transfer power to all non-reefer receptacle loads via the first ATS and half of the reefer receptacles via either the second or third ATS (depending on the position of the MTS).

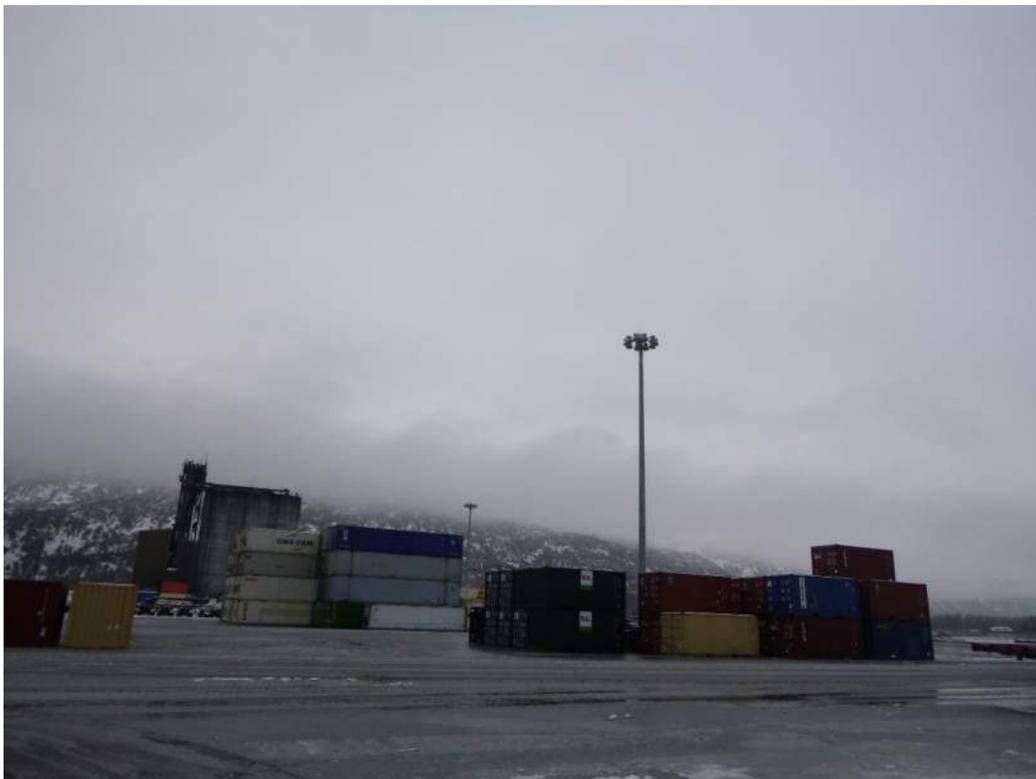
- i. Description of Upgrade – The COV would like to replace all existing High-Pressure Sodium (HPS) fixtures on the high mast lights with newer, energy efficient Light Emitting Diode (LED) type fixtures.
- ii. Existing Conditions – There are six high mast poles in the main container yard (Figure 8). These high masts are roughly 85' tall and contain ten, 1000W HPS fixtures each. These poles and fixtures were installed in 2011 and are in good condition.

There were discussions during the site visit about not replacing the light fixtures on the six high masts in the yard area since they are relatively new. The typically life for a HPS lamp is approximately 12,000 hours, after which time LED replacement becomes a cost preferred option. Assuming a conservative annual operation of 2000 hours per year, these HPS lamps have already reached their end of life. LED replacement is recommended.

Figure 8 – VCT Yard Area High Masts (Installed in 2011)

- iii. Recommendations – RSA recommends replacing all HPS fixtures with equivalent LED fixtures for maximum energy savings. The high mast poles all appear to be in good condition and are recommended to remain, however, we would like to have further discussions with the COV and maintenance personnel to verify this prior to proceeding with design

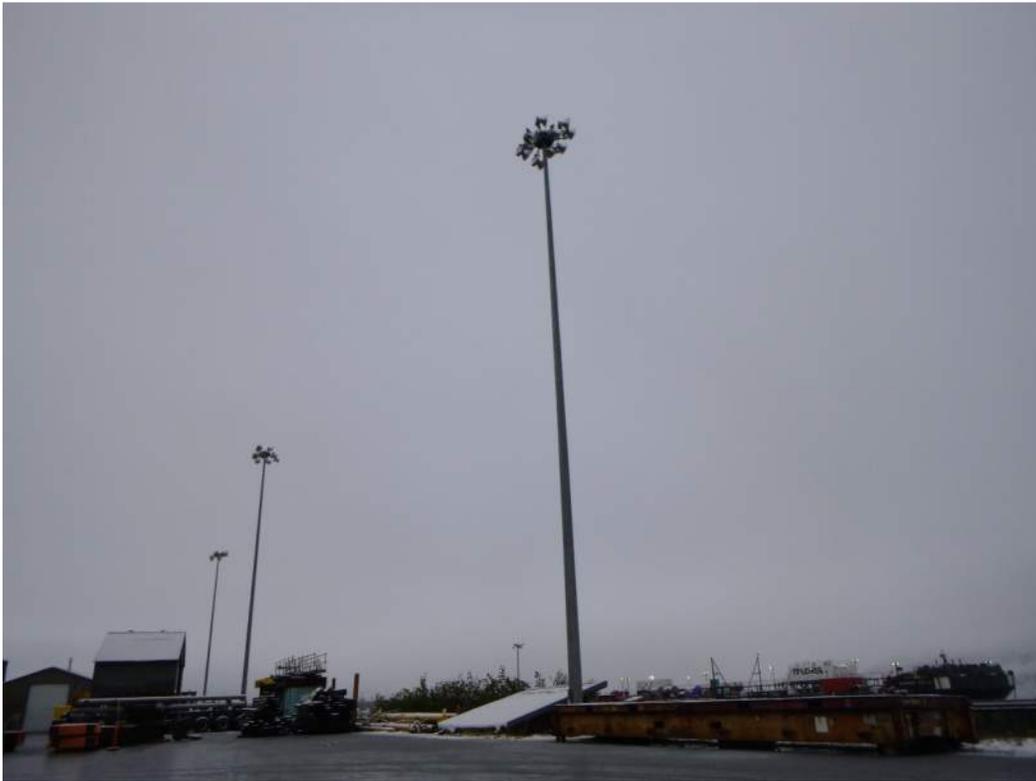
There are three high mast poles on the shore side near the dock (Figure 9). These high masts are roughly 85' tall and contain nine, 1000W HPS fixtures each. These poles and fixtures are assumed to have been installed in the early 2000s and are in good condition.

Figure 9 – VCT Shore Side High Masts (Installed in the early 2000s)

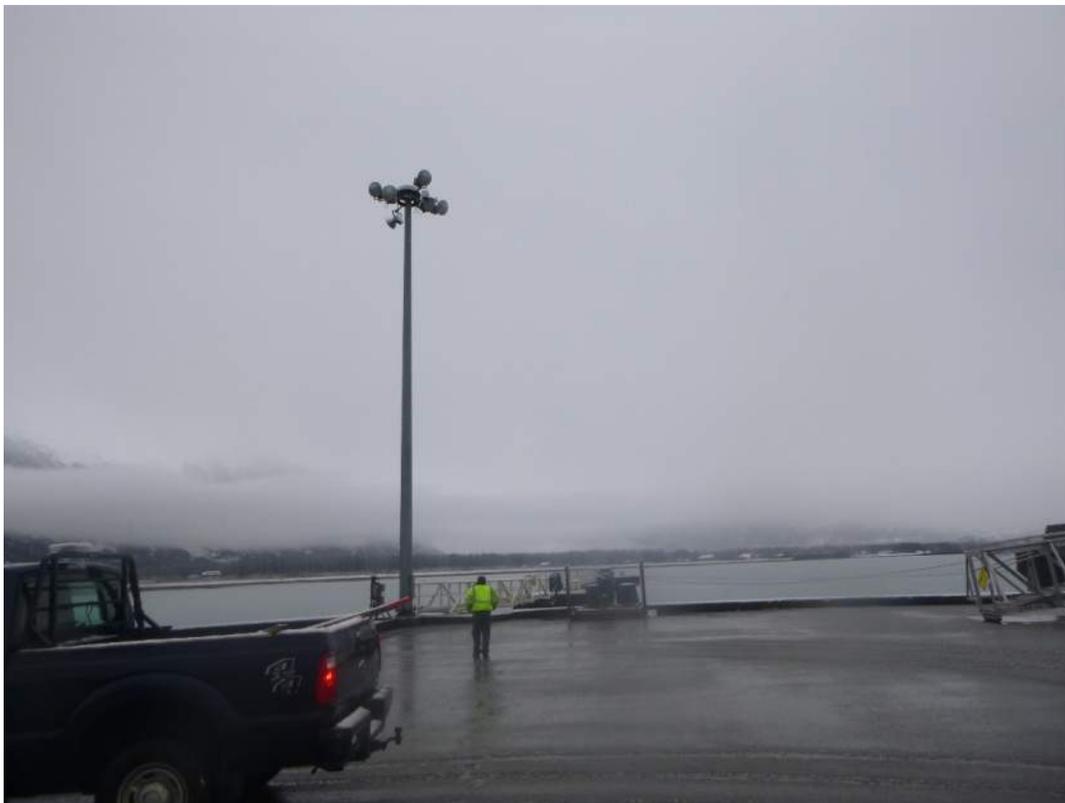
There are two high mast poles on the dock, one at each end (Figure 10). These poles are roughly 40' tall and contain six, 1000W HPS fixtures each. The poles and fixtures are assumed to have been installed in the early 2000s and are in good condition.

Figure 10 – VCT Dock High Mast (Installed in the early 2000s)

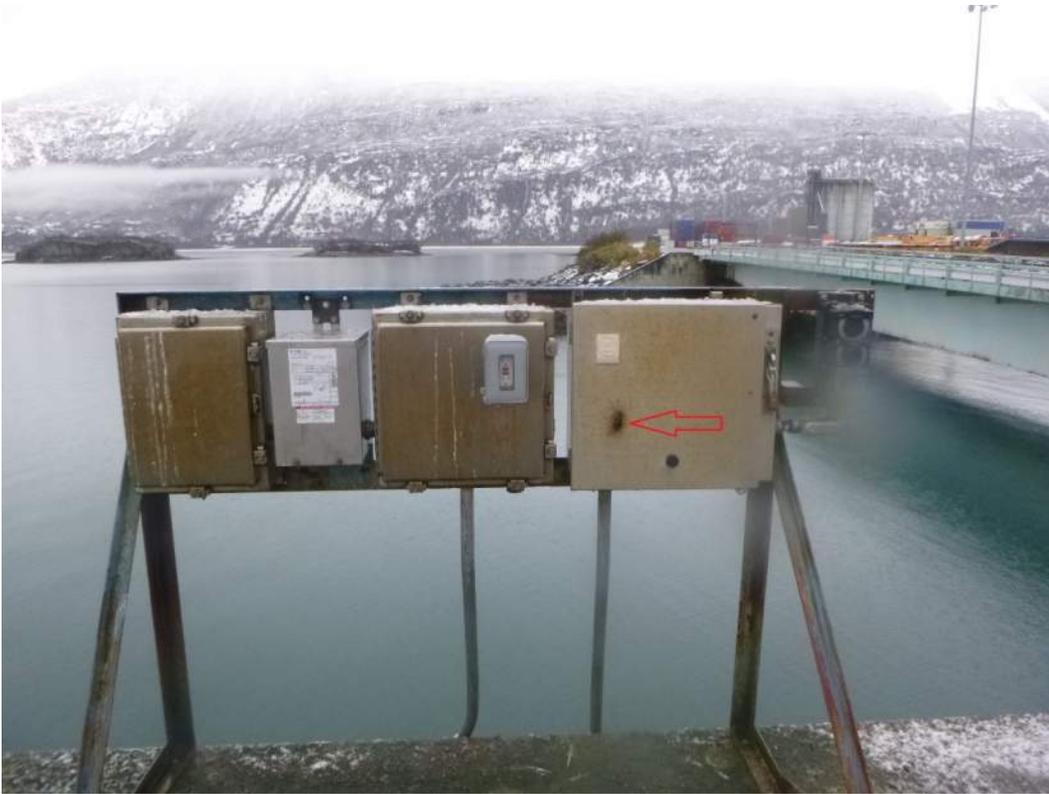
- iii. *Dock Electrical – There is an existing stainless steel electrical enclosure on the west end of the dock that has visible arc-fault damage on the cover of the enclosure (Figure 11). Jake and I opened the enclosure during the site visit and it was clear that the fault was caused by wiring being pinched between the enclosure door and a motor starter within the enclosure. The wires faulted and burned a hole through the enclosure cover. This enclosure is too small for the amount of equipment within and needs to be replaced with a listed assembly prior to operating. The equipment being fed from this enclosure was not able to be determined during the site visit, but can and will be verified during a future design site visit.*

- a. *Priority #1 – Dock Electrical (Part A.7.iii above) – This item was the only visual safety concern noted during the site visit. A design site visit will determine any additional dock safety concerns and they can be addressed accordingly.*

Figure 11 – VCT Dock Electrical Equipment (Arrow pointing to arc-fault damage)

RSA recommends a thorough investigation of all remaining electrical equipment on the dock to ensure no other safety hazards exist. Equipment deemed unsafe should be replaced as soon as possible to prevent injury to personnel and/or damage to equipment.

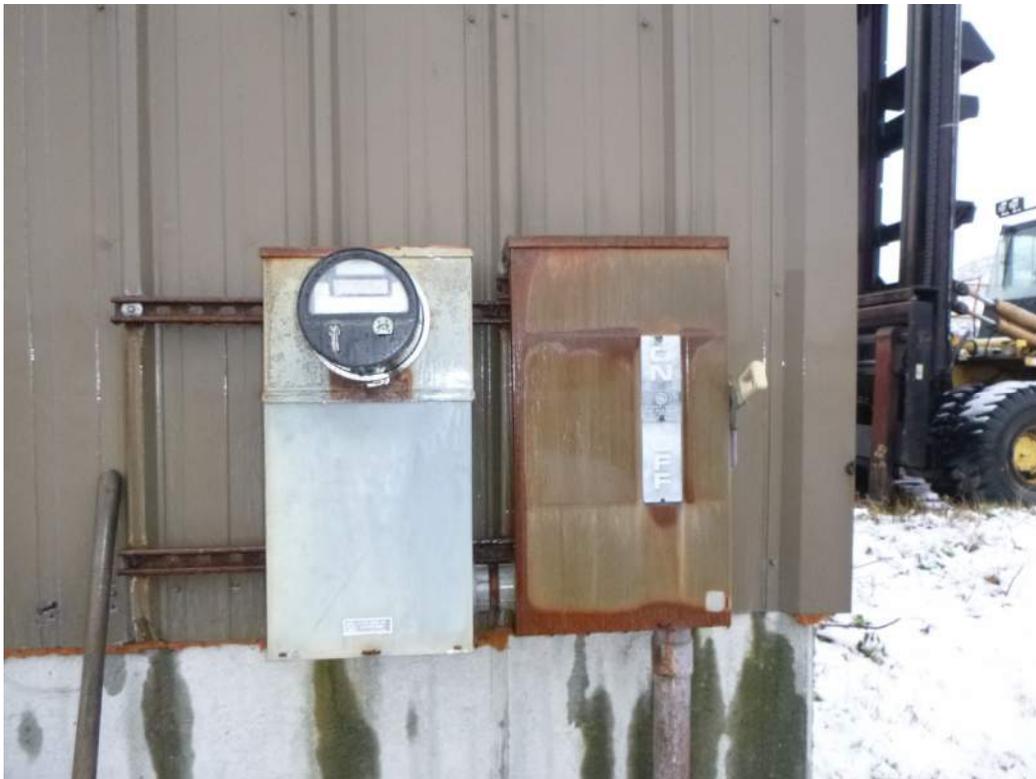
- iv. *Maintenance Building Exterior Electrical Equipment – The electrical disconnect and meterbase on the exterior of the Maintenance Building’s east side is showing major signs of corrosion and should be replaced (Figure 12).*

- d. *Priority #4 – Maintenance Building Exterior Electrical Equipment (Part A.7.iv above) – This item is prioritized due to the visible corrosion on the equipment. Due to its assumed limited use, it is not as high of a priority as the above two items, but the cost of replacement is small enough to justify replacement sooner than later.*

Figure 12 – VCT Maintenance Building Corroded Electrical Equipment

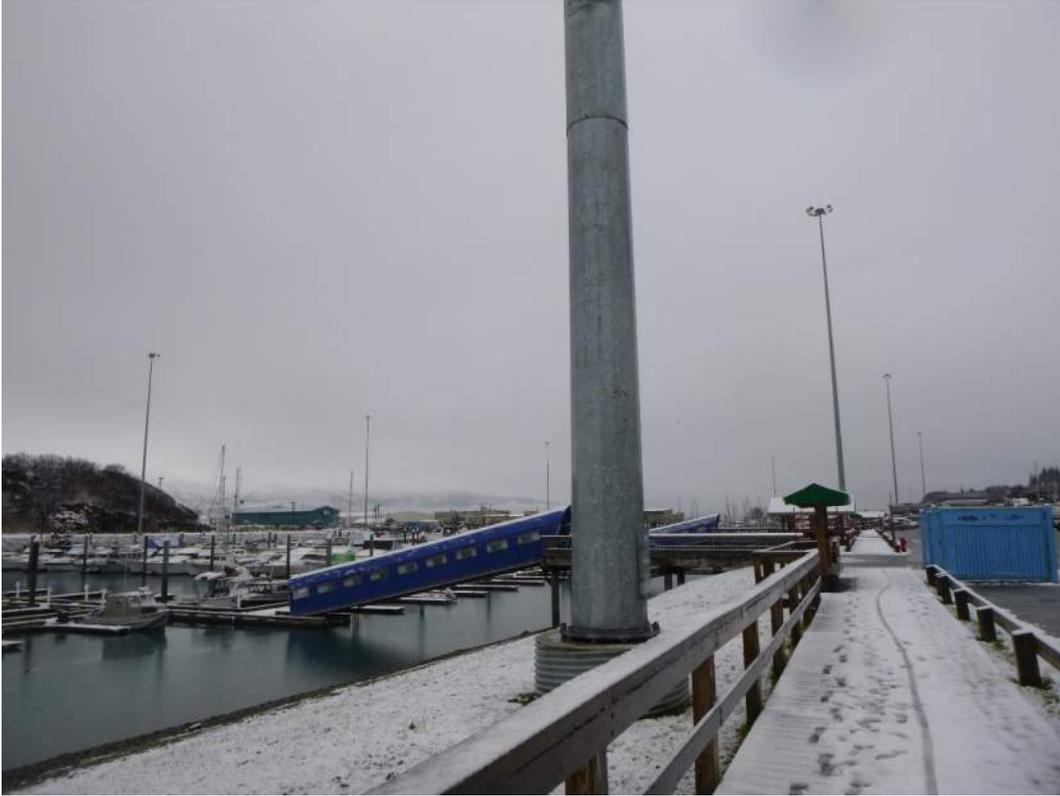
- i. Description of Upgrade - The COV would like to replace all existing High-Pressure Sodium (HPS) fixtures on the high mast lights with newer, energy efficient Light Emitting Diode (LED) type fixtures.
- ii. Existing Conditions – There are nine high mast poles surrounding the SBH (Figure 13), four on the north side (labeled *west to east* N1, N2, N3 and N4), four on the south side (labeled *west to east* S1, S2, S3 and S4) and one on the *northwest* side near the entrance to the harbor (labeled SS).

Figure 13 – SBH High Masts

- iii. Recommendations – RSA recommends replacing all HPS fixtures with equivalent LED fixtures for maximum energy savings. The high mast poles all appear to be in good condition and are recommended to remain, however, we would like to have further discussions with the COV and maintenance personnel to verify this prior to proceeding with design.

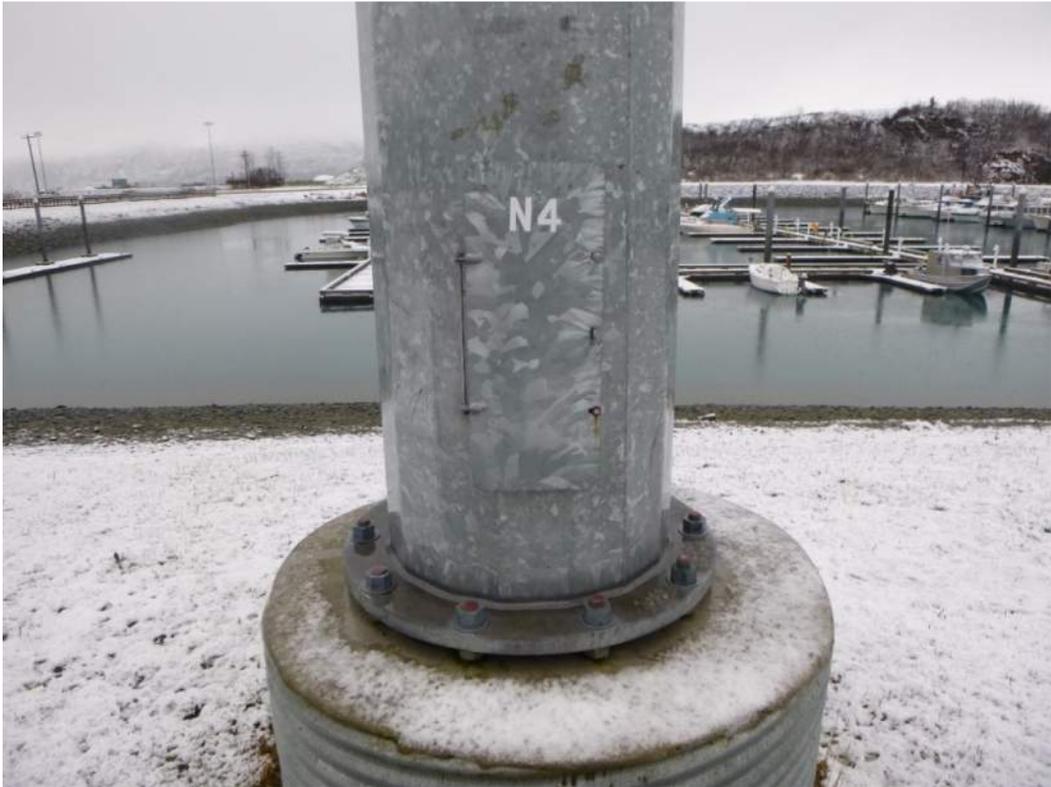
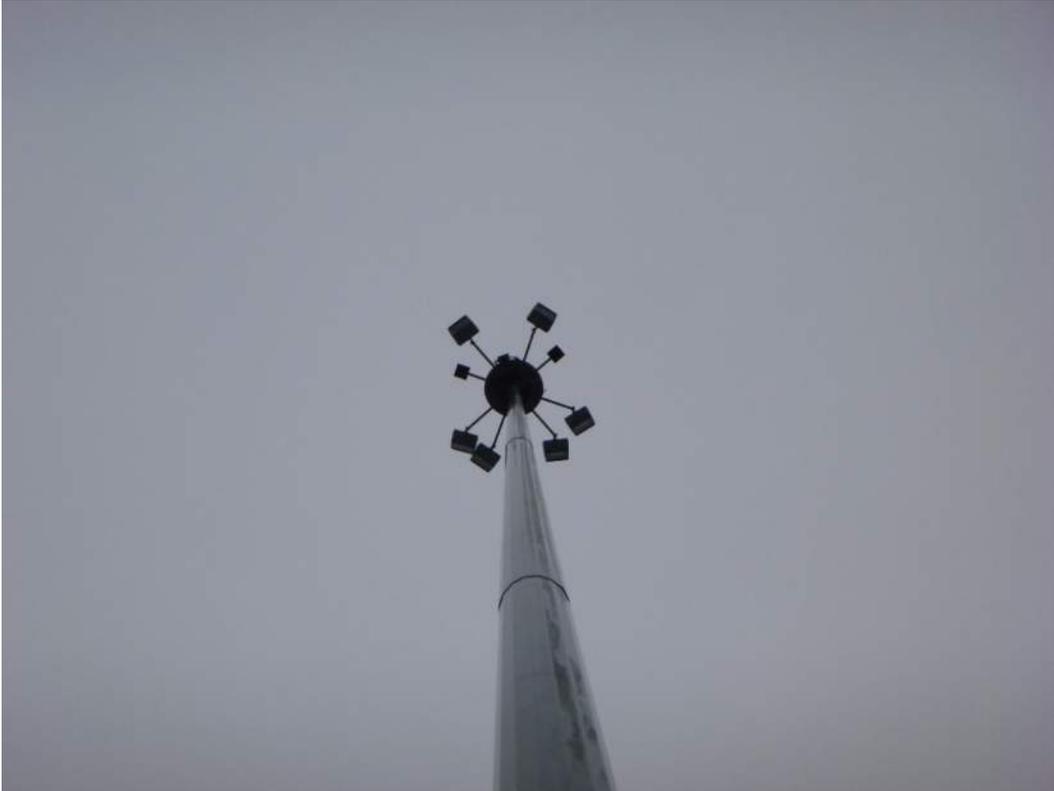
The four *eastern*-most high masts (N3, N4, S3 and S4) are 160' tall. N3 and N4 contain six, 1000W HPS fixtures each. S3 and S4 contain four, 1000W HPS fixtures each. These poles and fixtures were installed in 2010 and appear to be in good condition (Figures 14 and 15).

Figure 14 – SBH High Mast Base (Installed in 2010)

Figure 15 – SBH High Mast Lights (Installed in 2010)

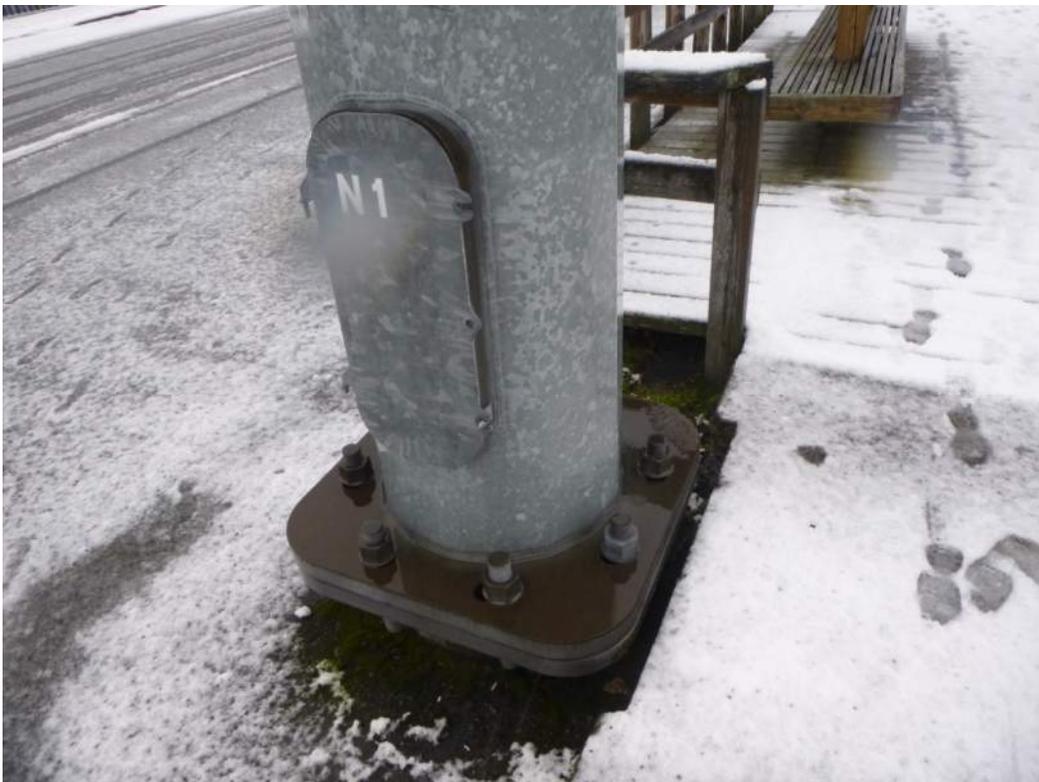
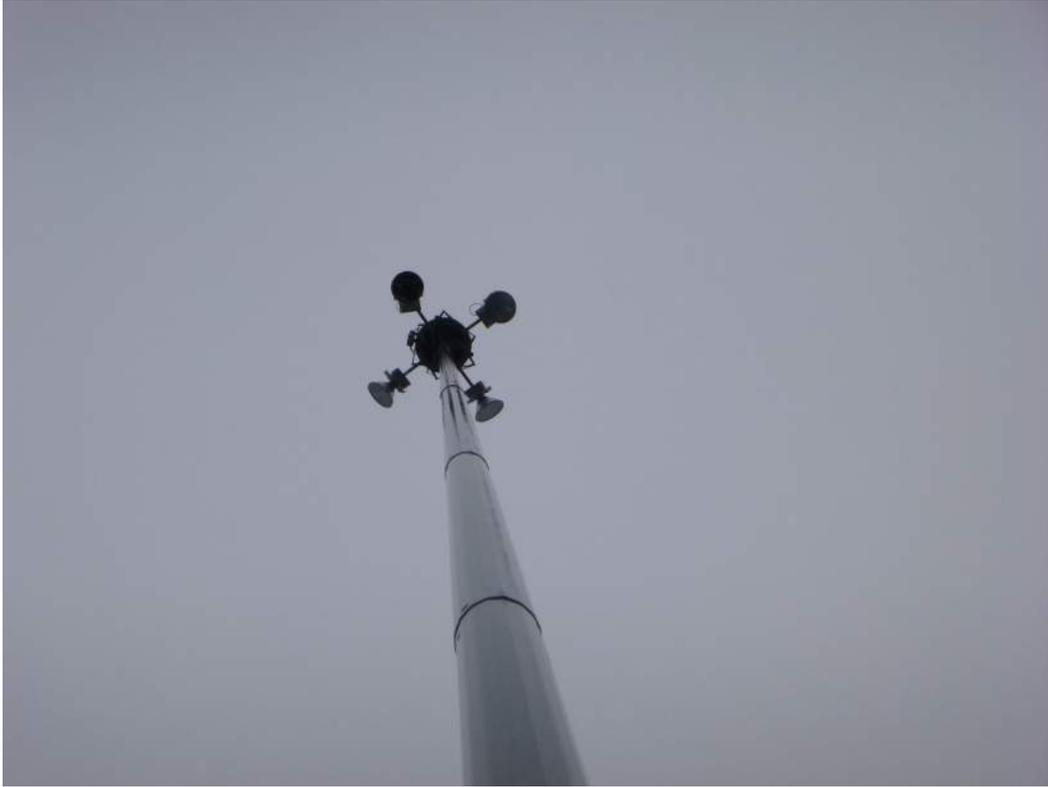
The five *western*-most high masts (N1, N2, S1, S2 and SS) are roughly 160' tall. N1, N2 and S2 contain four, 1000W HPS fixtures each. S1 and SS contain three, 1000W HPS fixtures each. The date of installation for these high mast poles and fixtures is unknown, however, they appear to be slightly older than the *eastern*-most high masts described above. Poles and fixtures both appear to be in fair to good condition (Figures 16 and 17).

Figure 16 – SBH High Mast Base (Older – Installation date unknown)

Figure 17 – SBH High Mast Lights (Older – Installation data unknown)
