Summary of Emergency High-Water Expenditures

As of September 28, 2016

Alpine Woods dike construction

Valdez Glacier Stream - Copper Ave emergency flood mitigation

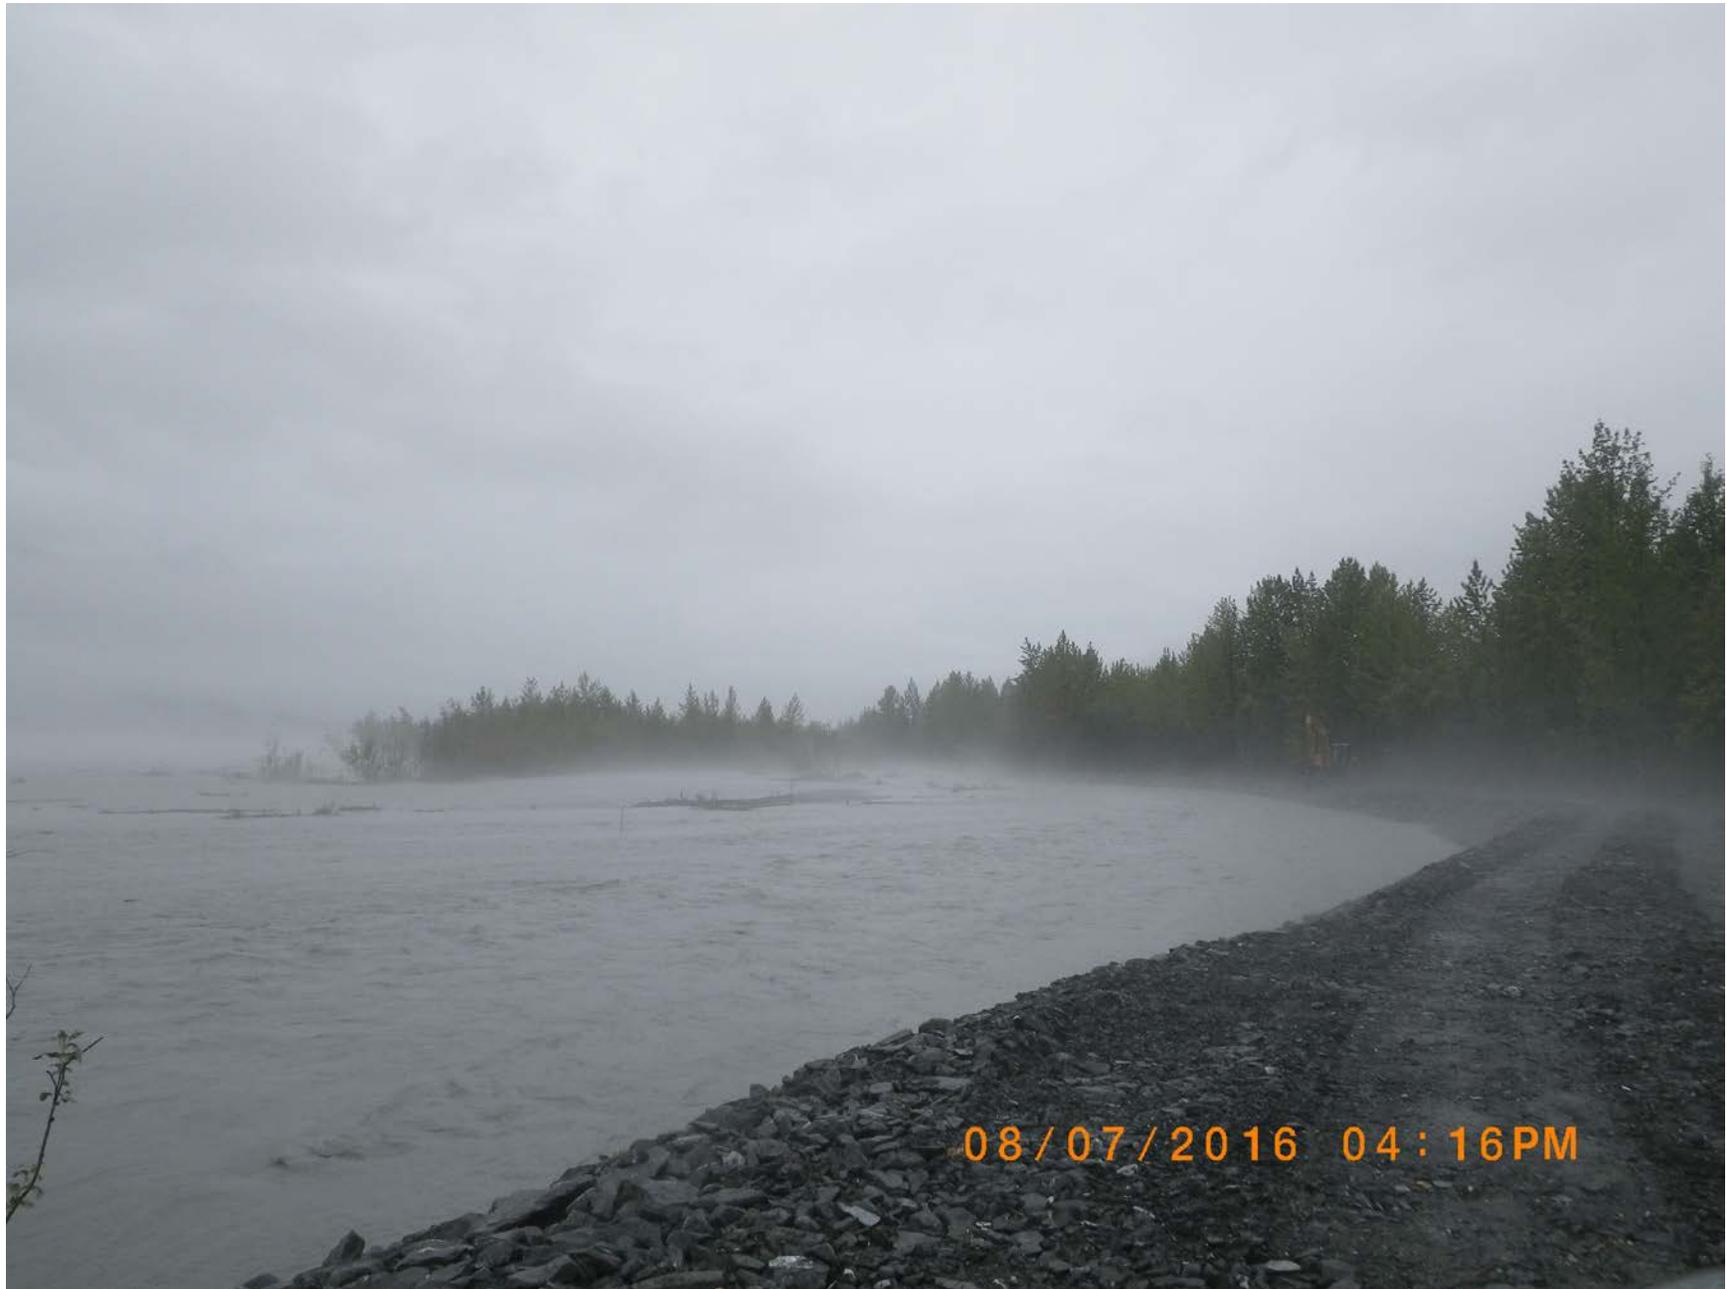
High water along groin #4 at the downstream end of the Lowe River dike system.

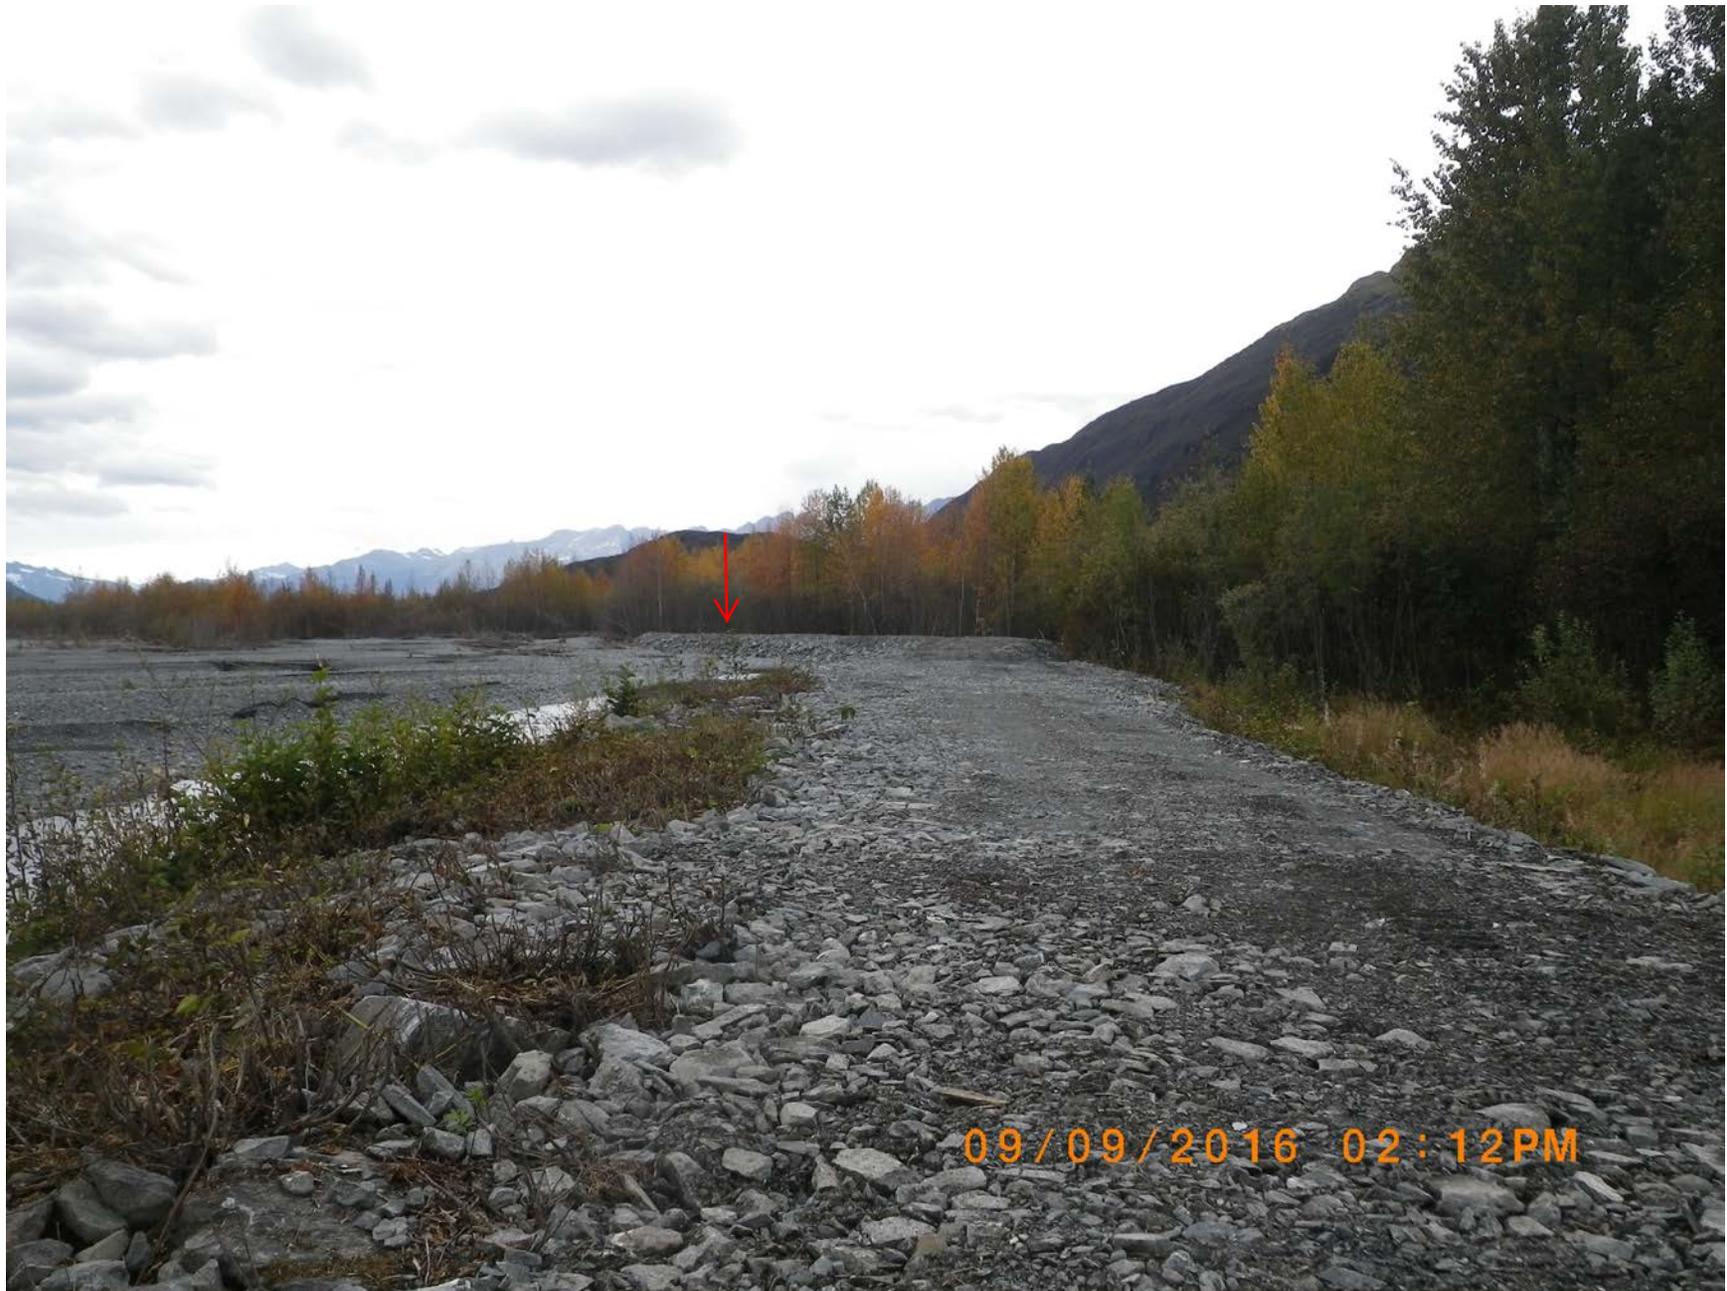
Groin #4 at low water. This section of dike was extended last summer and again this summer. Approximately 347' of new dike was constructed this year of the end of groin #4. It is approximately 13' wide at the top.

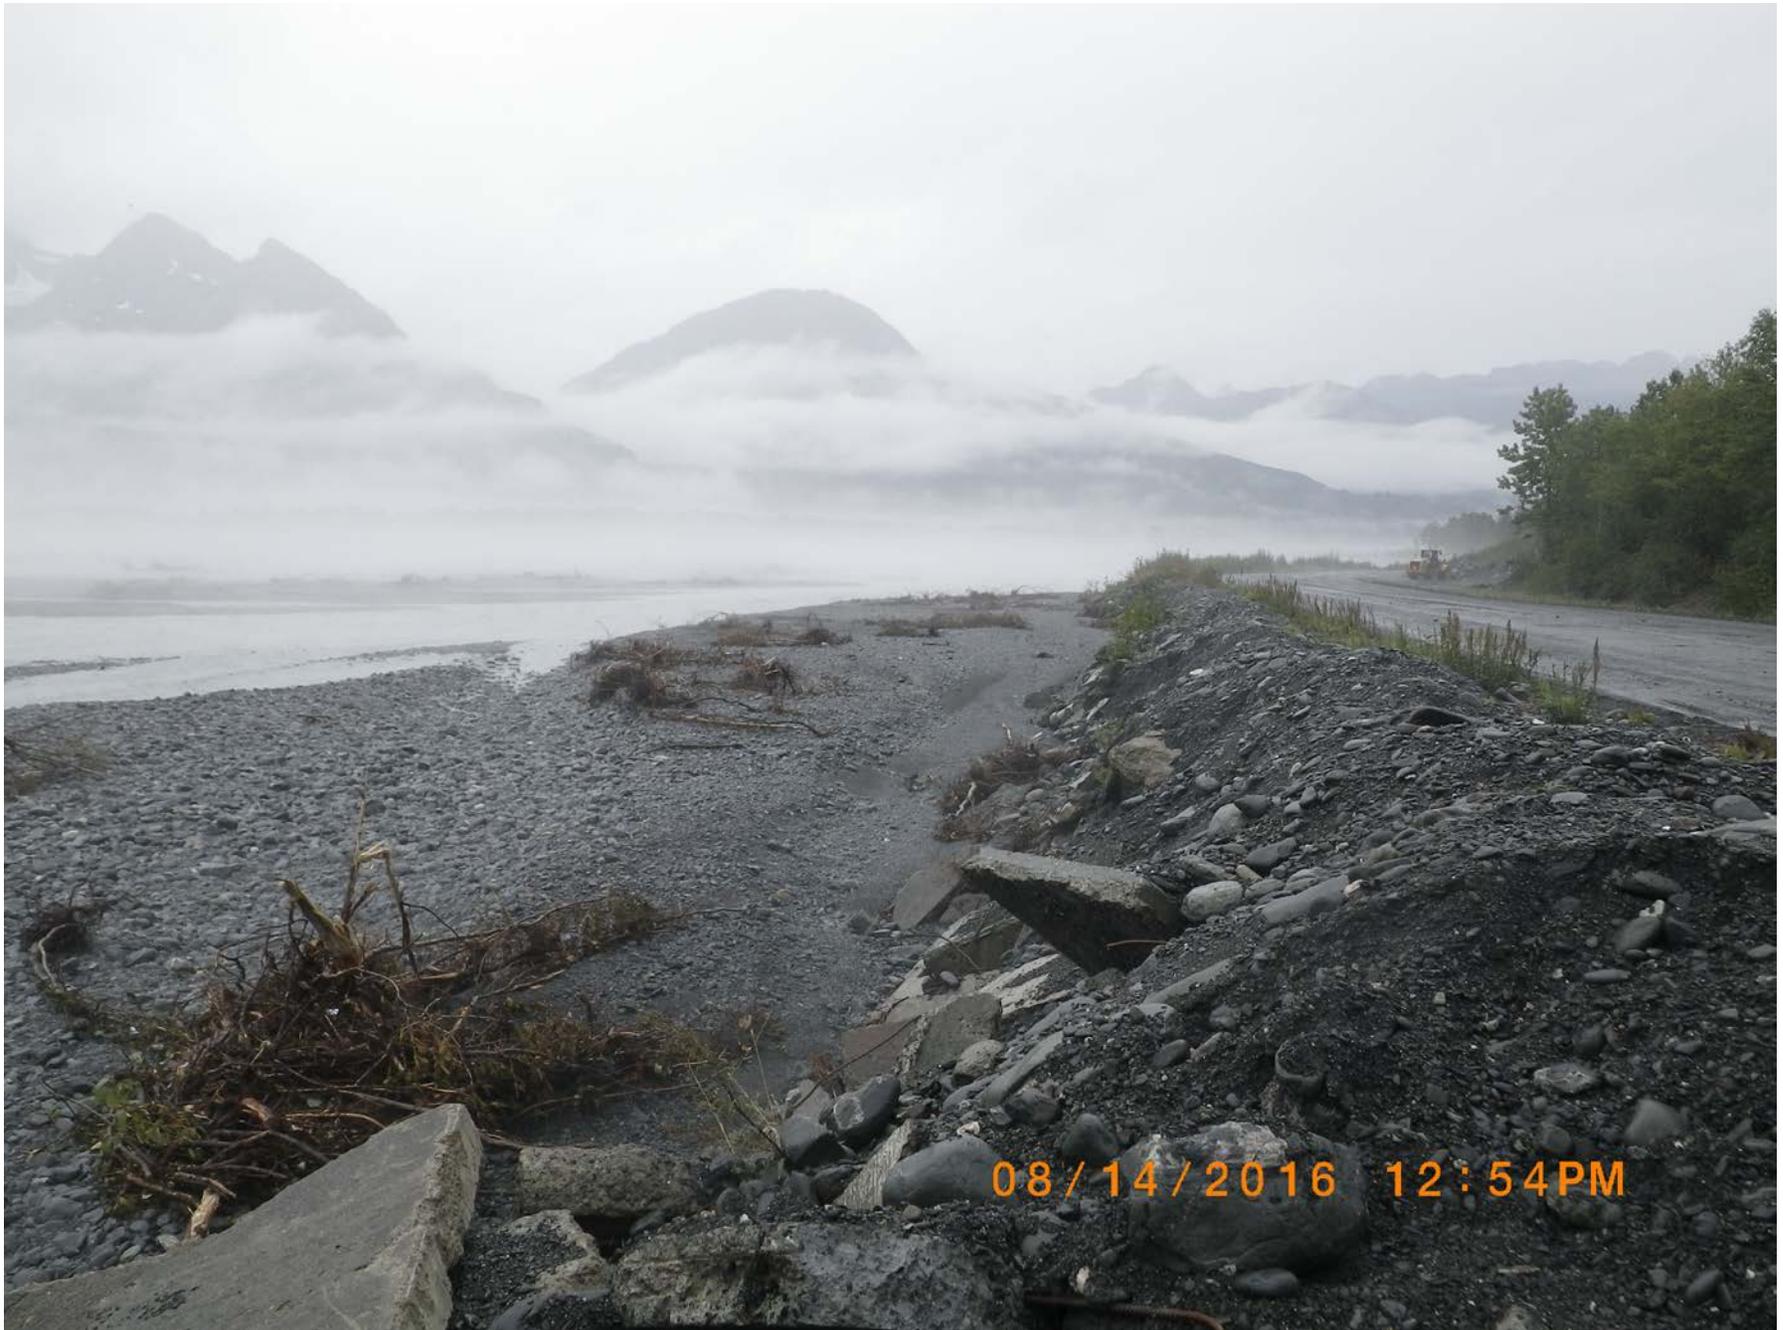
Before photo, looking towards bridge, of bank before construction..

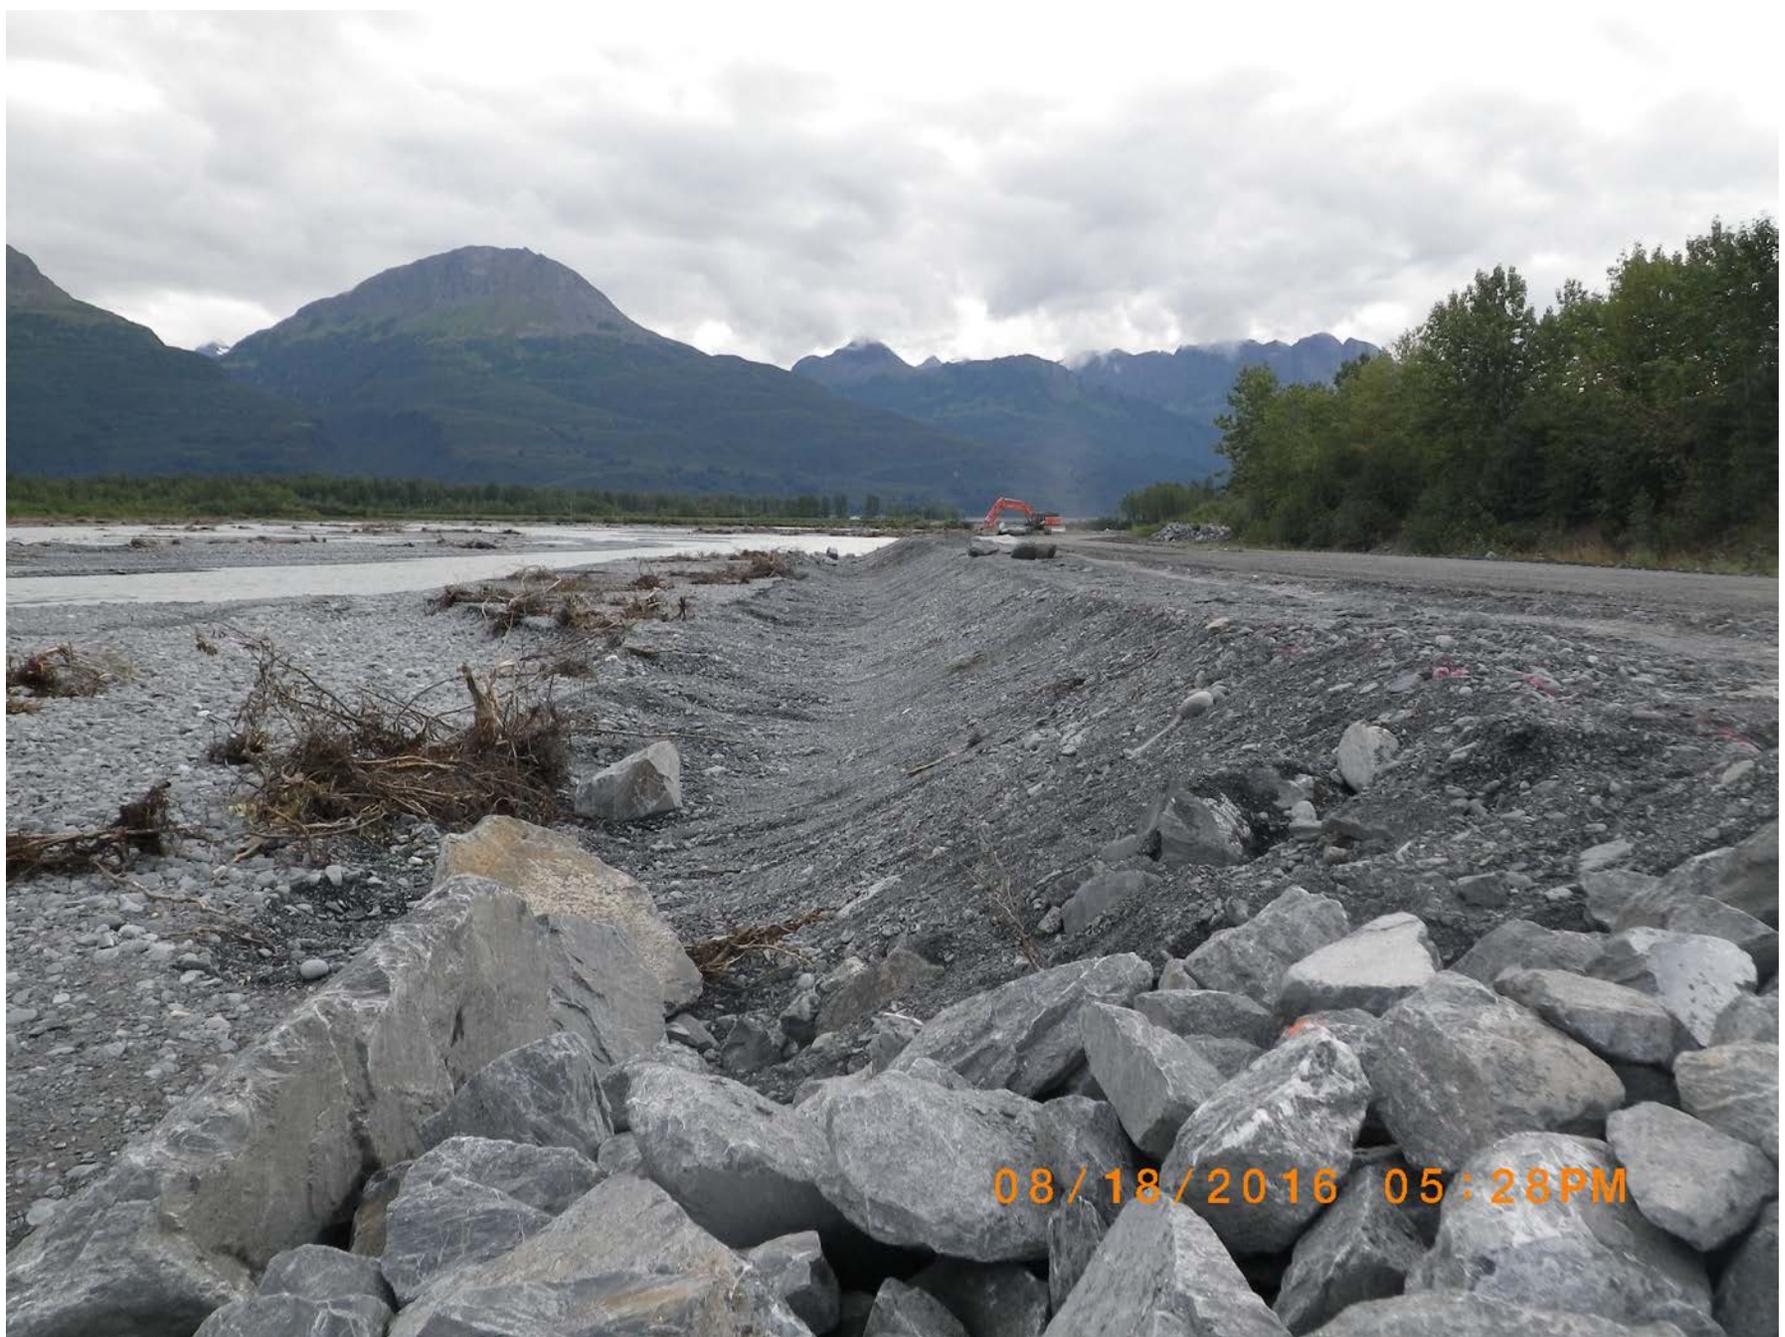
After photo, looking towards bridge. The bank has been sloped and riprap has been placed in the foreground.

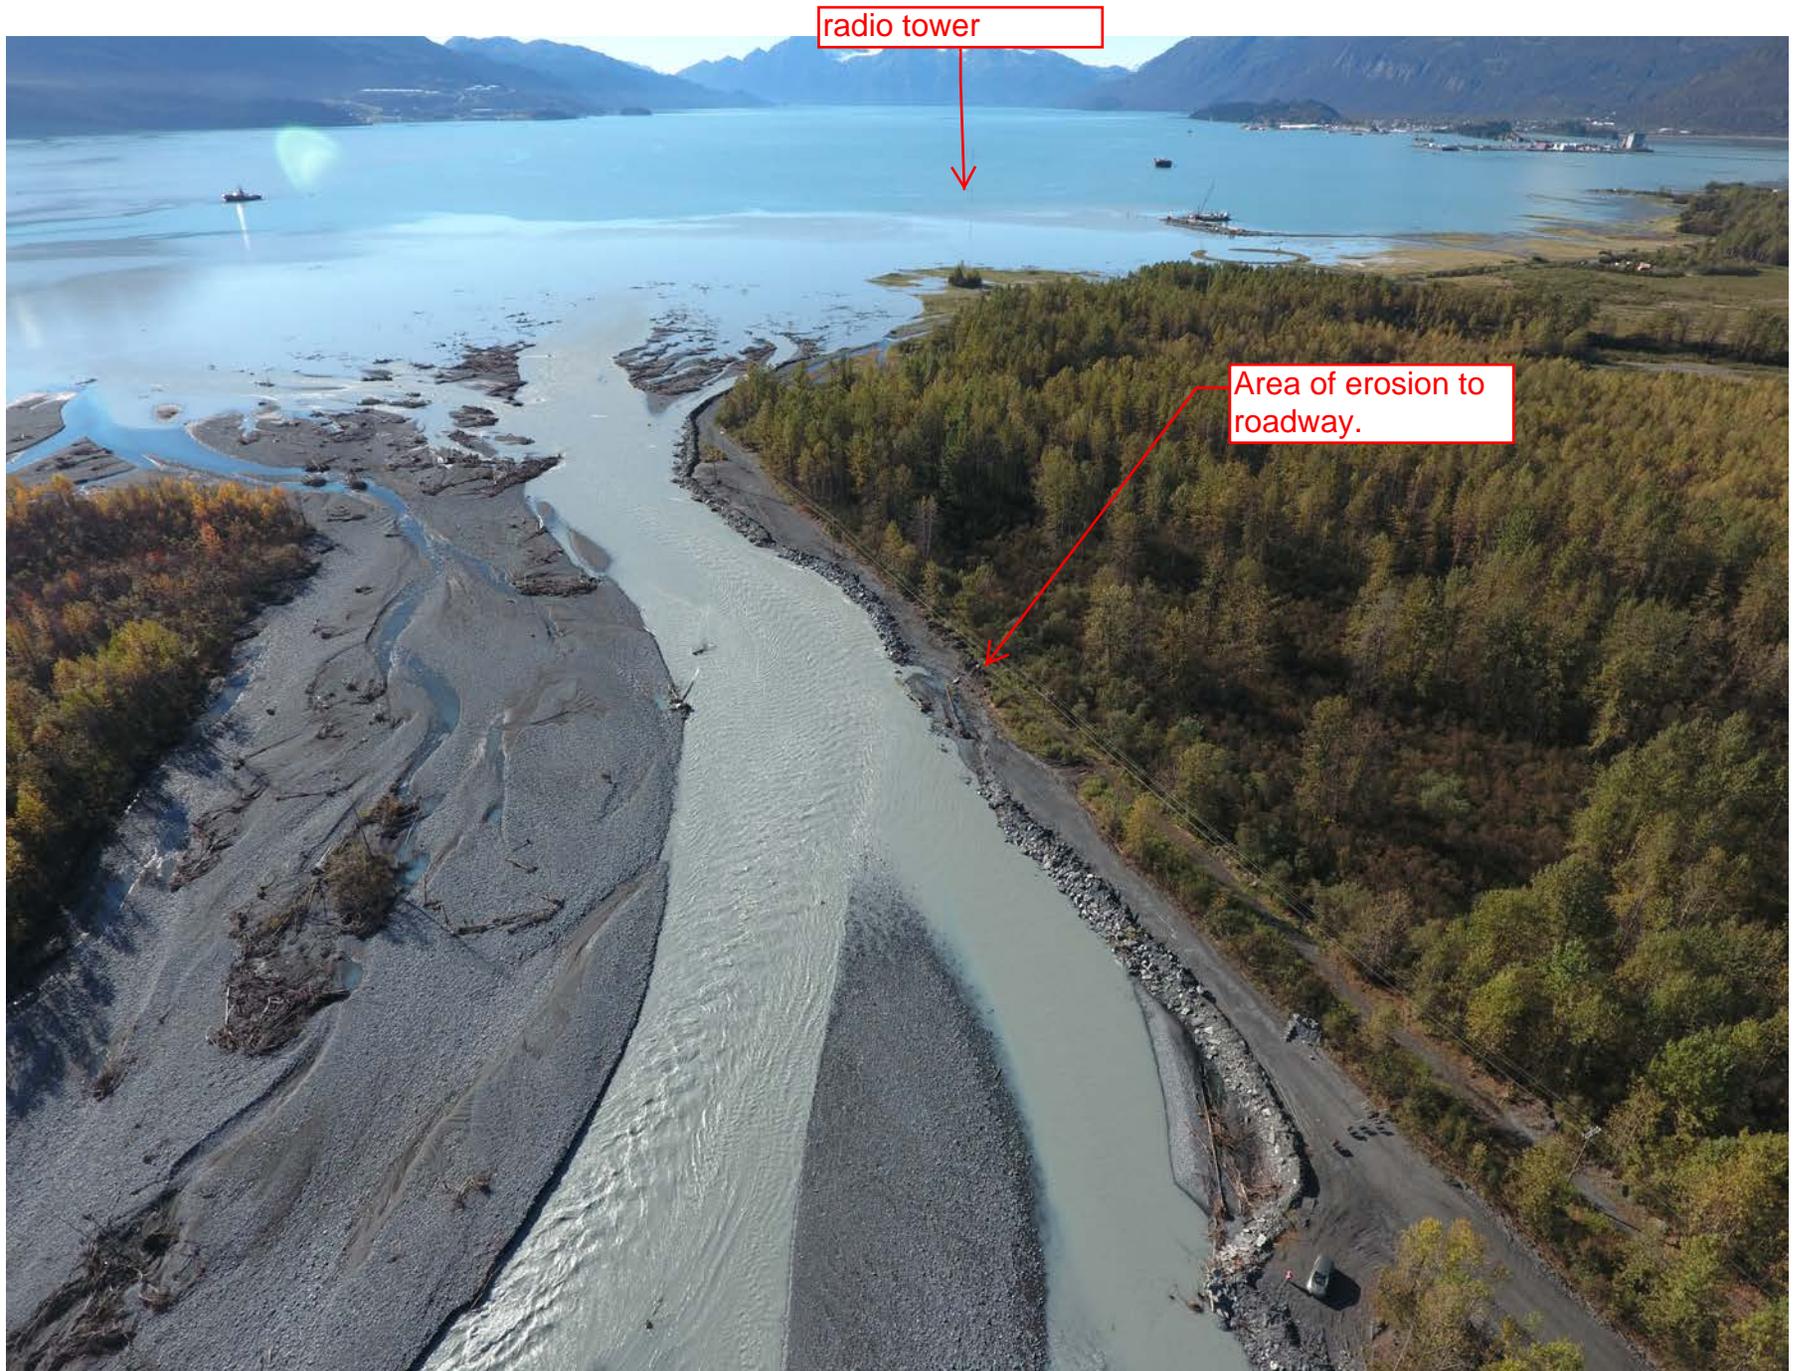
Area of erosion to roadway.

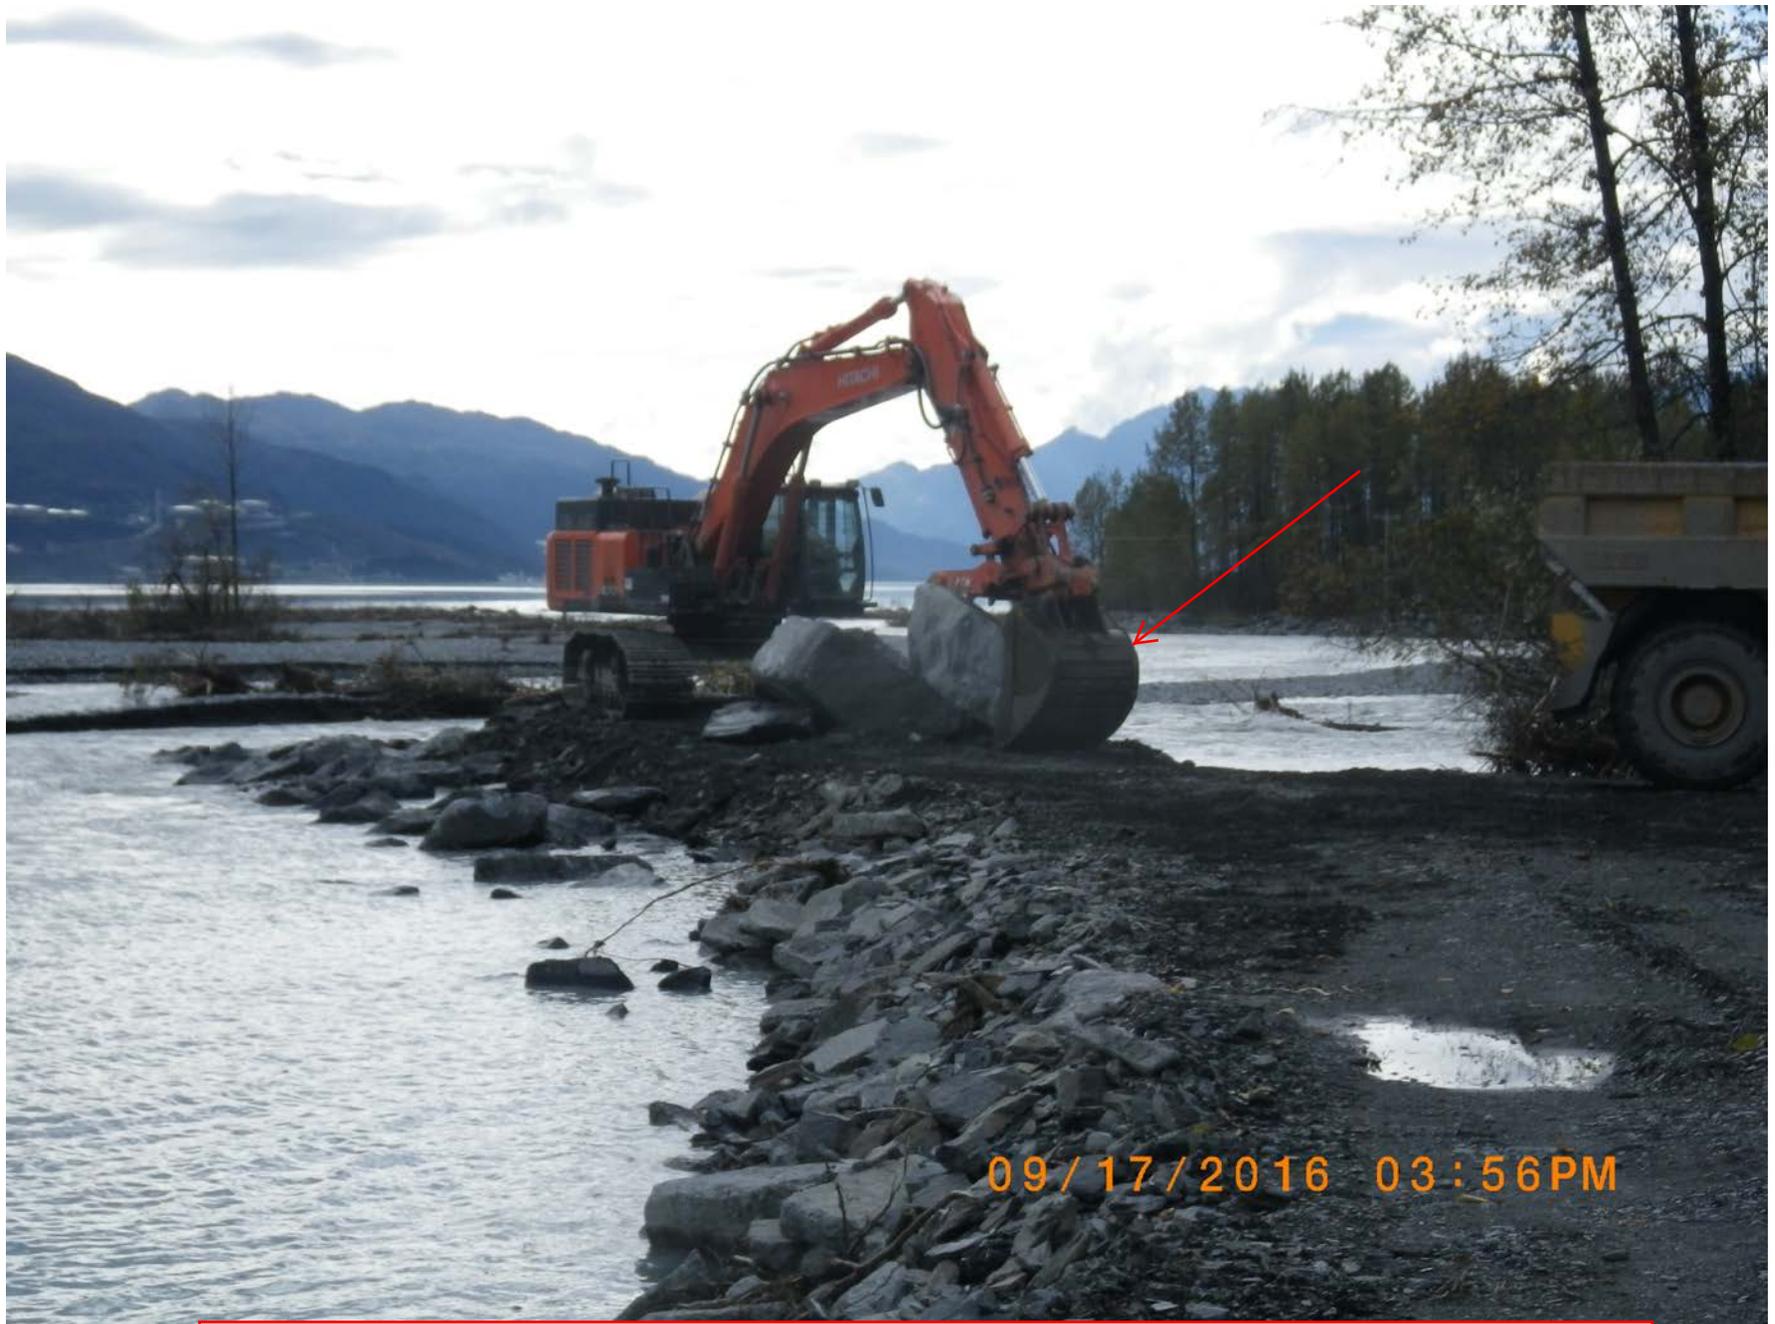
The excavator bucket is 6' tall. The rocks that had to be used to construct the kicker were very large. The force and depth of the river was strong enough to wash anything smaller away.

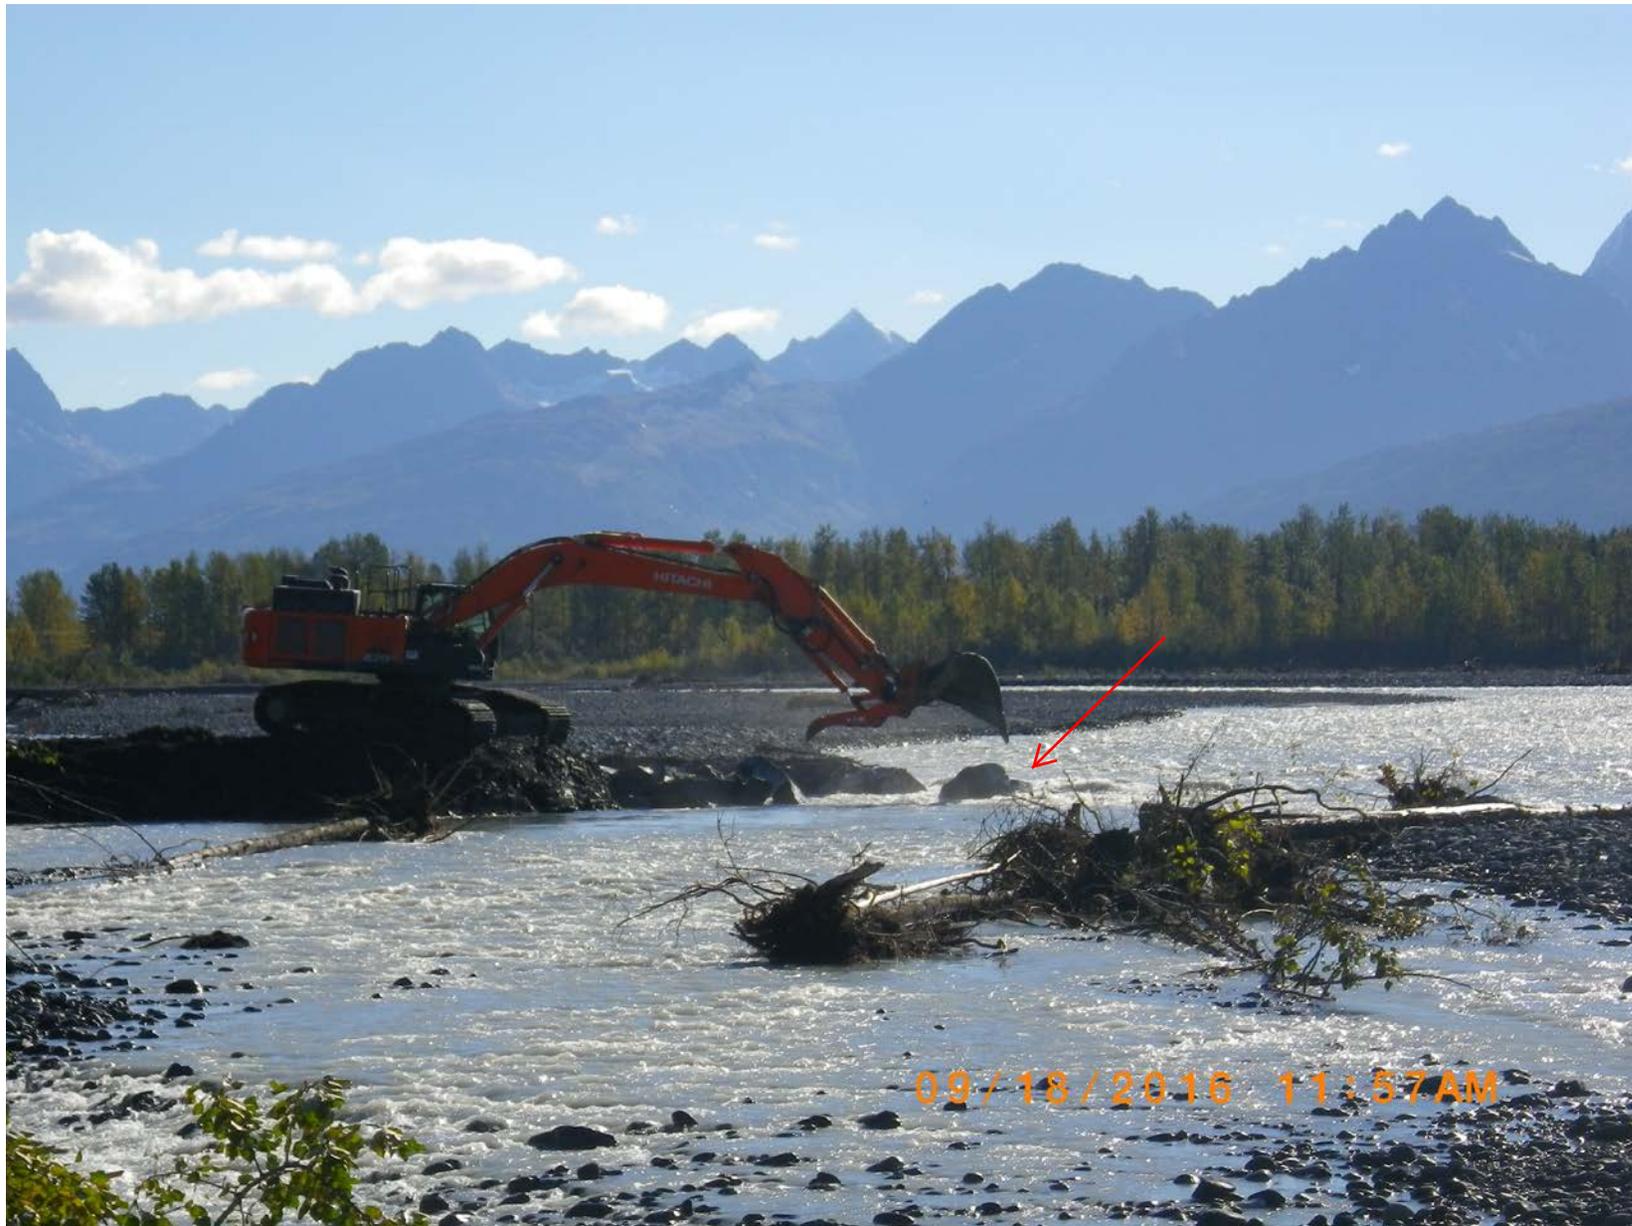
The same rock in the previous photo became over halfway submerged. The channel was much deeper than it appeared from shore and it continued to scour as the dike was being constructed.

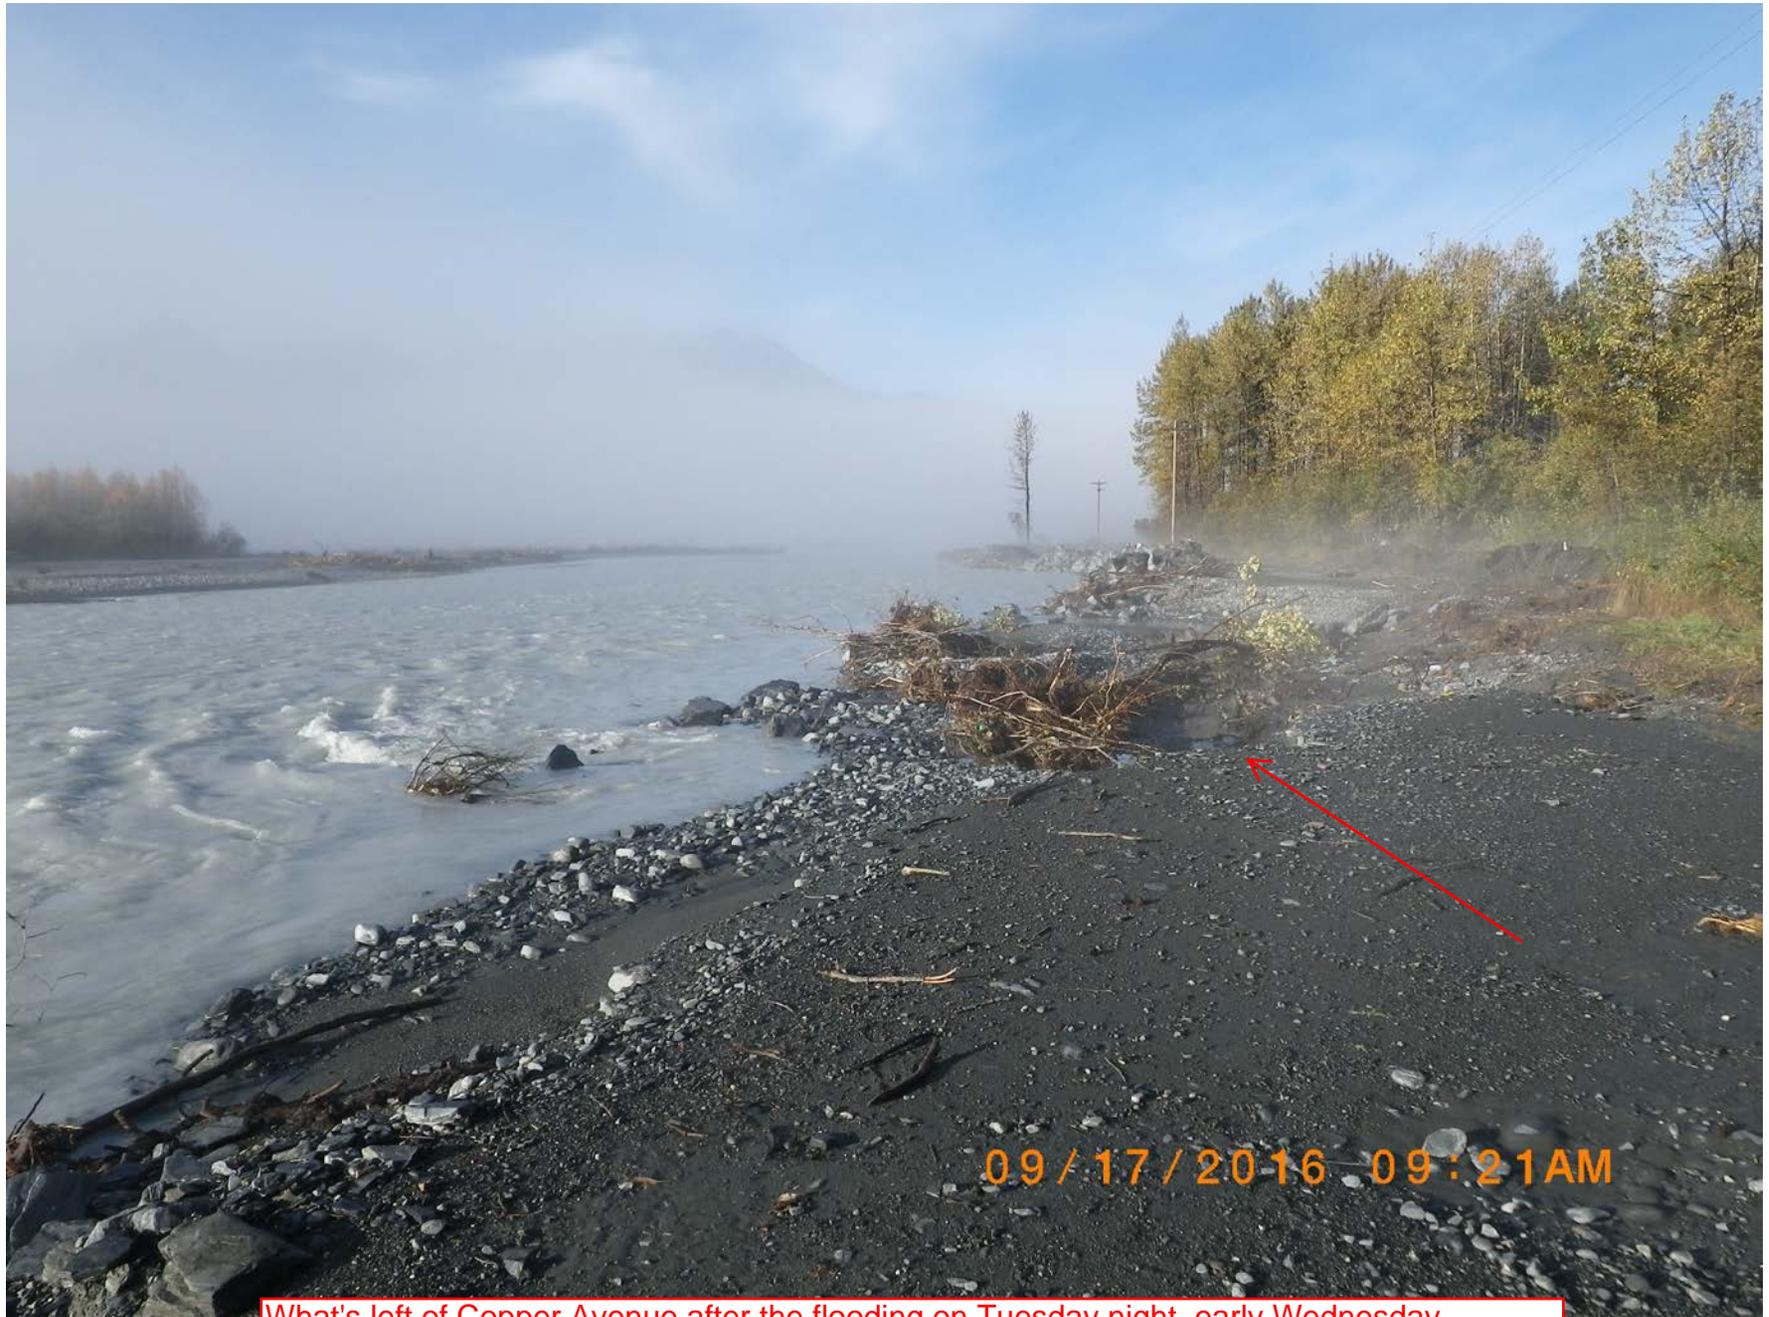
What's left of Copper Avenue after the flooding on Tuesday night, early Wednesday morning.

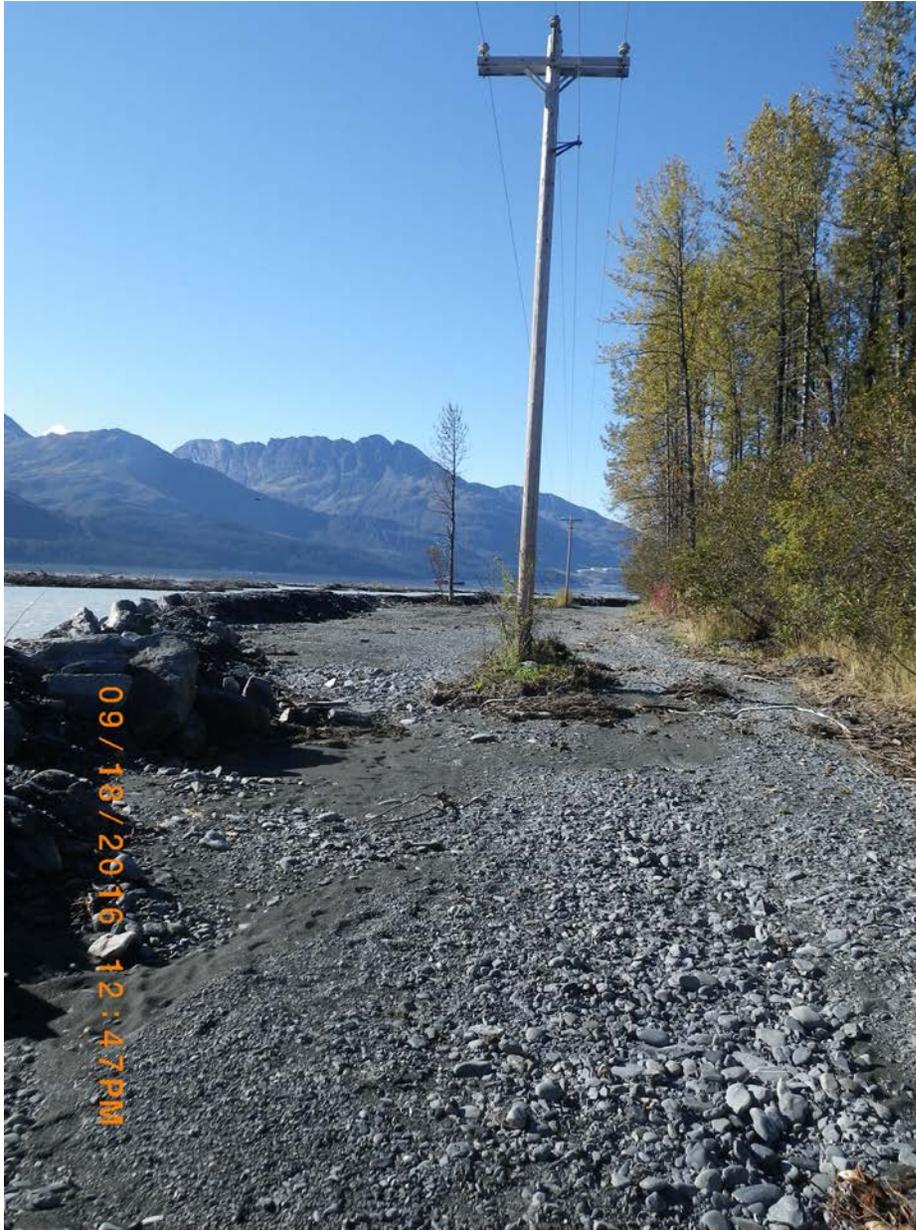
Flood damaged roadway and the proximity of the river to the electrical utilities.

bank erosion

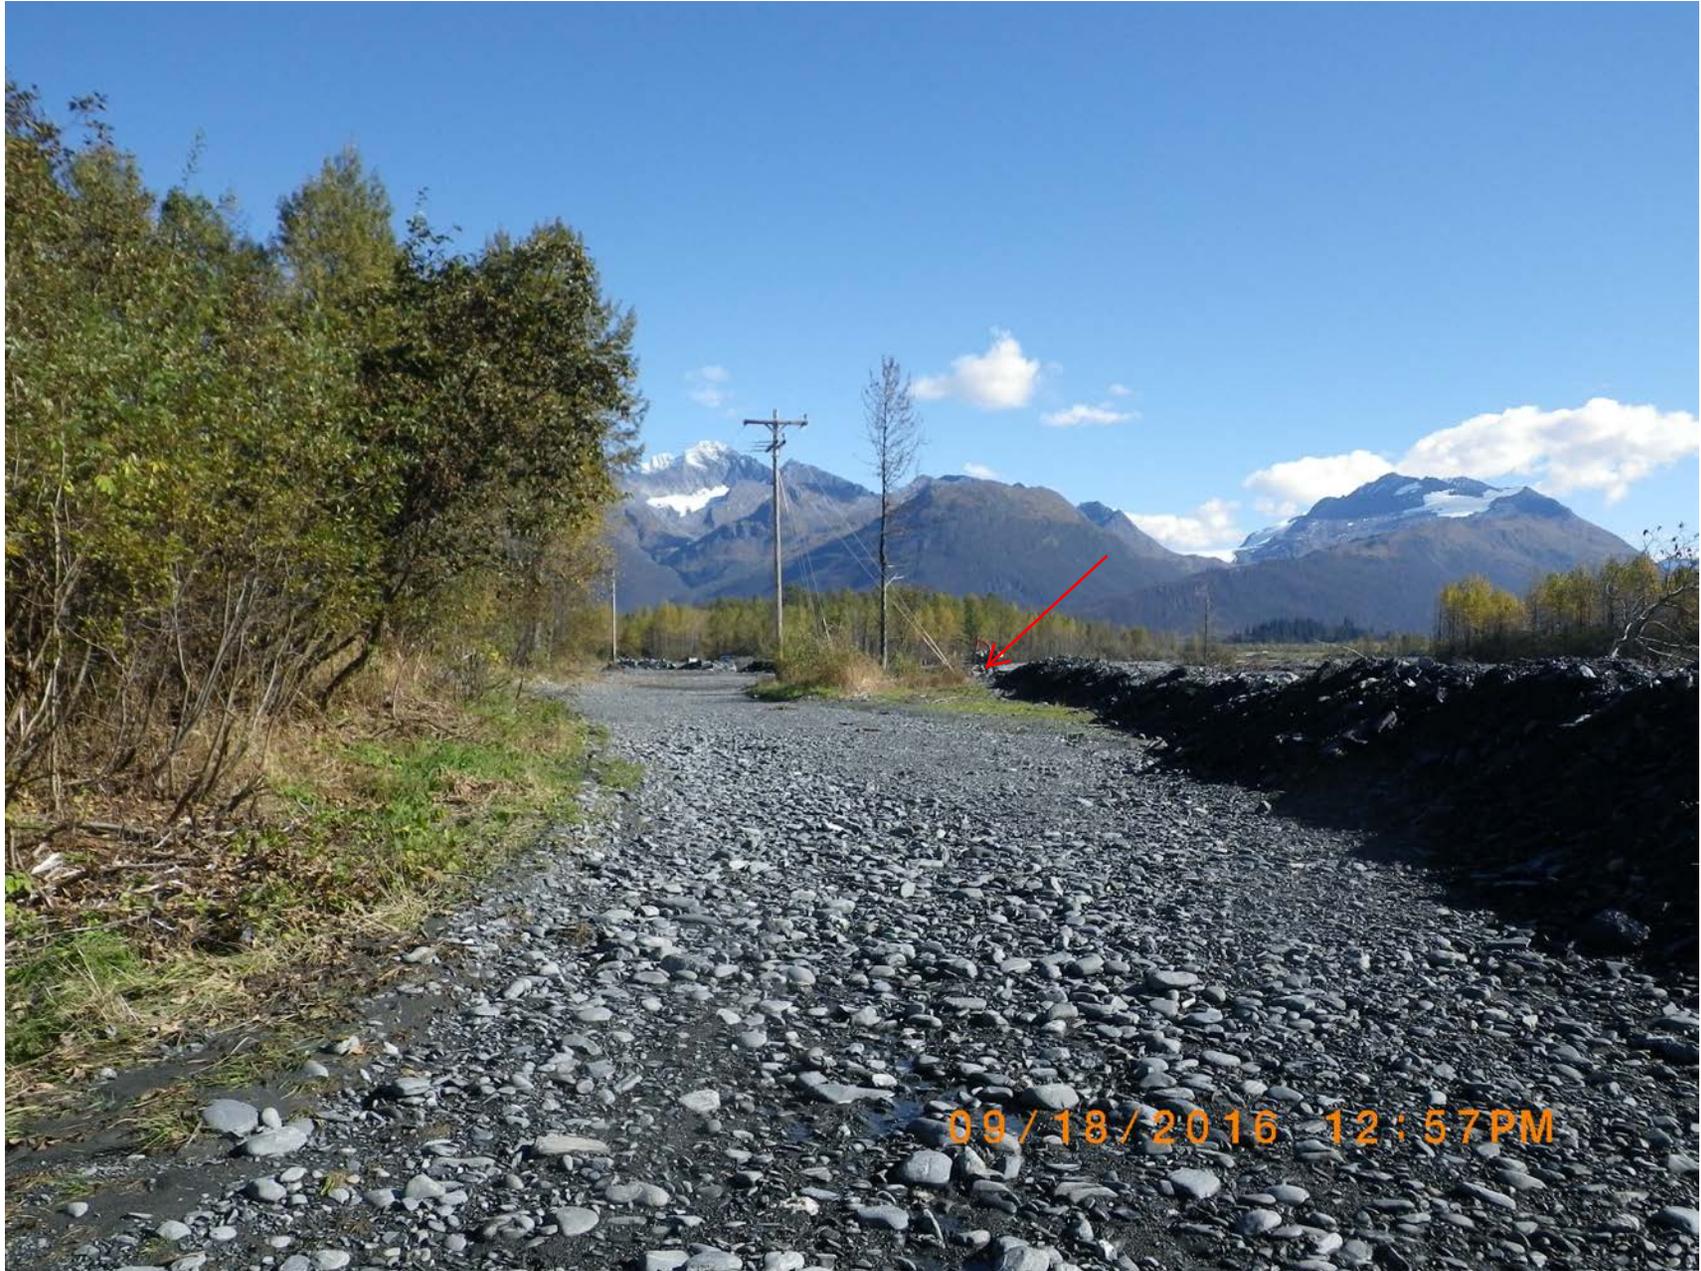
Looking upstream on Copper where the flood waters stripped away the topping material from the roadway. Note the proximity of the guy wire to the river bank.
