Summary of Emergency High-Water Expenditures

As of September 28, 2016

Alpine Woods dike construction

Valdez Glacier Stream - Copper Ave emergency flood mitigation

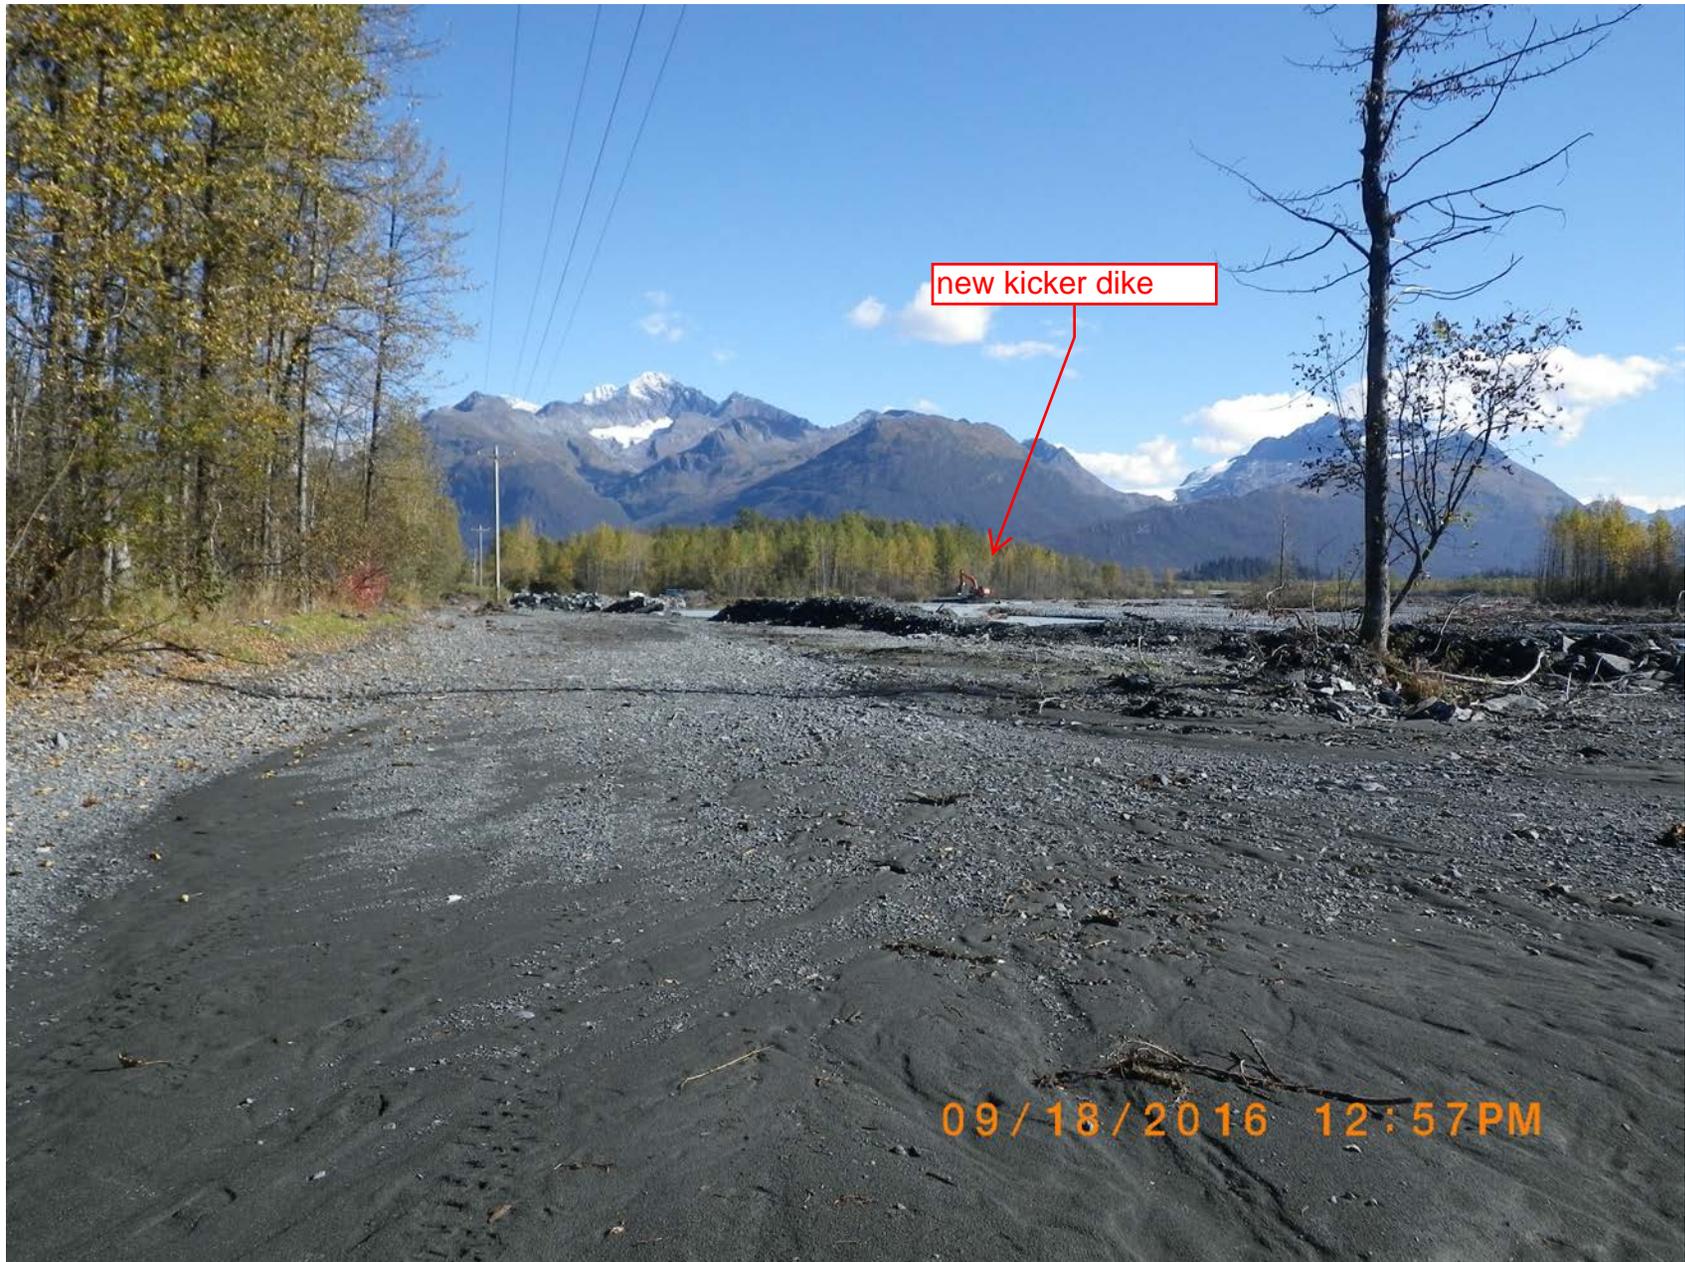
Silt and fines distributed on Copper Avenue from the high water.

Looking upstream
on Copper at the
erosion damage.

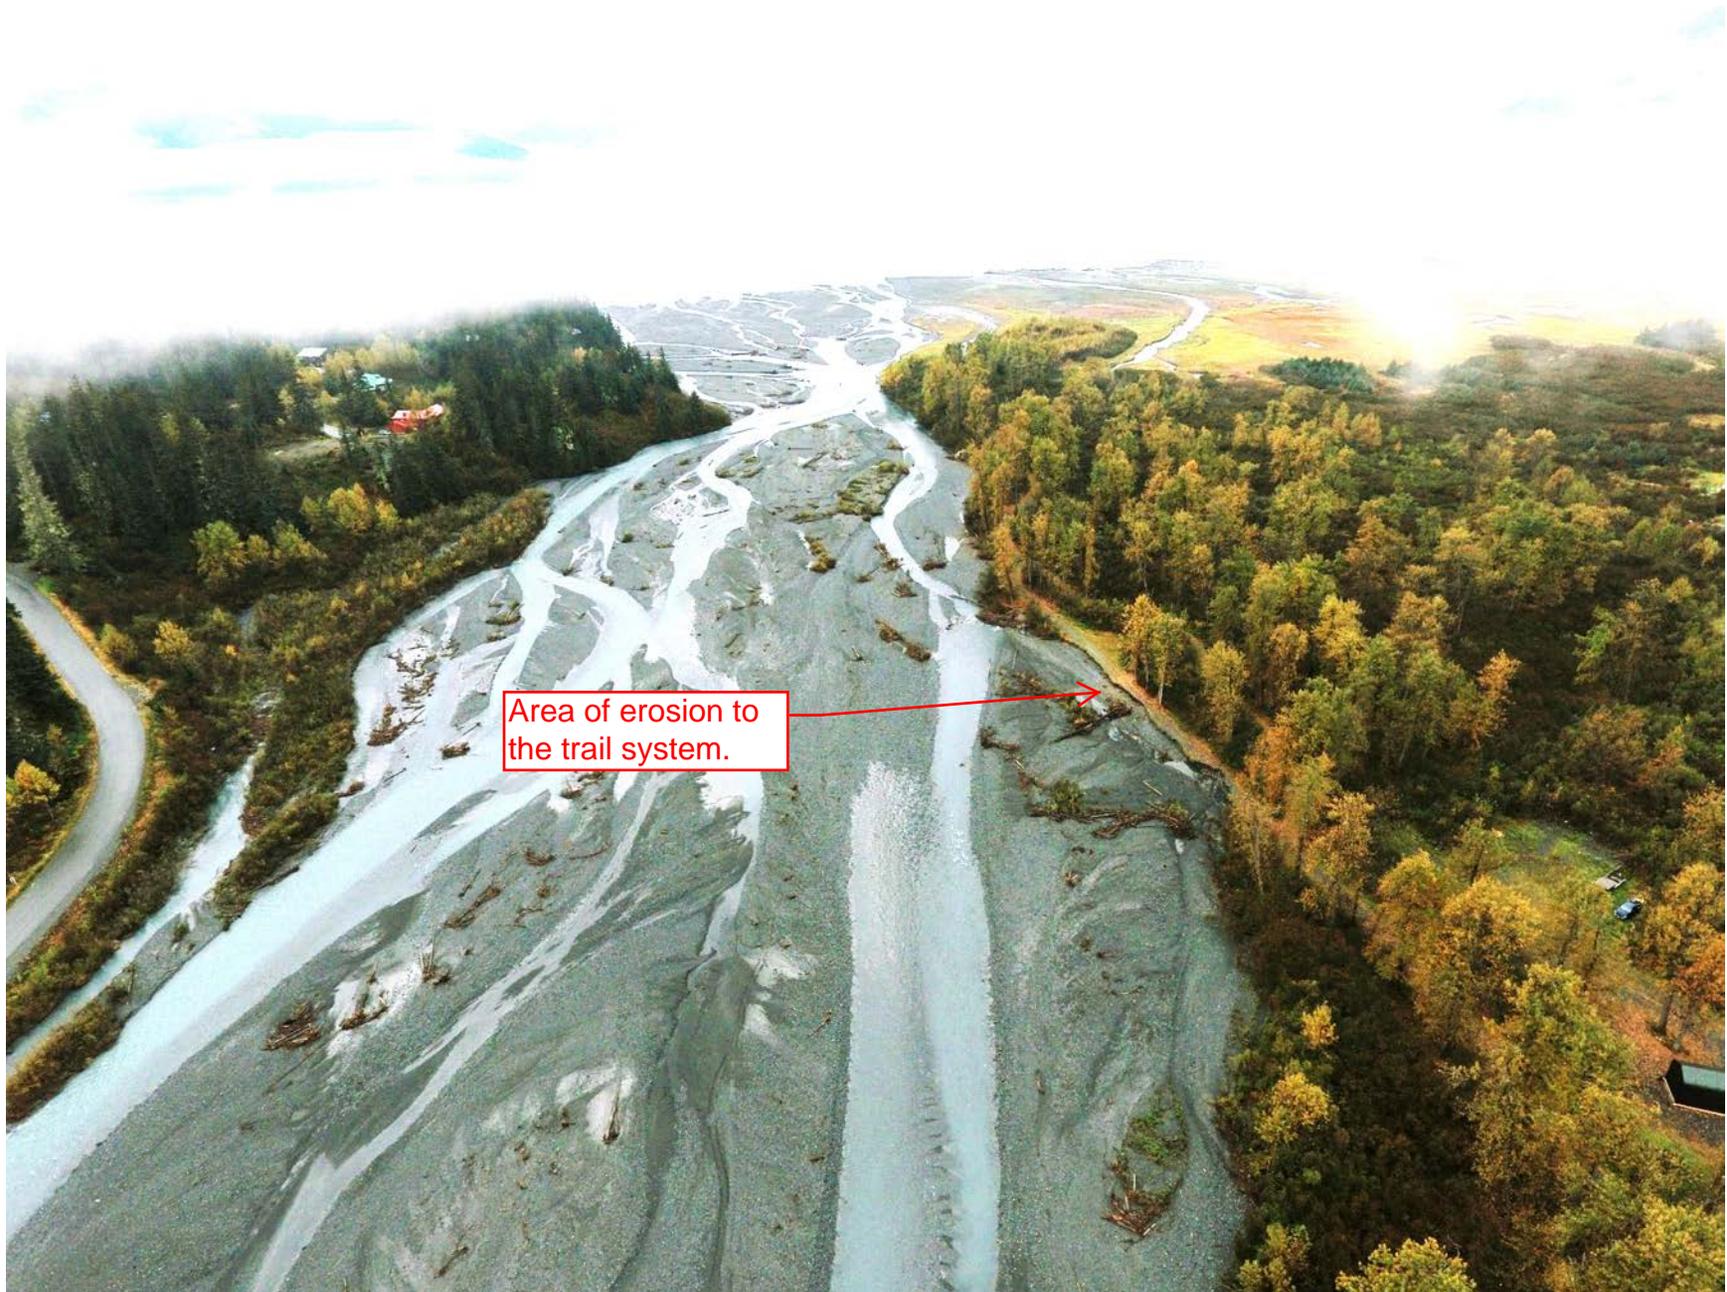
Area of erosion to
the trail system.

Looking downstream towards the ocean. Blueberry Hill road is on the left of the photo.

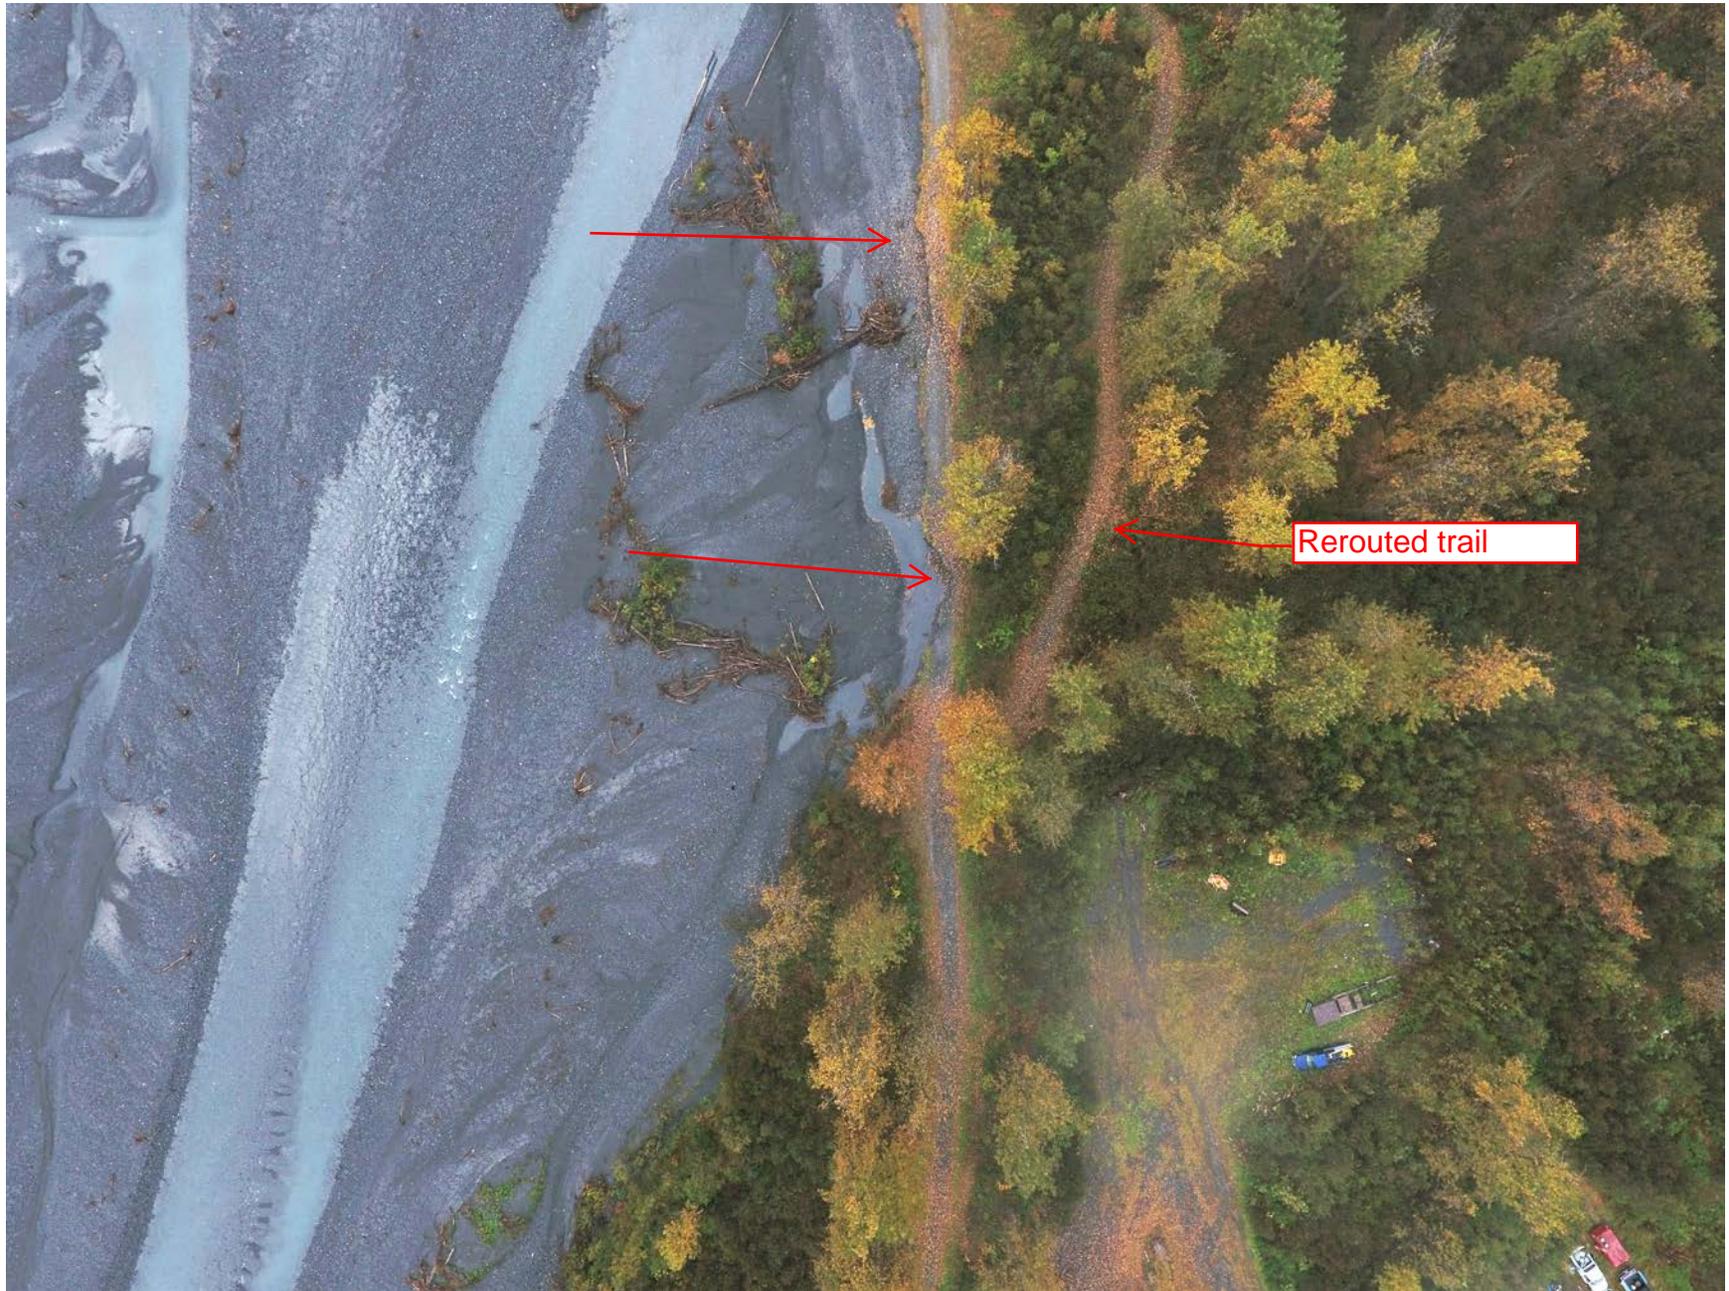
Birds eye view of the eroded section of trail and rerouted section of trail away from the creek.

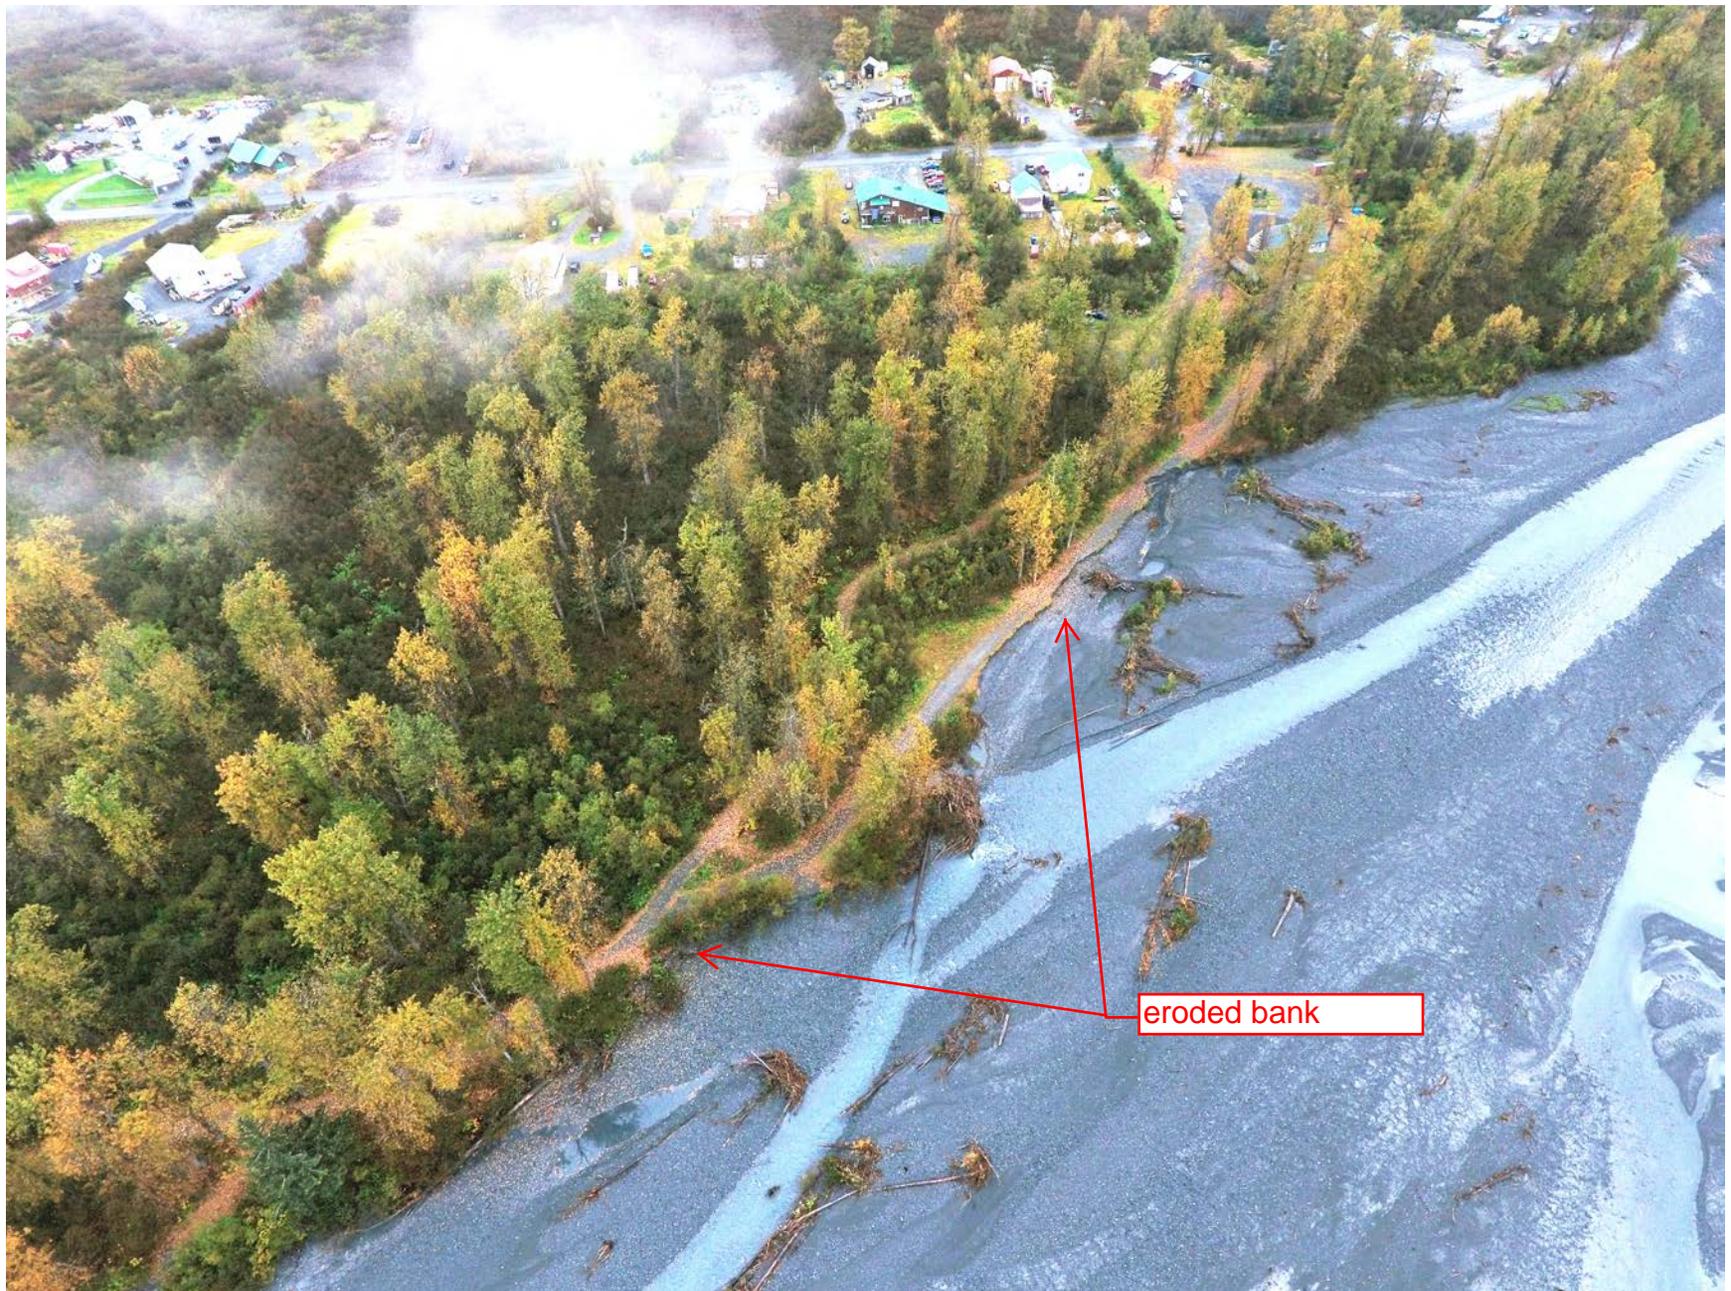
Another angle of the eroded bank and trail.

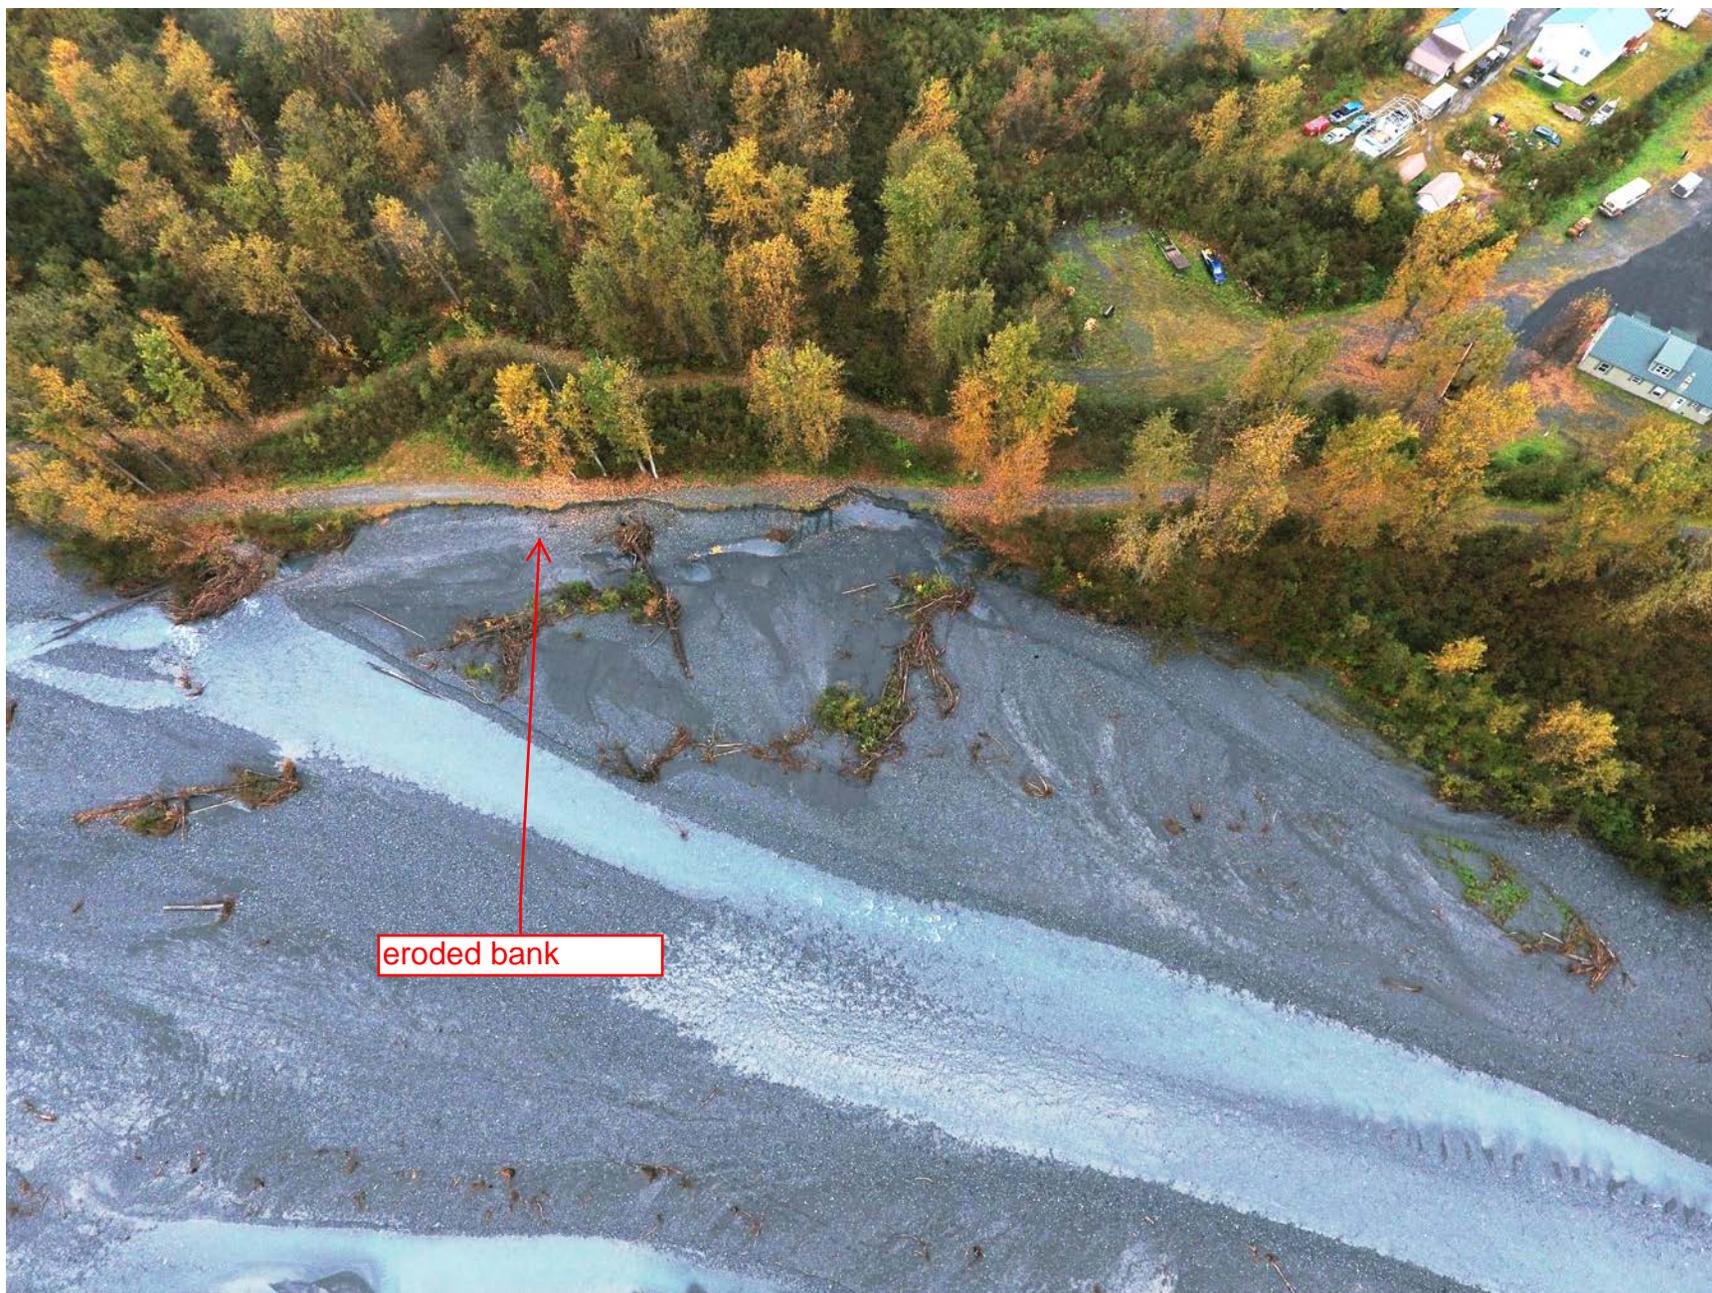
eroded bank

Another angle of the eroded bank and trail.

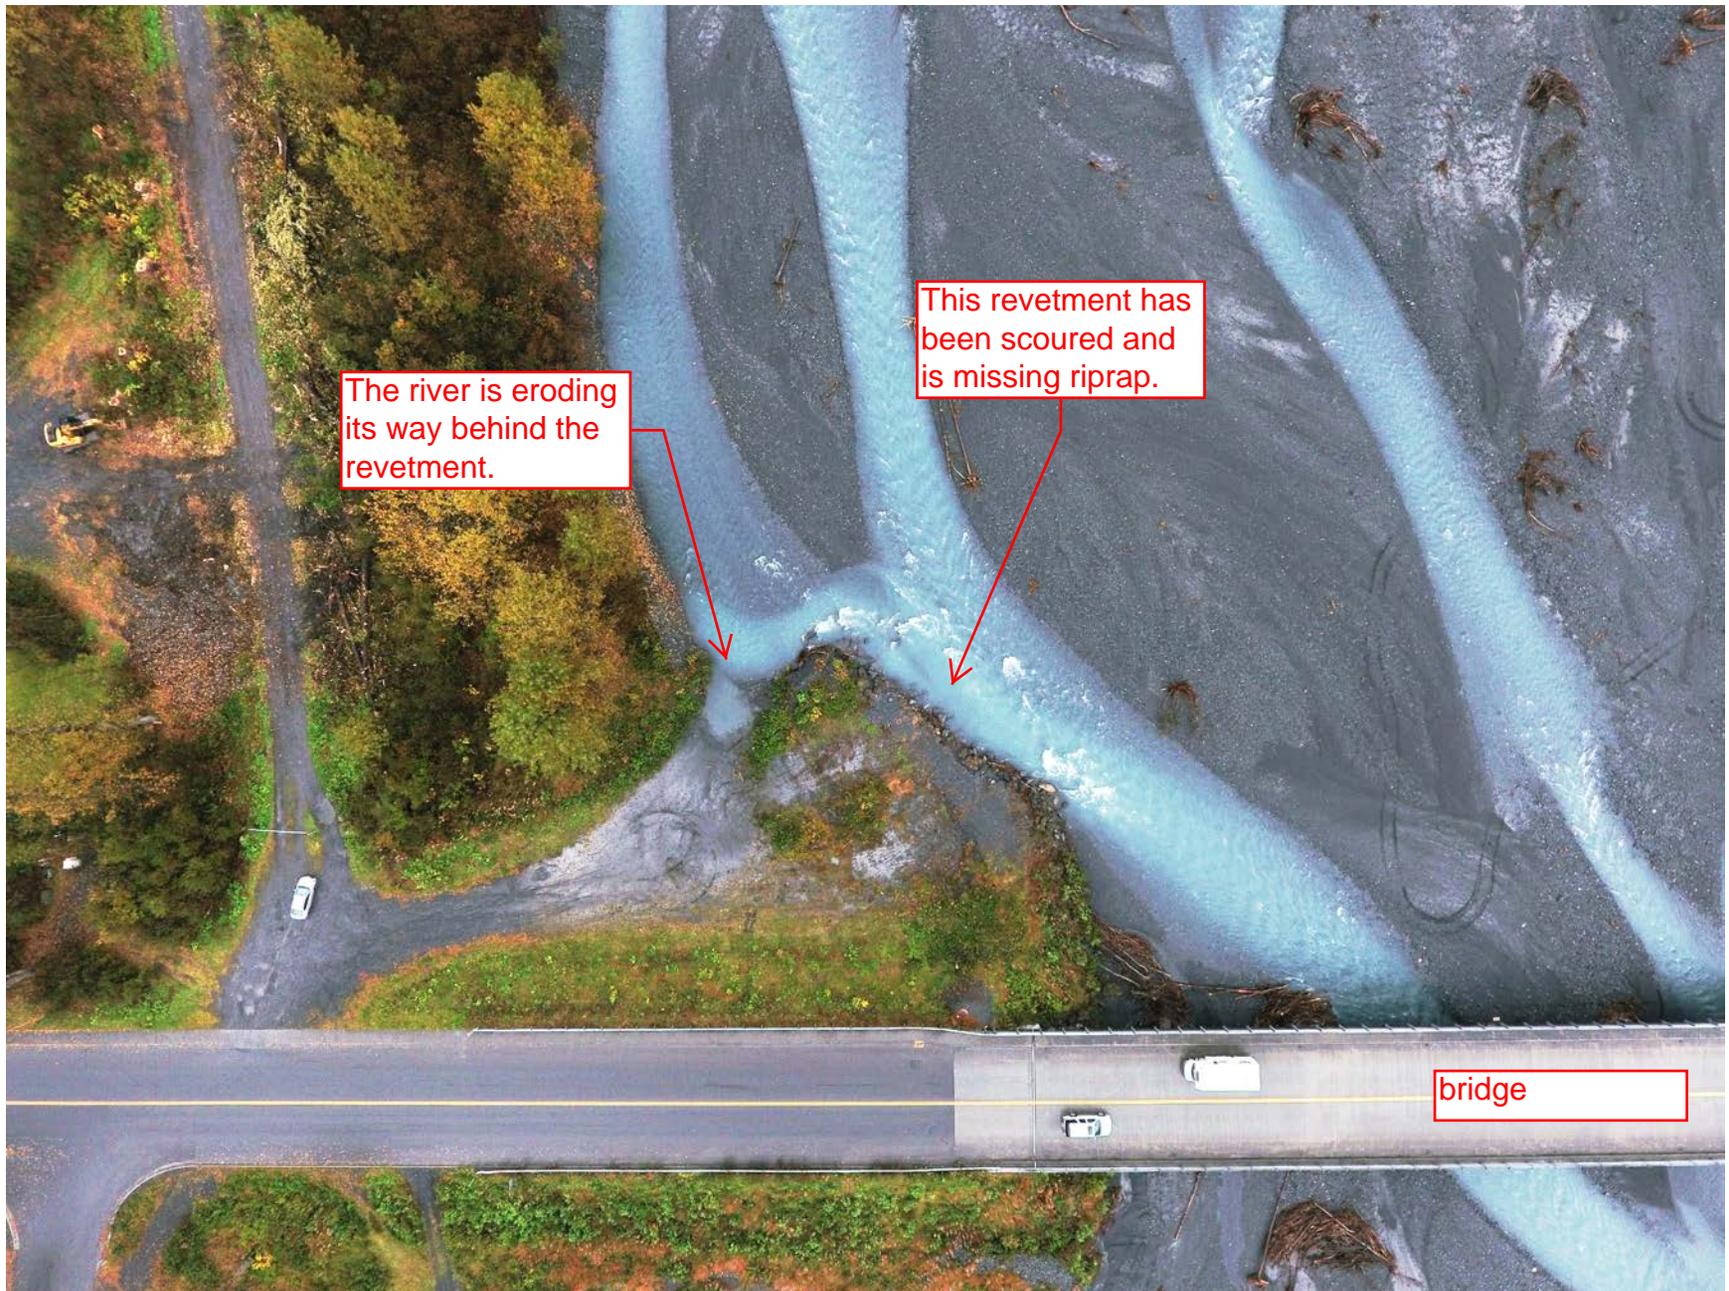
The river is eroding its way behind the revetment.

This revetment has been scoured and is missing riprap.

Birds eye view of the upstream side of the bridge on the Cottonwood Subdivision side.

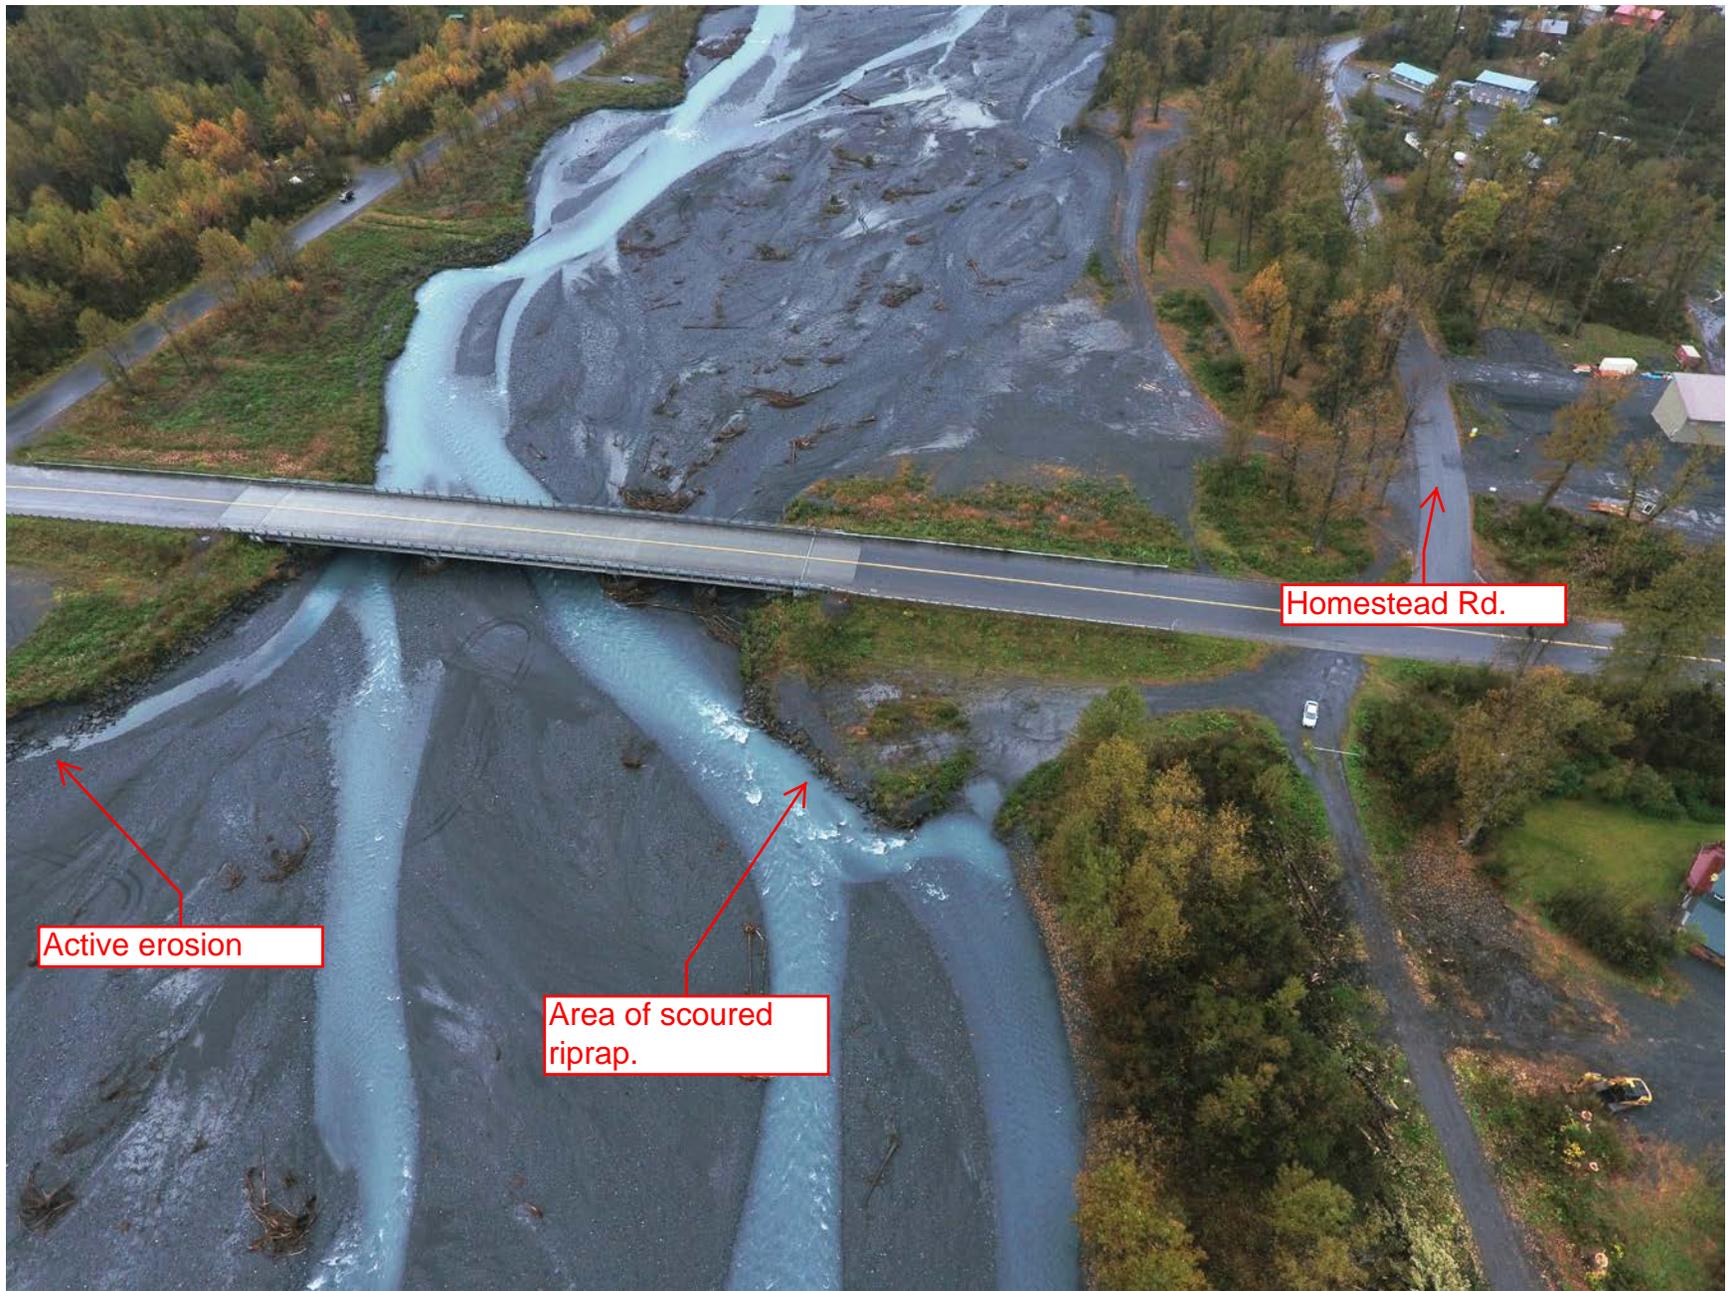
Active erosion

Area of scoured riprap.

Looking downstream towards the bridge on the Cottonwood/Homestead side.

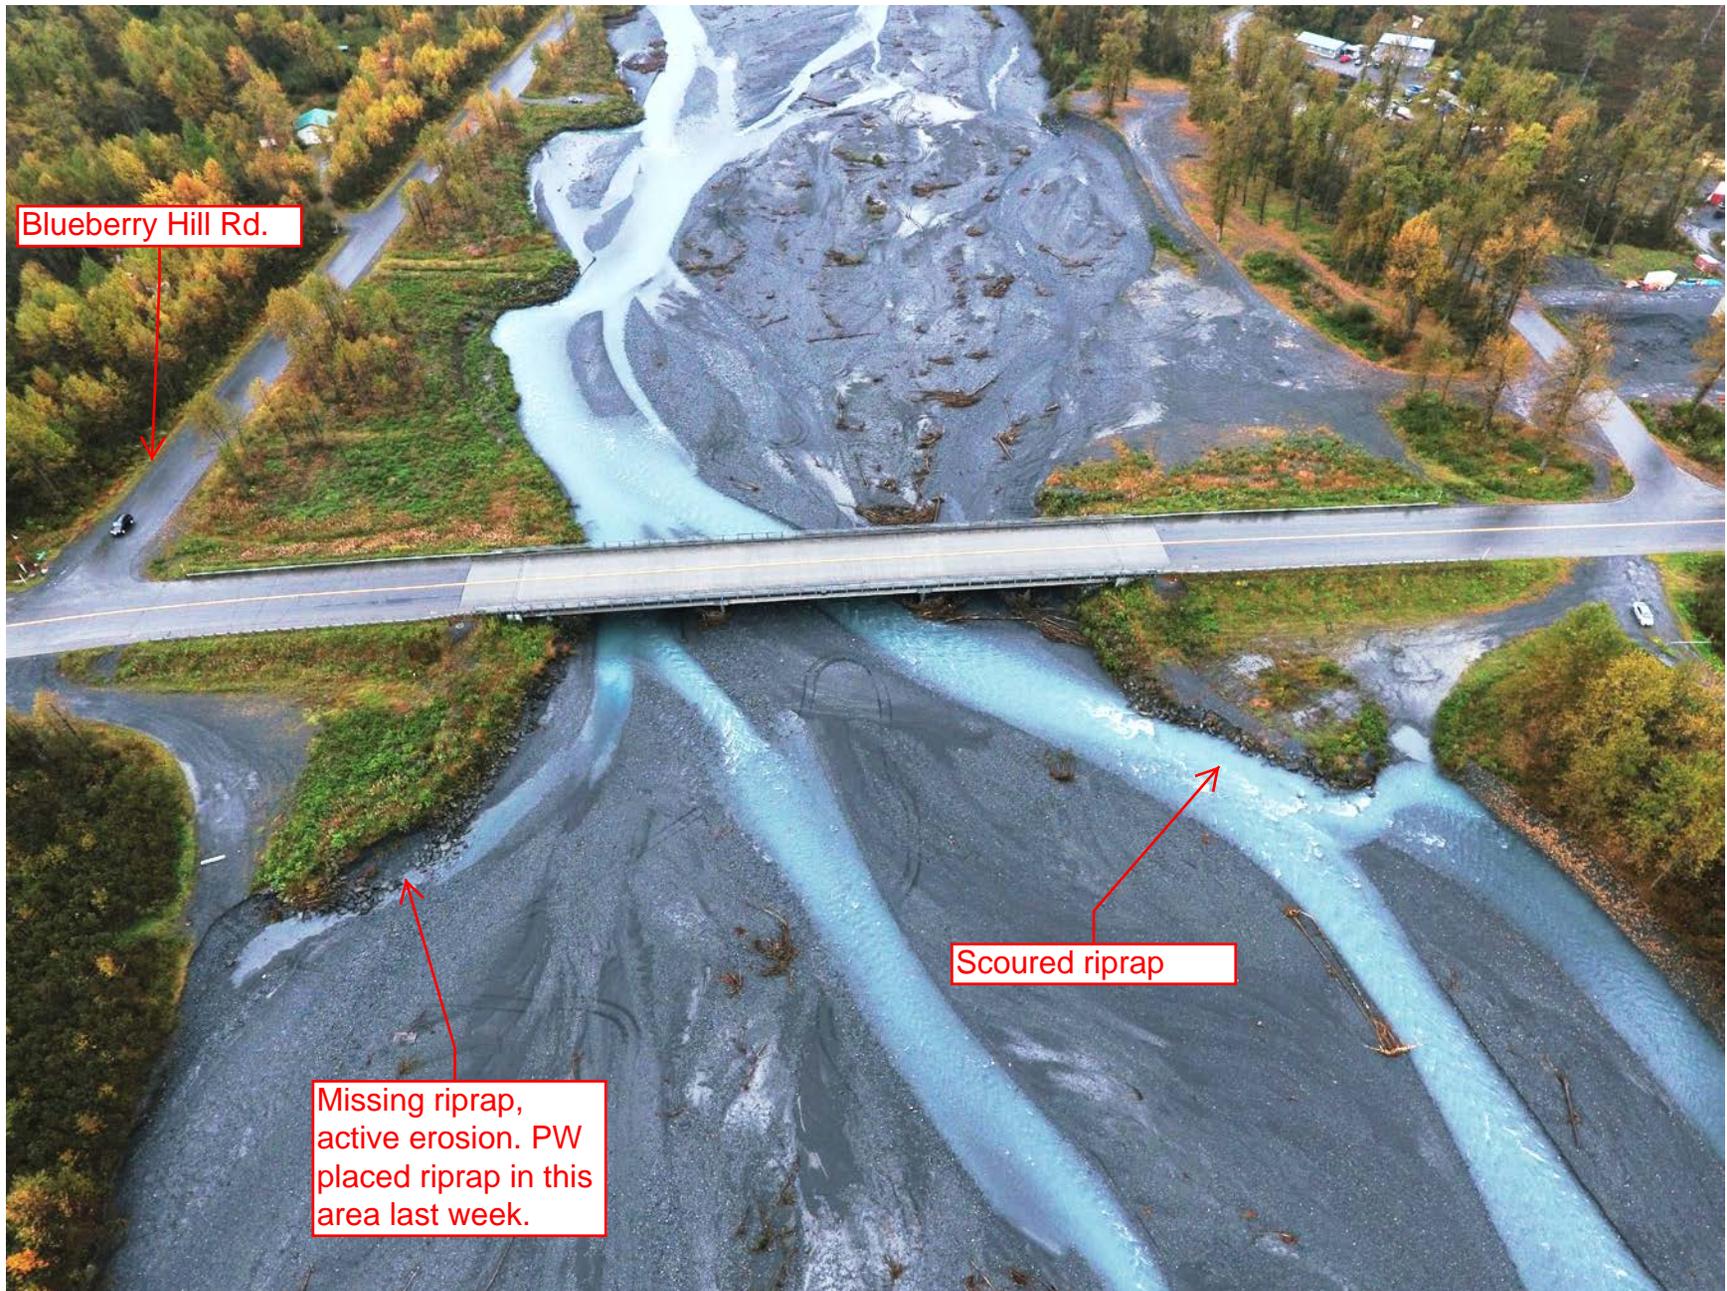
Missing riprap,
active erosion. PW
placed riprap in this
area last week.

Scoured riprap

Looking downstream towards the bridge.

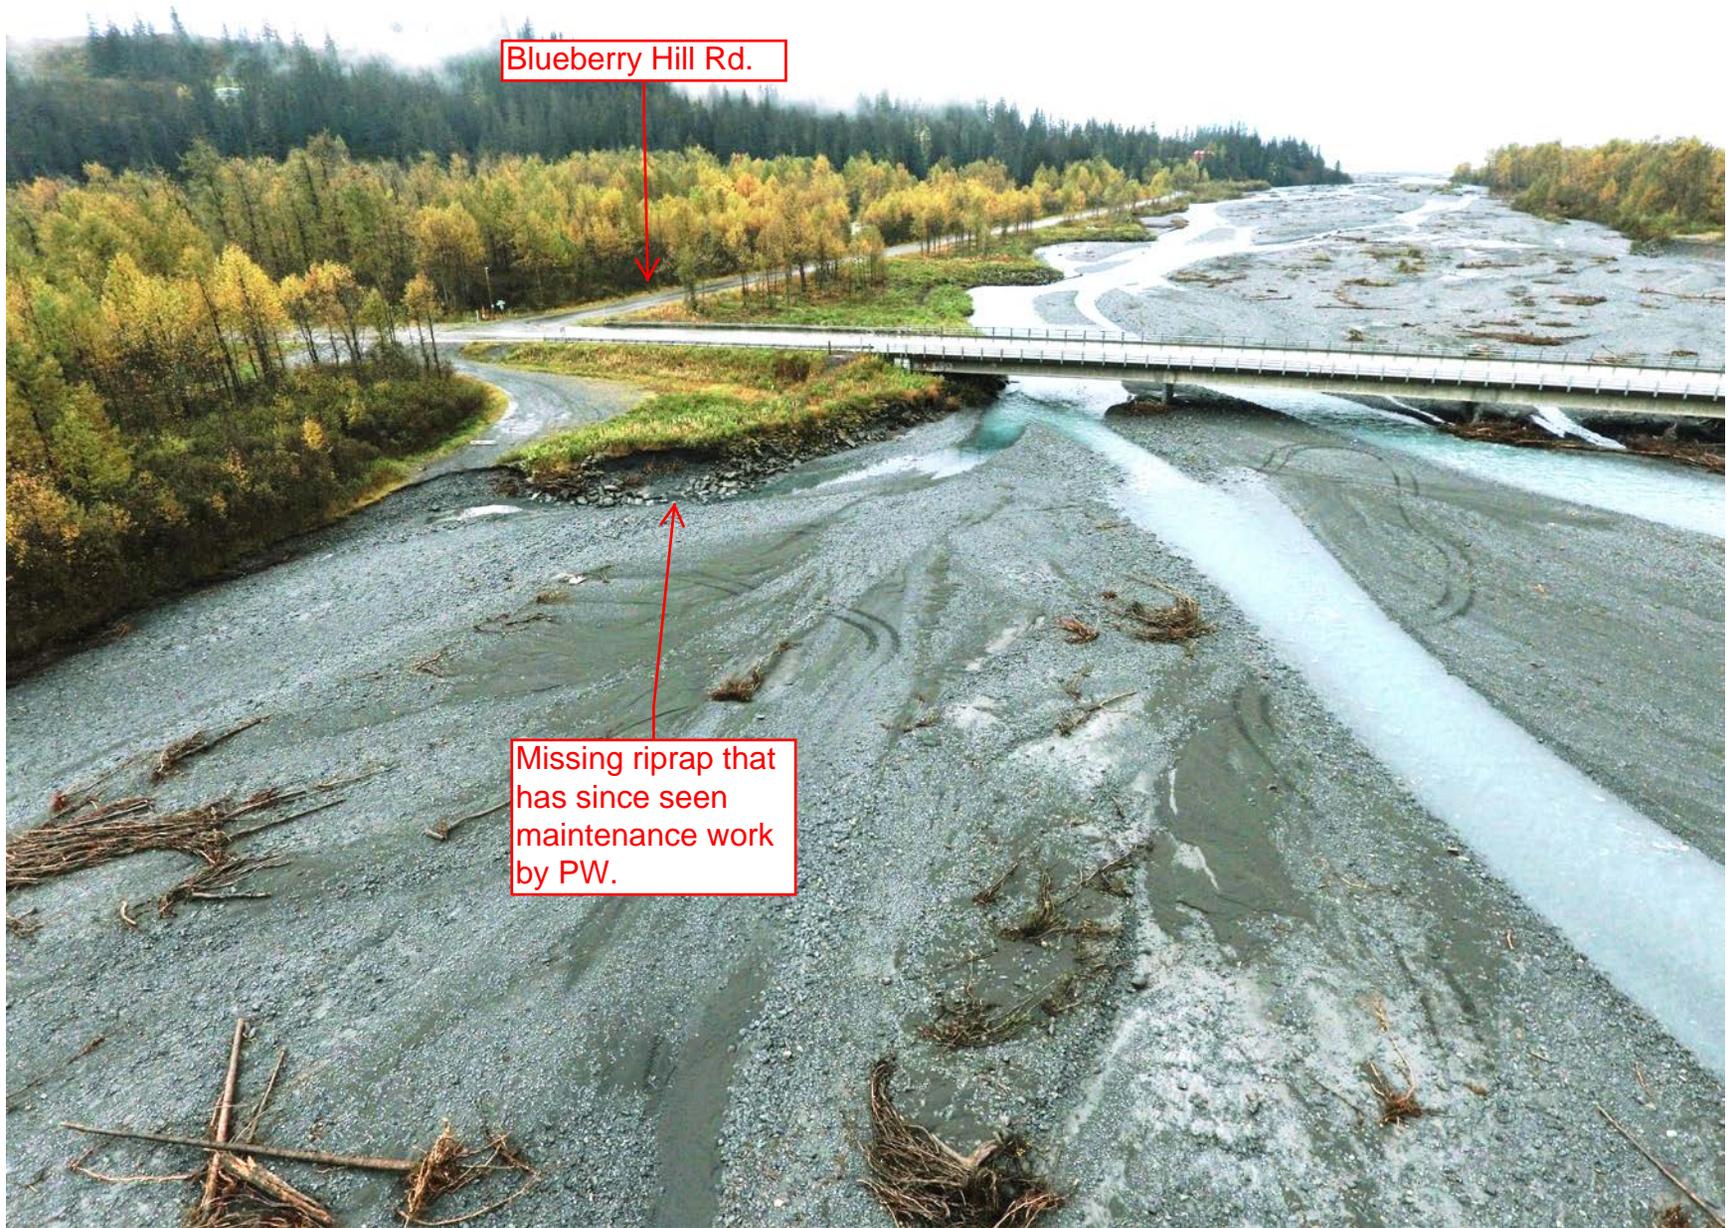
Missing riprap that has since seen maintenance work by PW.

Looking downstream towards the bridge.

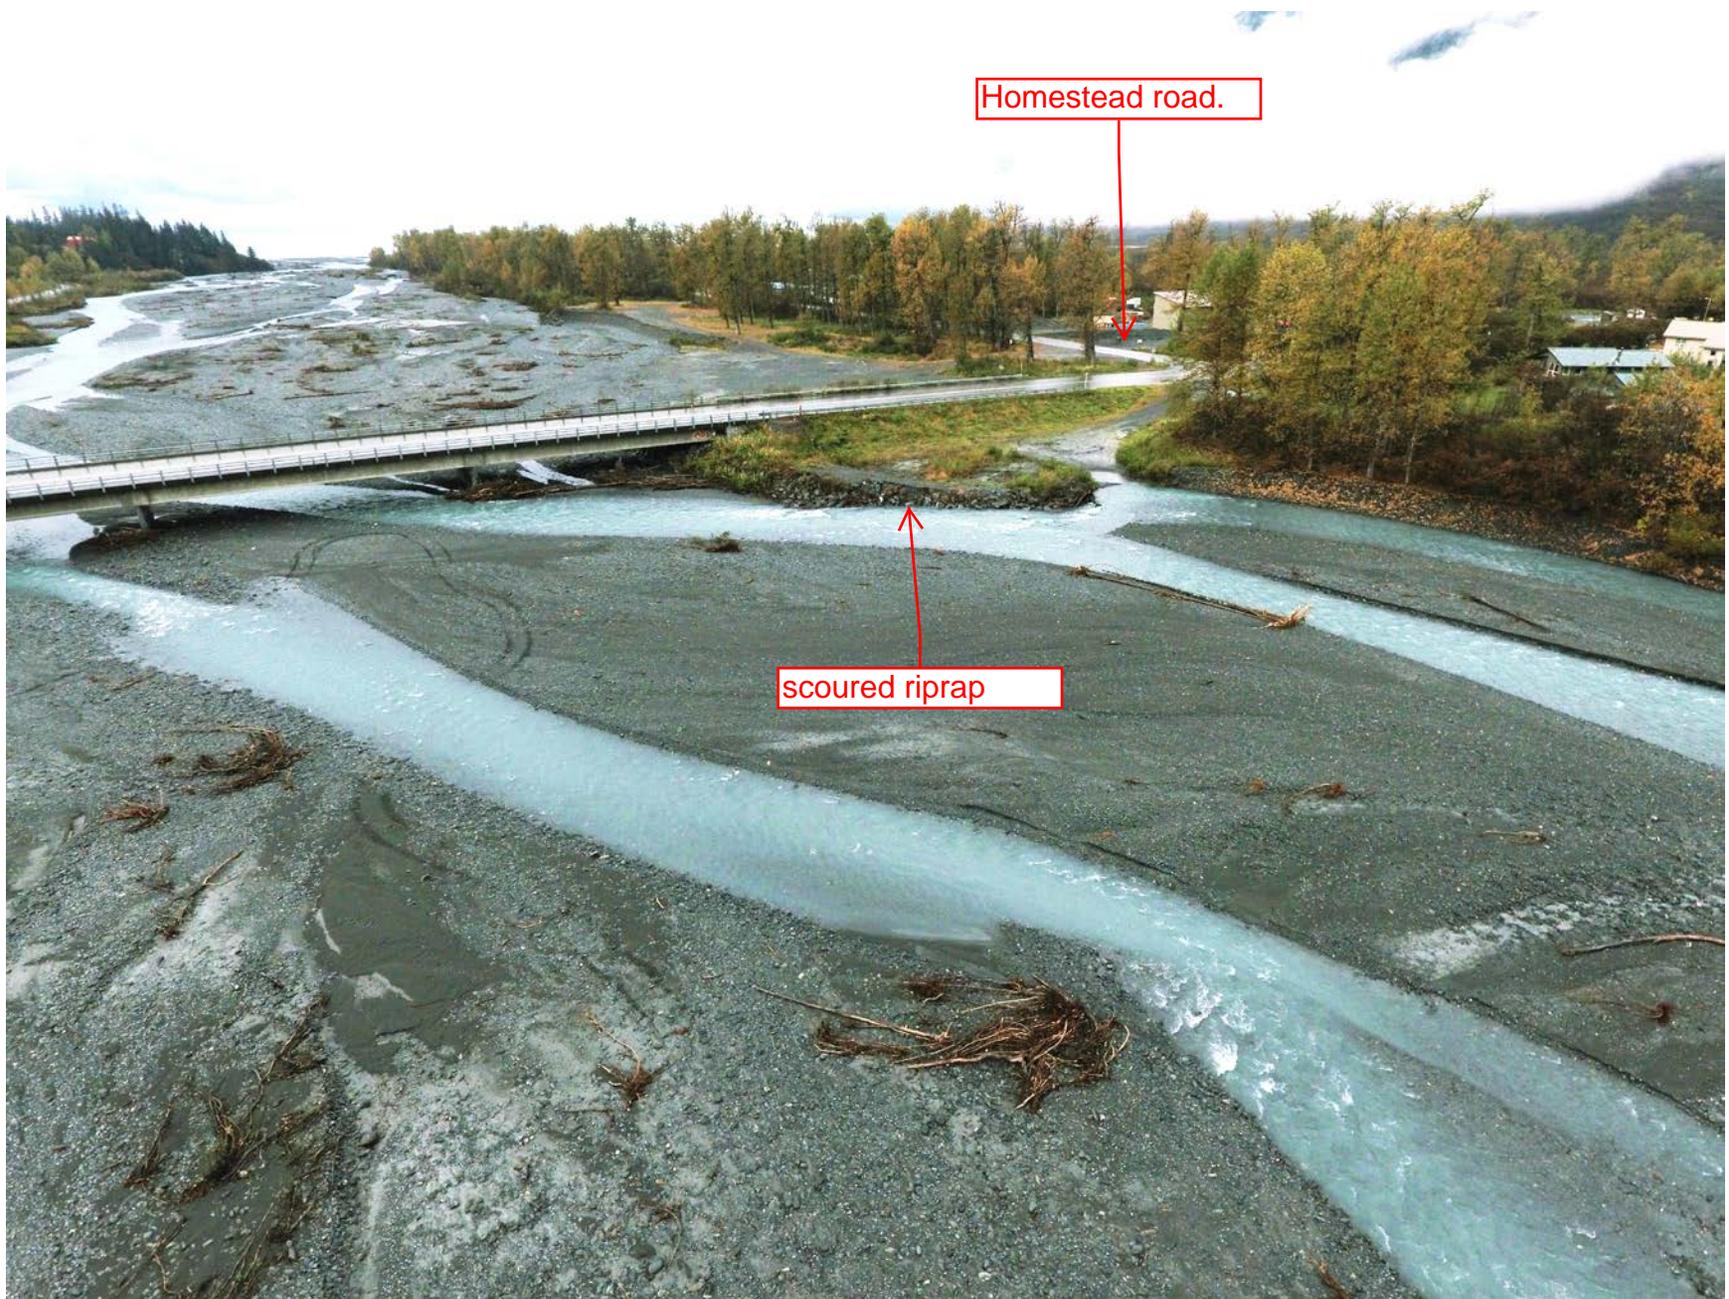
scoured riprap

Looking downstream towards bridge.
