Summary of Emergency High-Water Expenditures

As of September 28, 2016

Alpine Woods dike construction

Valdez Glacier Stream - Copper Ave emergency flood mitigation

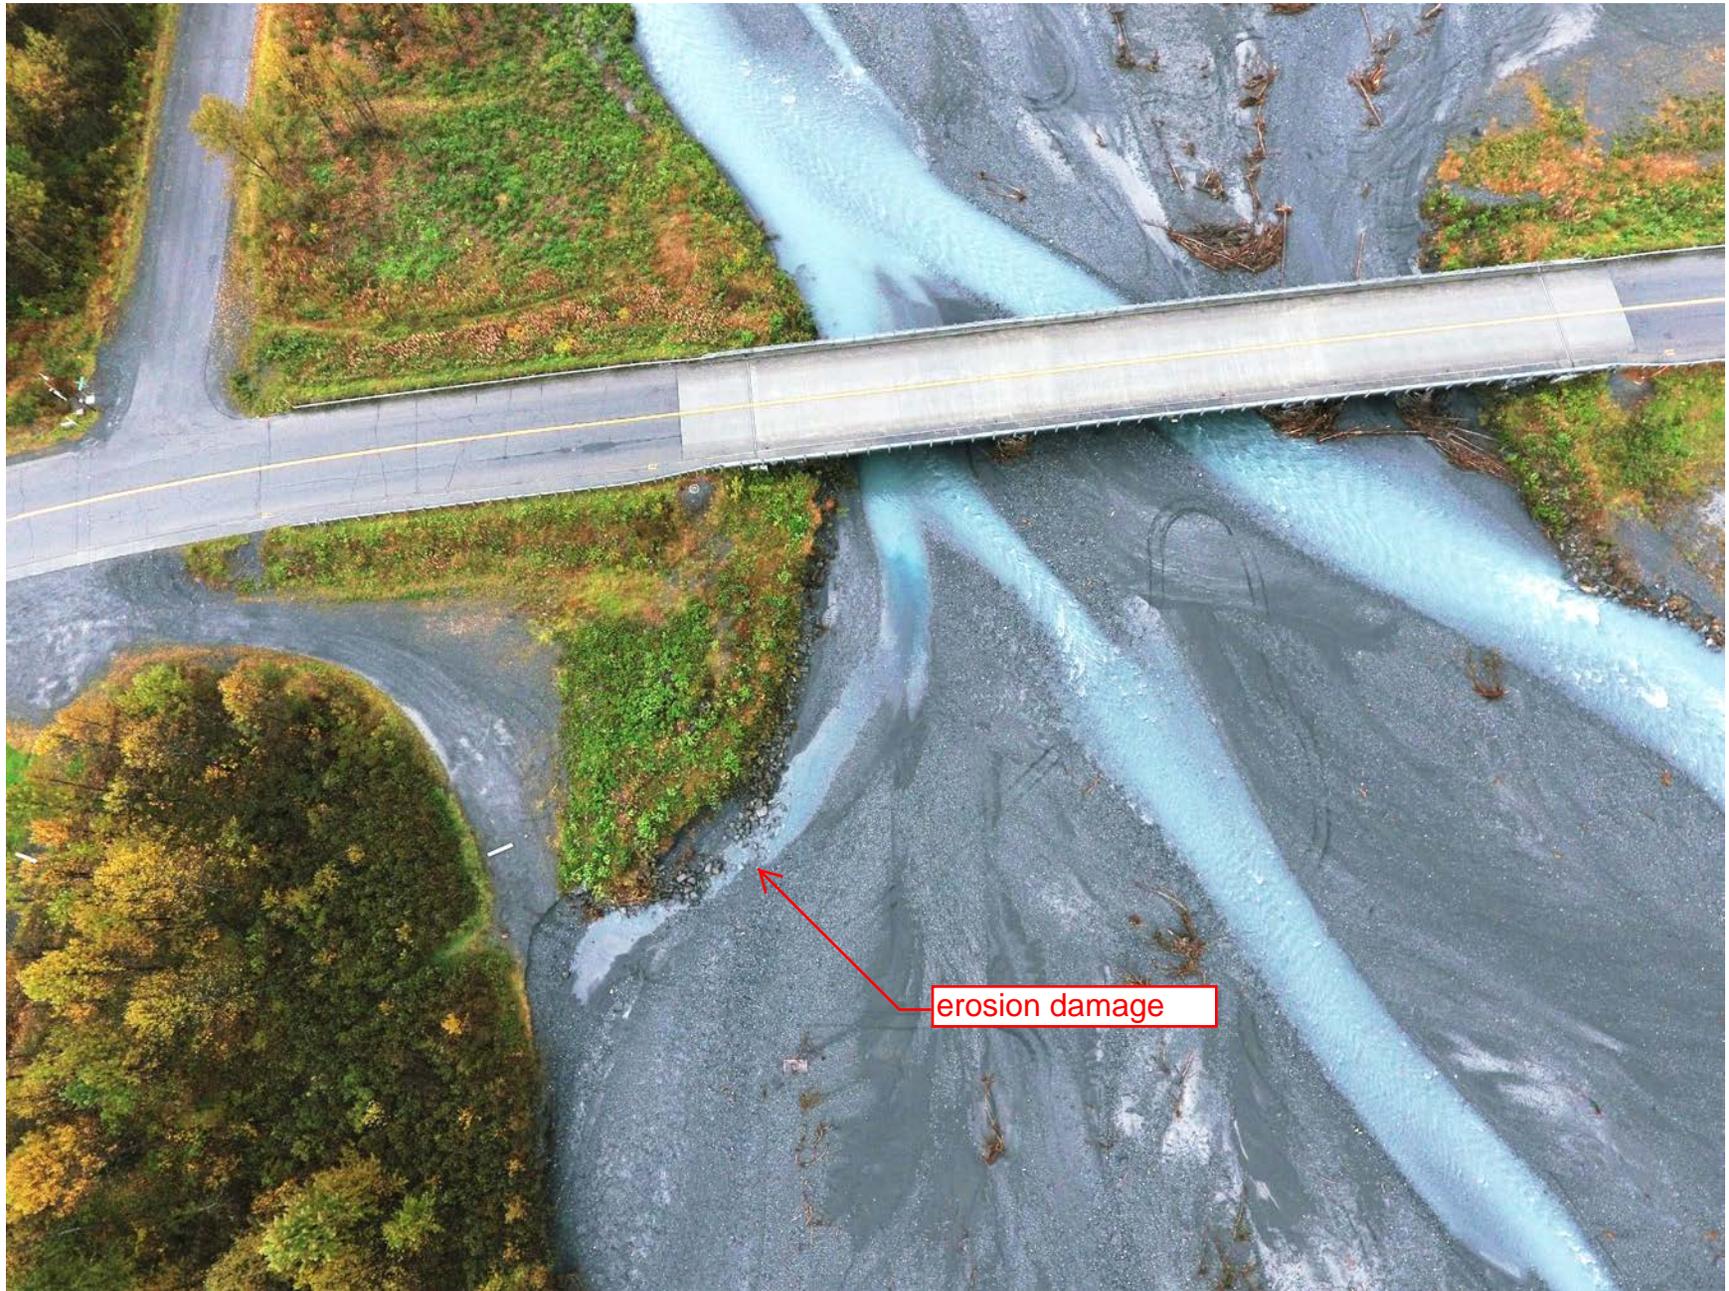
erosion damage

Birds eye view of the damaged area upstream of the bridge on the Blueberry Hill road side.

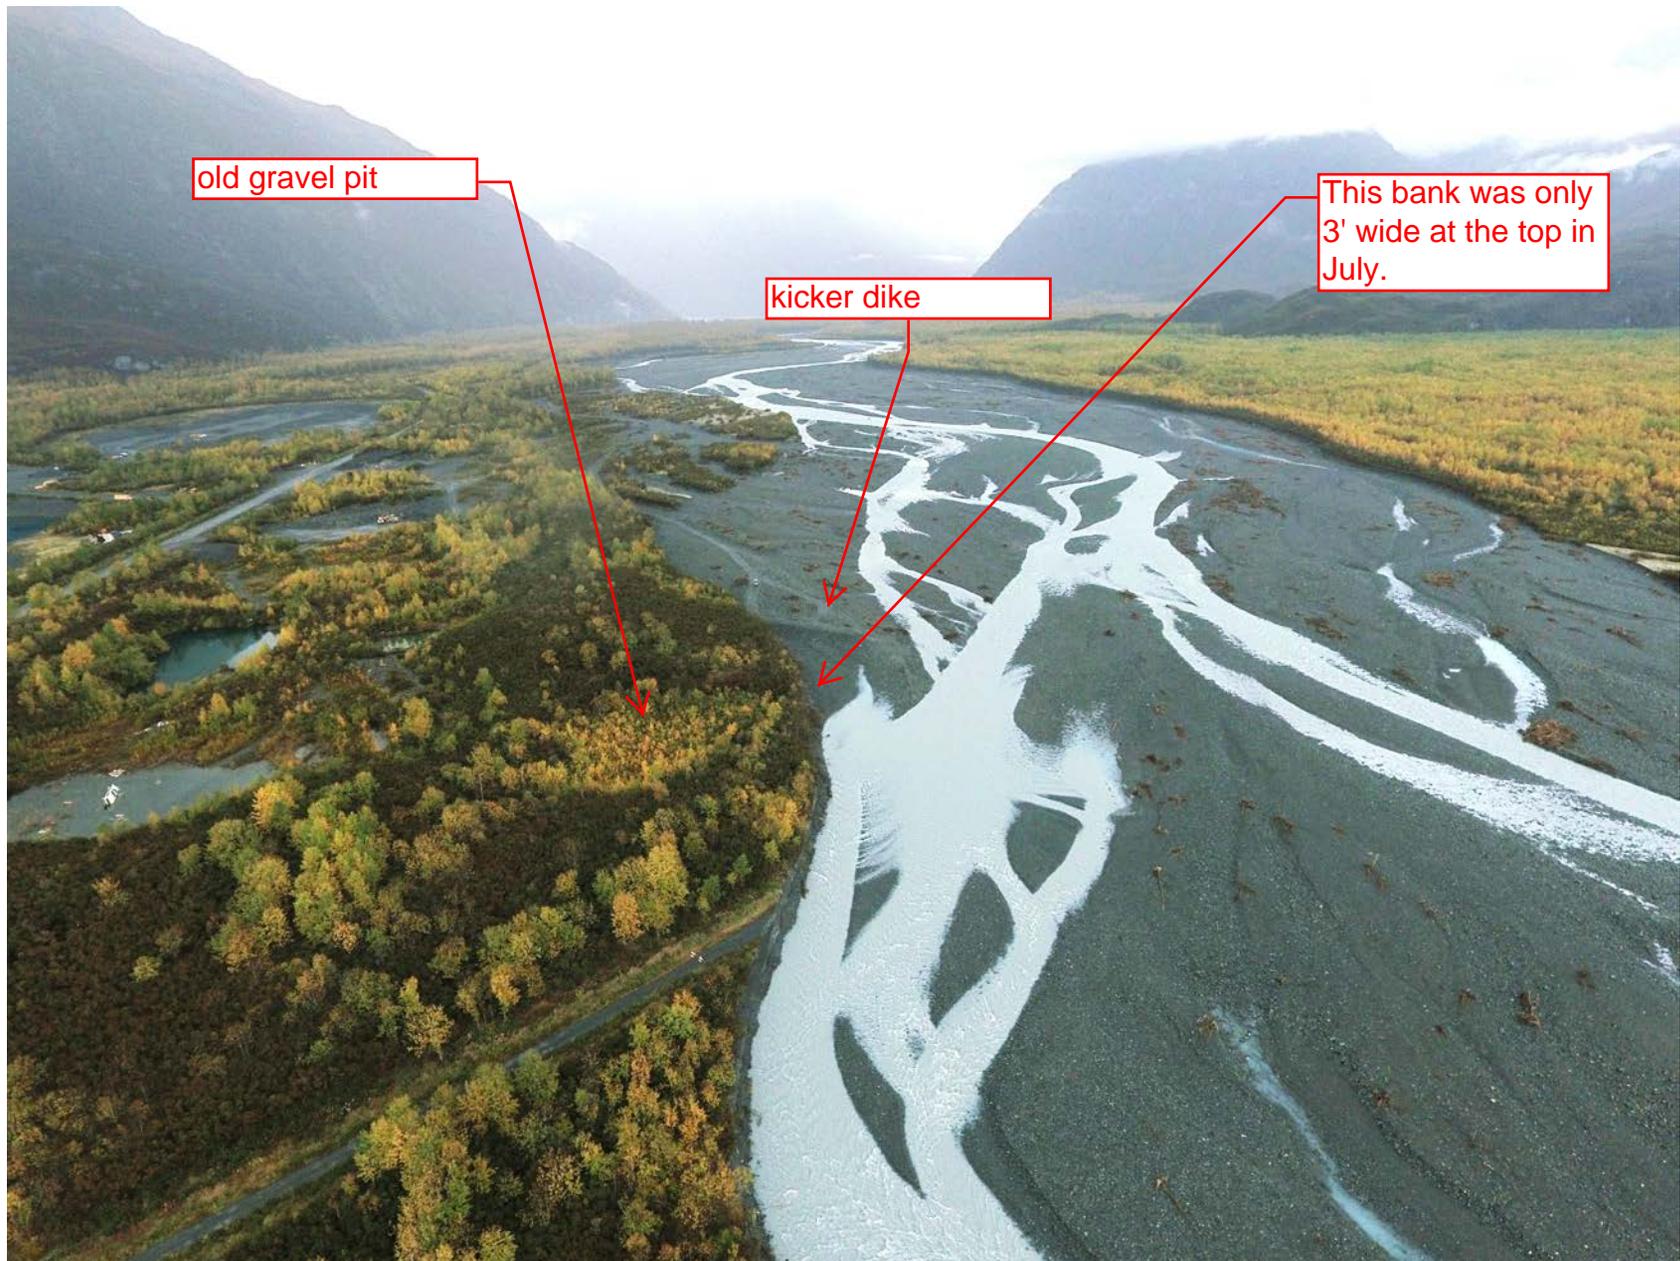
This bank was only 3' wide at the top in July.

Looking upstream towards the glacier lake.

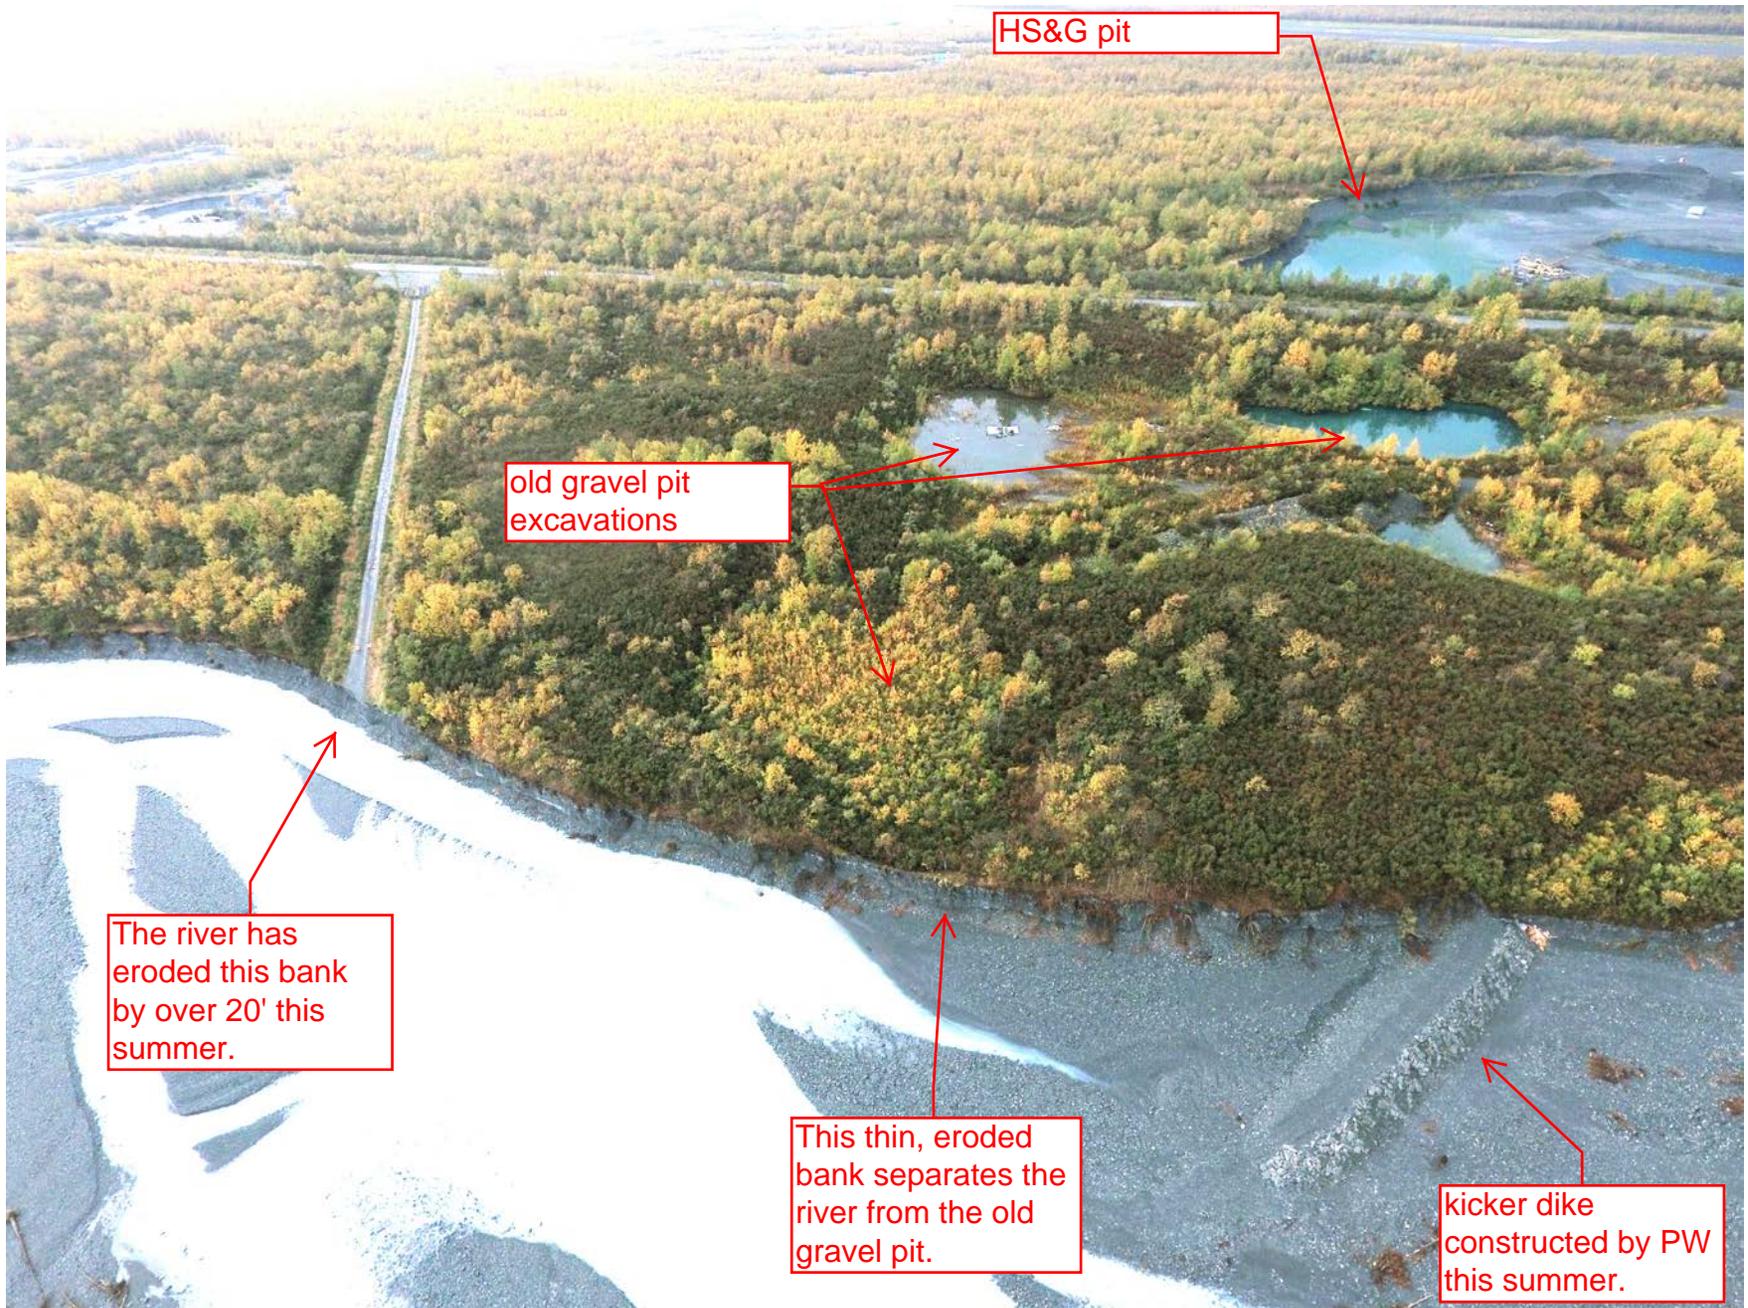
The river has eroded this bank by over 20' this summer.

This thin, eroded bank separates the river from the old gravel pit.
