VALDEZ RURAL ROADS ASSESSMENT

PHASING PLAN AND COST ESTIMATES

TO: Brad Sontag, City of Valdez Project Manager
FROM: Anna Ferntheil, P.E. and Elena Feghali, E.I.T.
THROUGH: Keri Nutter, CPG
DATE: March 27, 2025
PROJECT: Valdez Rural Roads Assessment
SUBJECT: Gravel Road Ratings and Recommendations

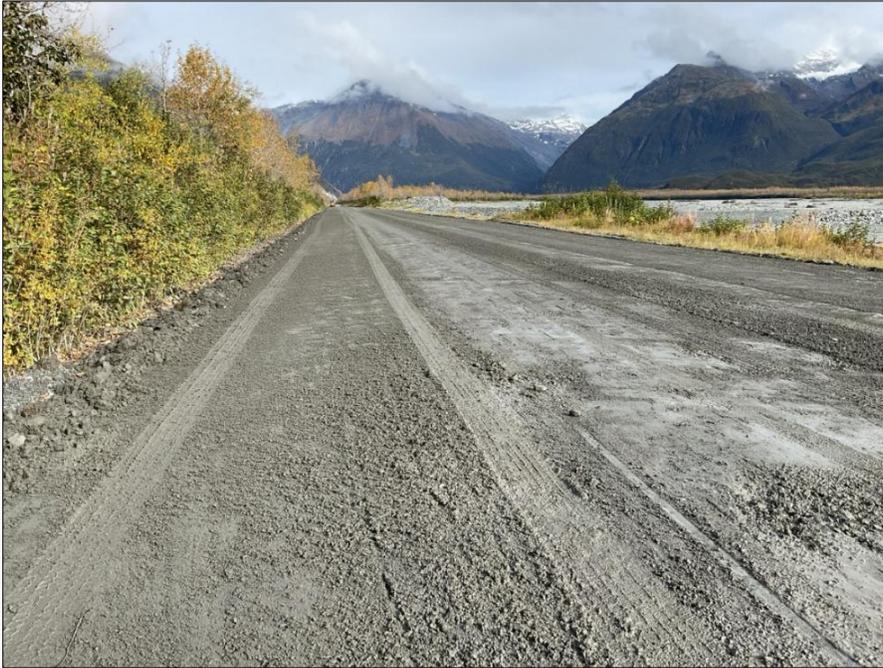
Berms were observed on the side of the gravel roads. Most were 2 to 6 inches in height, but some roads had berms 12 inches in height with a few extreme locations that were approximately 18 inches in height. Berms are created as a result of ineffective grading practices. Berms of any height can trap water on the road and lead to unsatisfactory performance of the wearing surface. Additionally, berms indicate that the maintenance practices are removing the surface course from the driving surface and pushing it to the edge of the road. In addition to the creation of berms, this

causes the road to widen past its structural section over time and fills the ditches with excess graded material.

Berms prevent water from exiting the roadway and appropriately draining into the drainage system. Any maintenance project undertaken should include the removal of berms from the side of the roadway and the regrading of the road so that water freely flows off the road surface and into the ditches. Recommended grading practices that prevent the creation of berms can be found in Section 2.2.1.

Figure 1: Berms on left created during routine grading on Glacier Haul Road

It is recommended that maintenance practices are modified to prevent further accelerated loss of surface courses and creation of berms. When grading the roads, roads should first be graded inward, to create a windrow in the middle of the road. The windrow should then be graded outwards, taking care to keep the established crown of the road intact and grading only as far as the existing edge of road. Berms should not be created during routine maintenance. Last, loose material should be compacted immediately using a steel drum or pneumatic rubber tire roller to prevent the premature creation of ruts, segregation, and loss of fine material.

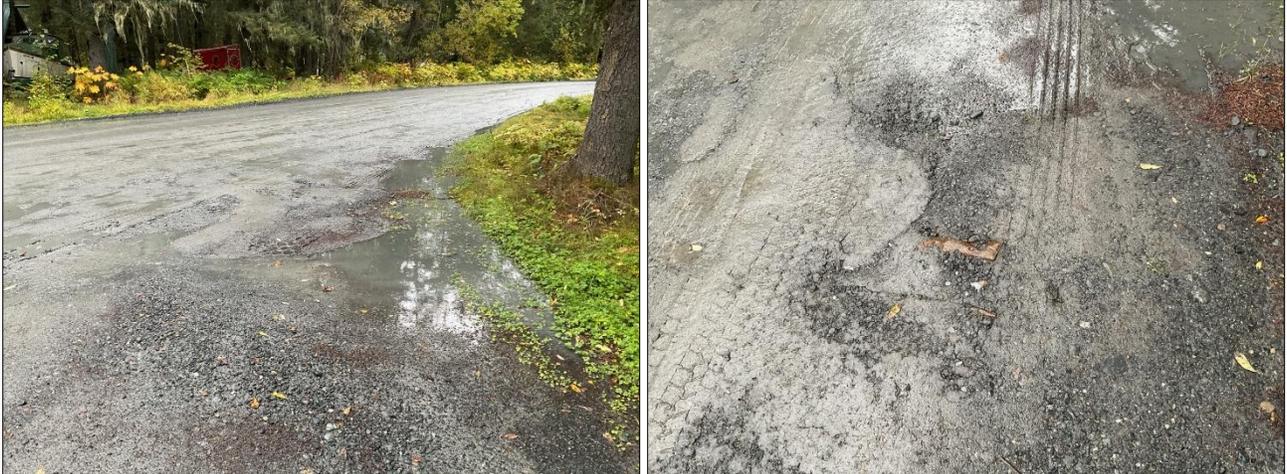
Increased distress, mostly in the form of moderate to severe potholes, were observed at multiple sites of culvert crossings. Where distress was the worst, culverts appeared to be under only 1 to 2 inches of soil. Culverts need a minimum coverage to be effective and maintain an adequate service life; this minimum coverage will vary based on the size and material of the culvert. Most of the culverts were 12- or 18-inch CMP; minimum coverage for these culverts should be 12 inches per State of Alaska Department of Transportation and Public Facilities (DOT&PF) Standards. For larger culverts, this coverage should be increased in accordance with DOT&PF Standards.

Figure 2: Intersection of Alder and Whispering Spruce - potholes and ponding above culvert (left) and remnants of crushed culvert (right)

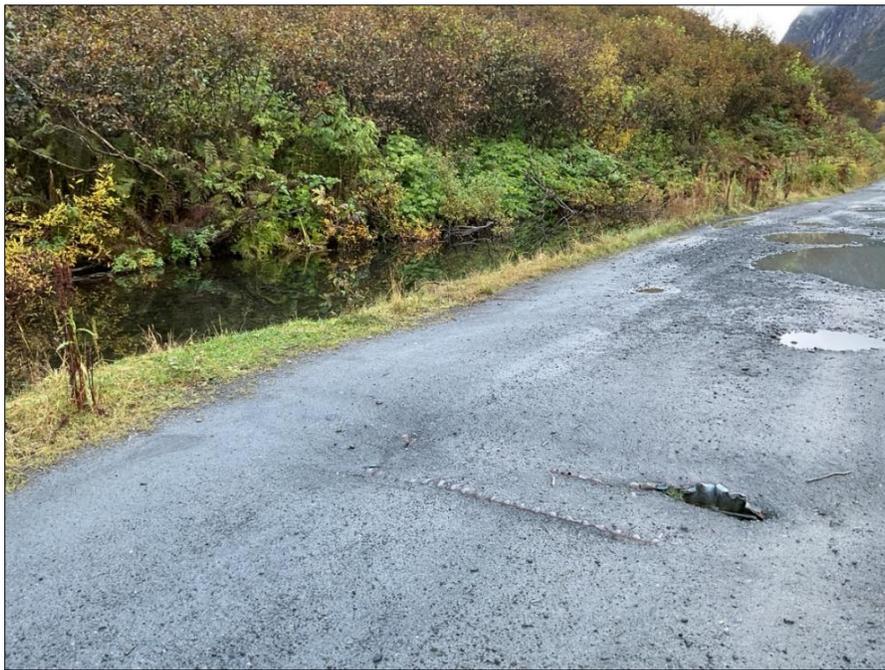
Figure 3: Damaged culvert causing standing water in ditch on Mineral Creek Road

It should be noted that the service level of Mineral Creek Road could be improved if material were added to the road. However, the logistics of hauling material up the road for the use it sees may not be economical or feasible due to truck access. Additionally, regrading the road is not currently feasible without first replacing the culverts and placing an appropriate amount of material cover; the tops of culverts are currently exposed through the driving surface in multiple locations.

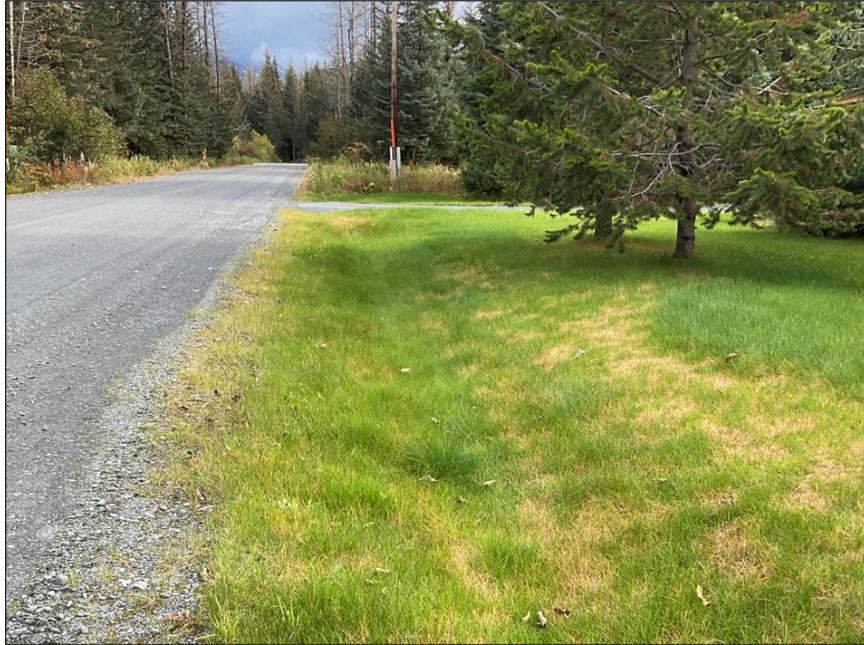
Figure 4: Well-maintained ditch on Childs Street

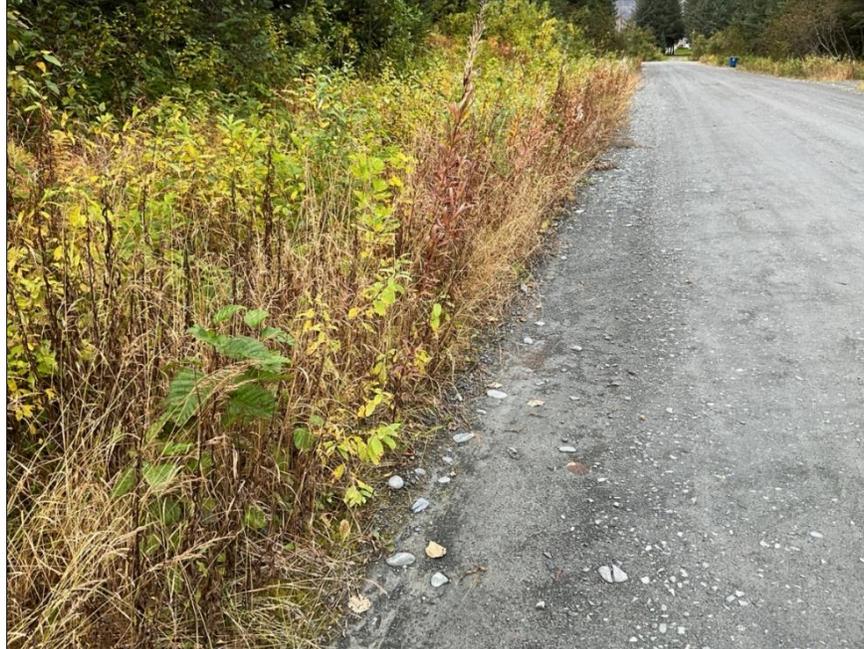
In general, ditches along the gravel roads observed were either non-existent or in a state of disrepair that rendered them useless. Water should be able to drain freely from the driving surface into the ditches. Ditches should be graded so that they do not hold water and so that water drains away from the road system. In general, ditches should be sufficiently deep to hold runoff, be graded so that water drains, have adequate culverts that are not damaged or blocked by debris, and be free of vegetation. Most ditches that were observed were filled with soil that prevented drainage and caused water to pond and were overgrown.

Figure 5: Existing overgrown ditch on Mendenhall Street

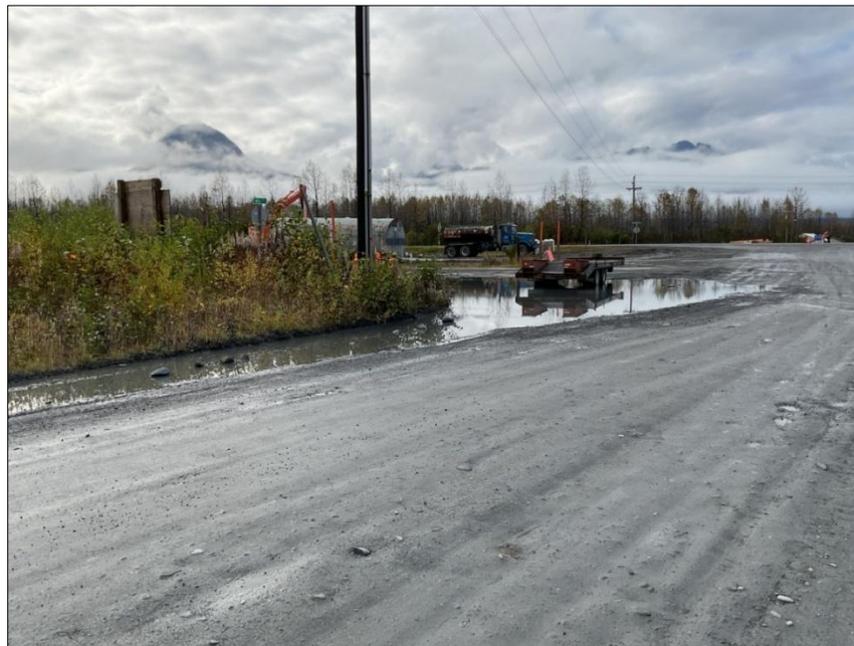
Figure 6: Lack of ditches causing standing water at N. Sawmill Dr./ Mill St. intersection

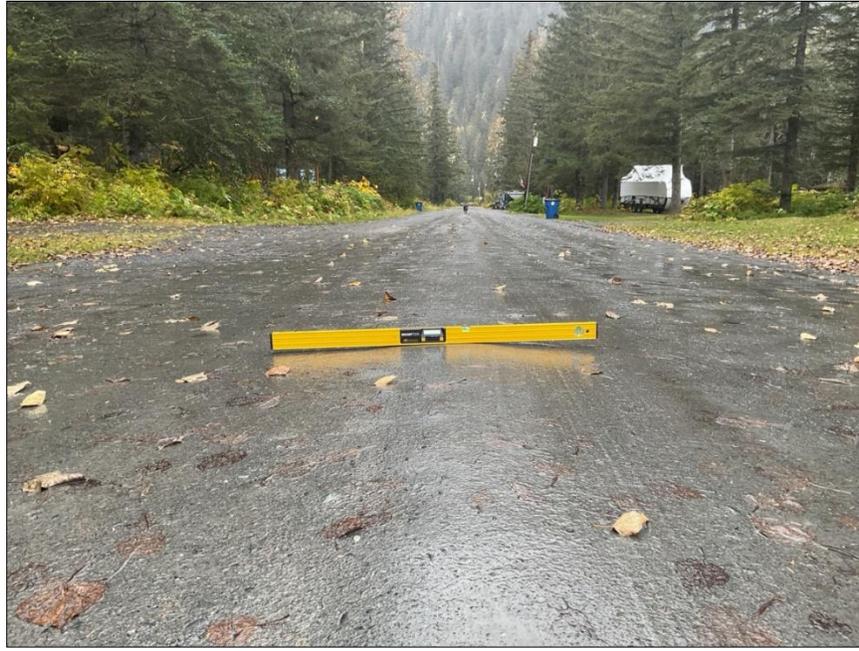
Some roads assessed had an adequate crown, though many did not. A proper crown is necessary to prevent water from ponding in the middle of the road and for proper drainage into the ditches. Roads should be graded with an approximately 3 percent drop from the center of the road to its edge.

Figure 7: Defined crown on Nordic Drive

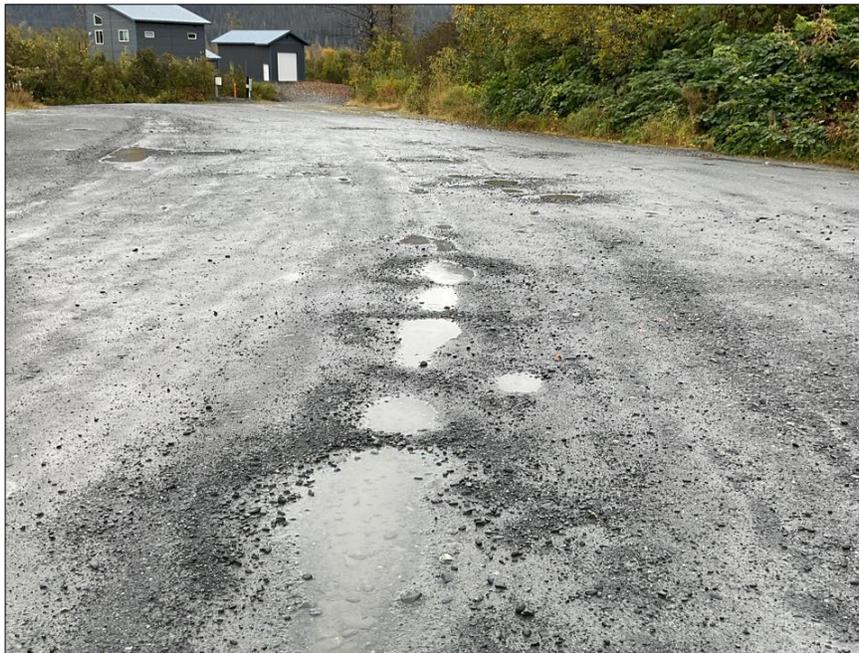
Figure 8: Potholes developing within the crown area on Cummings Way

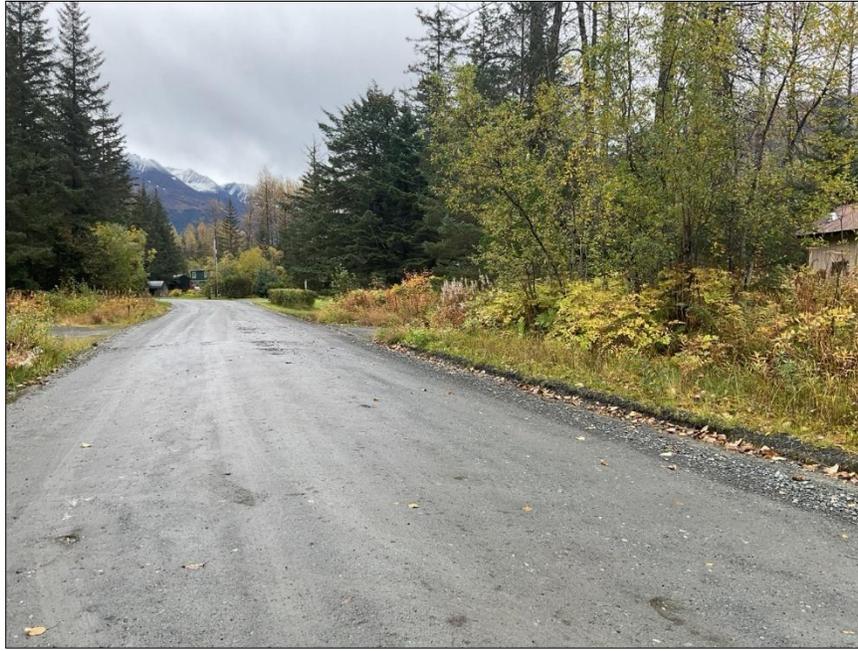
Most roads assessed had no notable surface course remaining on the wearing surface. On some roads, material that appeared to be from a surface course was seen in the berms created along the sides of the road, but the wearing surface contained mostly base course. This indicates that current maintenance practices are stripping the roads of the surface course.

Figure 9: Surface course graded off road into berm on Chalet Drive
