VALDEZ RURAL ROADS ASSESSMENT

PHASING PLAN AND COST ESTIMATES

TO: Brad Sontag, City of Valdez Project Manager
FROM: Anna Ferntheil, P.E. and Elena Feghali, E.I.T.
THROUGH: Keri Nutter, CPG
DATE: March 27, 2025
PROJECT: Valdez Rural Roads Assessment
SUBJECT: Gravel Road Ratings and Recommendations

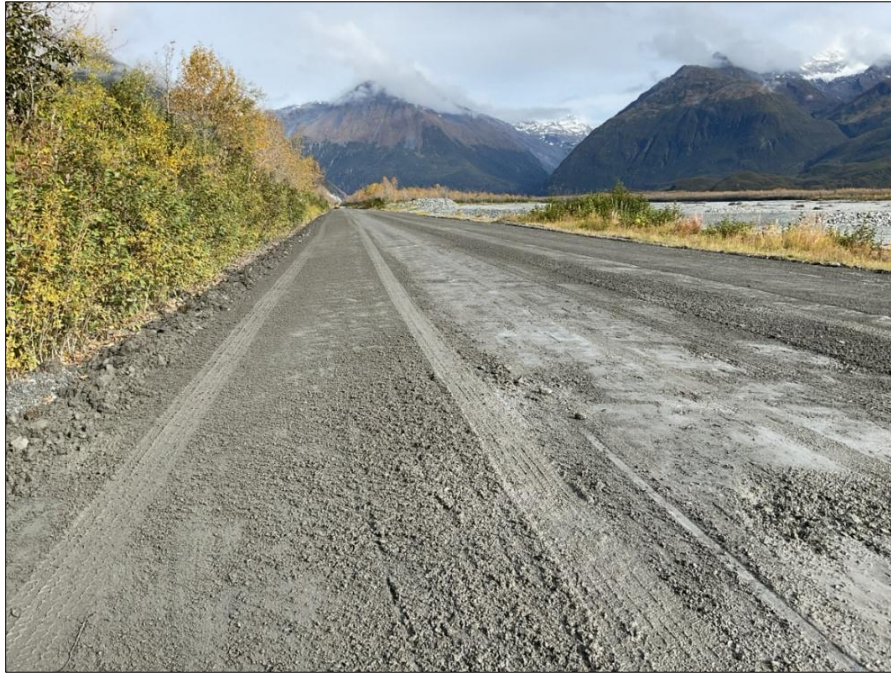
Berms were observed on the side of the gravel roads. Most were 2 to 6 inches in height, but some roads had berms 12 inches in height with a few extreme locations that were approximately 18 inches in height. Berms are created as a result of ineffective grading practices. Berms of any height can trap water on the road and lead to unsatisfactory performance of the wearing surface. Additionally, berms indicate that the maintenance practices are removing the surface course from the driving surface and pushing it to the edge of the road. In addition to the creation of berms, this

causes the road to widen past its structural section over time and fills the ditches with excess graded material.

Berms prevent water from exiting the roadway and appropriately draining into the drainage system. Any maintenance project undertaken should include the removal of berms from the side of the roadway and the regrading of the road so that water freely flows off the road surface and into the ditches. Recommended grading practices that prevent the creation of berms can be found in Section 2.2.1.

Figure 1: Berms on left created during routine grading on Glacier Haul Road

It is recommended that maintenance practices are modified to prevent further accelerated loss of surface courses and creation of berms. When grading the roads, roads should first be graded inward, to create a windrow in the middle of the road. The windrow should then be graded outwards, taking care to keep the established crown of the road intact and grading only as far as the existing edge of road. Berms should not be created during routine maintenance. Last, loose material should be compacted immediately using a steel drum or pneumatic rubber tire roller to prevent the premature creation of ruts, segregation, and loss of fine material.

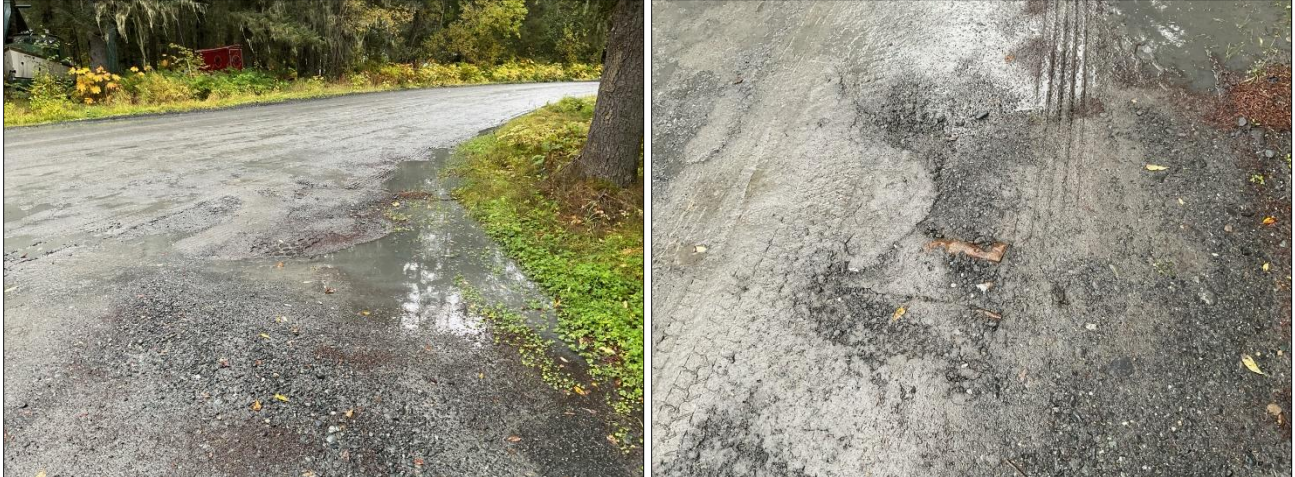
Increased distress, mostly in the form of moderate to severe potholes, were observed at multiple sites of culvert crossings. Where distress was the worst, culverts appeared to be under only 1 to 2 inches of soil. Culverts need a minimum coverage to be effective and maintain an adequate service life; this minimum coverage will vary based on the size and material of the culvert. Most of the culverts were 12- or 18-inch CMP; minimum coverage for these culverts should be 12 inches per State of Alaska Department of Transportation and Public Facilities (DOT&PF) Standards. For larger culverts, this coverage should be increased in accordance with DOT&PF Standards.

Figure 2: Intersection of Alder and Whispering Spruce - potholes and ponding above culvert (left) and remnants of crushed culvert (right)

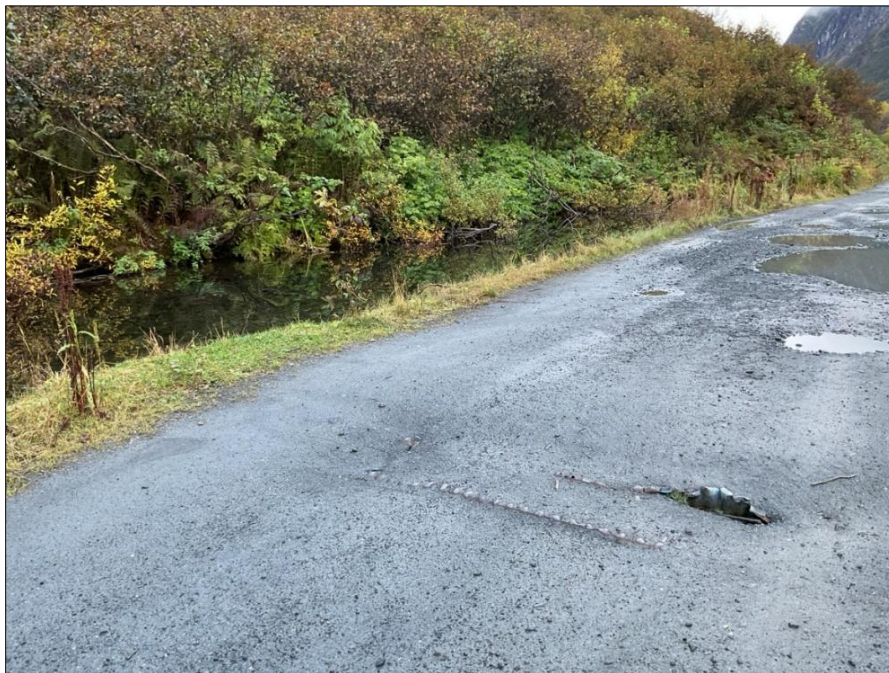
Figure 3: Damaged culvert causing standing water in ditch on Mineral Creek Road

It should be noted that the service level of Mineral Creek Road could be improved if material were added to the road. However, the logistics of hauling material up the road for the use it sees may not be economical or feasible due to truck access. Additionally, regrading the road is not currently feasible without first replacing the culverts and placing an appropriate amount of material cover; the tops of culverts are currently exposed through the driving surface in multiple locations.

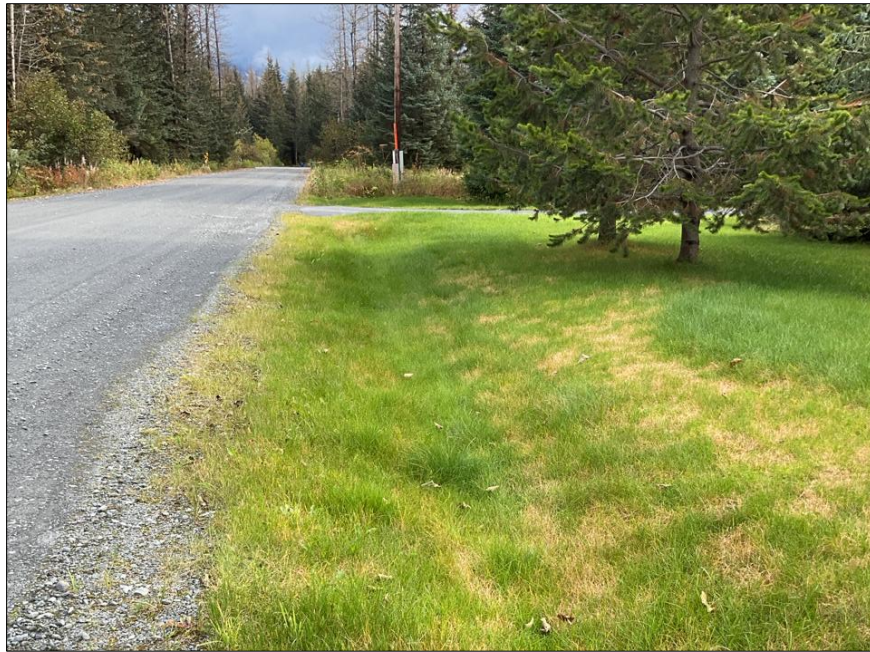
Figure 4: Well-maintained ditch on Childs Street

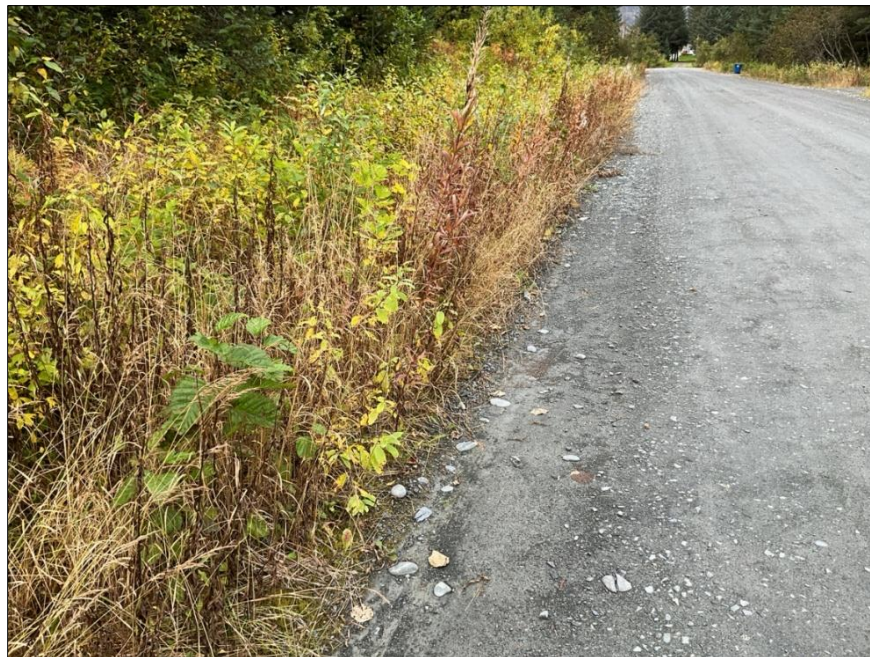
In general, ditches along the gravel roads observed were either non-existent or in a state of disrepair that rendered them useless. Water should be able to drain freely from the driving surface into the ditches. Ditches should be graded so that they do not hold water and so that water drains away from the road system. In general, ditches should be sufficiently deep to hold runoff, be graded so that water drains, have adequate culverts that are not damaged or blocked by debris, and be free of vegetation. Most ditches that were observed were filled with soil that prevented drainage and caused water to pond and were overgrown.

Figure 5: Existing overgrown ditch on Mendenhall Street

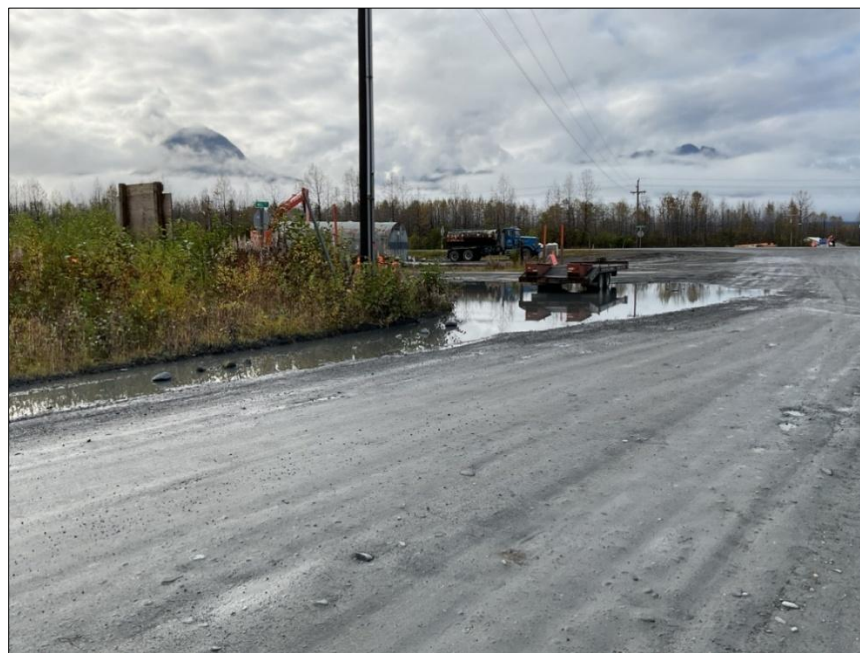
Figure 6: Lack of ditches causing standing water at N. Sawmill Dr./ Mill St. intersection

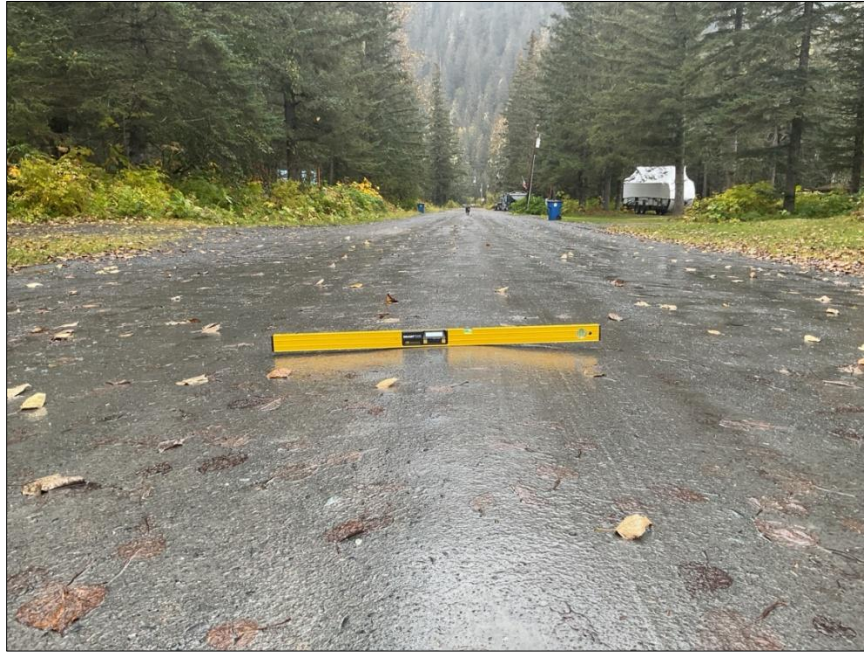
Figure 7: Defined crown on Nordic Drive

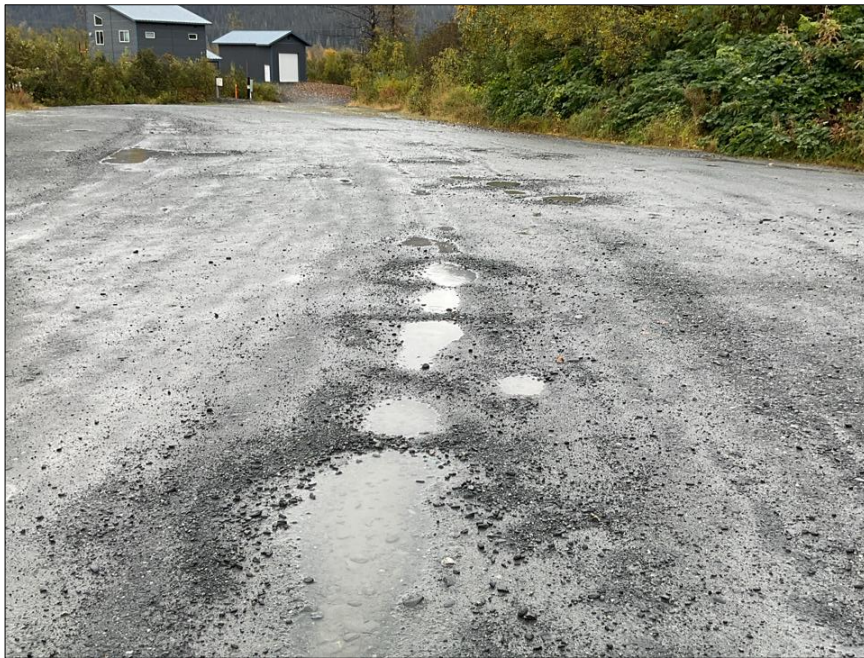
Some roads assessed had an adequate crown, though many did not. A proper crown is necessary to prevent water from ponding in the middle of the road and for proper drainage into the ditches. Roads should be graded with an approximately 3 percent drop from the center of the road to its edge.

Figure 8: Potholes developing within the crown area on Cummings Way

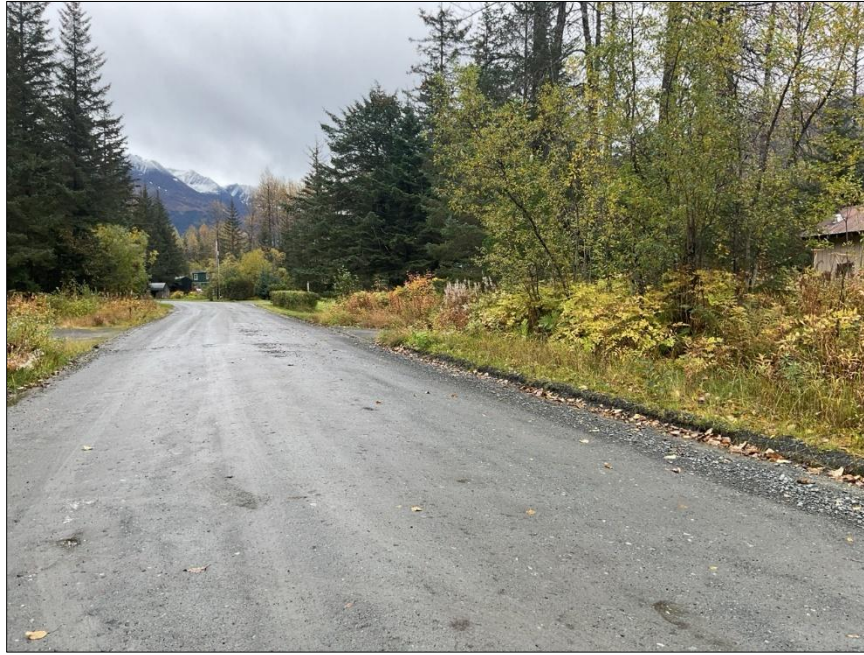
Most roads assessed had no notable surface course remaining on the wearing surface. On some roads, material that appeared to be from a surface course was seen in the berms created along the sides of the road, but the wearing surface contained mostly base course. This indicates that current maintenance practices are stripping the roads of the surface course.

Figure 9: Surface course graded off road into berm on Chalet Drive
