**Tax Year 2024
Real Property Assessment Appeal
City of Valdez
Office of the City Clerk**

Appeal Number 19

Property ID Number:	7010-005-002-0	NOTE: A SEPARATE FORM IS REQUIRED FOR EACH PARCEL.
Property Owner:	Jaranda and Josh	
Legal Description:	lot 2, block 5, Black Gold #1, lot size 10000 SF	
Physical Address of Property:	616 S. Waterfall

Attached is a full home inspection report for 616 S. waterfall. Highlighted in the 164-page report you will find several repairs on the home that negatively affect the homes value. In my appeal I wrote that the home value should be dropped by \$100,000 based on the repairs outlined in the report. The costliest repairs include.

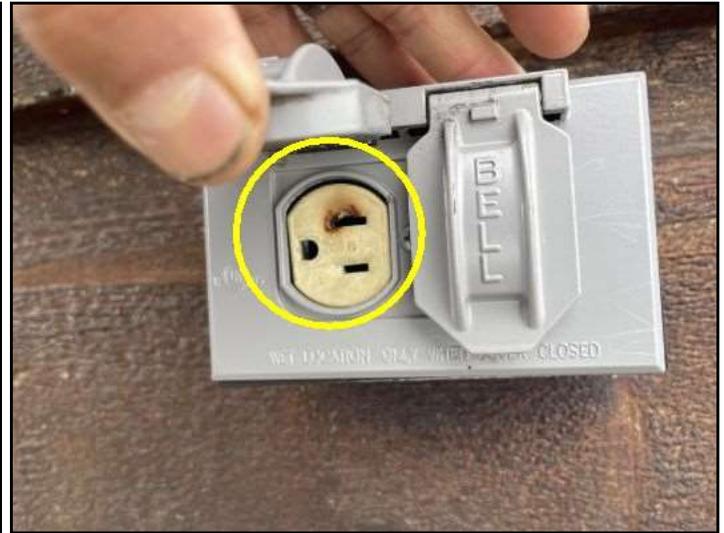
6. Grounds Electrical

- Exterior outlet had burn marks on outlet. Recommend licensed electrician to evaluate for repair or replacement.
- Extension cord pulled through garage wall to be used in the storage area. Recommend removing extension cord and installing more permanent outlet in storage area.

Burn marks noted when testing exterior outlet.

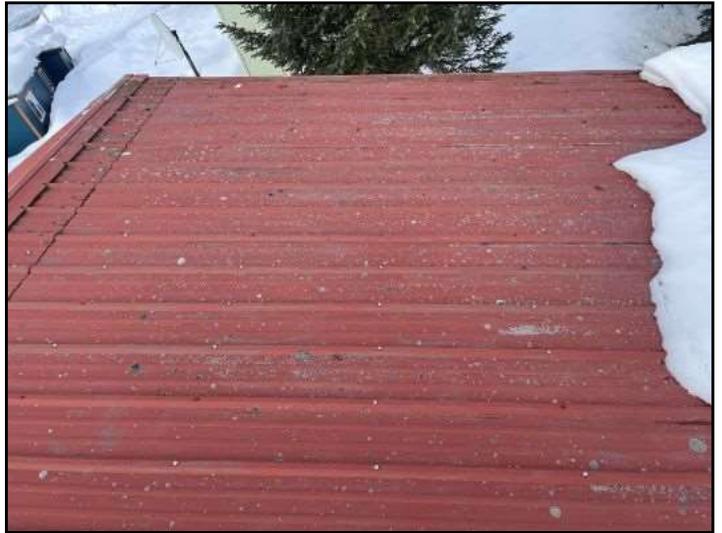
Multiple hold down screws placed in roofing material.

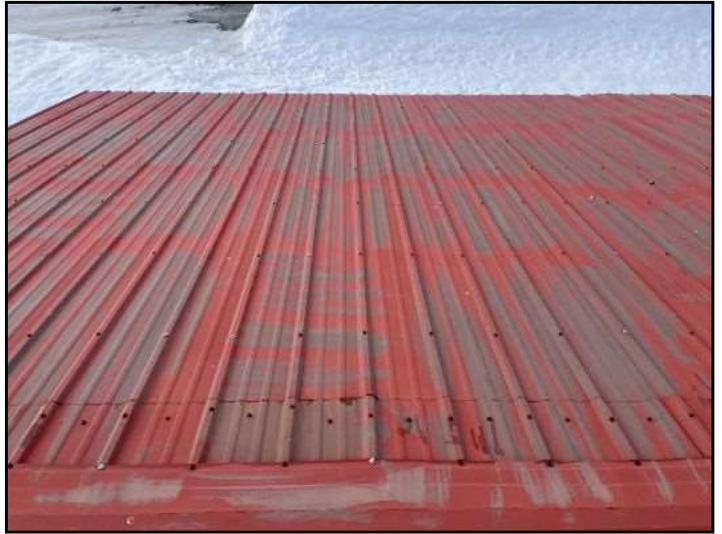
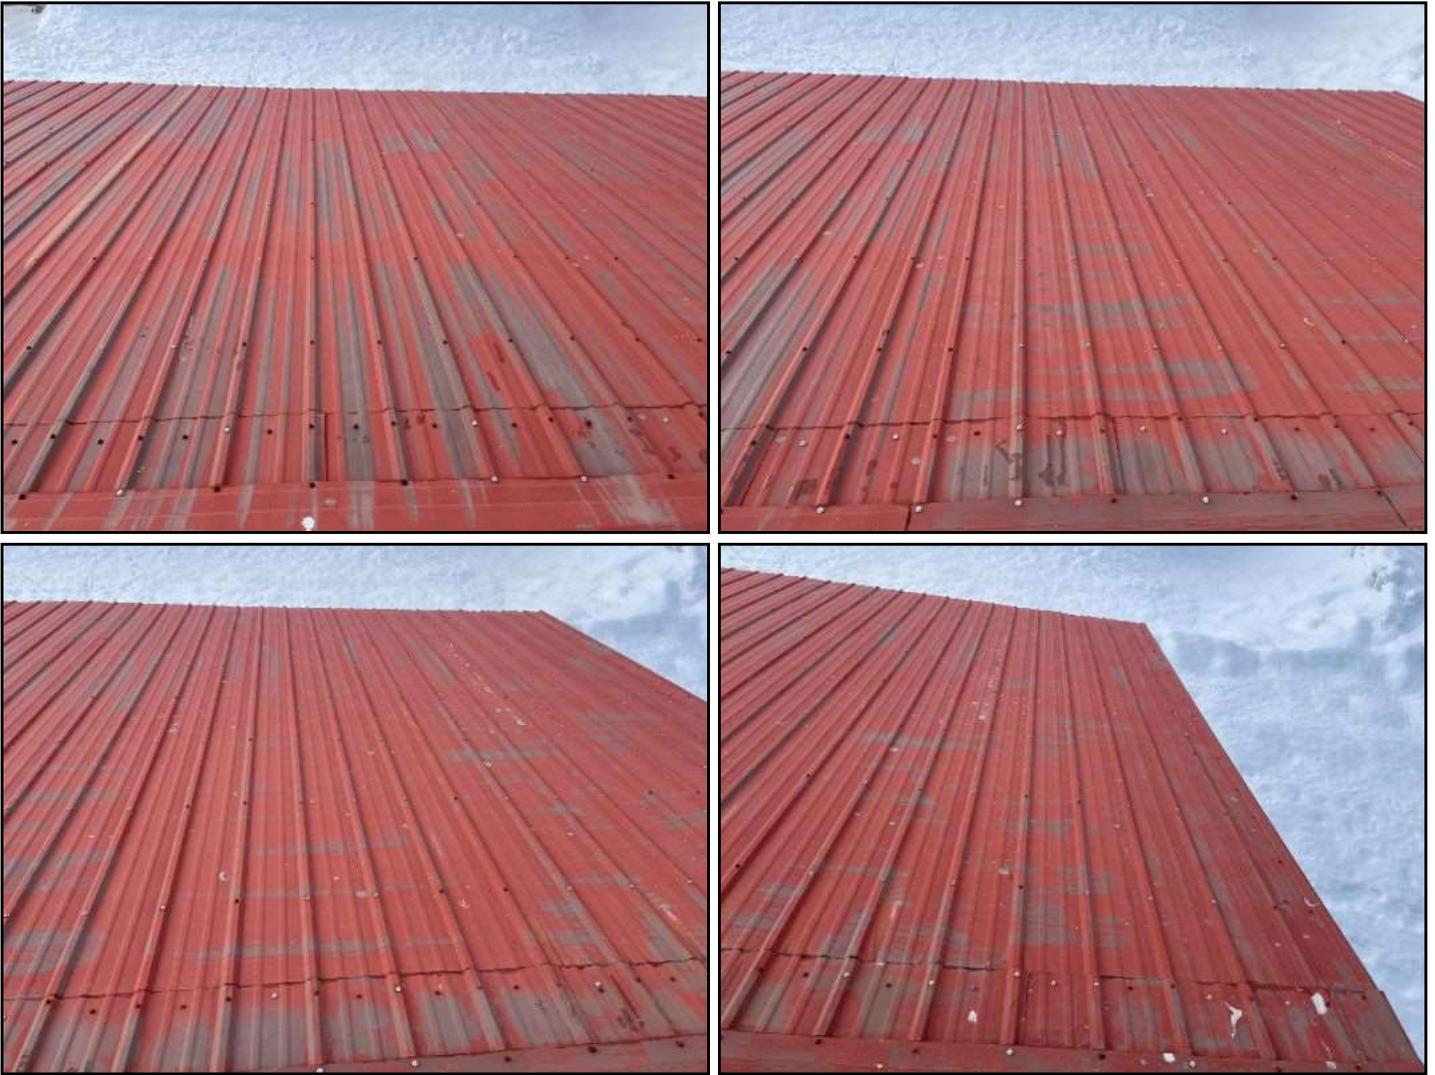
Missing roofing screw noted.

- Partially snow covered, not fully inspected.
- Note that experts recommend that any roof over 10 years old receive a roof certification by a local roofing specialist.
- Serviceability of roof is questionable; it should be evaluated and repaired as necessary by a professional roofing contractor.
- Moisture intrusion in multiple spots in roofing material of the storage extension fascia. Recommend a qualified roofer to evaluate for repair or replacement.
- Ridge cap damaged at the edge of roof. Recommend a qualified roofer to evaluate for repair or replacement.
- Multiple roofing screws applied to roof. Recommend a qualified roofer to evaluate roofing screws for repair or replacement.

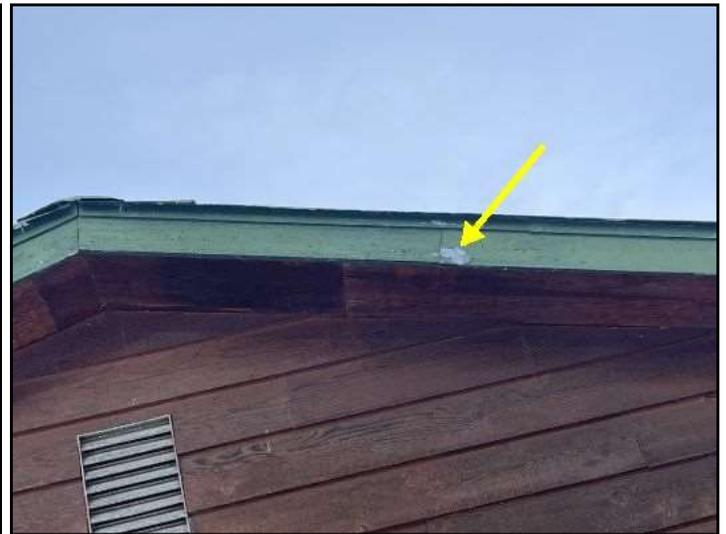
Paint on fascia is worn and weathered.

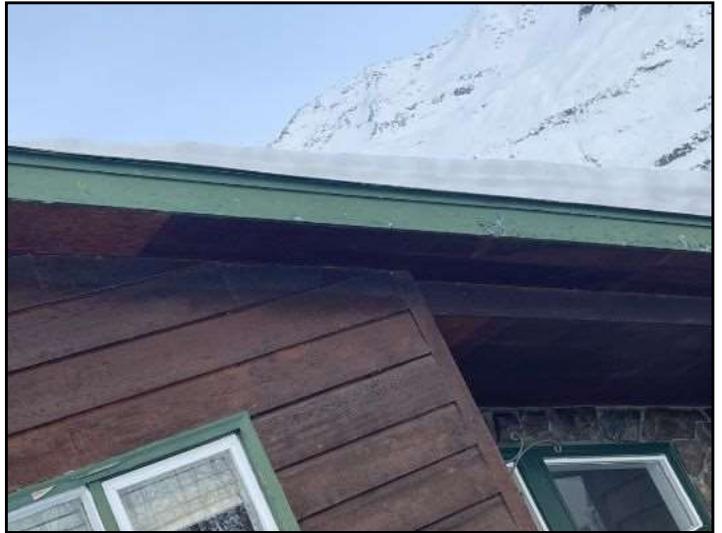
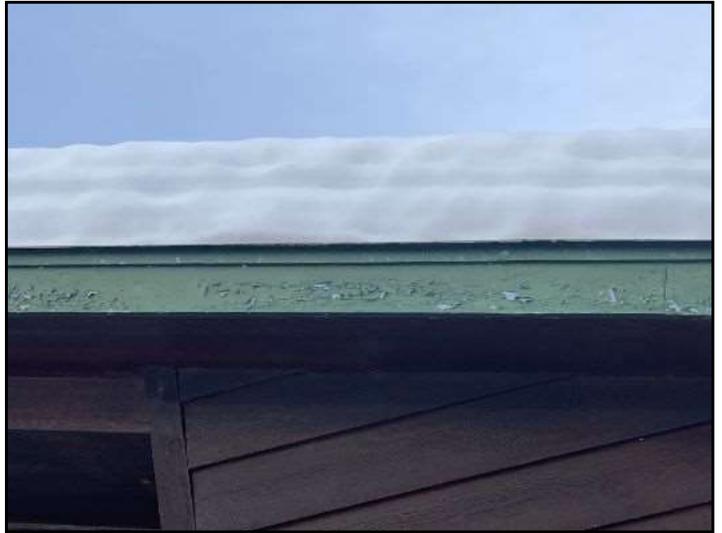
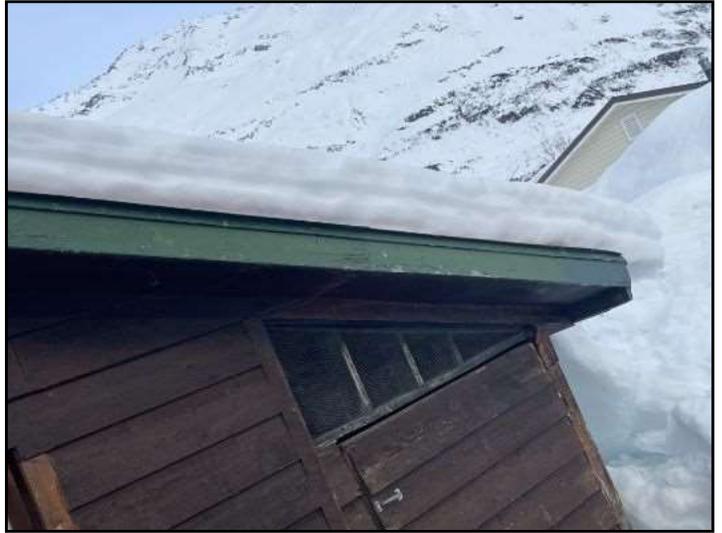
Fascia damaged and leaking in to storage area roof.

- Paint on fascia is worn and weathered. Recommend prime and paint to extend life of the fascia.
- Corner of roof of extension storage appears to be damaged from snow and ice. Recommend qualified roofer to evaluate for repair or replacement.

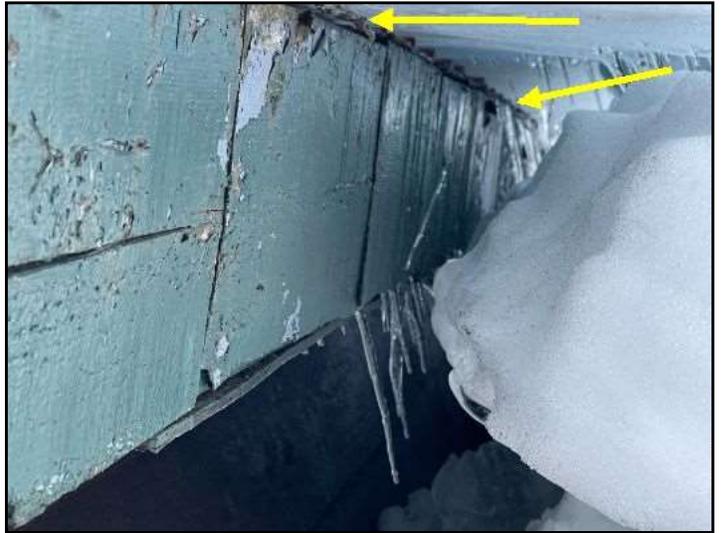
Ice and snow build up causing moisture intrusion in storage roof.

Roofing torn and damaged from the winters snow and ice.

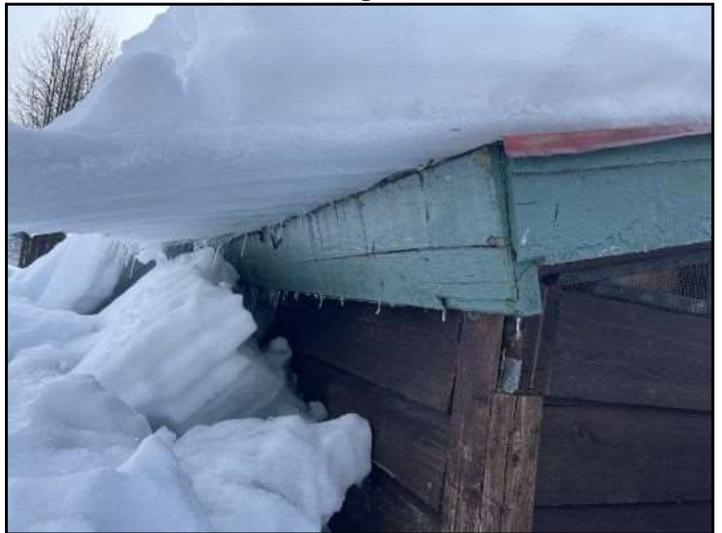
Paint on fascia is worn and weathered.

Paint chipping on fascia.

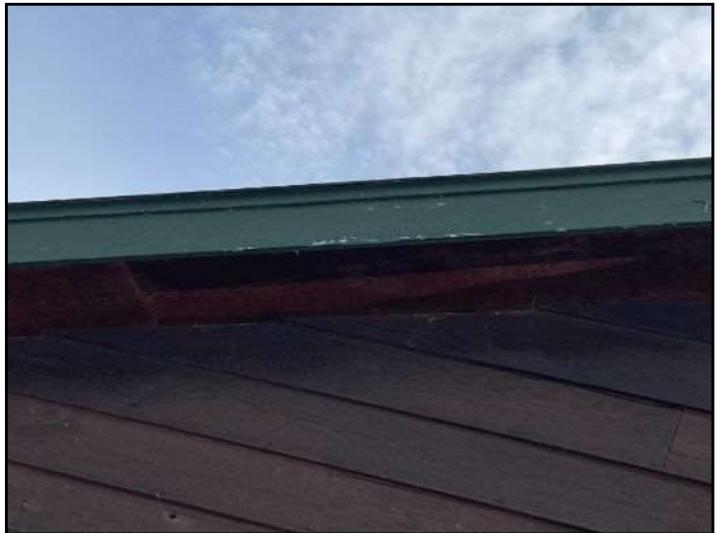
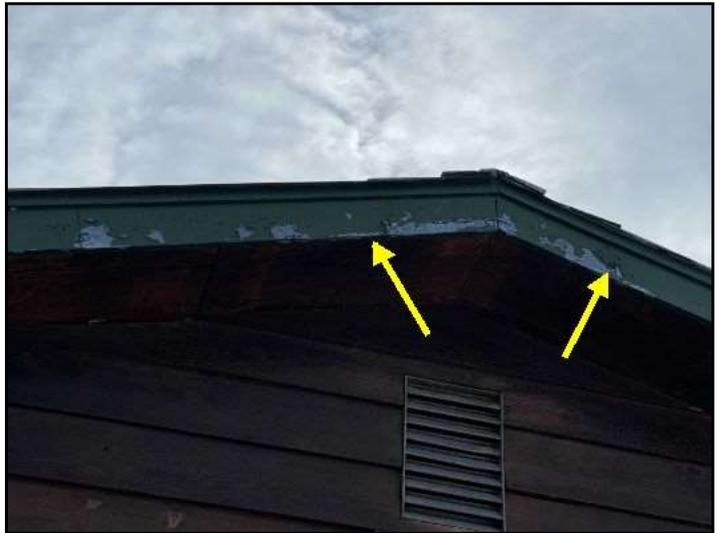
Paint on fasica is worn and weathered.

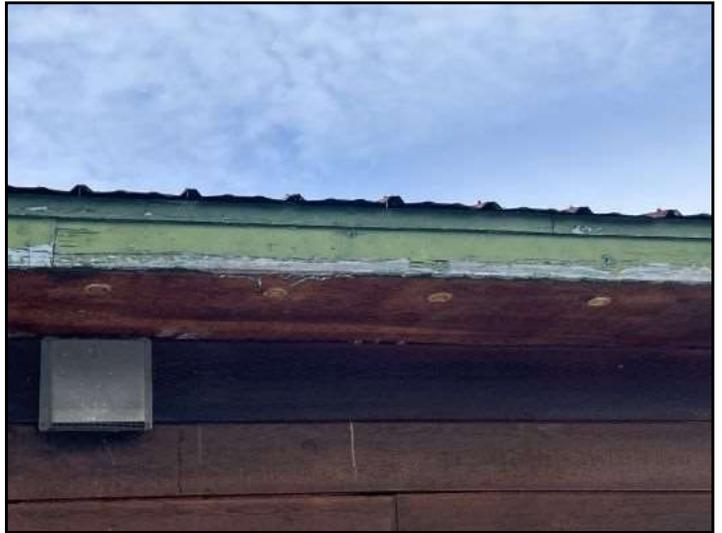
Paint on fascia is worn and weathered.

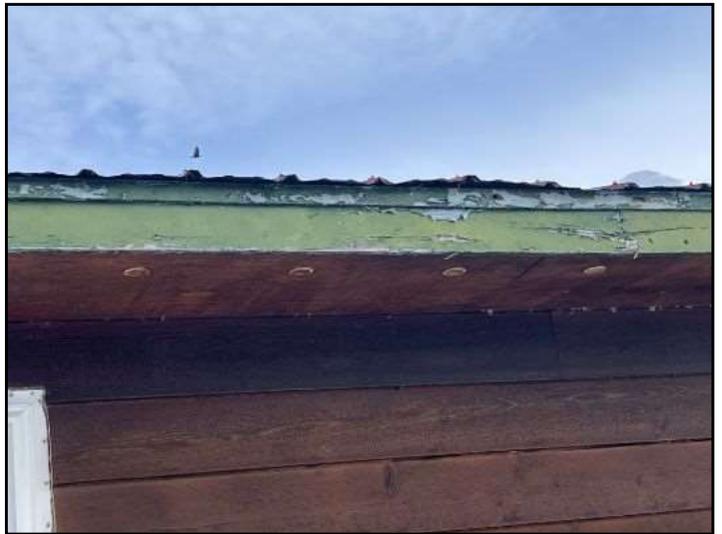
Chip in fascia noted.

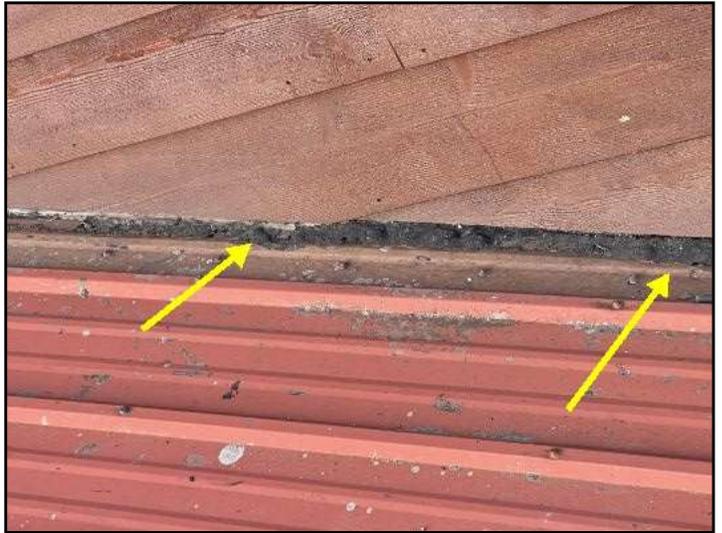
Organic debris build up on flashing of chimney.

- Typical maintenance necessary, now and on an annual or semi-annual basis. This generally consists of resealing gaps at through-the-roof projections and at the parapet walls as necessary.
- In the inspectors opinion the flashings are near the end of their useful life due to wear.
- Recommend review by a licensed roofer for repair or replacement as necessary.

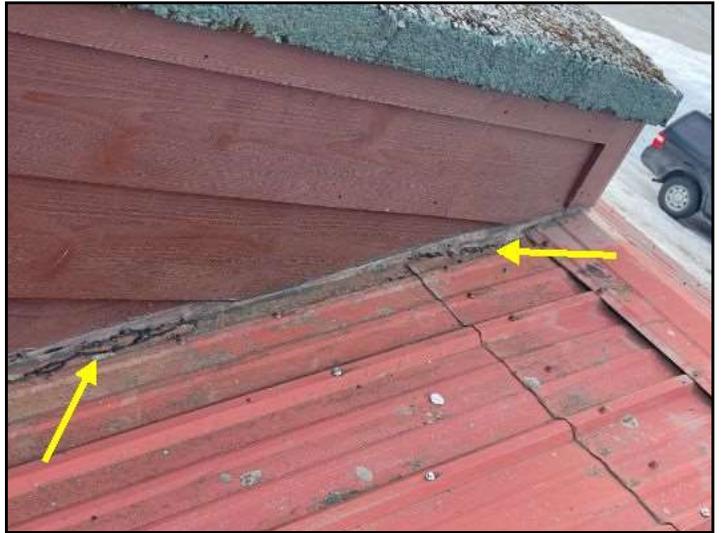
Sealant appears worn and weathered on flashing.

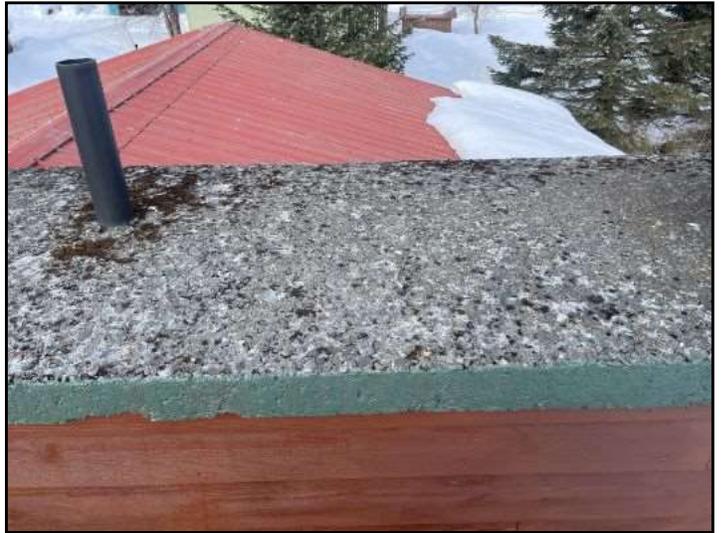
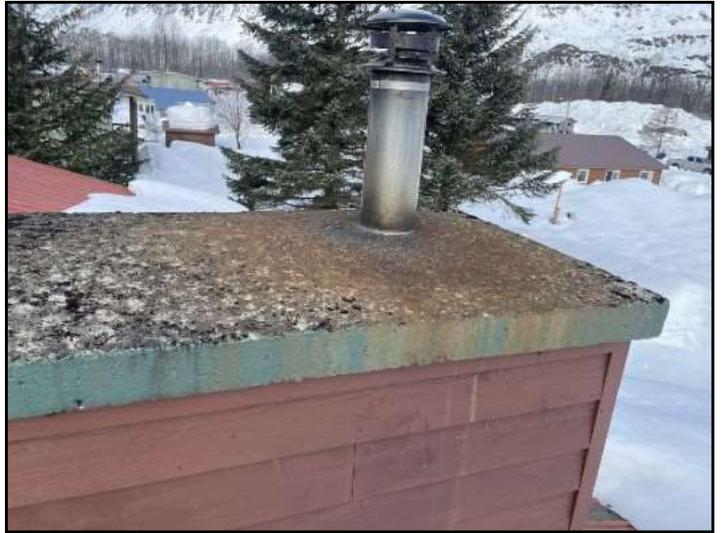
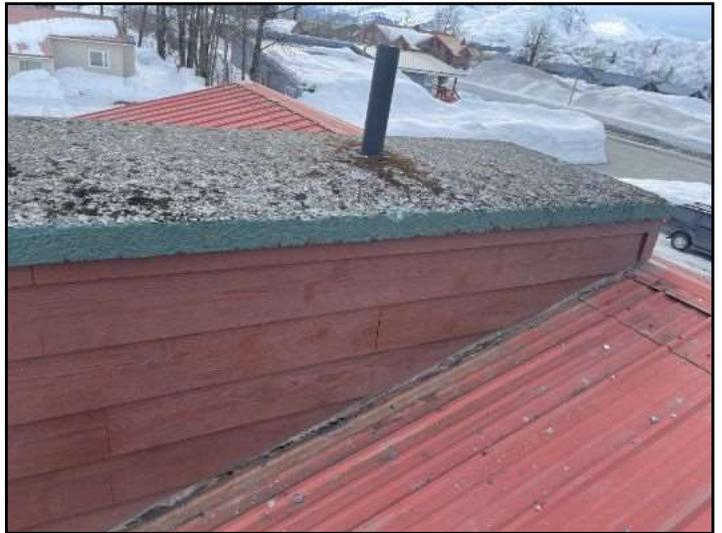
Corner piece on concrete for chimney chase broken off.

- Chimney Mortar shows sign of deterioration. Recommend having repaired as necessary.
- Minor mortar deterioration at chimney; moss present. Recommend cleaning and maintenance as needed.

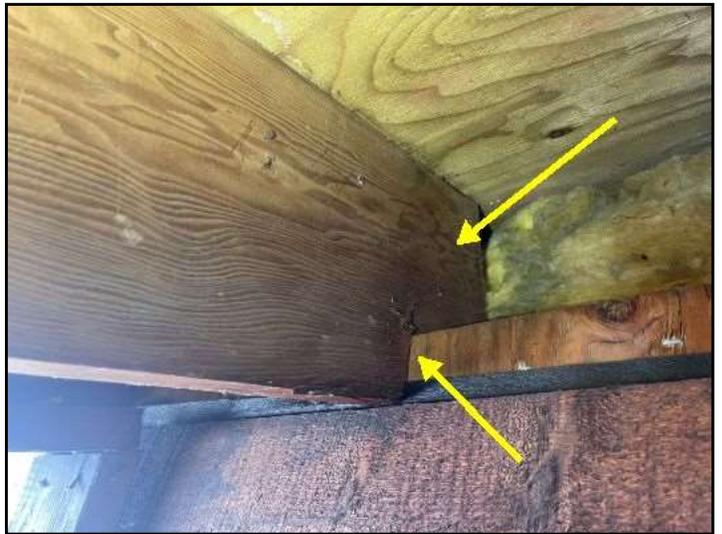
- Extension roofing rafters are only nailed and notched to the homes rafter system. There is no mechanical attachments tying the extension rafters to the homes roofing system. Recommend a qualified roofing contractor to evaluate for repair or replacement.

Rafter only notched and nailed to homes rafter system no mechanical attachment present.

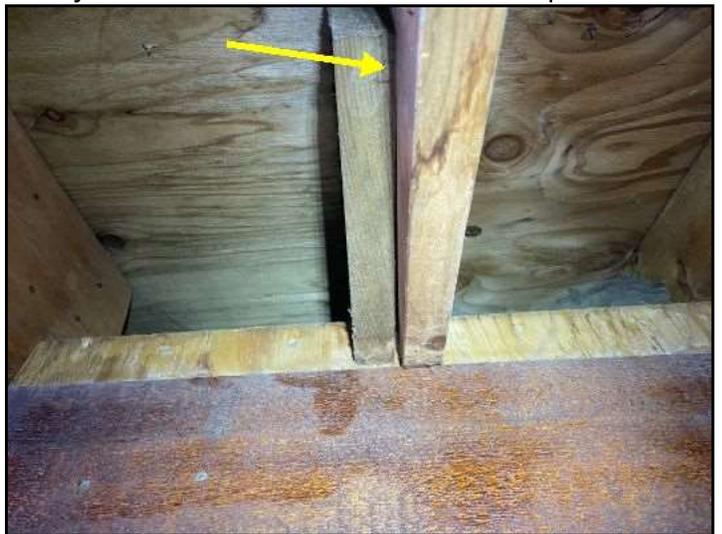
- Extension roof rafters are only nailed and notched to the existing homes roofing system. With the weight of the yearly snow and ice. It's in the inspector's opinion this is the cause of the drywall cracking above the home's doors.

Weight of snow load has caused rafters to spread apart.

Recommend a qualified roofing contractor to evaluate the roofing system for repair or replacement.

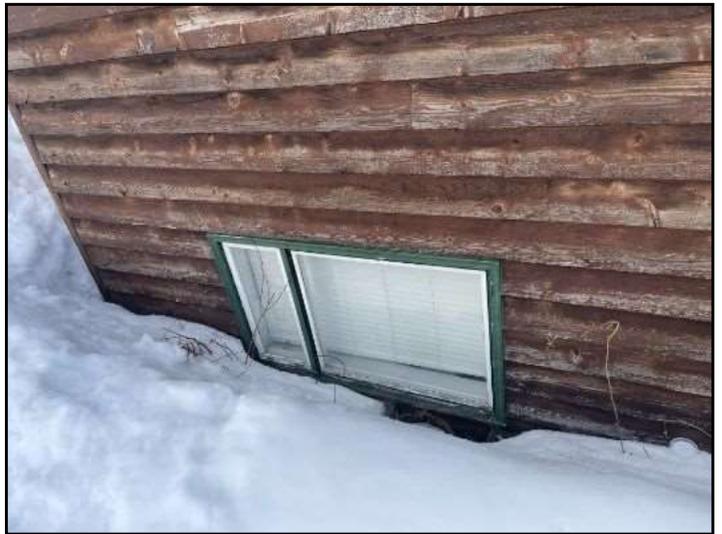
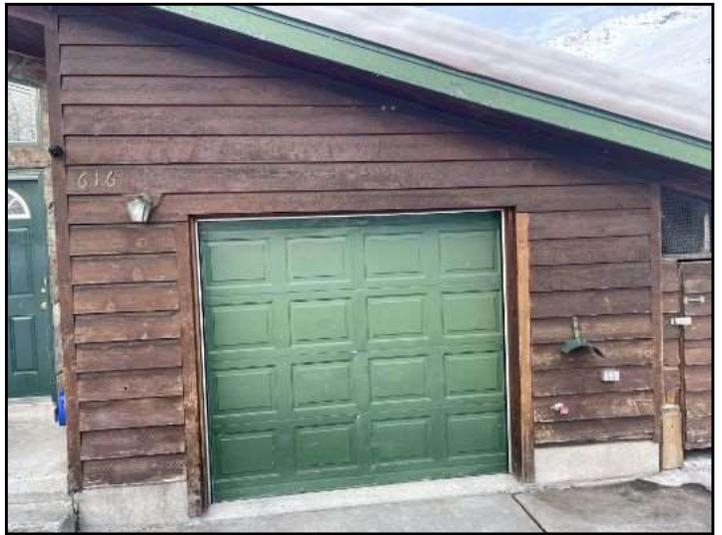
Staining on siding is worn and weathered.

- Exterior siding is worn and weathered in some areas of the home.
Recommend qualified contractor to evaluate for restaining and painting of siding.

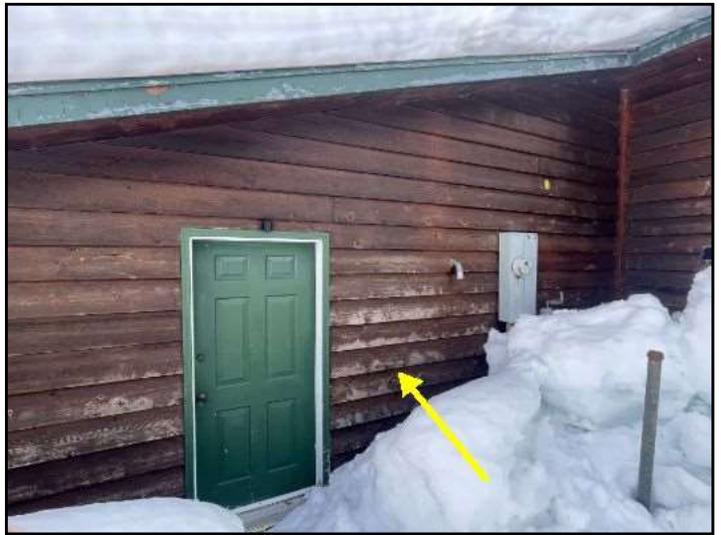
Staining on siding is worn and weathered.

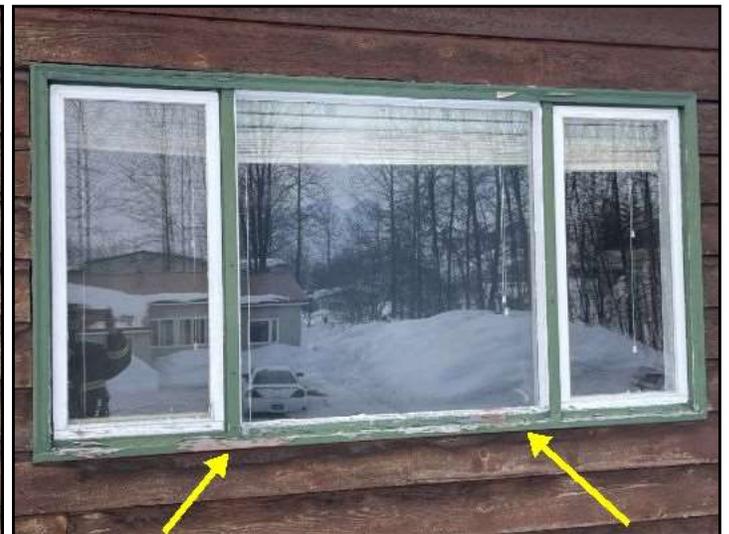
2. Window Condition

- Deterioration of wooden frames noted. While basic maintenance may prolong the life of these window frames, replacement may be necessary at some point.
- Mostly original style window treatments outside home; they may not be as energy efficient as newer windows would be.
- In the inspectors opinion the windows/frames are near the end of their useful life.

Paint on window trim in chipping and peeling.

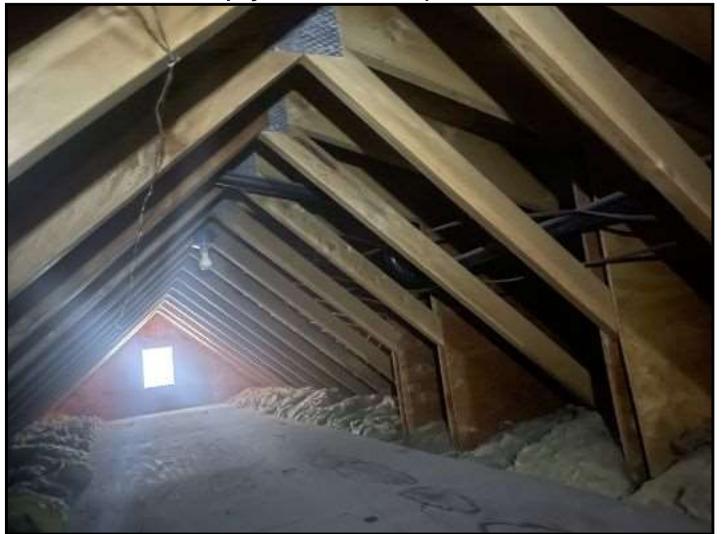
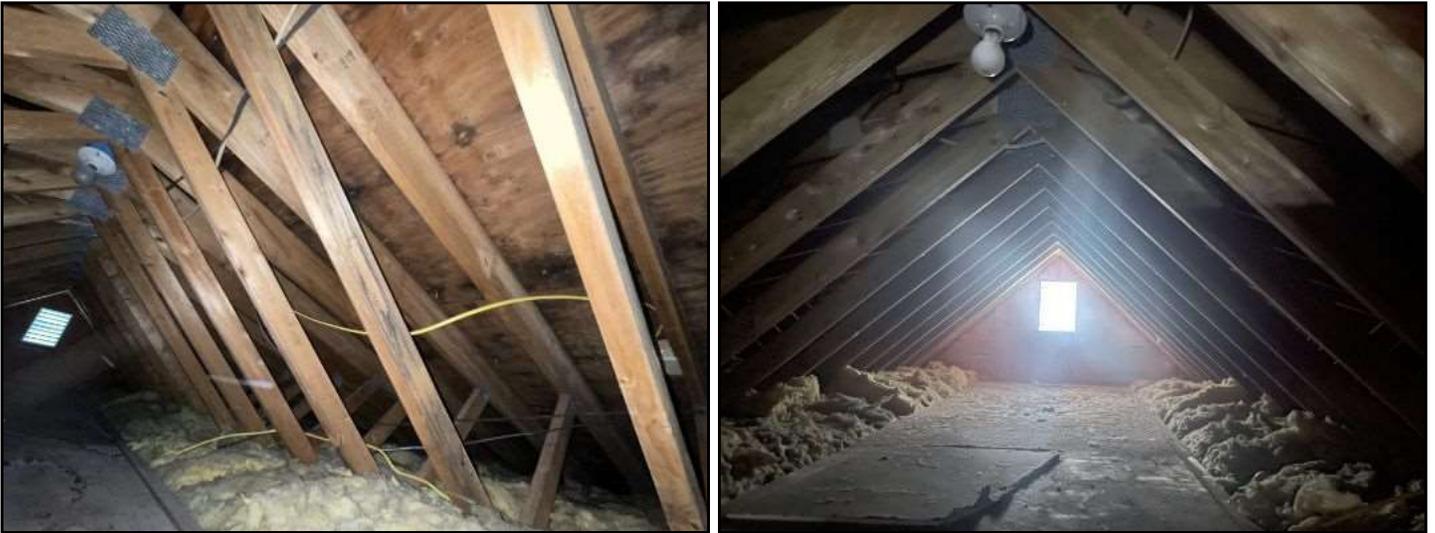
- Evidence of past or present leaks, dry at time of the inspection. Monitor for leaks &/or have roofing contractor evaluate.

Stains on plywood from previous leaks.

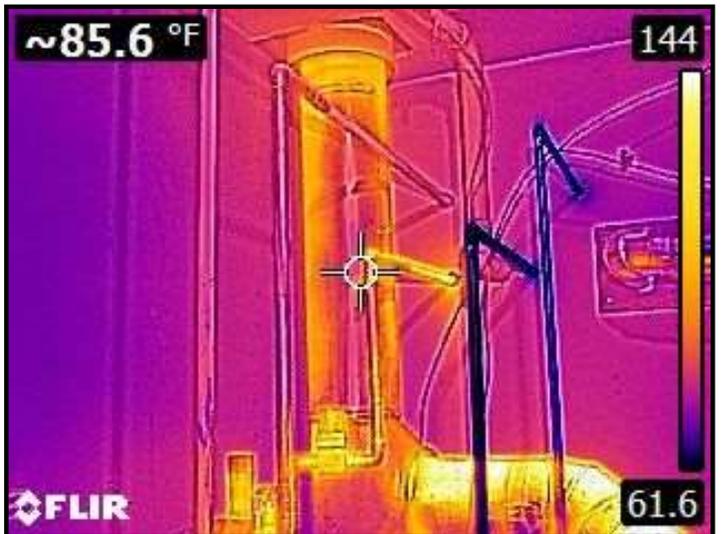
2. Exhaust

- The visible portions of the vent pipes appeared functional.
- **SAFETY CONCERN:** Chimney flue/vent pipe has inadequate clearance to combustible materials. Repair as needed.

It's recommended to keep exhaust stack clear of anything flammable.

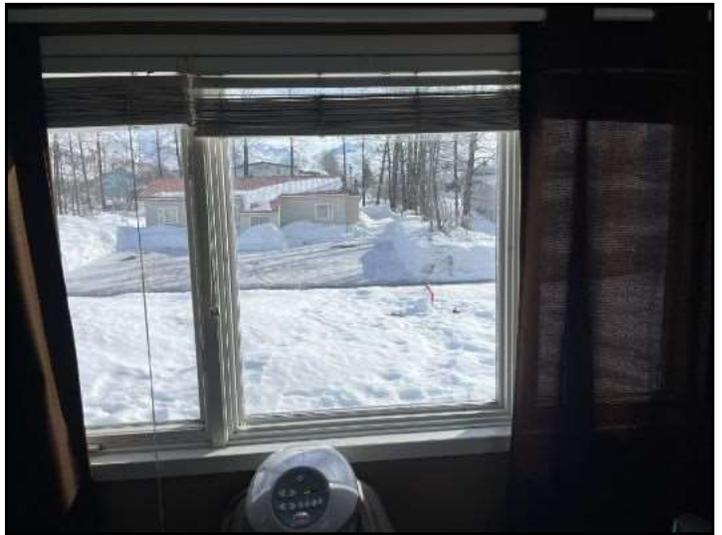
Paint on window sill is worn and weathered.

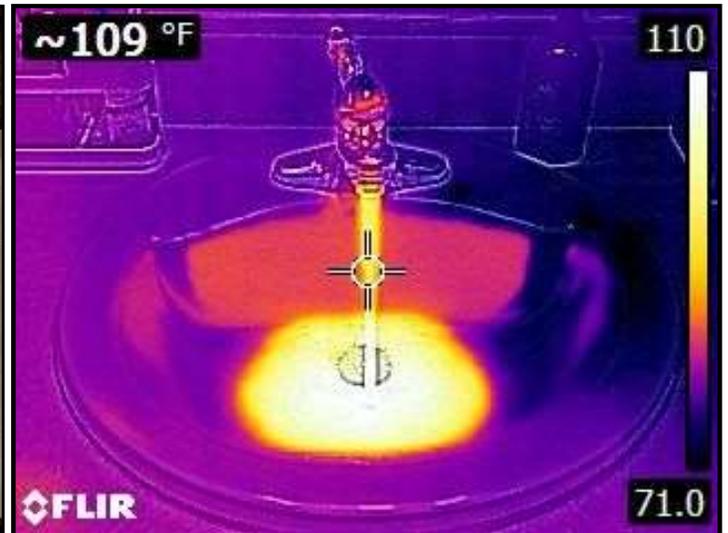
- Sink in bathroom was slow to drain. Recommend clearing drain line to help sink drain better.

Sink was slow to drain.

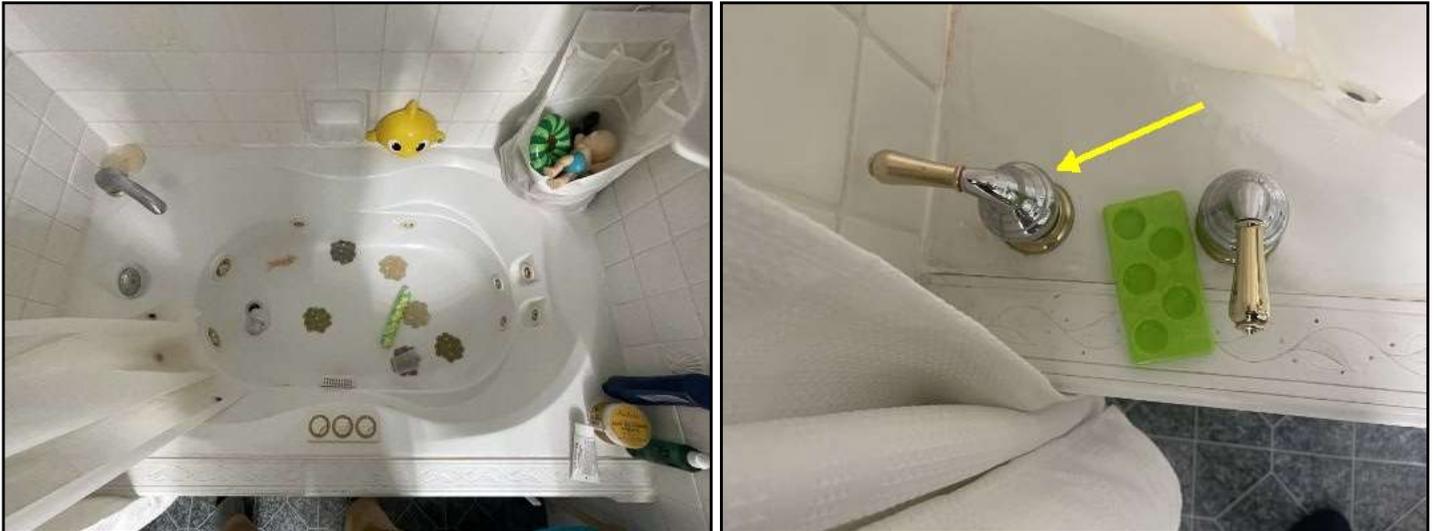
- Hot water control knob is loose and not fully secured. Recommend qualified plumber evaluate for repair or replace.

Knob for hot water was not fully secured to the tub.
