# Gilson Middle School

## CPVC Plastic Piping Failure Analysis

## GEORGE H. GILSON MIDDLE SCHOOL CPVC PIPING FAILURE ANALYSIS

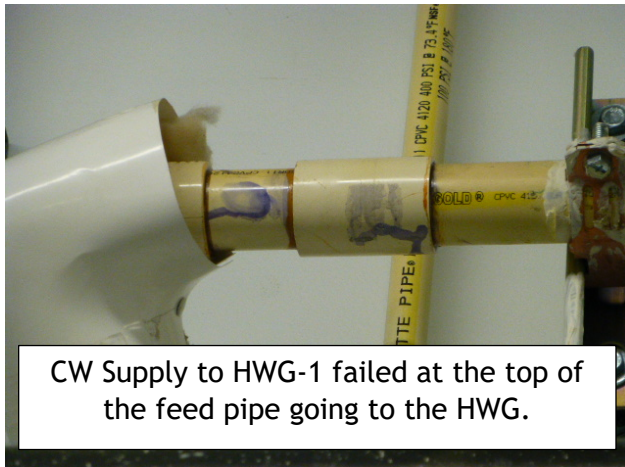
1. **Failure #1:** CW feed to HWG-1 at top of pipe: This failure occurred in a 1.5" CW supply pipe that feeds the hot water generator. The CW pipe runs horizontally along the back wall of the boiler room, which feeds both HWG-1 and HWG-2. The pipe or fitting breakage occurred at or close to the downturn elbow at the left (south) end of the horizontal run. (see photo below). There is a Unistrut and clamp within a few inches to the right of the downturn elbow that appears to be cemented to the strut (see photo below), which is made up very tight to the pipe. The vertical pipe that feeds down to the HWG-1 appears to have movement available, but the horizontal run

did not have any movement available up or down or left to right. As cold water flows through the pipe to feed the HWG-1, it can cool from room temperature (Est at 70F) to an estimated 36-degree service temperature for a temperature difference of 34F. The vertical pipe is about 10' long. Charlotte Pipe has published the coefficient of expansion for CPVC pipe to be 0.408 inches/10 deg F/100 LF. The vertical pipe would therefore expand approximately 0.1387" when it went from 70 deg F to 36 deg F. It is recommended that the clamp on the horizontal pipe be loosened to allow vertical and horizontal movement for this expansion and contraction.

CW Supply to HWG-1 failed at the top of the feed pipe going to the HWG.

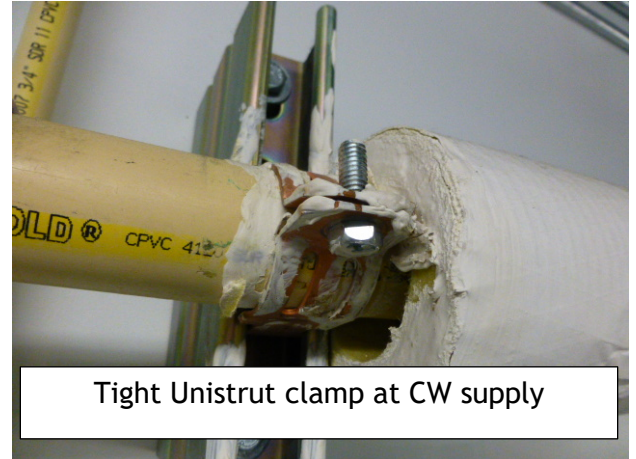
Tight Unistrut clamp at CW supply

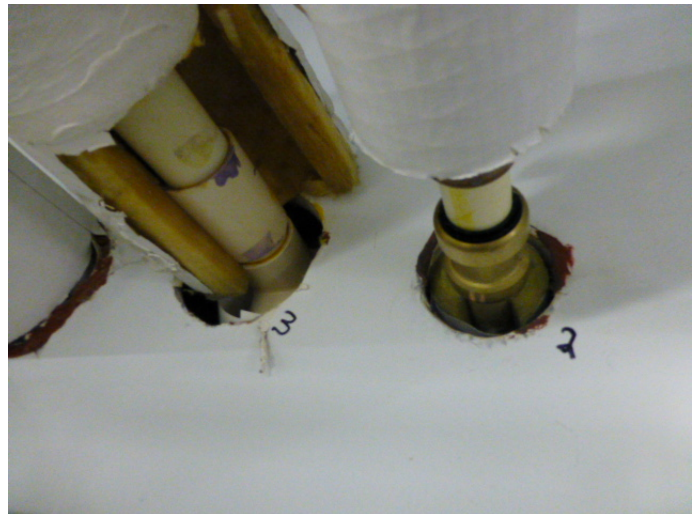
2. **Failure #2, #3:** These two failures occurred high at the plan south wall of the boiler room. The failure shown as #2 was in a 1" CPVC 120-degree hot water recirculation (HWC) line where it went into the wall. We were advised that the leak occurred at the coupling, but we could not verify this since the repair was already completed. A 1" shark bite coupling was used to make the repair. There is a downturn 90-degree elbow just inside the wall

that would have restrained thermal expansion and contraction, and which failed at the opposite side of the wall as well at another time. The 1.5" HW pipe just to the left of failure #2 is identified as #3. It also has a 90-degree elbow just inside the wall and is at the end of a run of piping that is supported with trapeze hangers and Unistrut clamps. It appears that expansion could not occur due to the 90-degree downturn elbows at each pipe, and the wall behind trapping those fittings. As noted below, both pipes on the opposite side of the wall also failed at or near the lower 90-degree

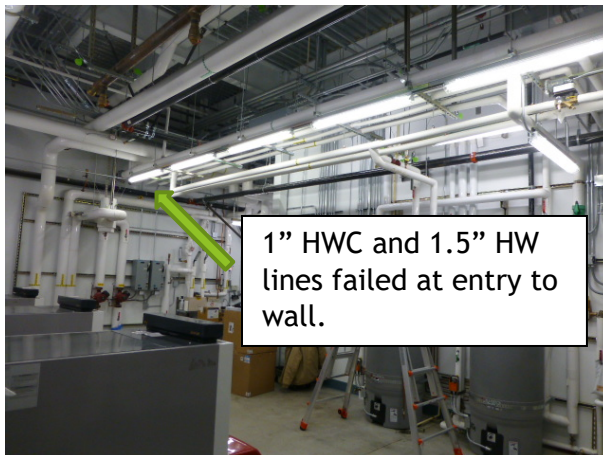
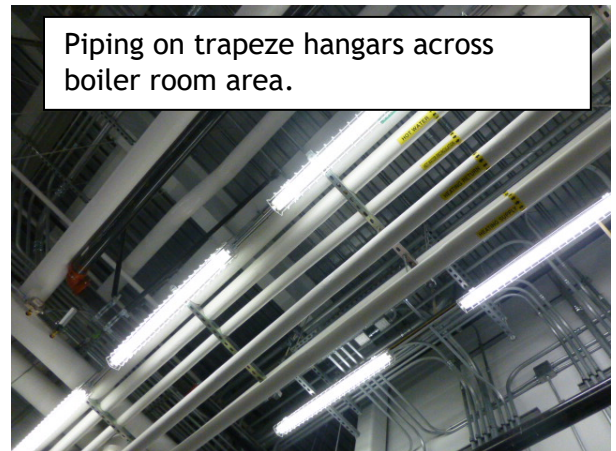
The length of the straight run of piping on the trapeze hangars was measured to be about 25', and there were no expansion loops or offsets in that run. It was not determined if the Unistrut clamps were loose or tight along the trapeze hangers. Project specifications Section 22 05 29, 2.1 C 5, and 3.3 I do permit use of trapeze hangers, especially where piping is installed parallel and at the same elevation. Section 3.3 M also does require that the hangers be designed for pipe movement without disengagement of supported pipe.

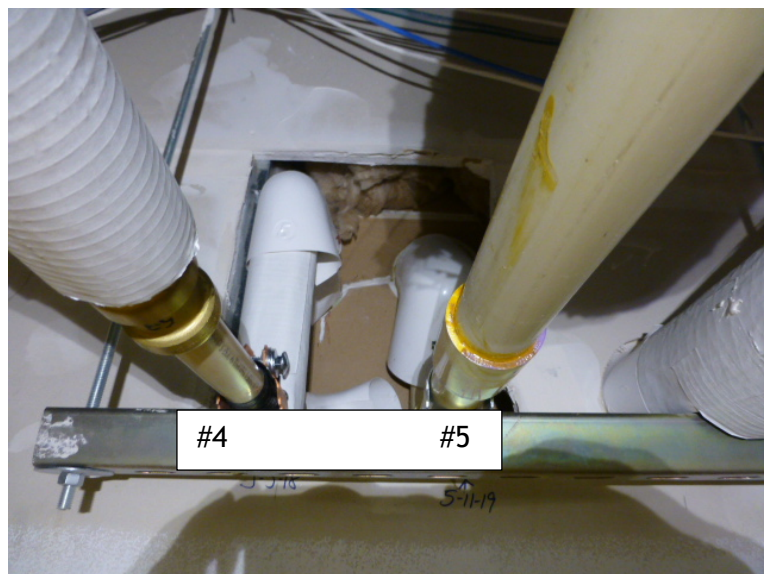
3. **Failure #4, #5:** These two failures occurred on the opposite side (south side) of the boiler room wall above the lay-in ceiling in the gym storage room, on the same two pipes described in failure 2,3 above. Both the 1.5" HW line and the 1" HWC lines failed at or near the lower 90-degree elbow facing the plan north, as the piping continued to the boy's locker room ceiling cavity on the opposite side of the corridor outside of the gym storage wall. As noted on the wall, the 1.5" HW line failed on 5/11/19, and the 1" HWC line failed on 5/3/18. We do not know if the trapeze clamps were tight or loose, but either

way there was no room for thermal expansion. The pipes continue to run to the south to a space above the boy's locker room. Plans 1/M222 and 2/M222 show a 28" offset

expansion loop in the piping above the boy's locker room (which has a hard ceiling with no access), but it is not known if the trapeze hanger clamps from failure point 4A and 3A above were loose or tight to adsorb or restrain movement. It is recommended that a horizontal design expansion loop be installed at the south boiler room wall where these four failures occurred, with one horizontal leg for each pipe in the south side of the boiler room and the other horizontal leg for each pipe in the space above the storage room, with a restraint at the loop center. See Exhibit A for sizing details.

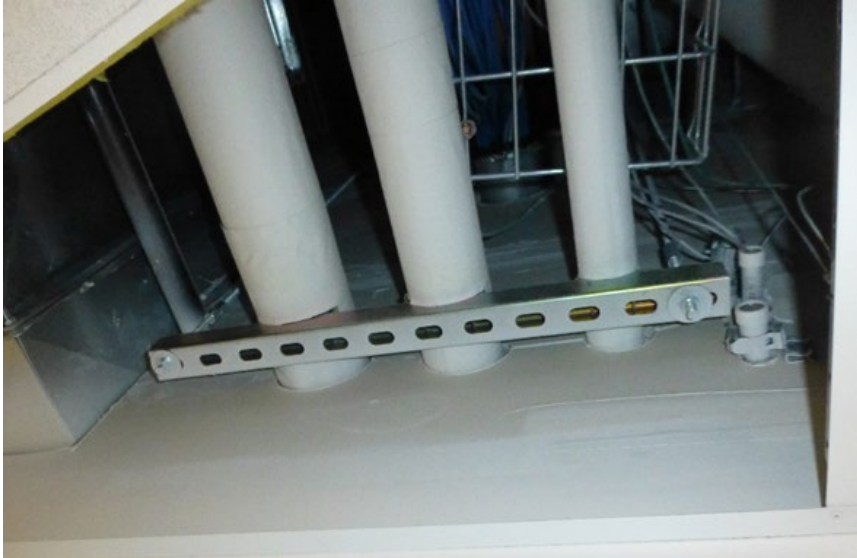
CW, HW, HWC piping above drop ceiling in corridor outside entry to boys' locker room. Piping with offset expansion loop is above hard ceiling and is concealed.

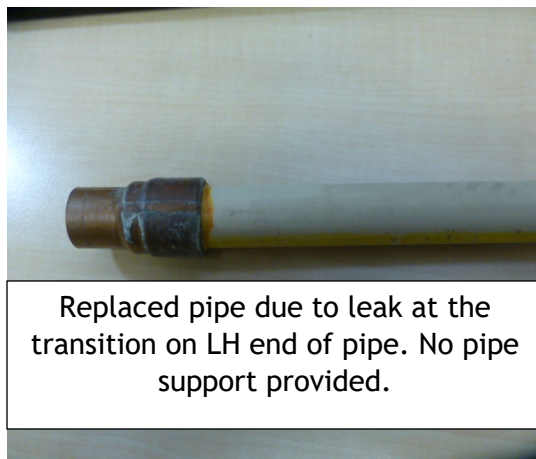
4. **Failure #6:** This was a  $\frac{3}{4}$ " CPVC pipe above the kitchen food storage lay-in ceiling. The failure occurred in a copper to CPVC transition coupling. The solvent weld at the transition leaked, and the pipe was able to be twisted at the female transition. It is suspected that the fitting was dirty or inadequate solvent was applied, since there was no fillet of solvent evident at the fitting. The pipe was not adequately supported, that may have stressed the fitting as well. The pipe itself did not leak, only the fitting connection.

Replaced pipe due to leak at the transition on LH end of pipe. No pipe support provided.

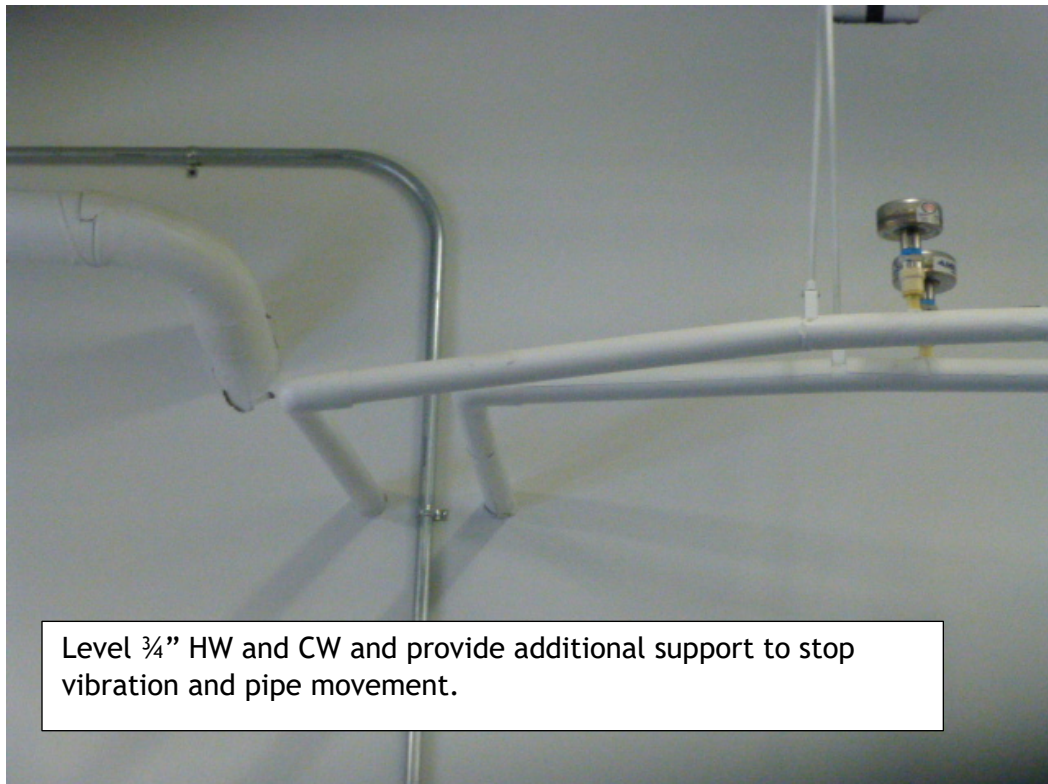
5. **Potential Failure #1:** There is a hot and cold water  $\frac{3}{4}$ " CPVC feed to a clothes washer in the receiving room. See detail 5/M801 and 1/M212, upper RH corner of plan leading to washer box P-9. The two pipes each have a water hammer arrestor, but when water is drawn from the piping on the south end of that room, the HW and CW pipes vibrate and move around enough to eventually cause a failure in the piping. Recommend seismic pipe support at the piping, and adjustment of the clevis hanger levels or offset 90s to provide level piping to the wall.
