**CITY OF VALDEZ ASSESSOR'S REVIEW FORM**Appeal # 234

Property address (or legal description, mile, etc.): 714 N SNOWTREE DR

# *Arctic Home Inspections* Property Inspection Report

714 North Snowtree Drive, Valdez, AK 99686

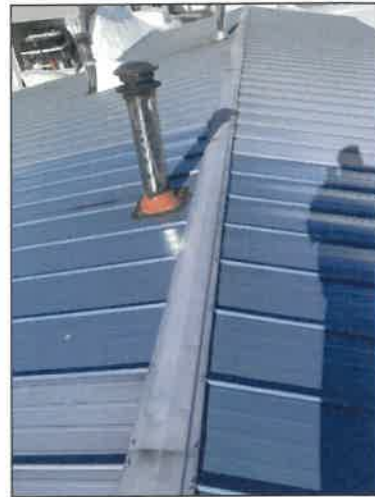
Missing screw on ridge.

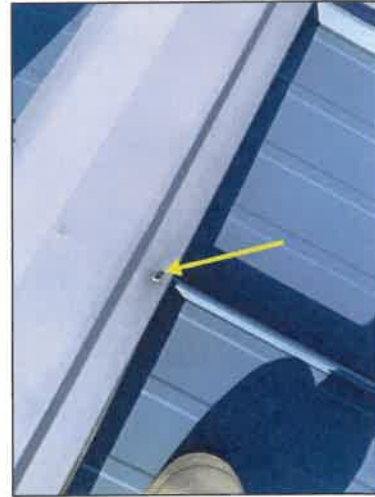
Missing screw on ridge.

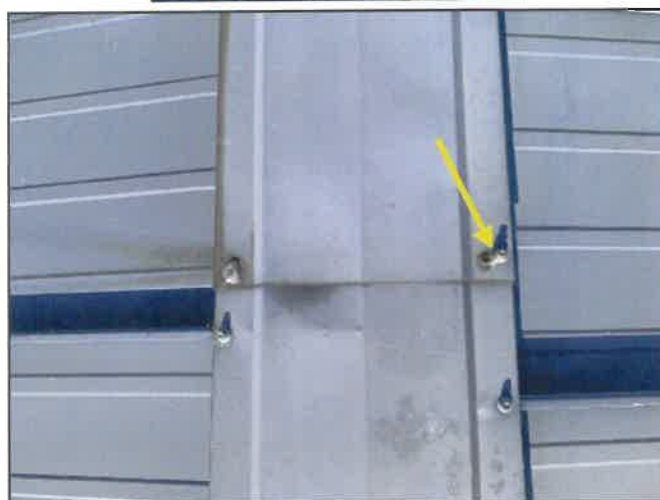
Screw loose on ridge.

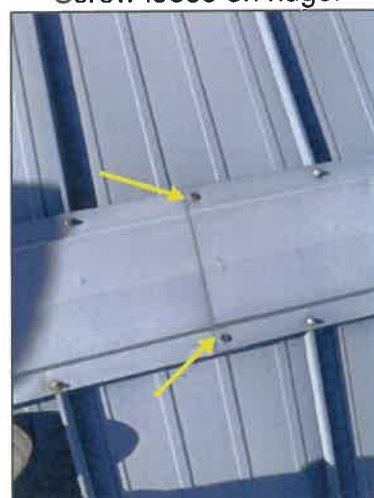
No fasteners on joining of ridge pieces.

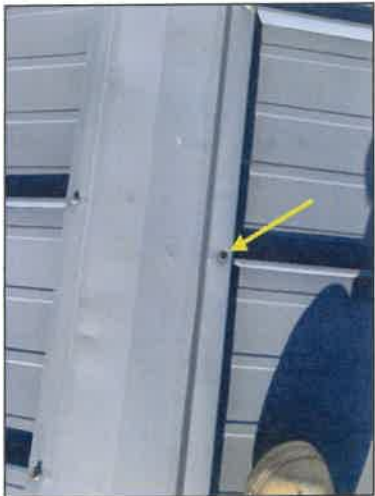
Missing screw on ridge.

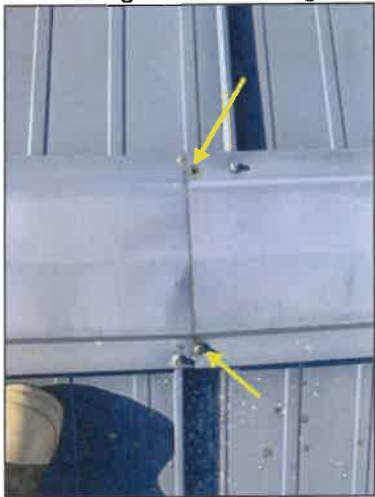
No fasteners on joining of ridge pieces. Loose screw.

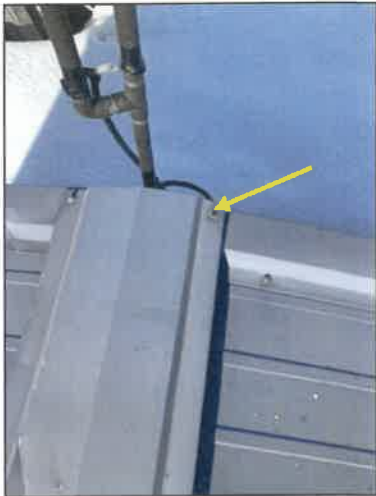
Missing screw on ridge.

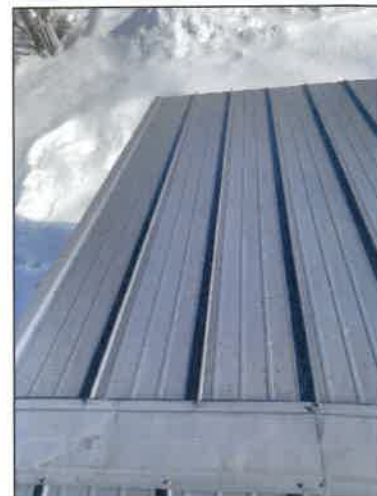
Dent in roof.

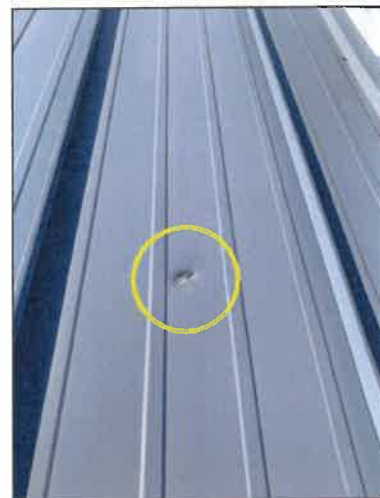
- Multiple screws missing on the ridge of the roof. Recommend having licensed roofer to repair.
- Two dents detected at the time of inspection. One dent has a small crack and may cause a leak in the garage roof. Recommend a licensed roofer to evaluate for repair or replacement.

Dent with a small crack in the roof panel over the garage.

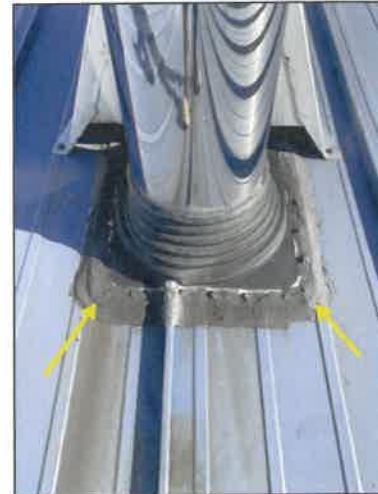
Recommend proper sealing of boot.

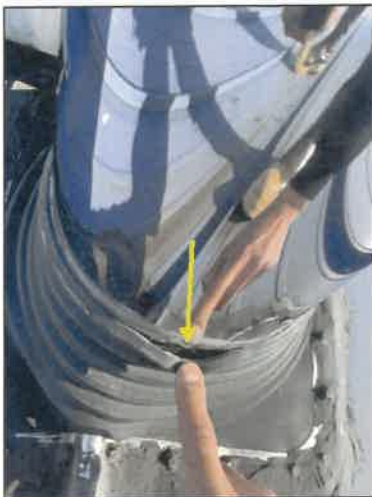
Recommend resealing boot.

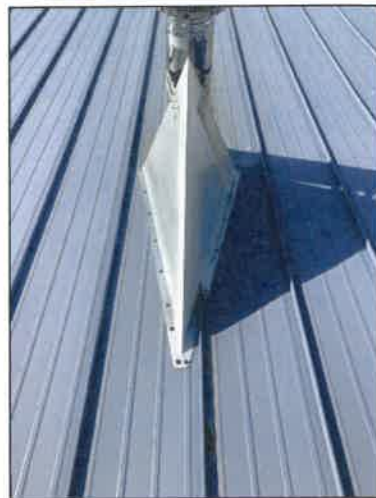
Recommend sealing cricket around seam of roof.

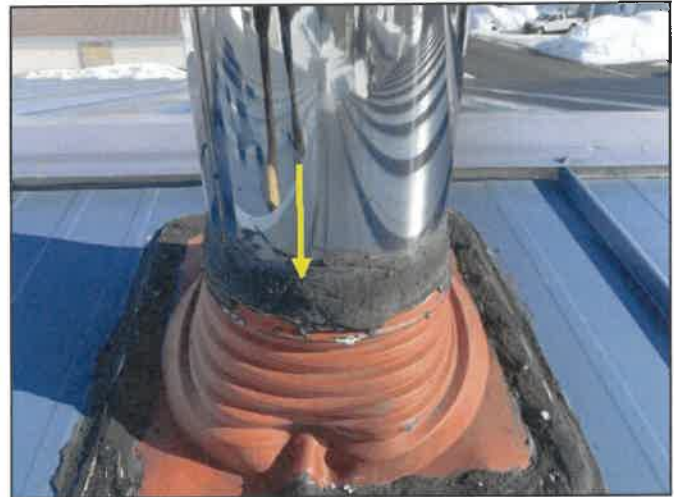
Recommend proper sealing of boot.

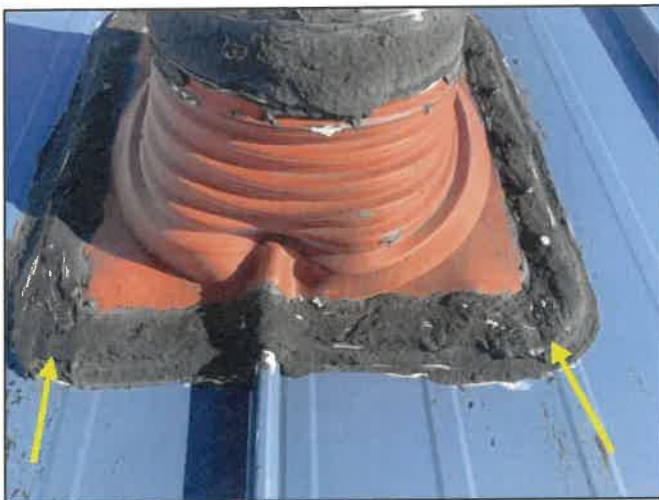
Recommend proper sealing of boot.

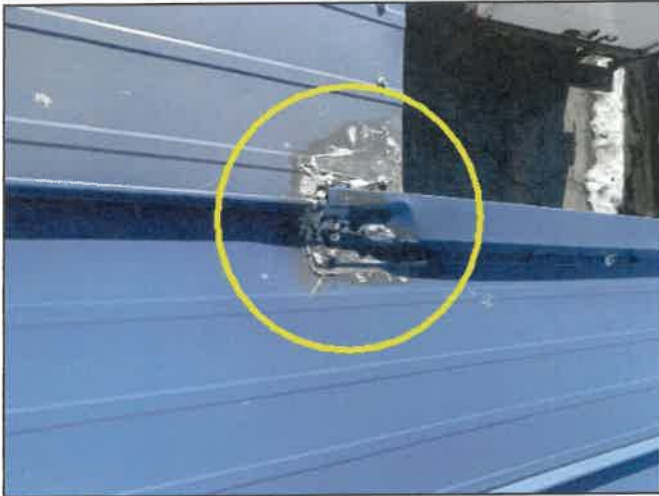
Recommend proper sealing of flashing.

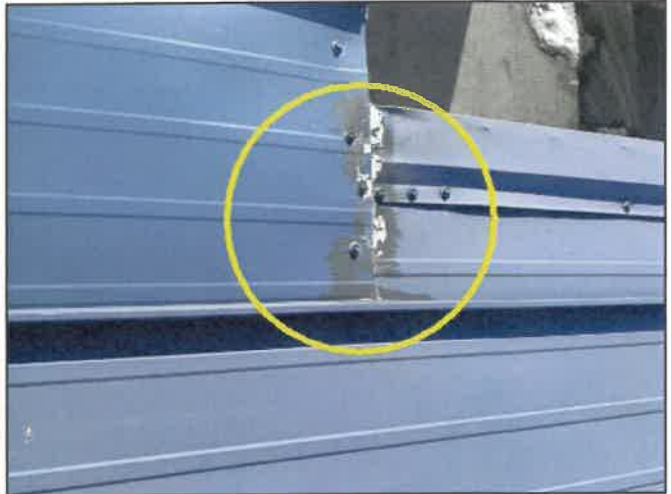
Recommend proper sealing of flashing.

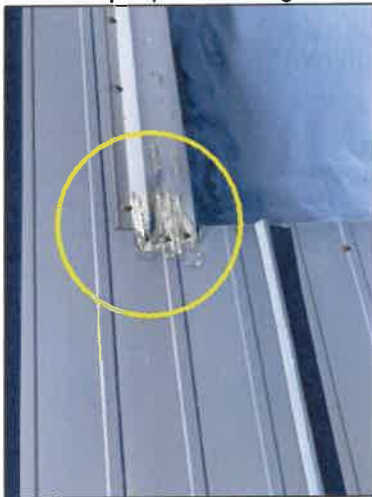
Recommend proper sealing for flashing.

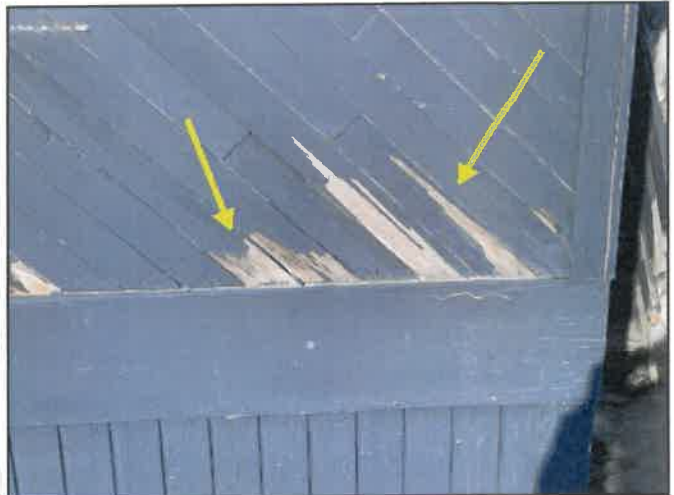
Paint chipping on homes siding.

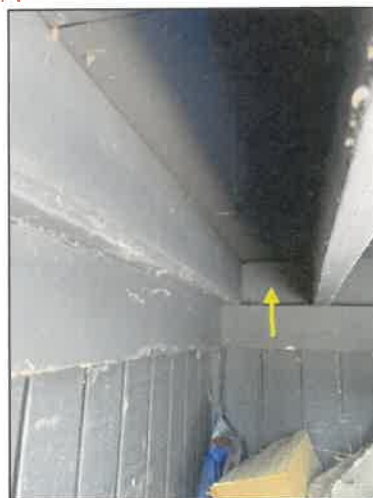
No lag bolts attaching porch to the home.

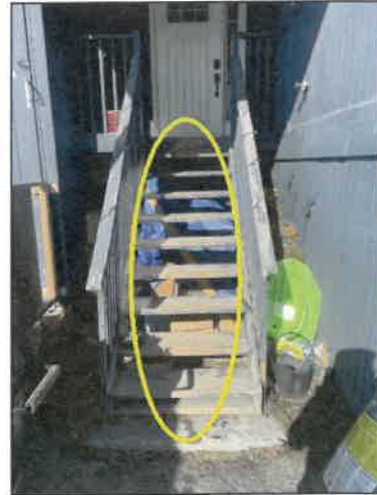
Stairs are worn and weathered. Some steps are damaged.

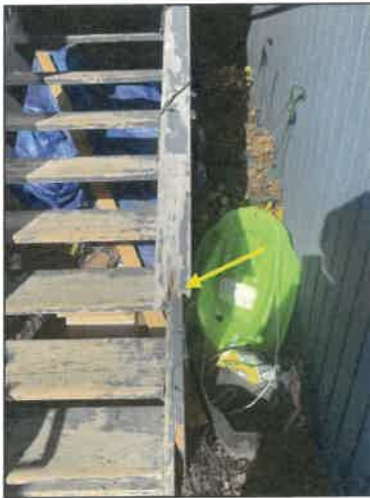
Handrail is damaged.

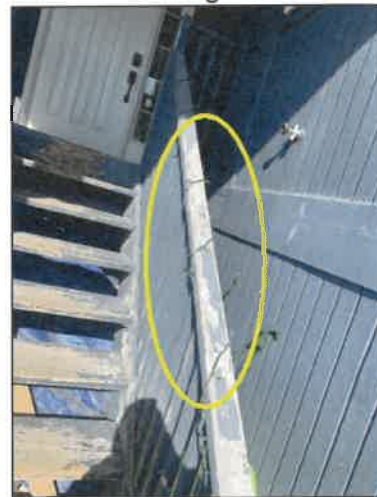
Handrail is not fully secure.
