## WEEKLY PROGRESS REPORT

LEGAL DESCRIPTION: GLACIER HAUL ROAD  
RIP RAP PROJECT  
VALDEZ, ALASKA

PREPARED FOR: HARRIS SAND AND GRAVEL

Glacier Haul Road bank armoring

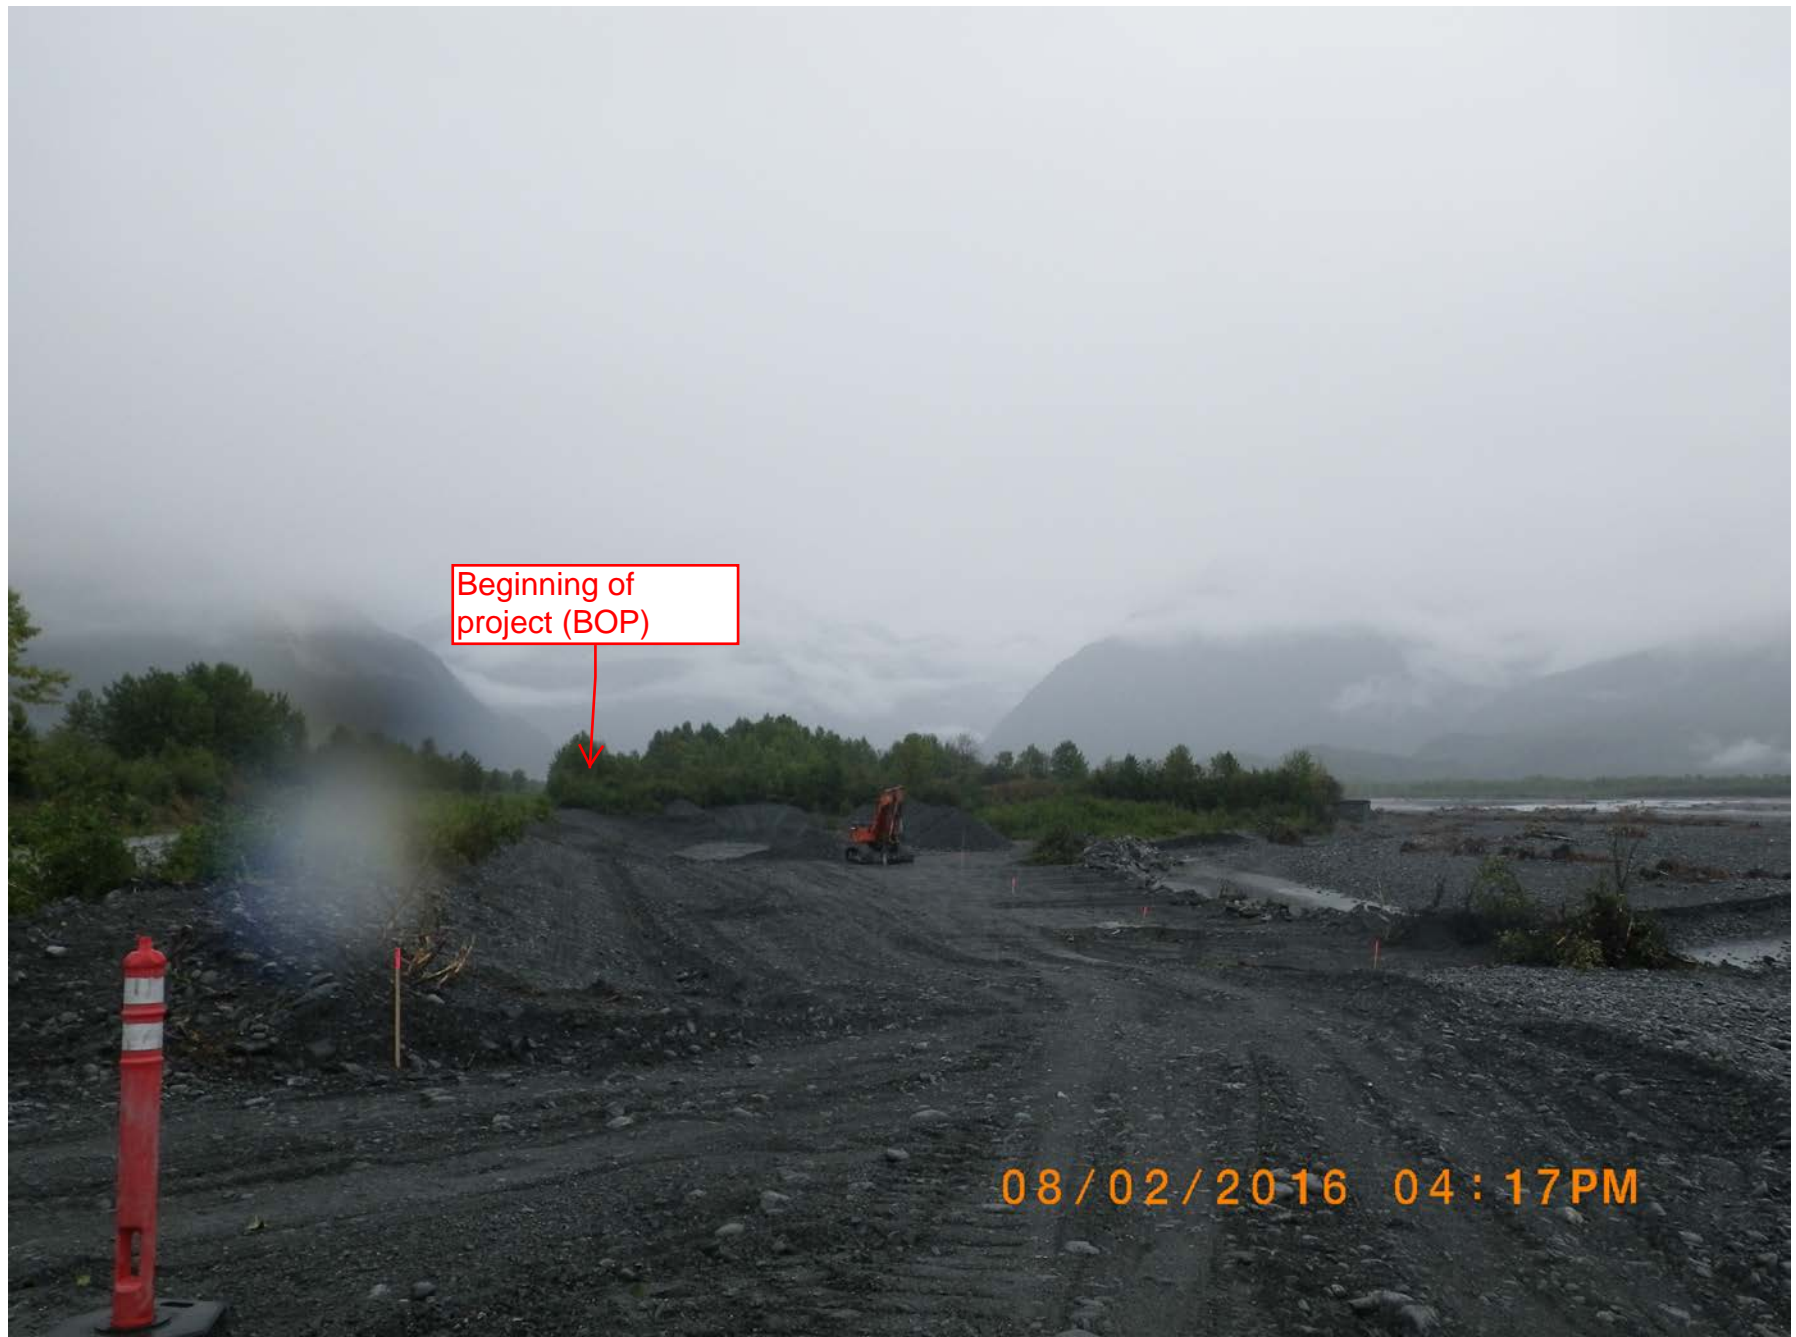
Earthwork started to slope bank and excavate toe at BOP.

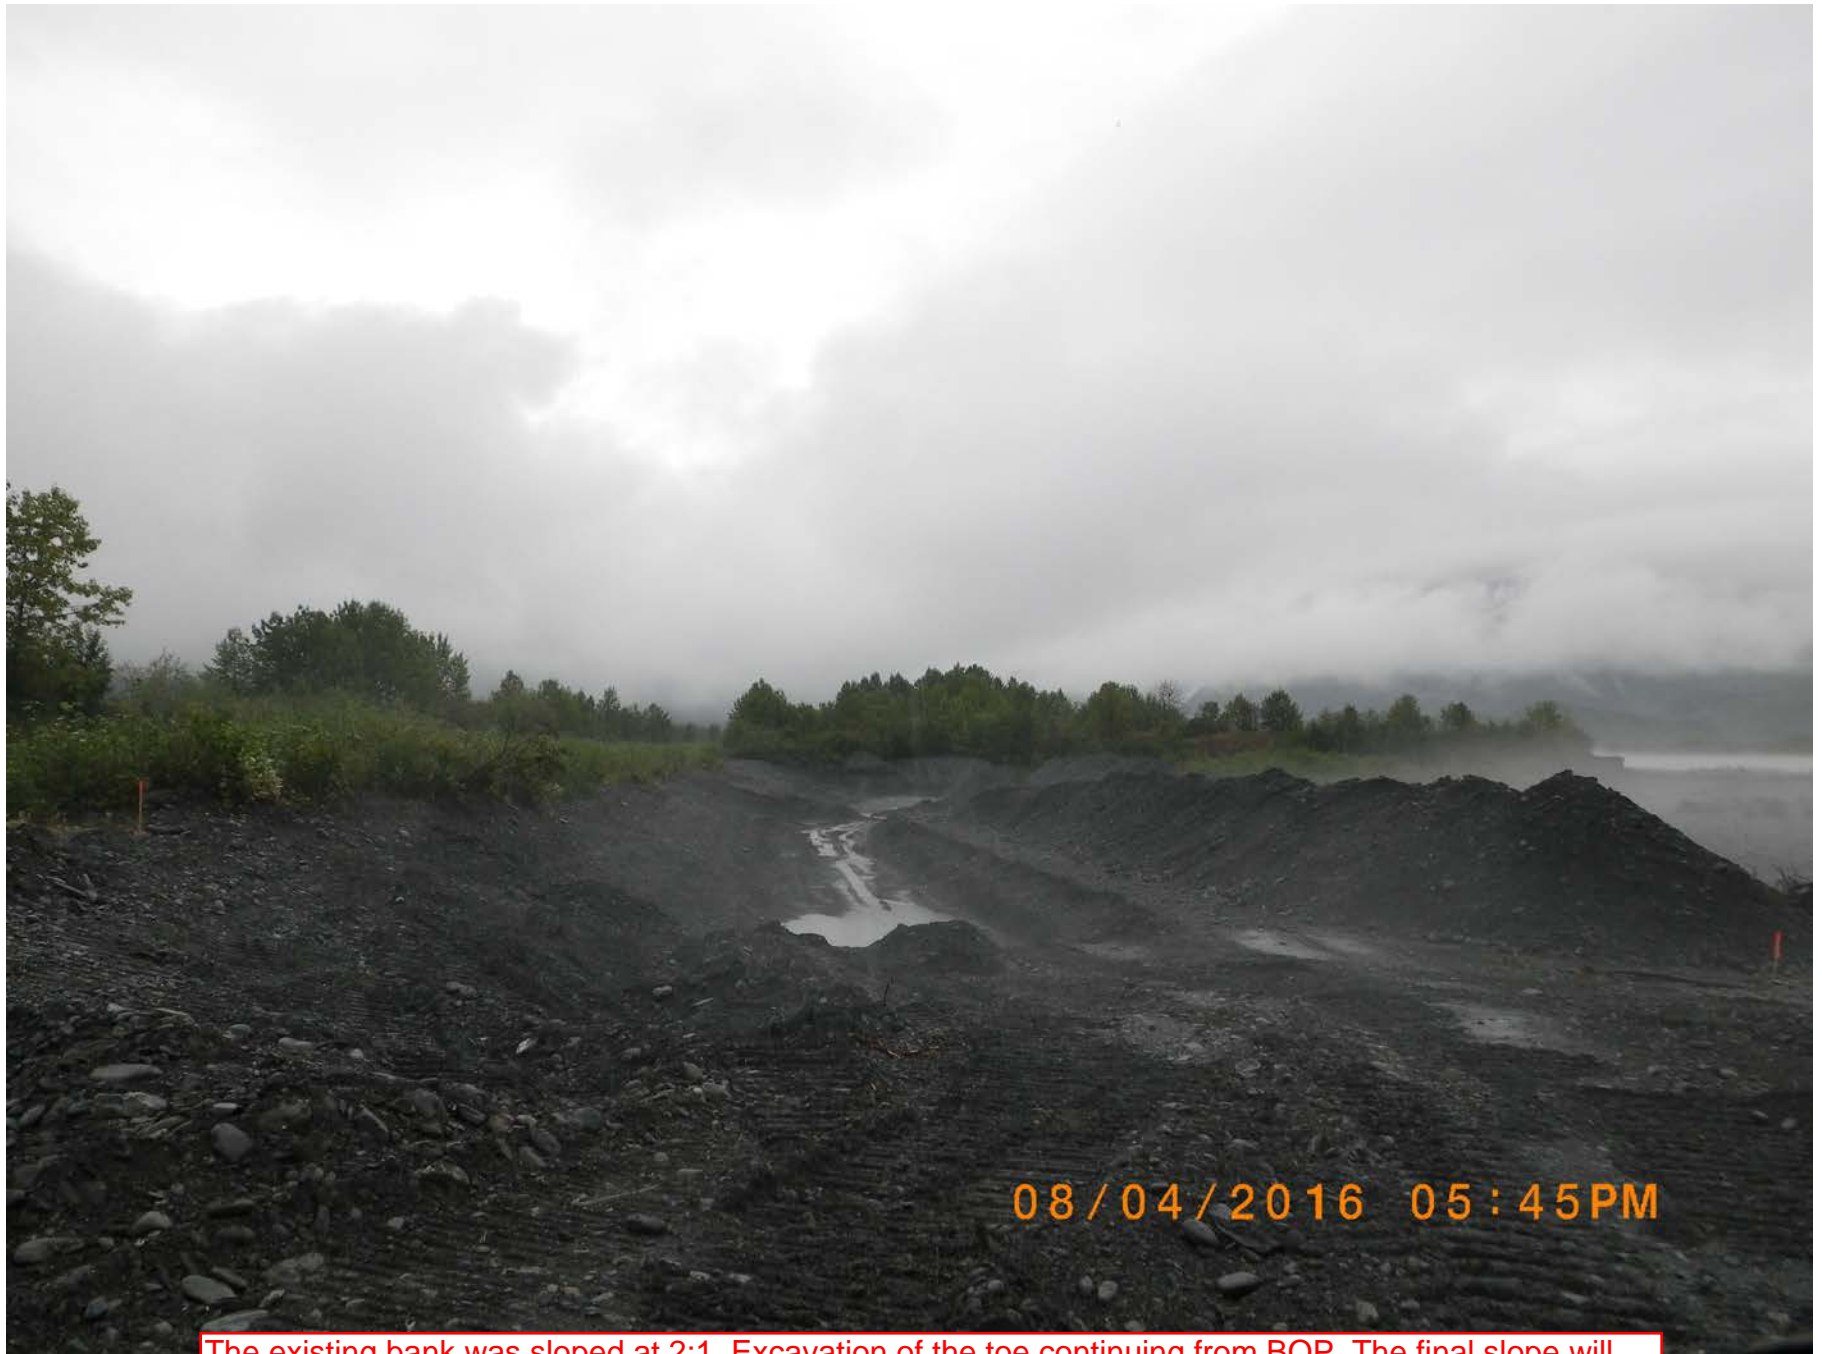
The existing bank was sloped at 2:1. Excavation of the toe continuing from BOP. The final slope will be 3:1 when riprap is placed.

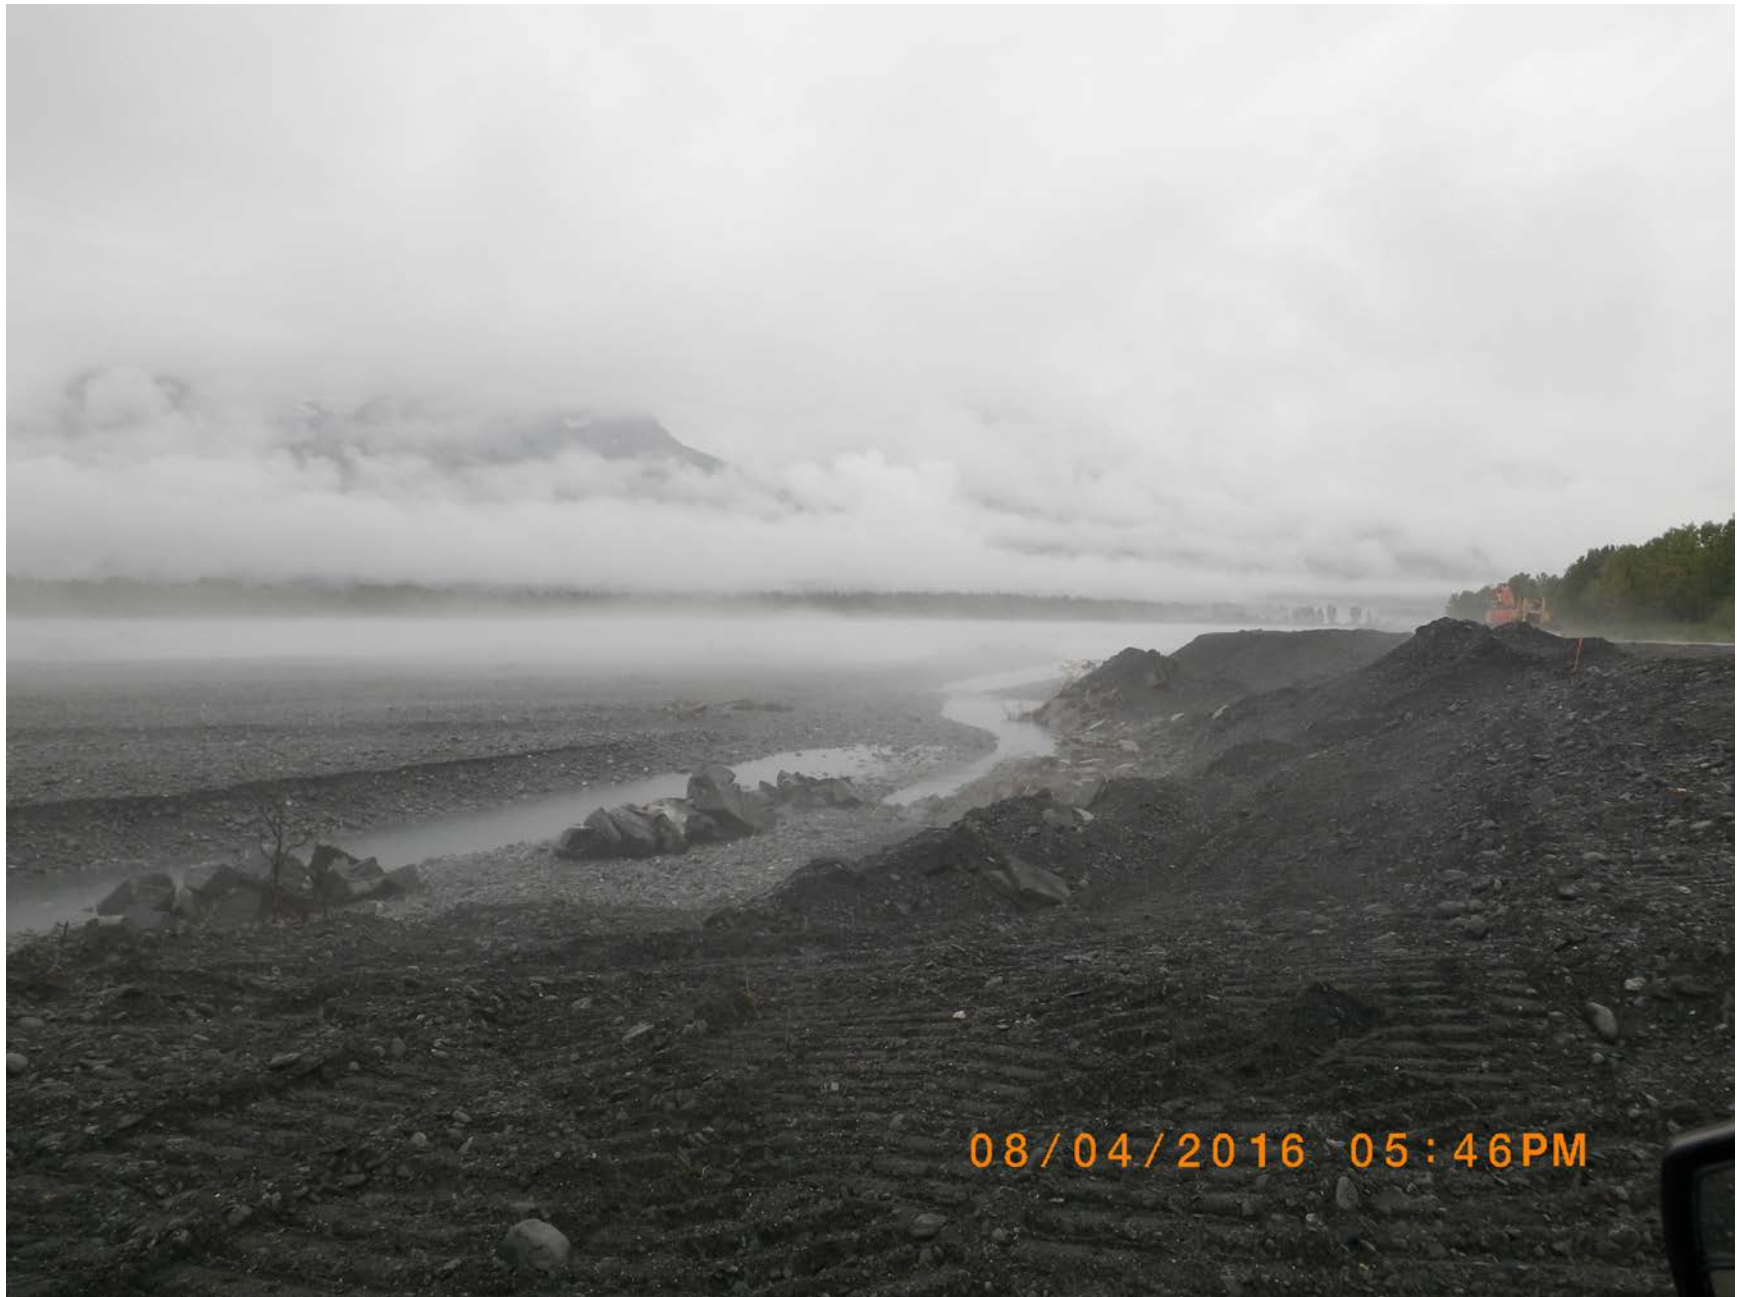
Looking downstream towards bridge as work continues to slope existing bank.

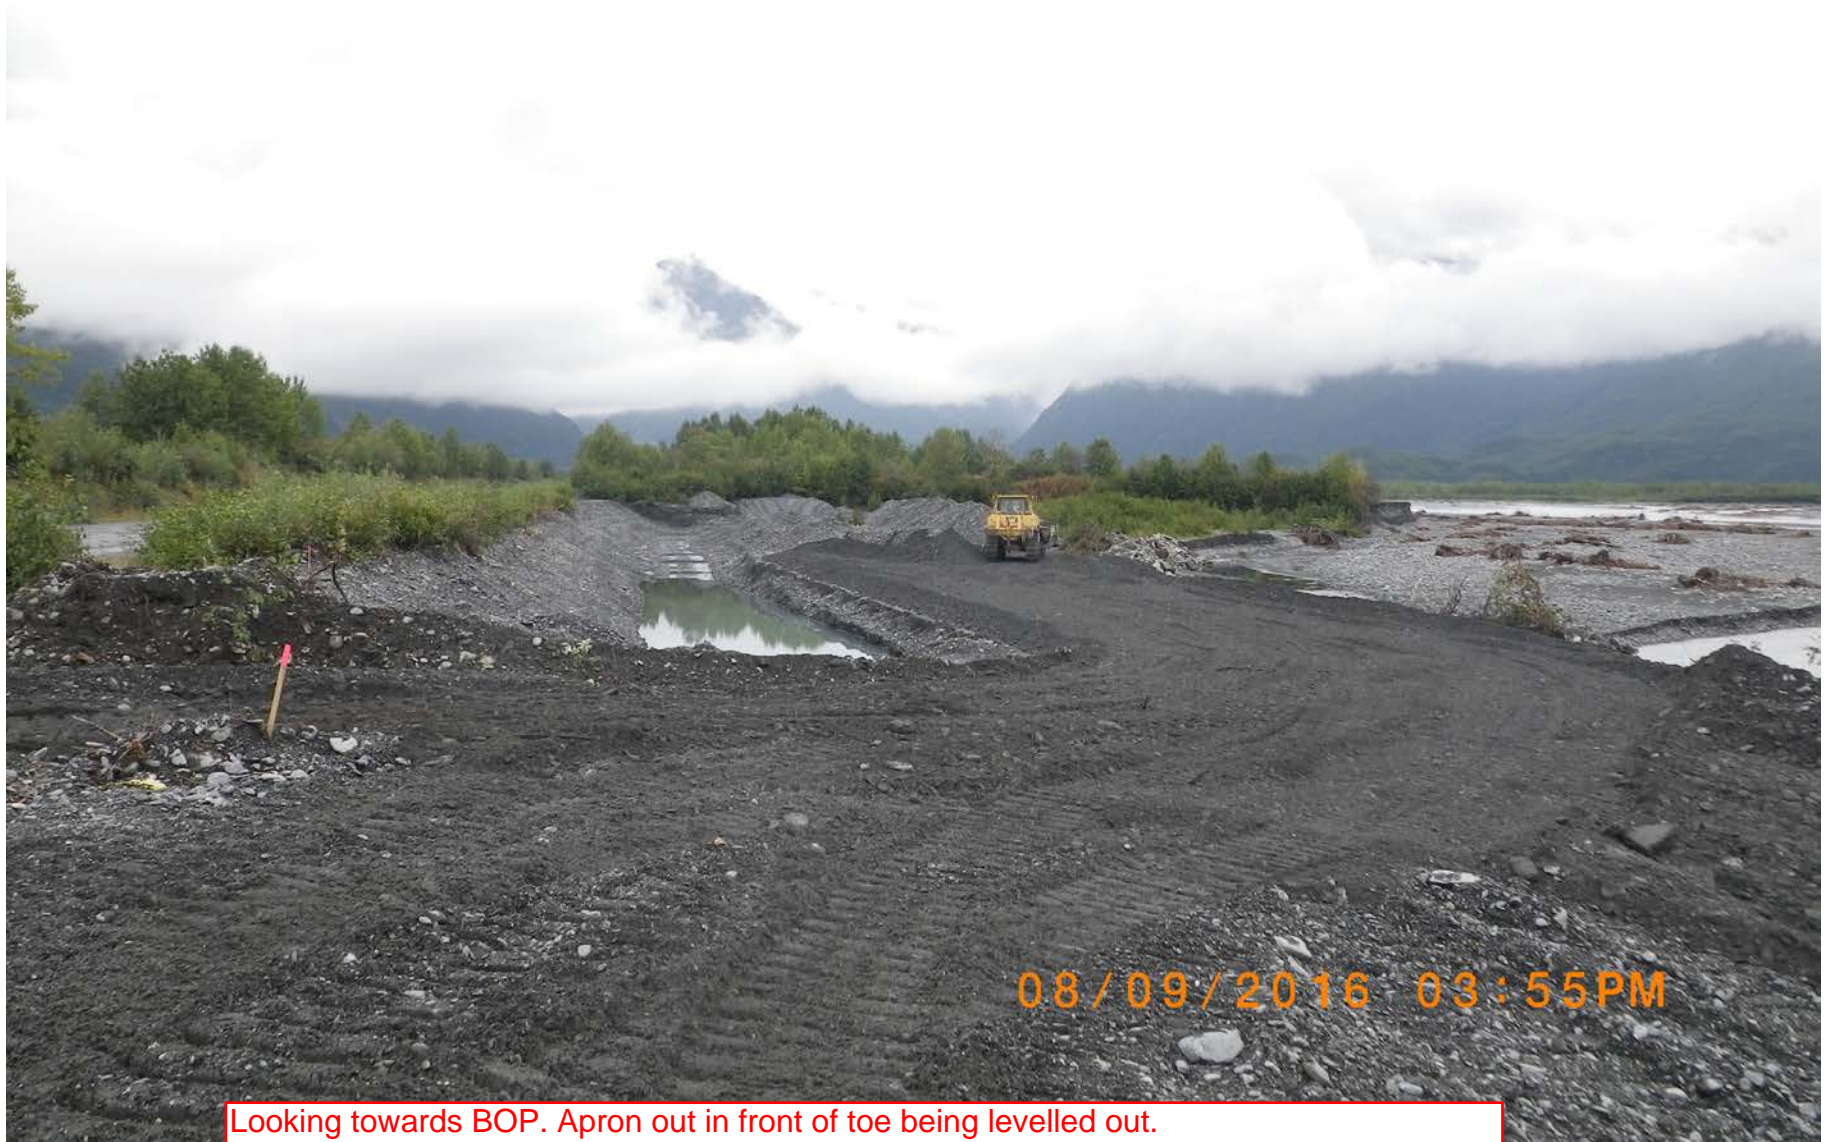
Looking towards BOP. Apron out in front of toe being levelled out.

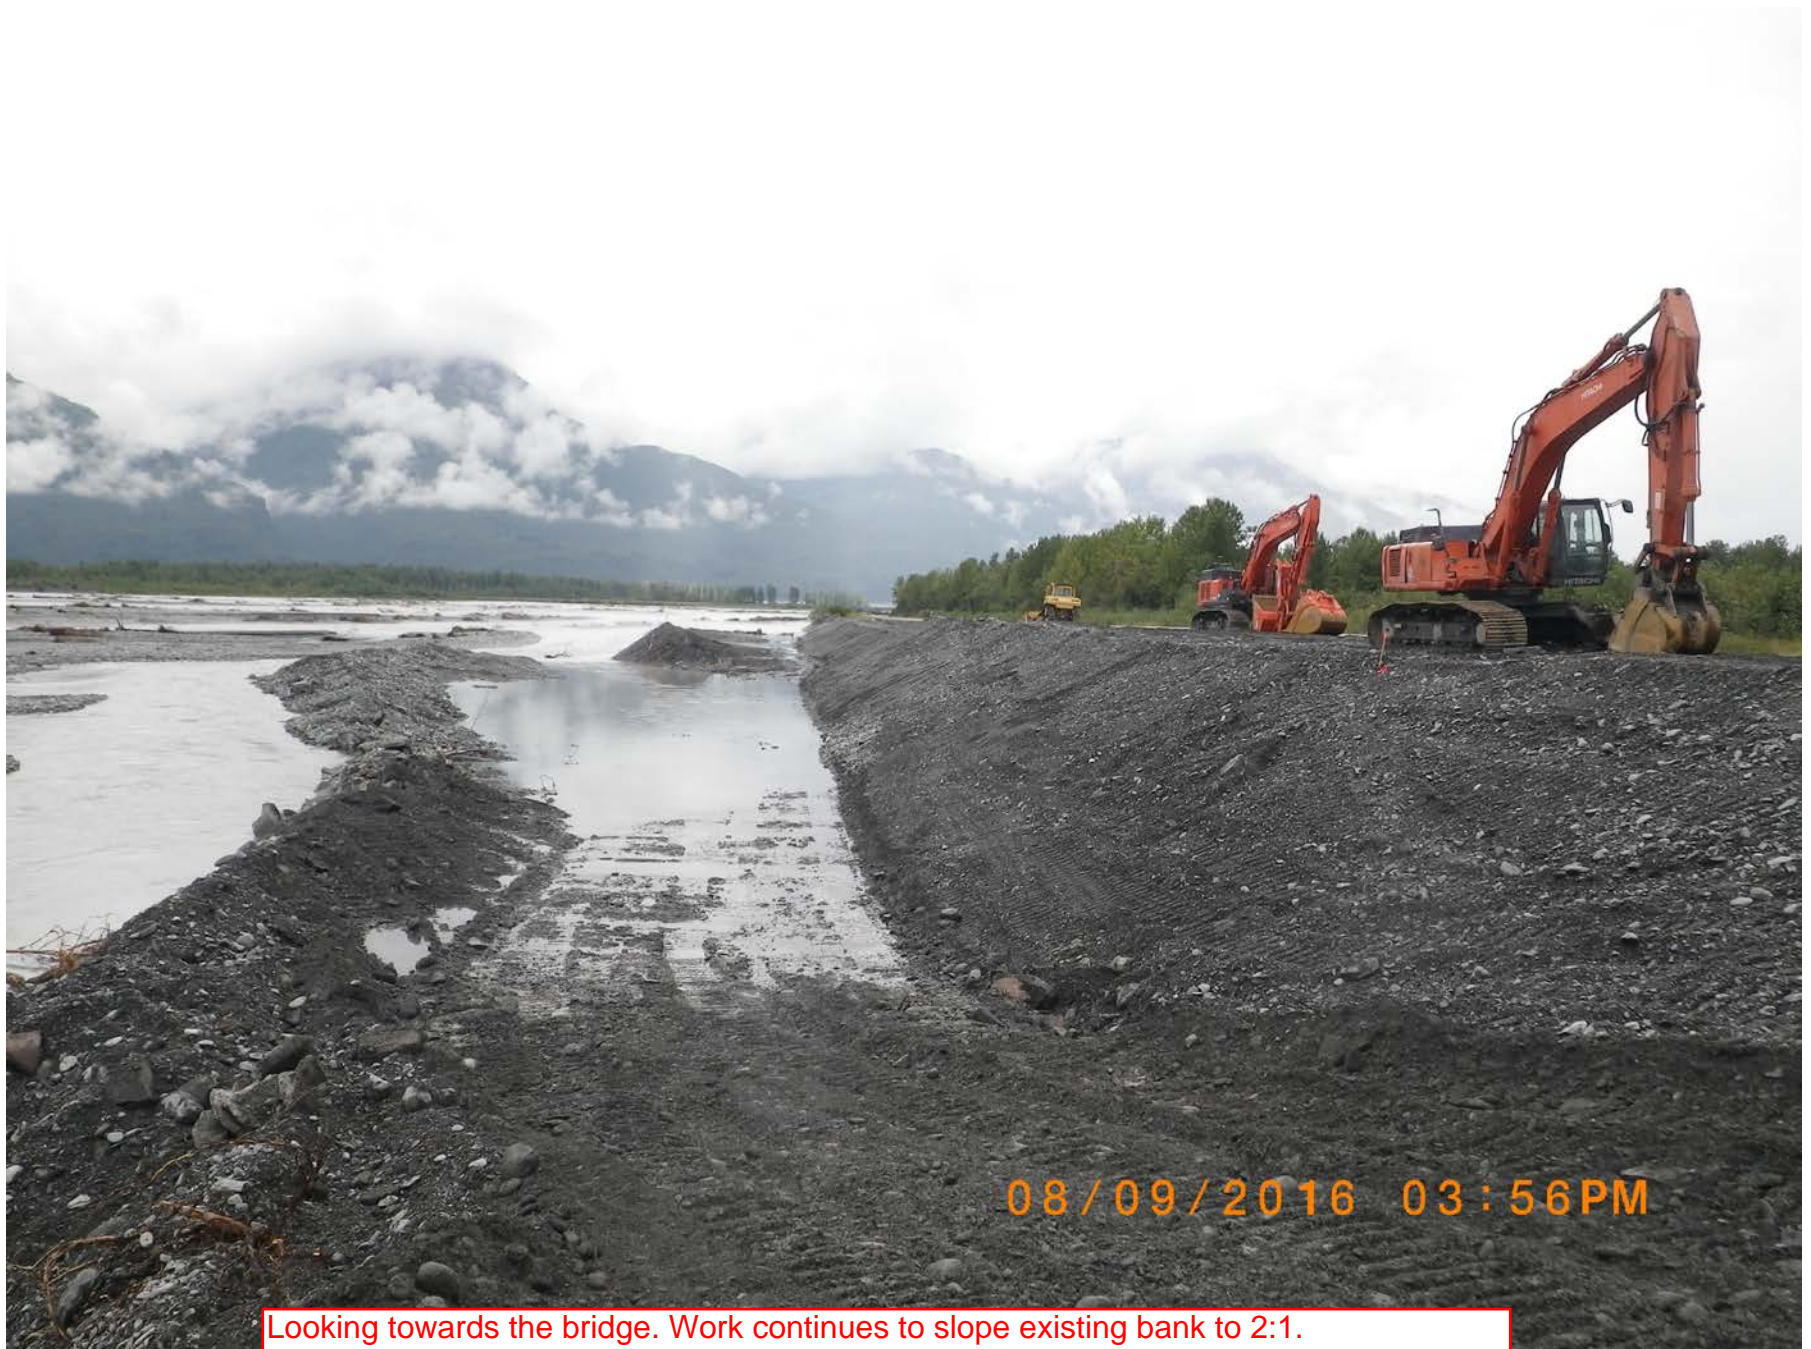
Looking towards the bridge. Work continues to slope existing bank to 2:1.

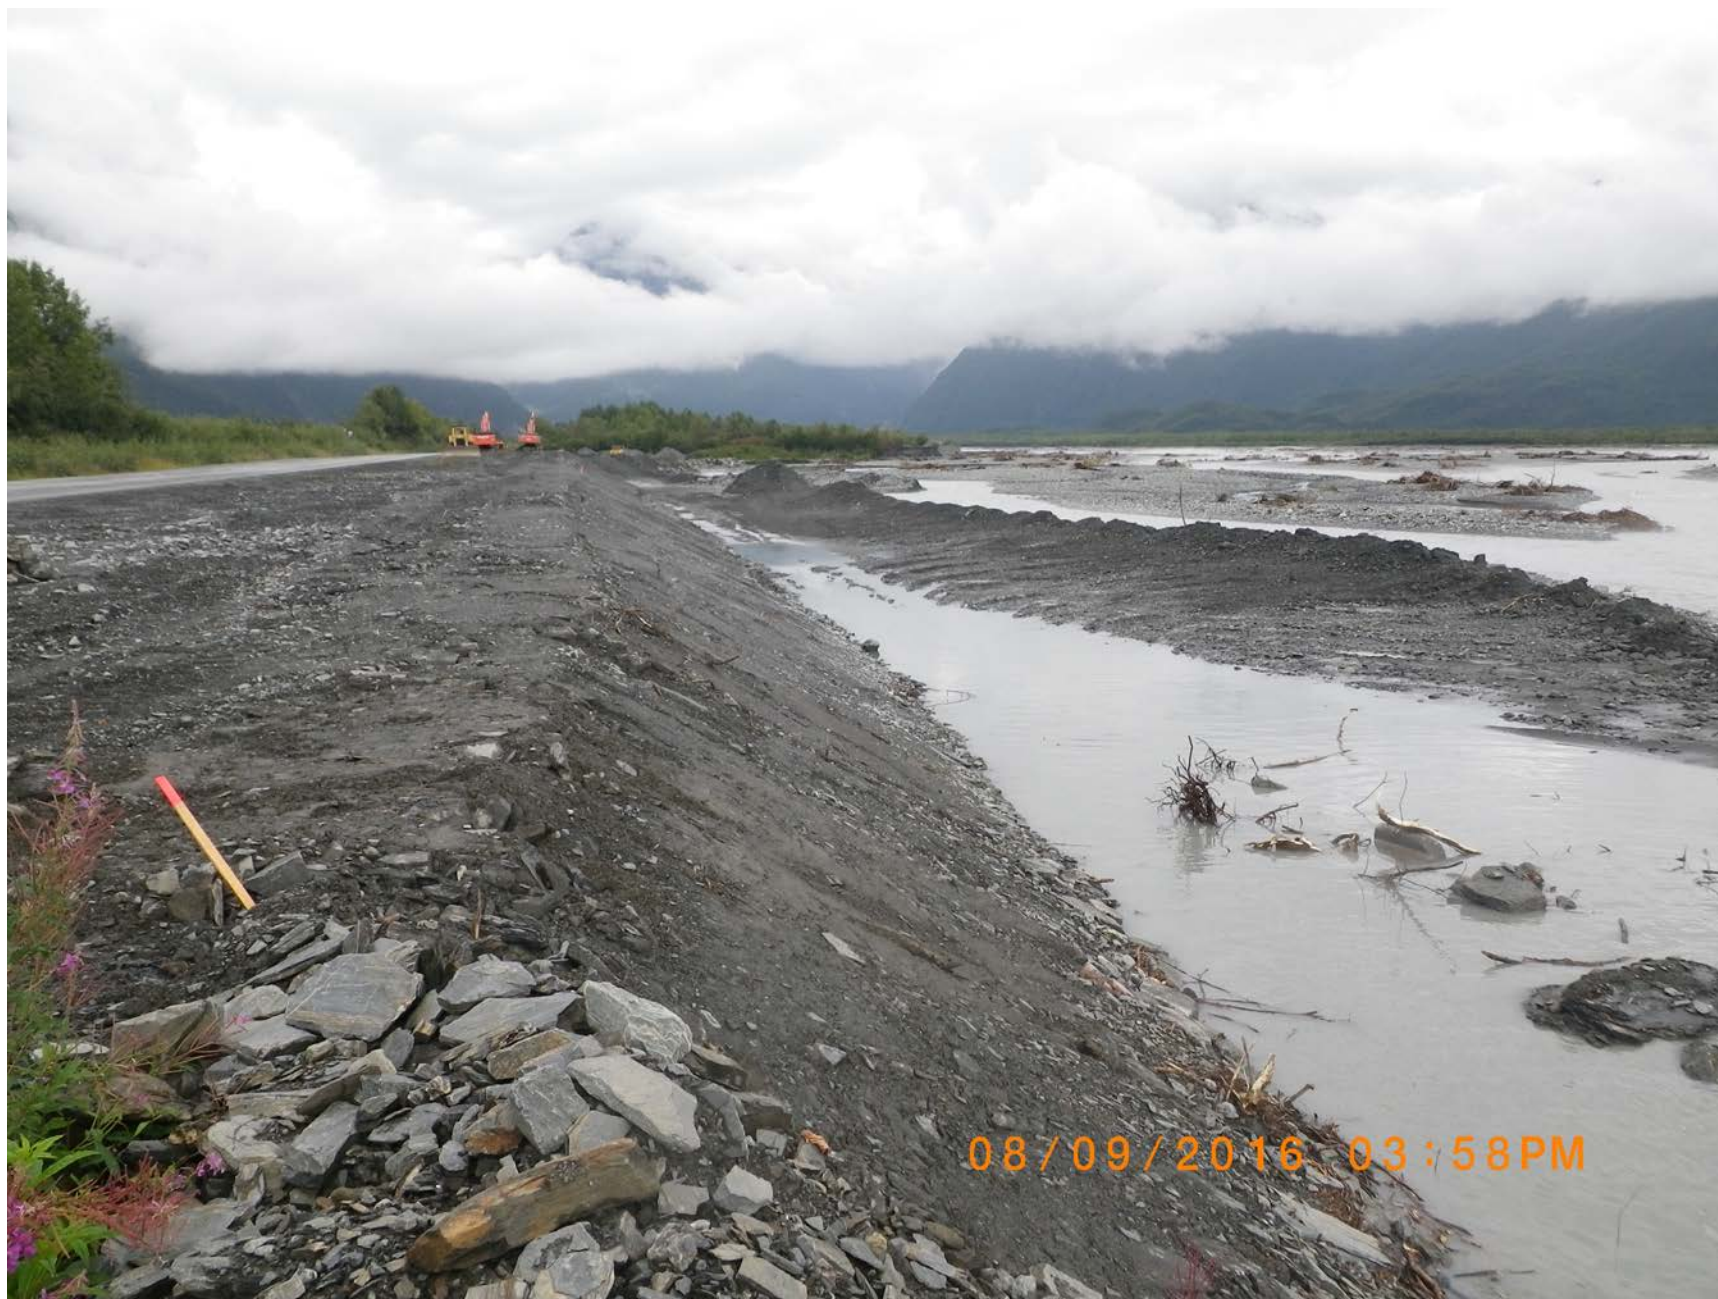
Looking back towards BOP. The contractor constructed a gravel berm to keep the flowing water out of the work area.

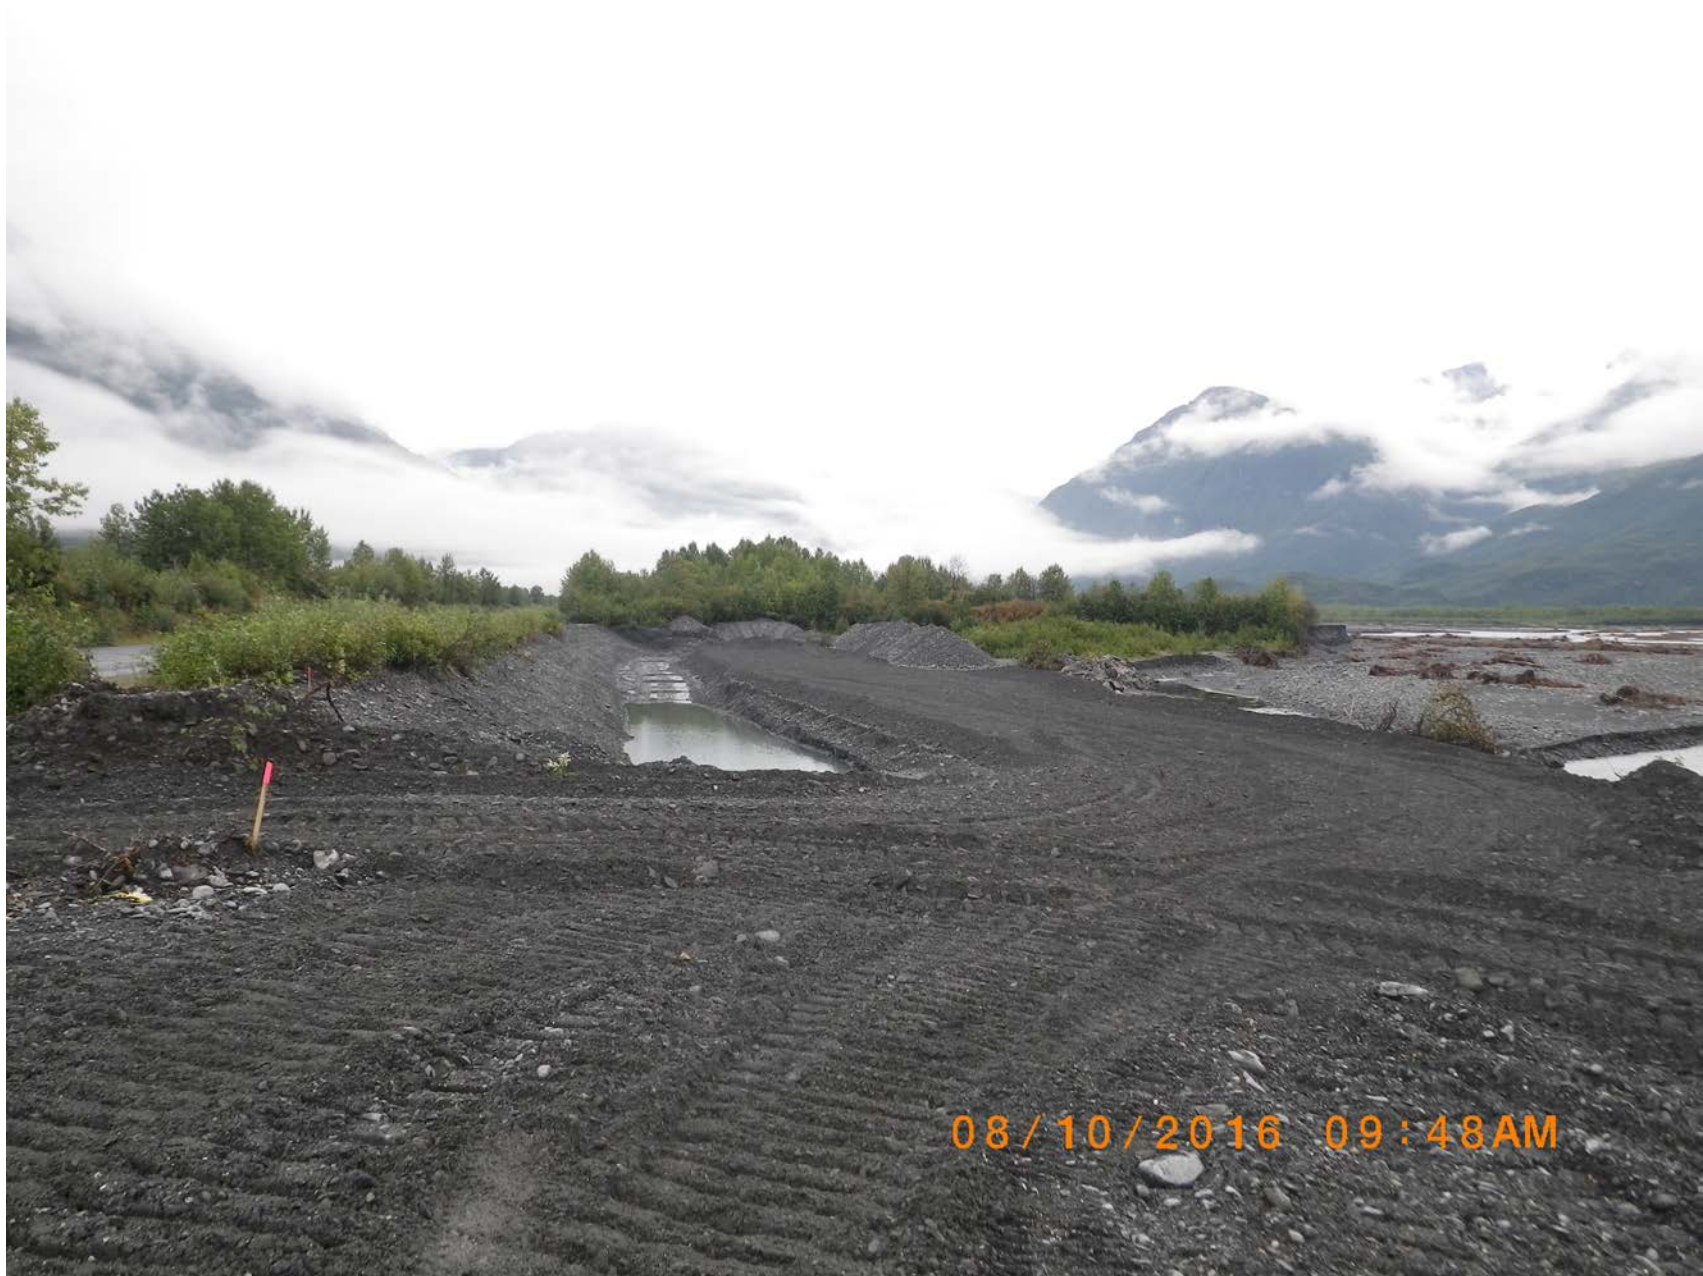
Looking back towards BOP after apron was graded out flat.

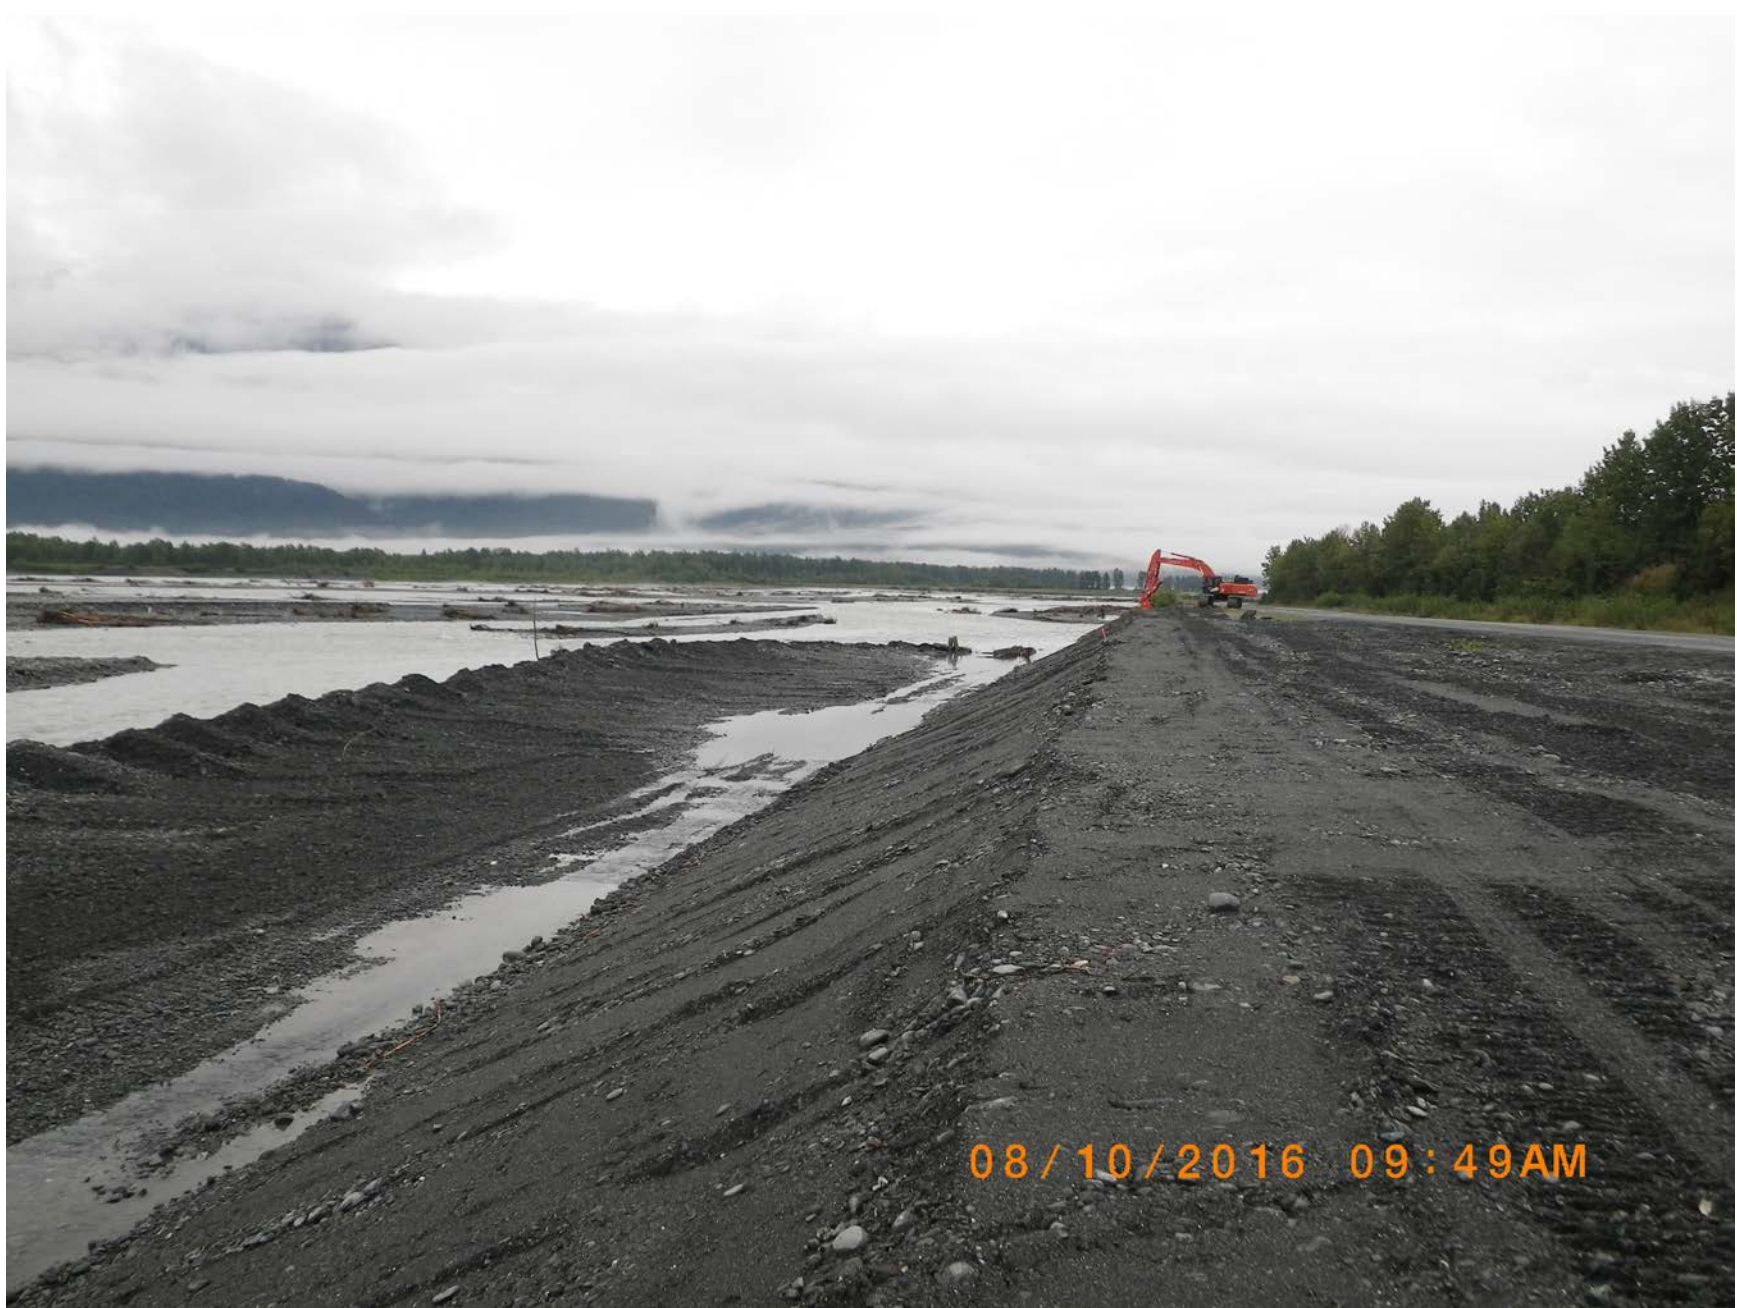
Looking towards bridge as the Hitachi 470 excavator works to slope the existing bank.

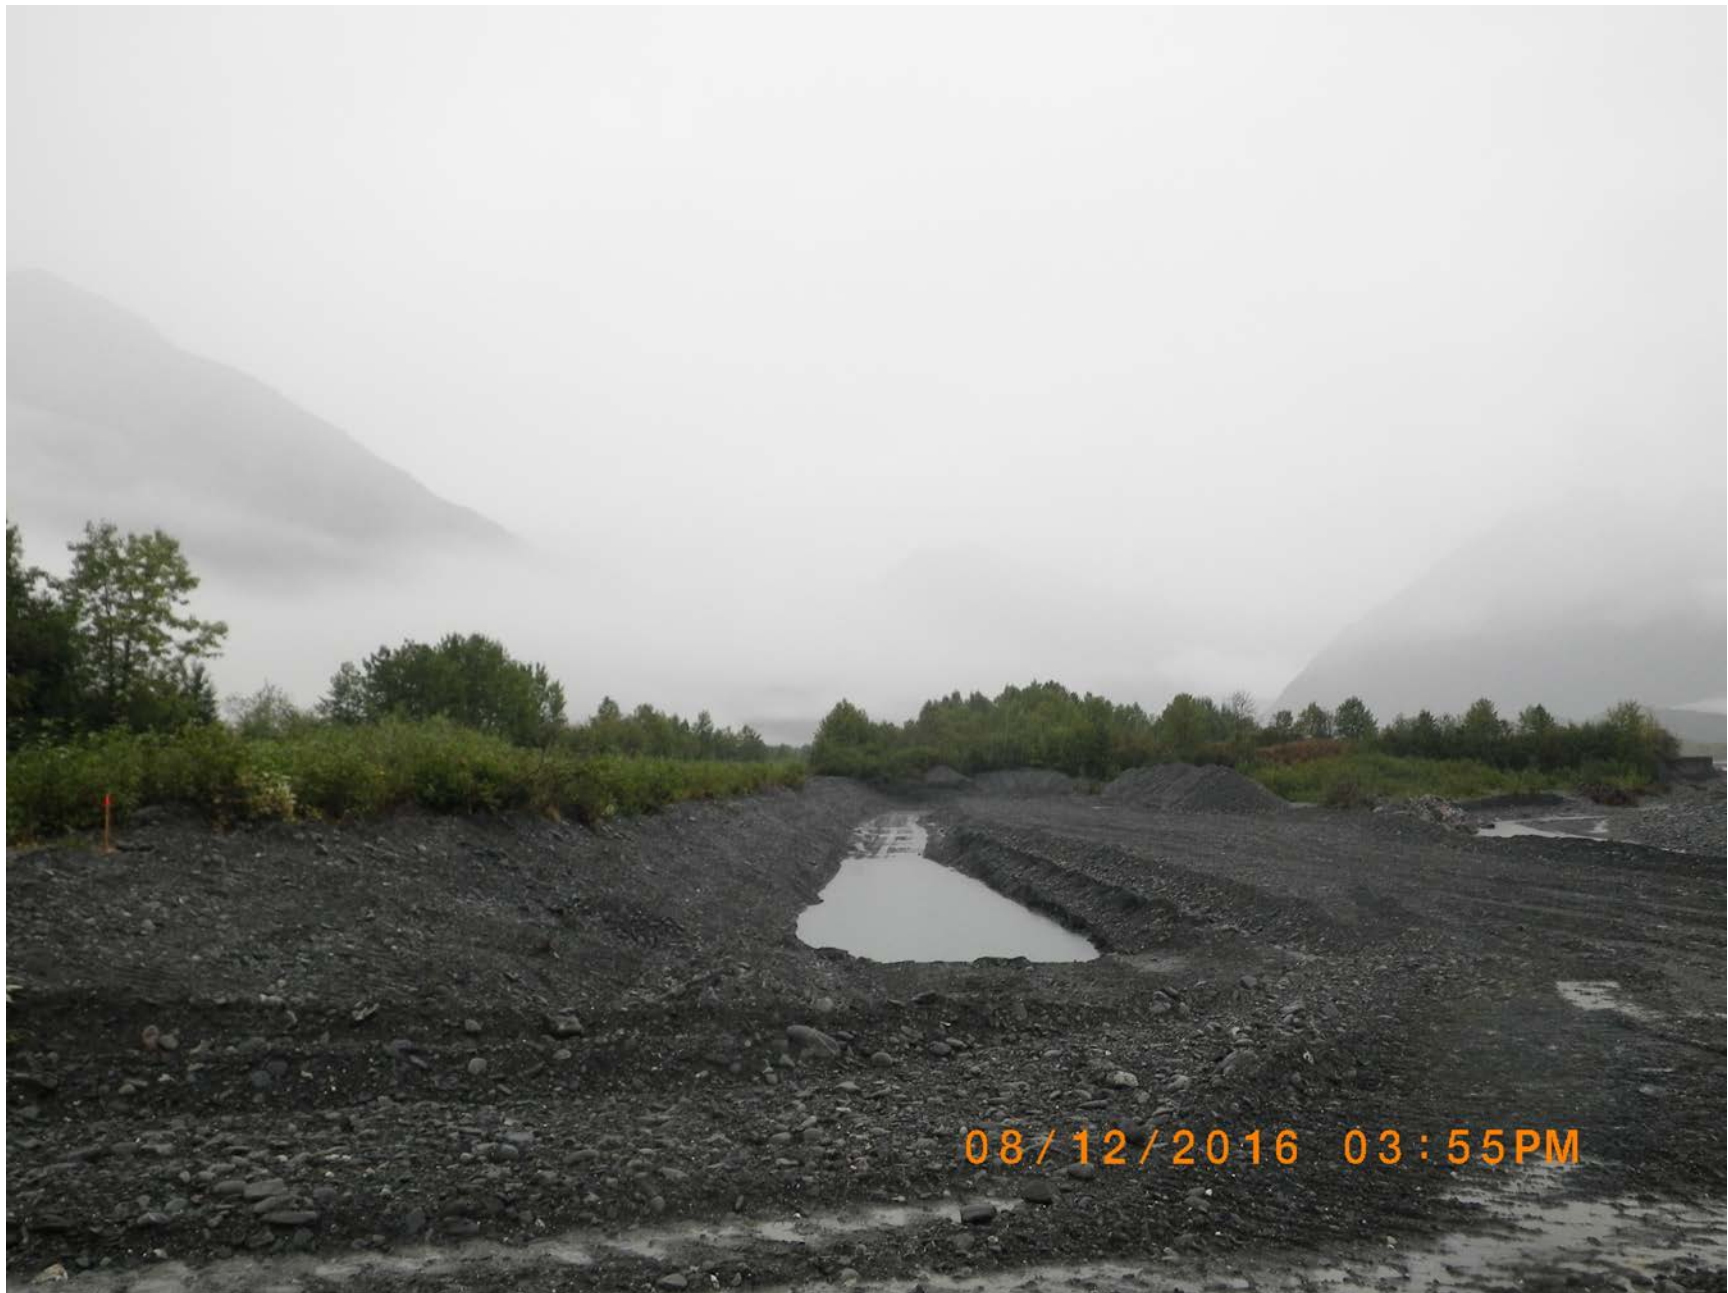
Ground water can be seen in the toe at the BOP.

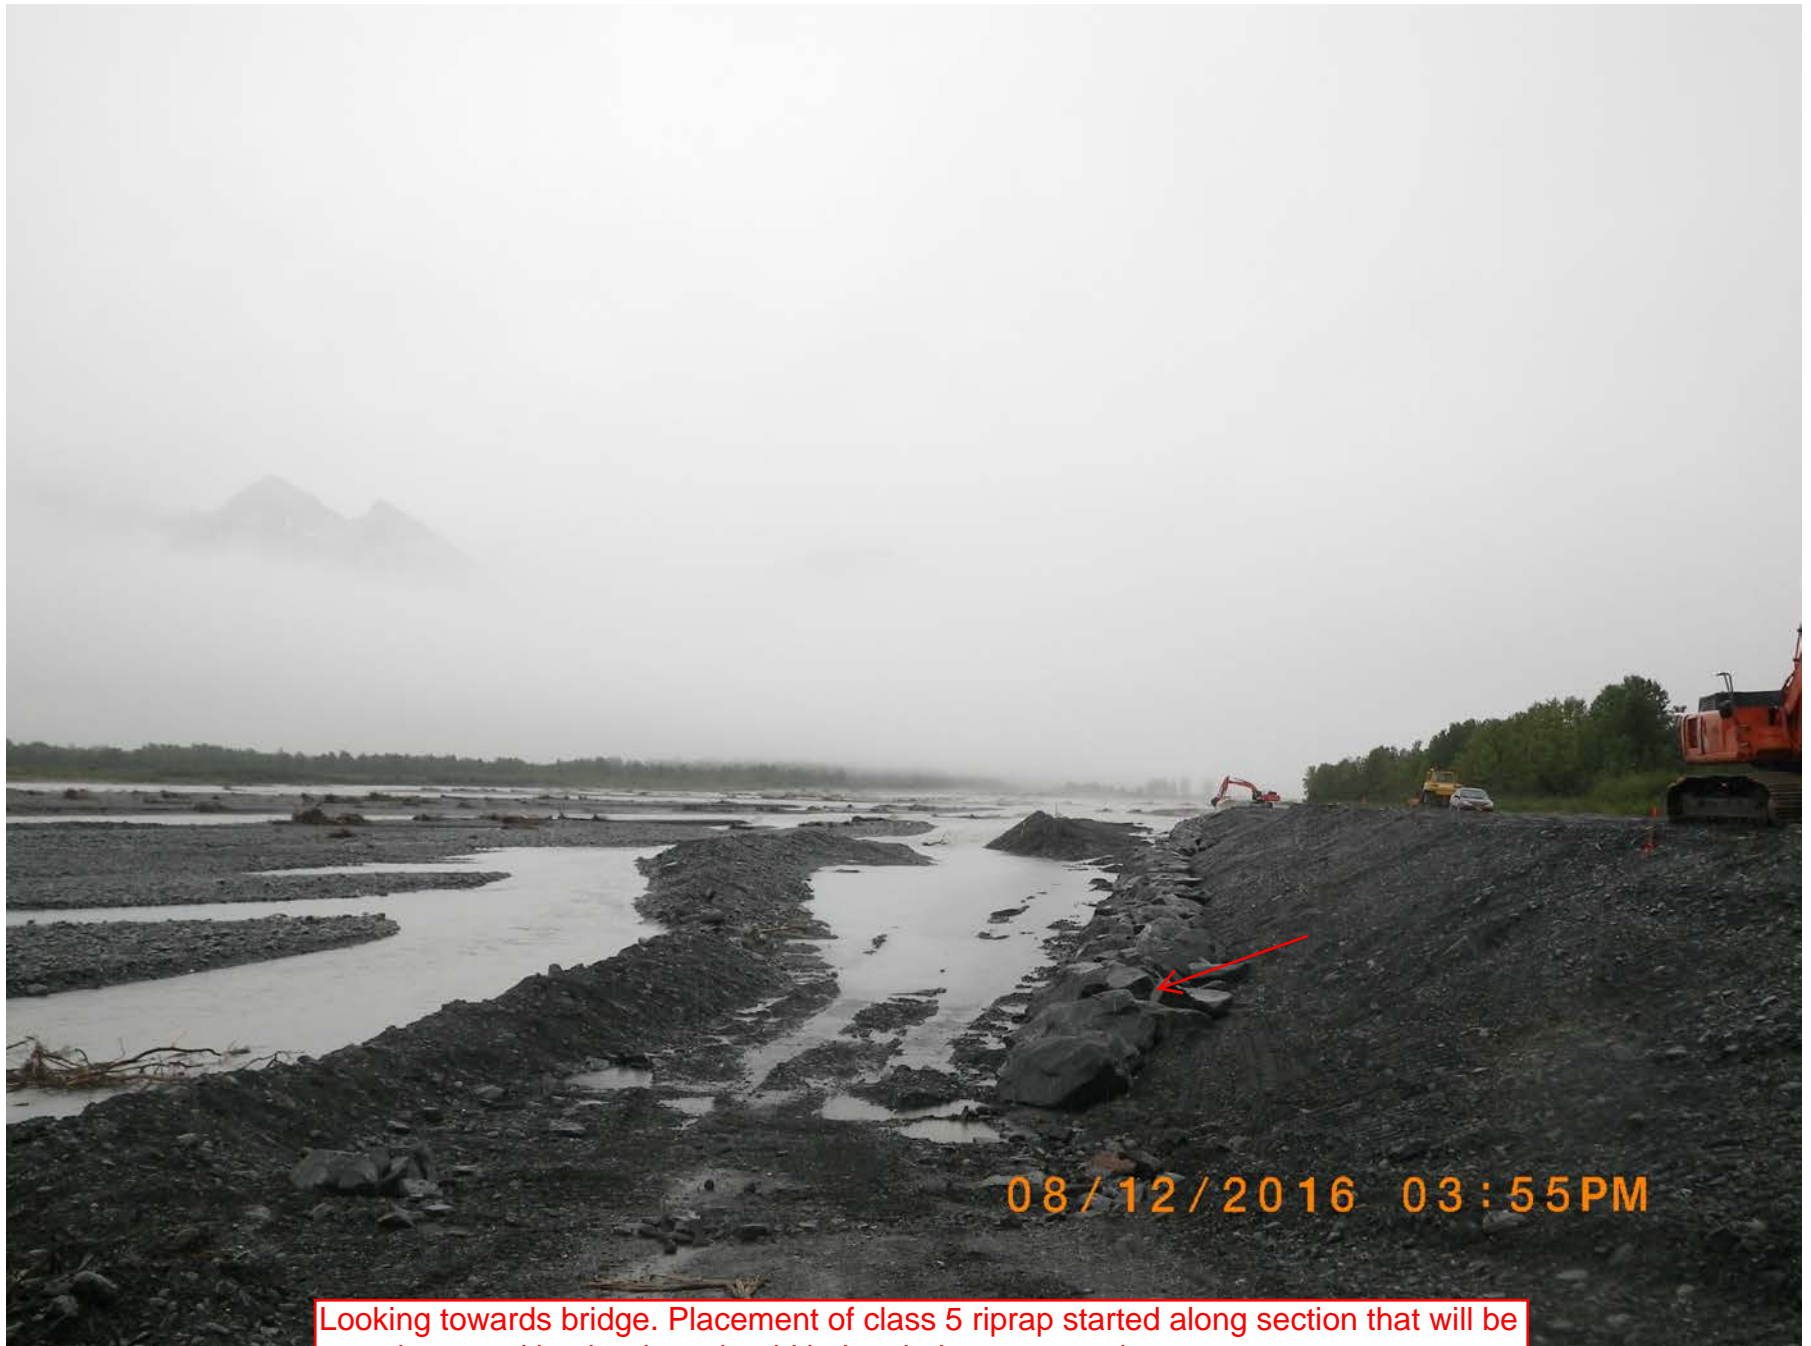
Looking towards bridge. Placement of class 5 riprap started along section that will be most impacted by the river should it rise during construction.
