## WEEKLY PROGRESS REPORT

LEGAL DESCRIPTION: GLACIER HAUL ROAD  
RIP RAP PROJECT  
VALDEZ, ALASKA

PREPARED FOR: HARRIS SAND AND GRAVEL

Glacier Haul Road bank armoring

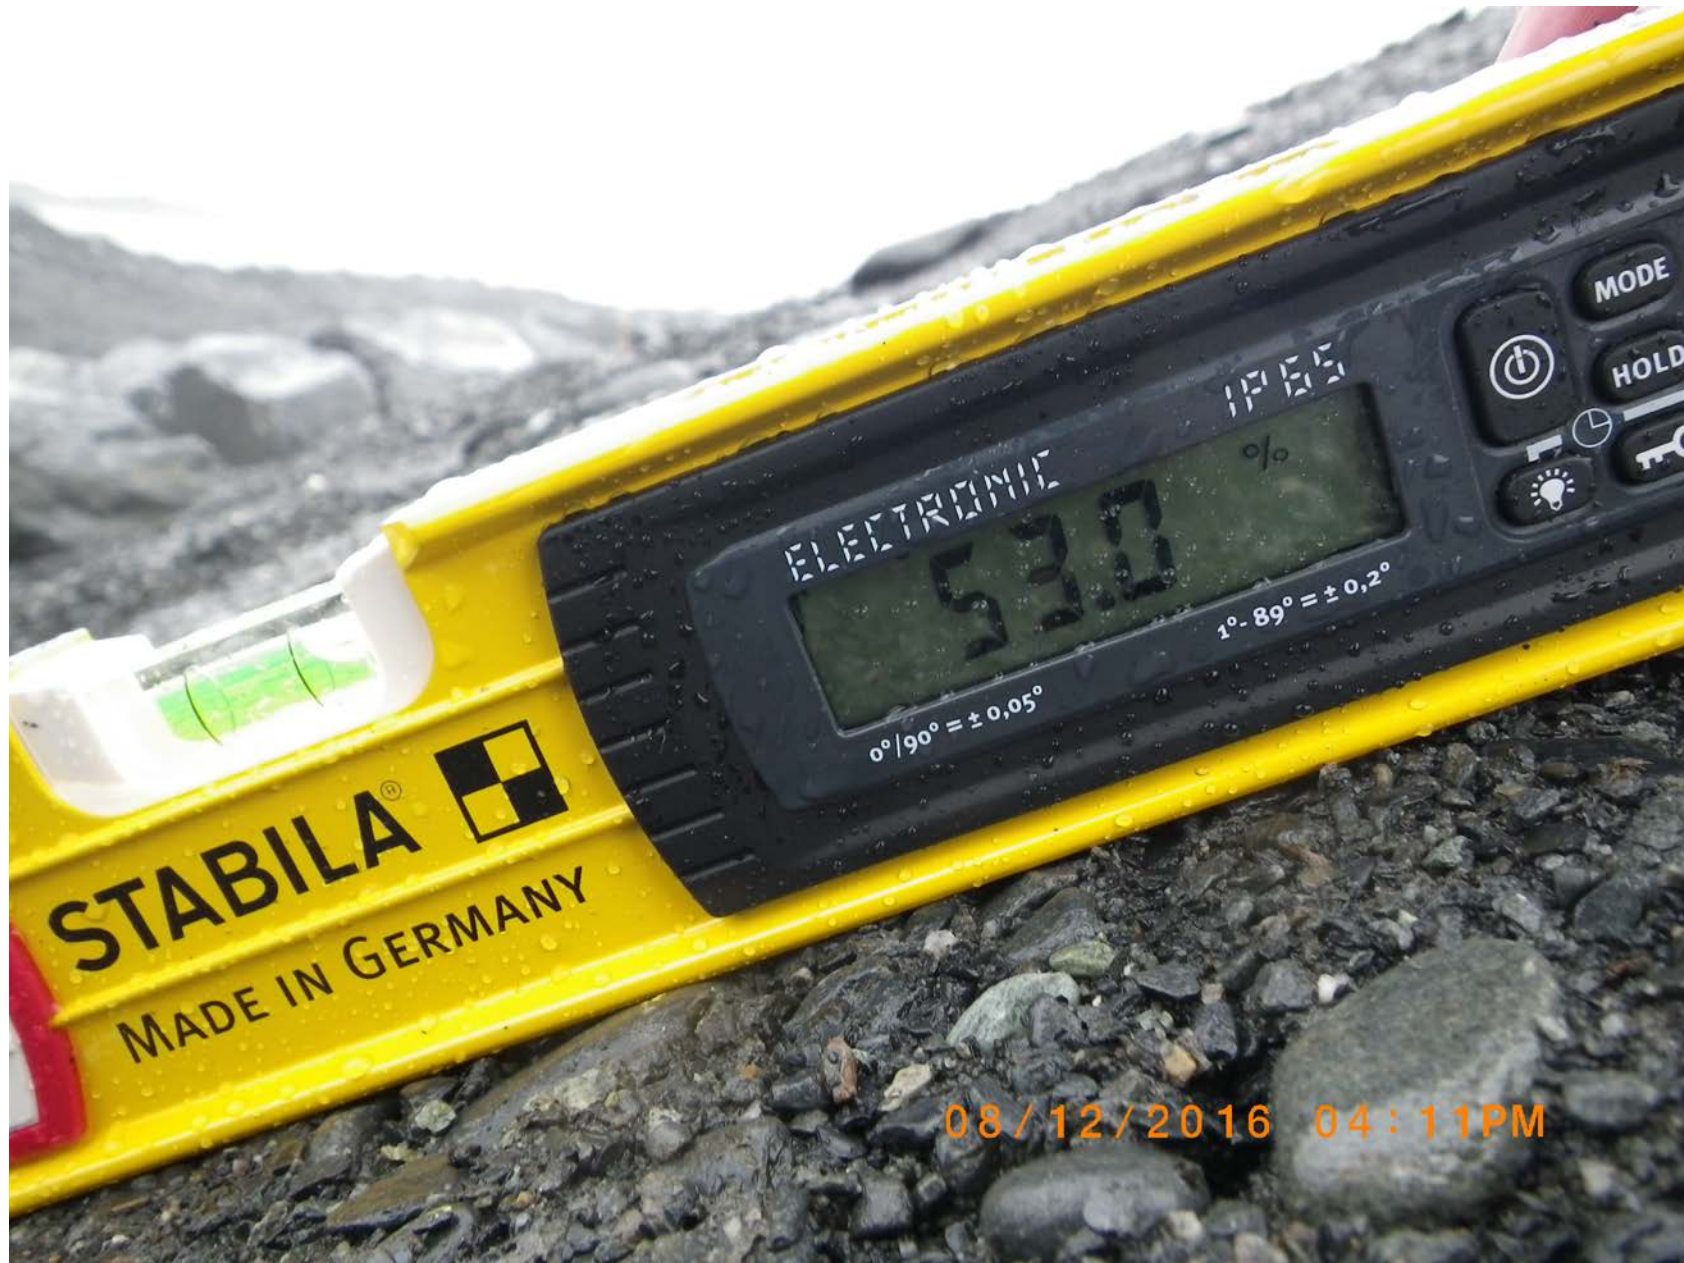
Spot checking one of many areas on the slope. Due to the roughness of the gravel surface, finding an area smooth enough for the level to obtain an accurate reading was a bit of a challenge. This location is just a hair away from being a perfect 2:1.

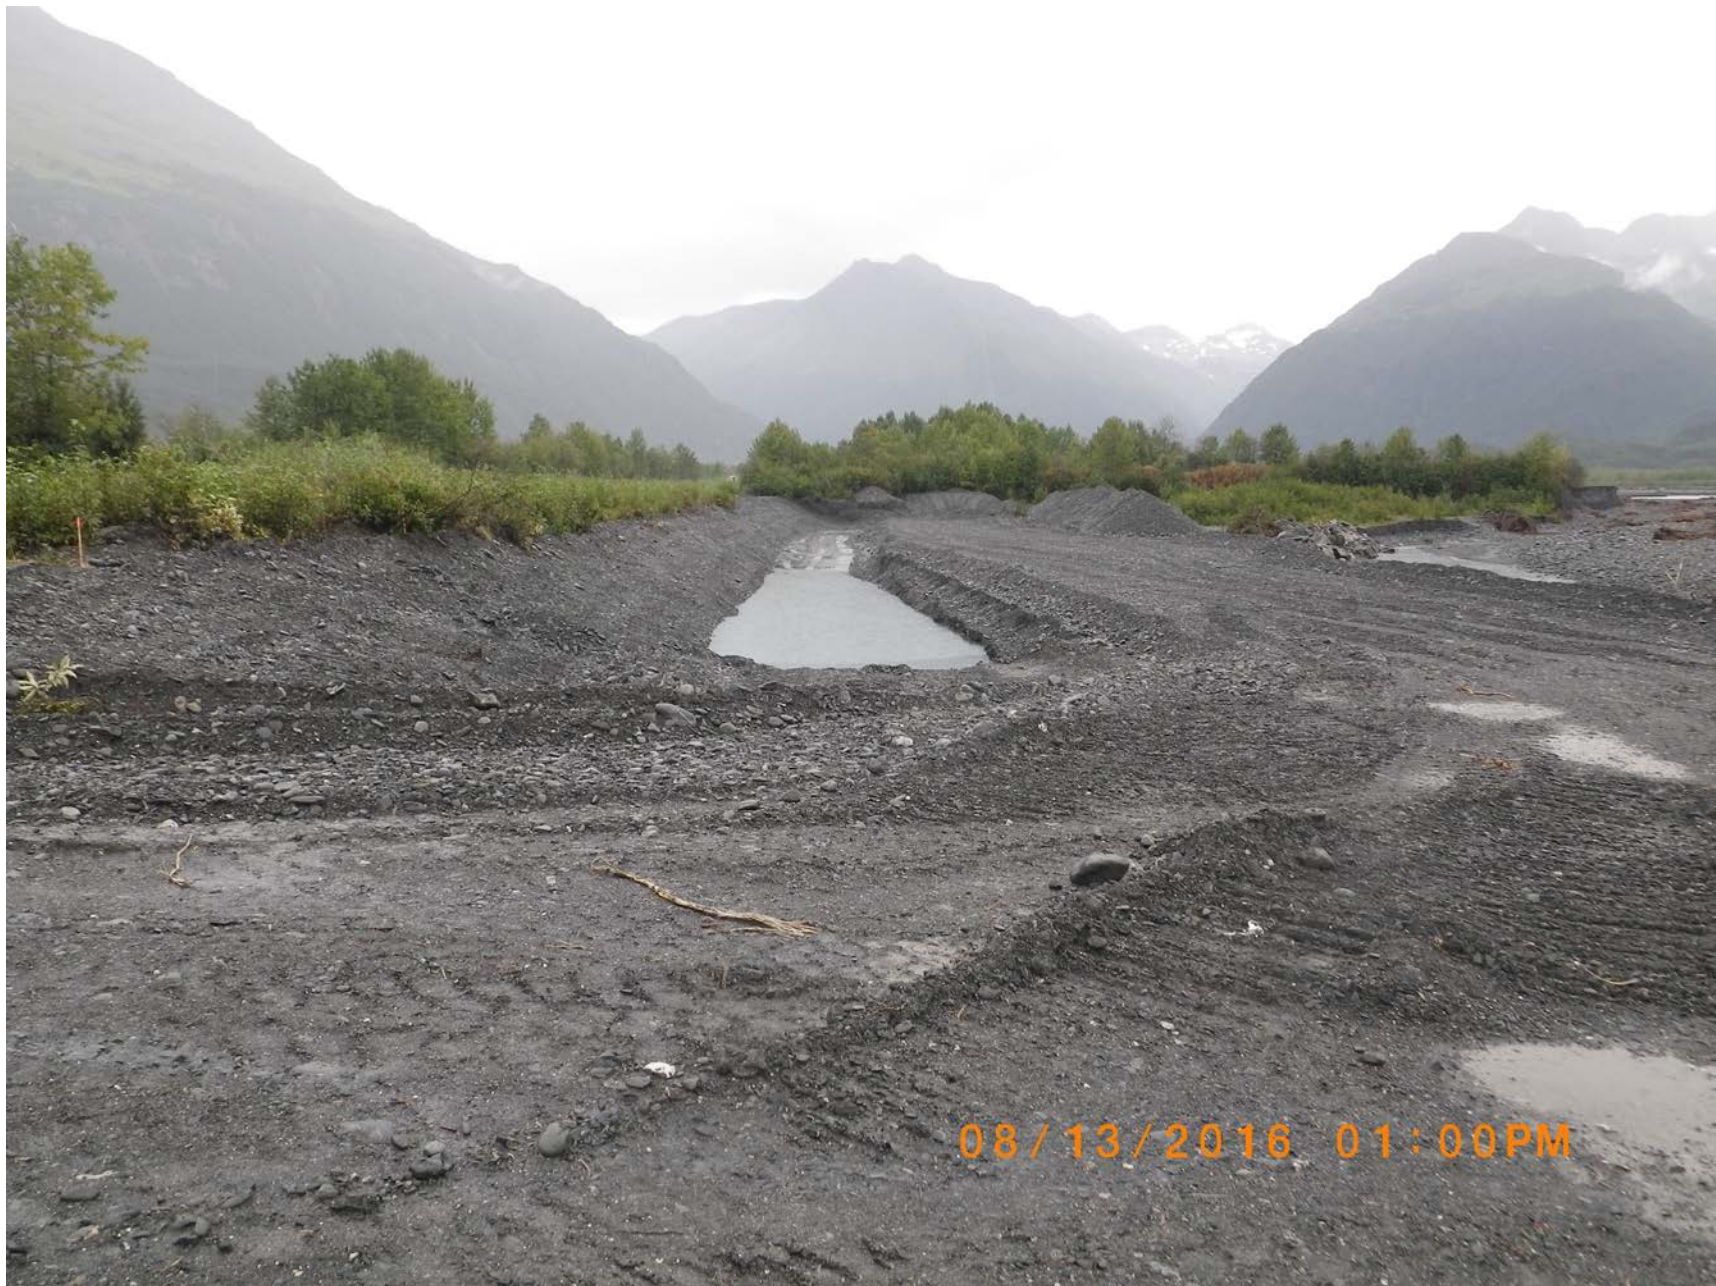
Looking back towards BOP, no new activity has occurred.

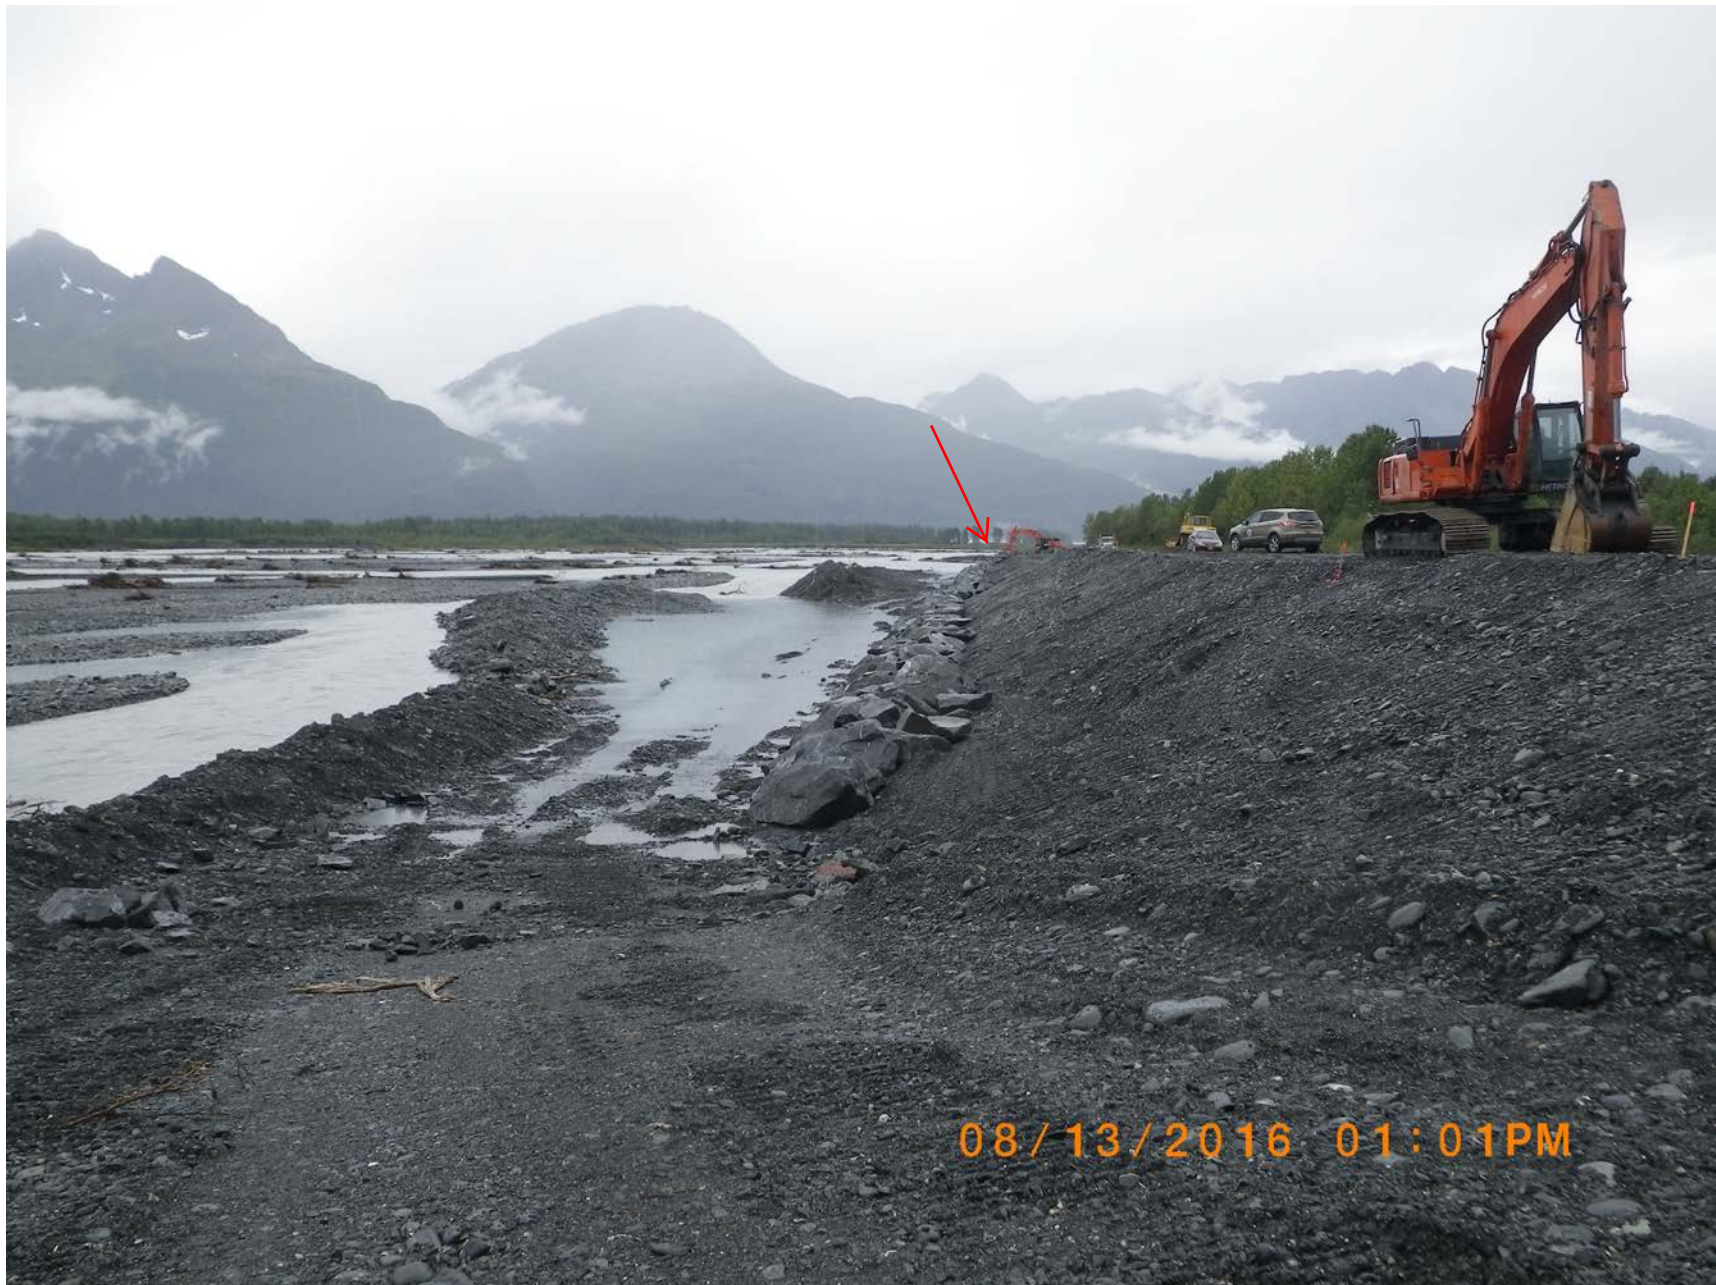
Looking towards bridge, the Hitachi 470 excavator working to place class 3 riprap.

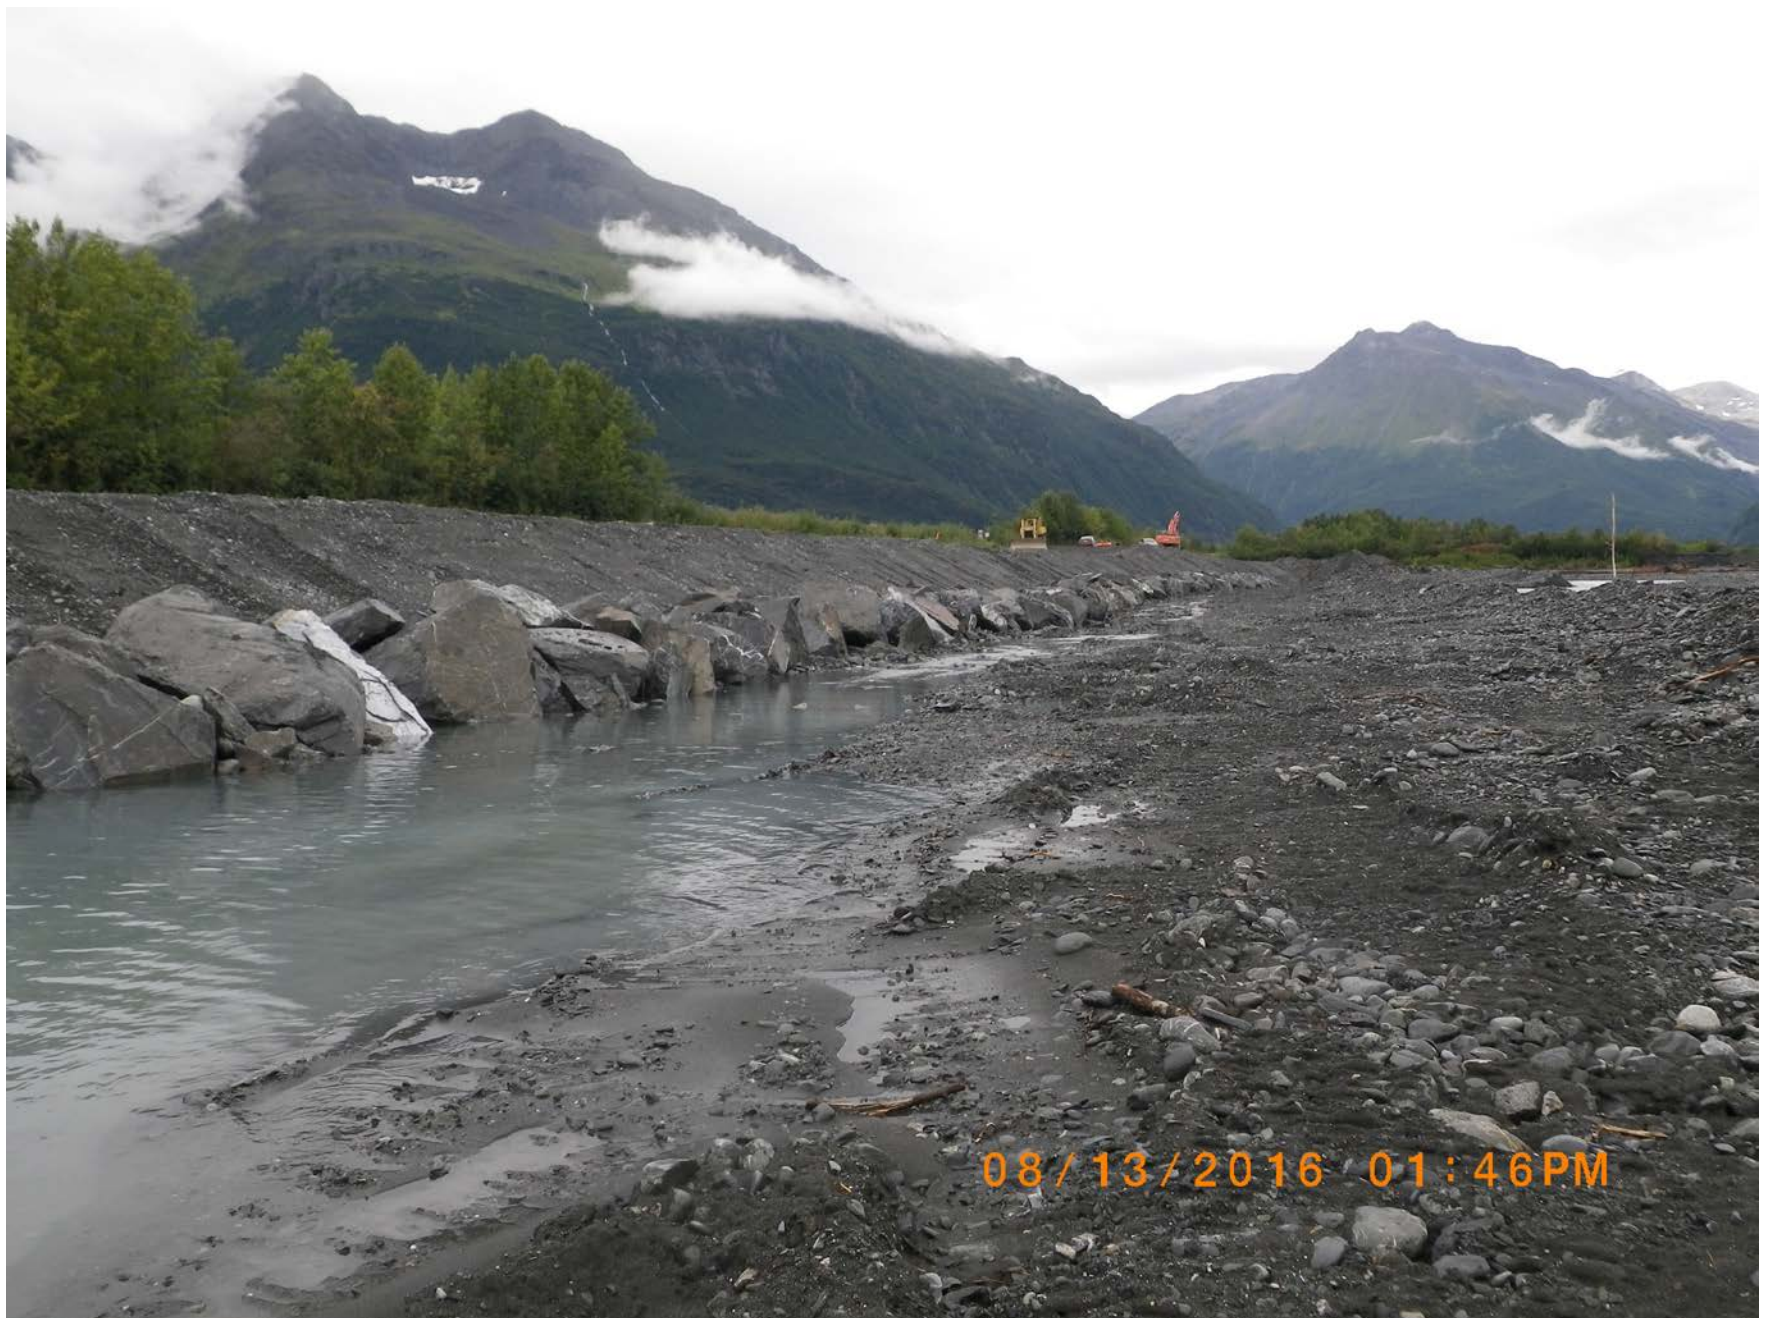
Looking back towards BOP with class 5 riprap placed at the toe of the slope.

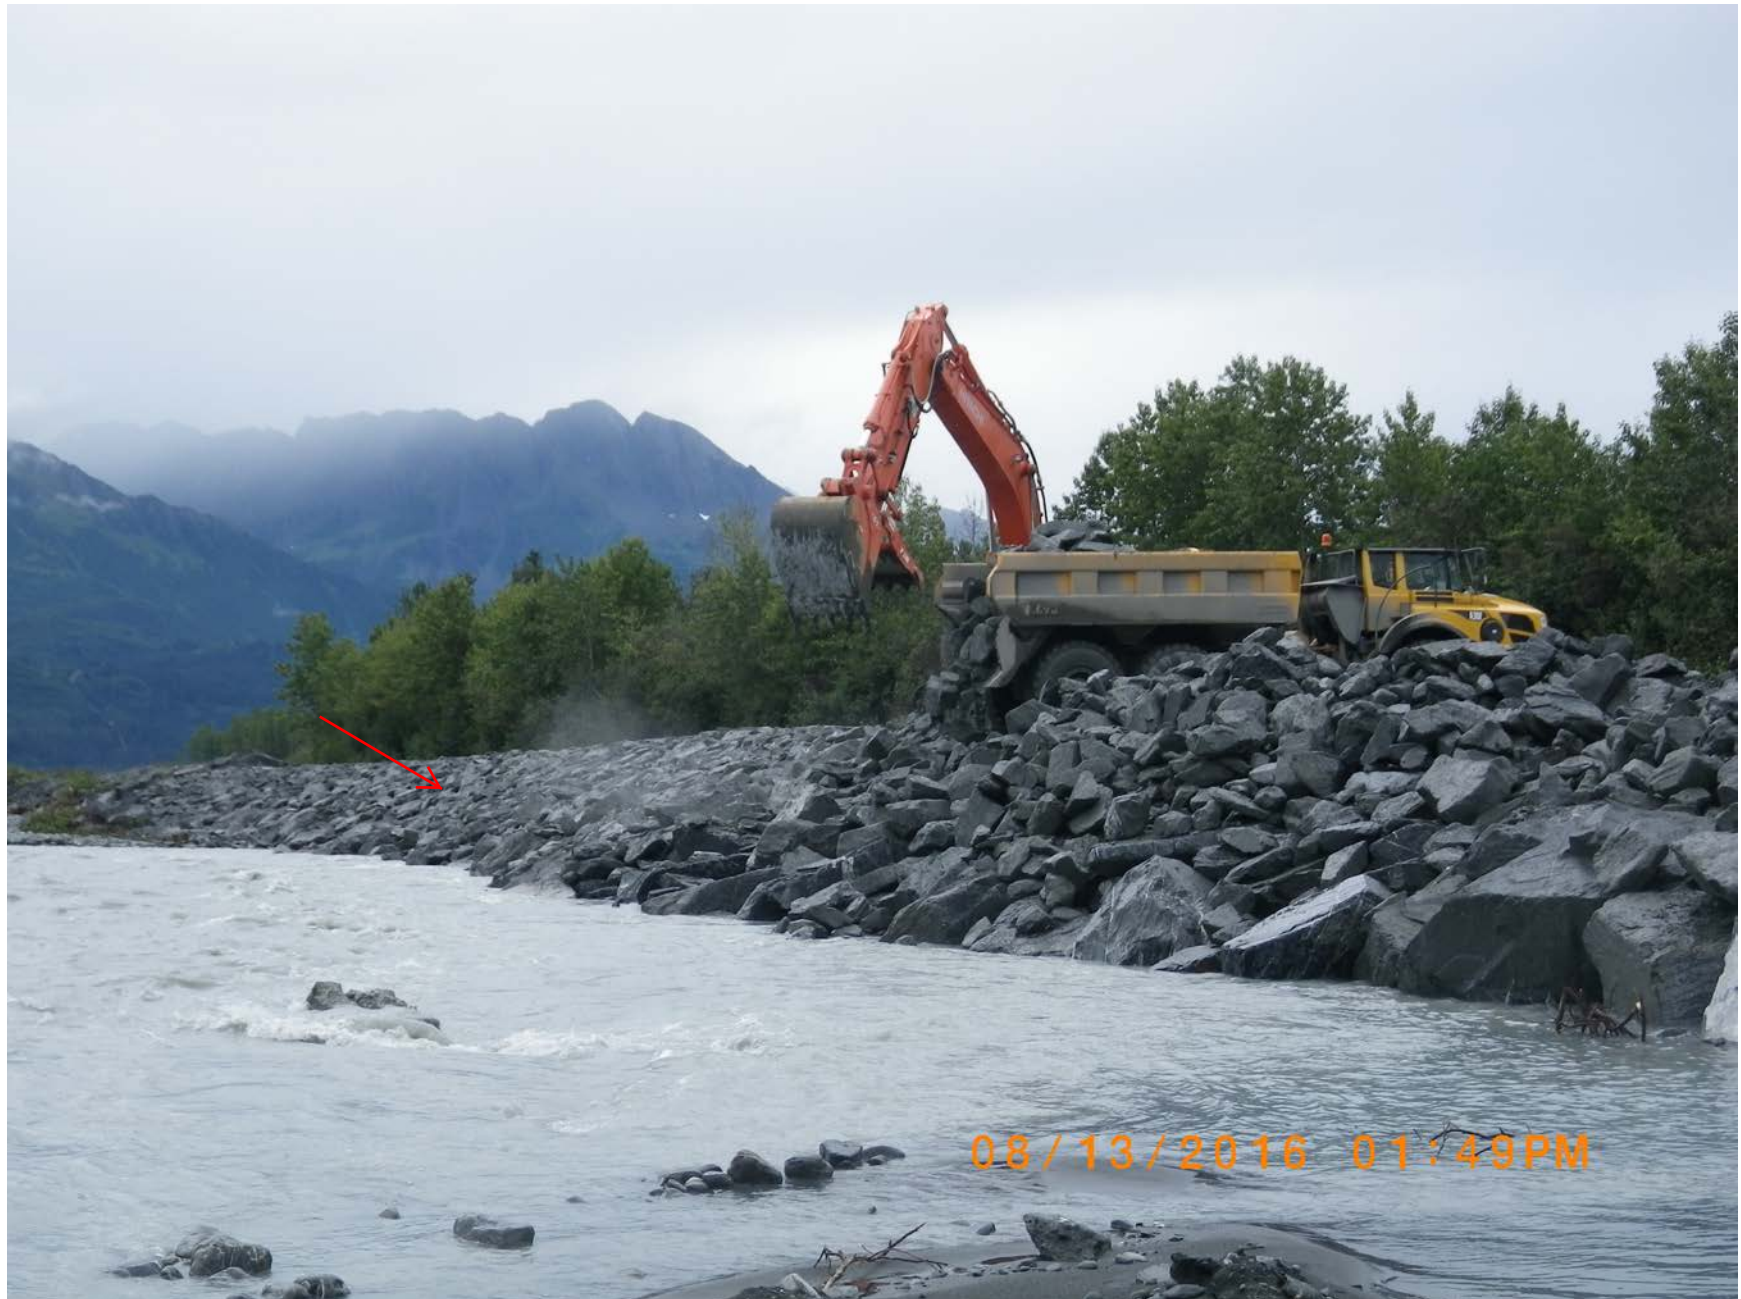
A rock truck delivers a load of class 3 riprap. The excavator has placed and sloped the class 3 riprap at 3:1.

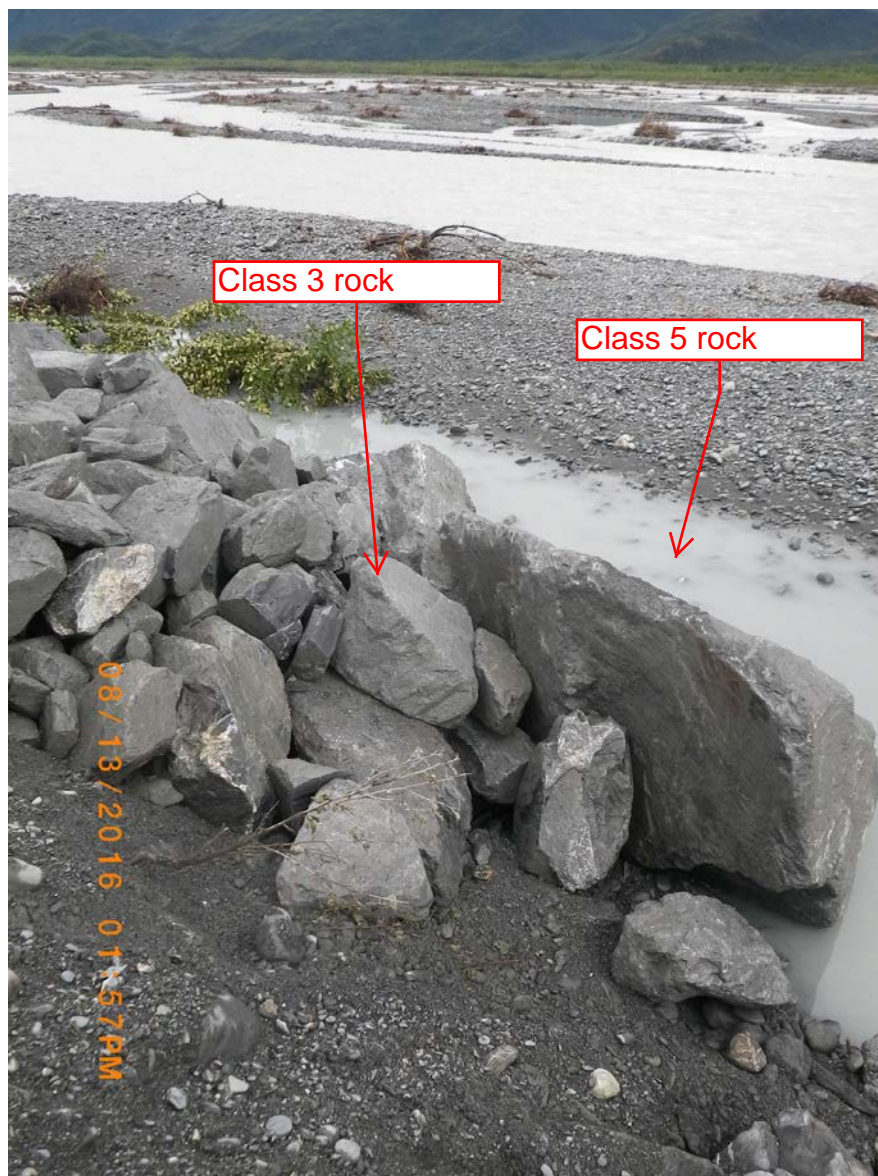
This location is approximately 3/4 of the way down the road from the BOP. The differences in the sizes of riprap can be seen as well as the thickness of the riprap on the slope.

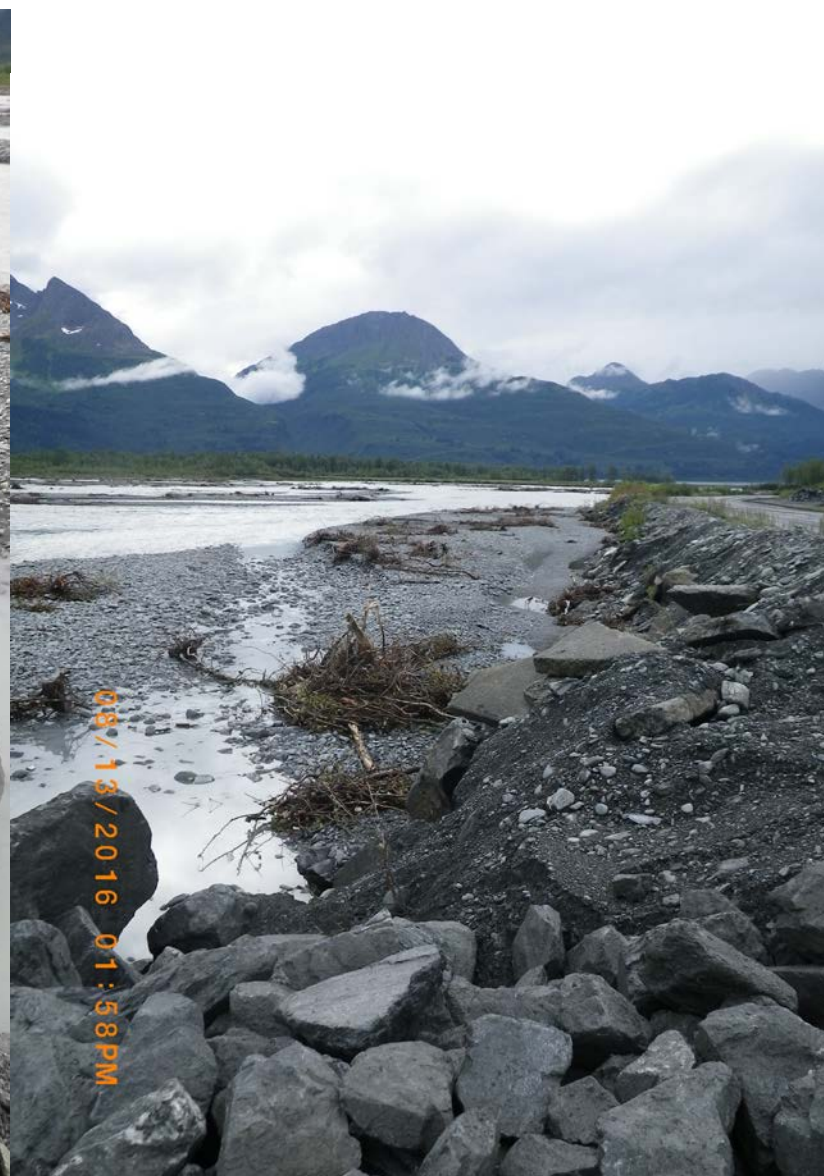
Looking towards the bridge at a section of the existing bank that has not yet been sloped.

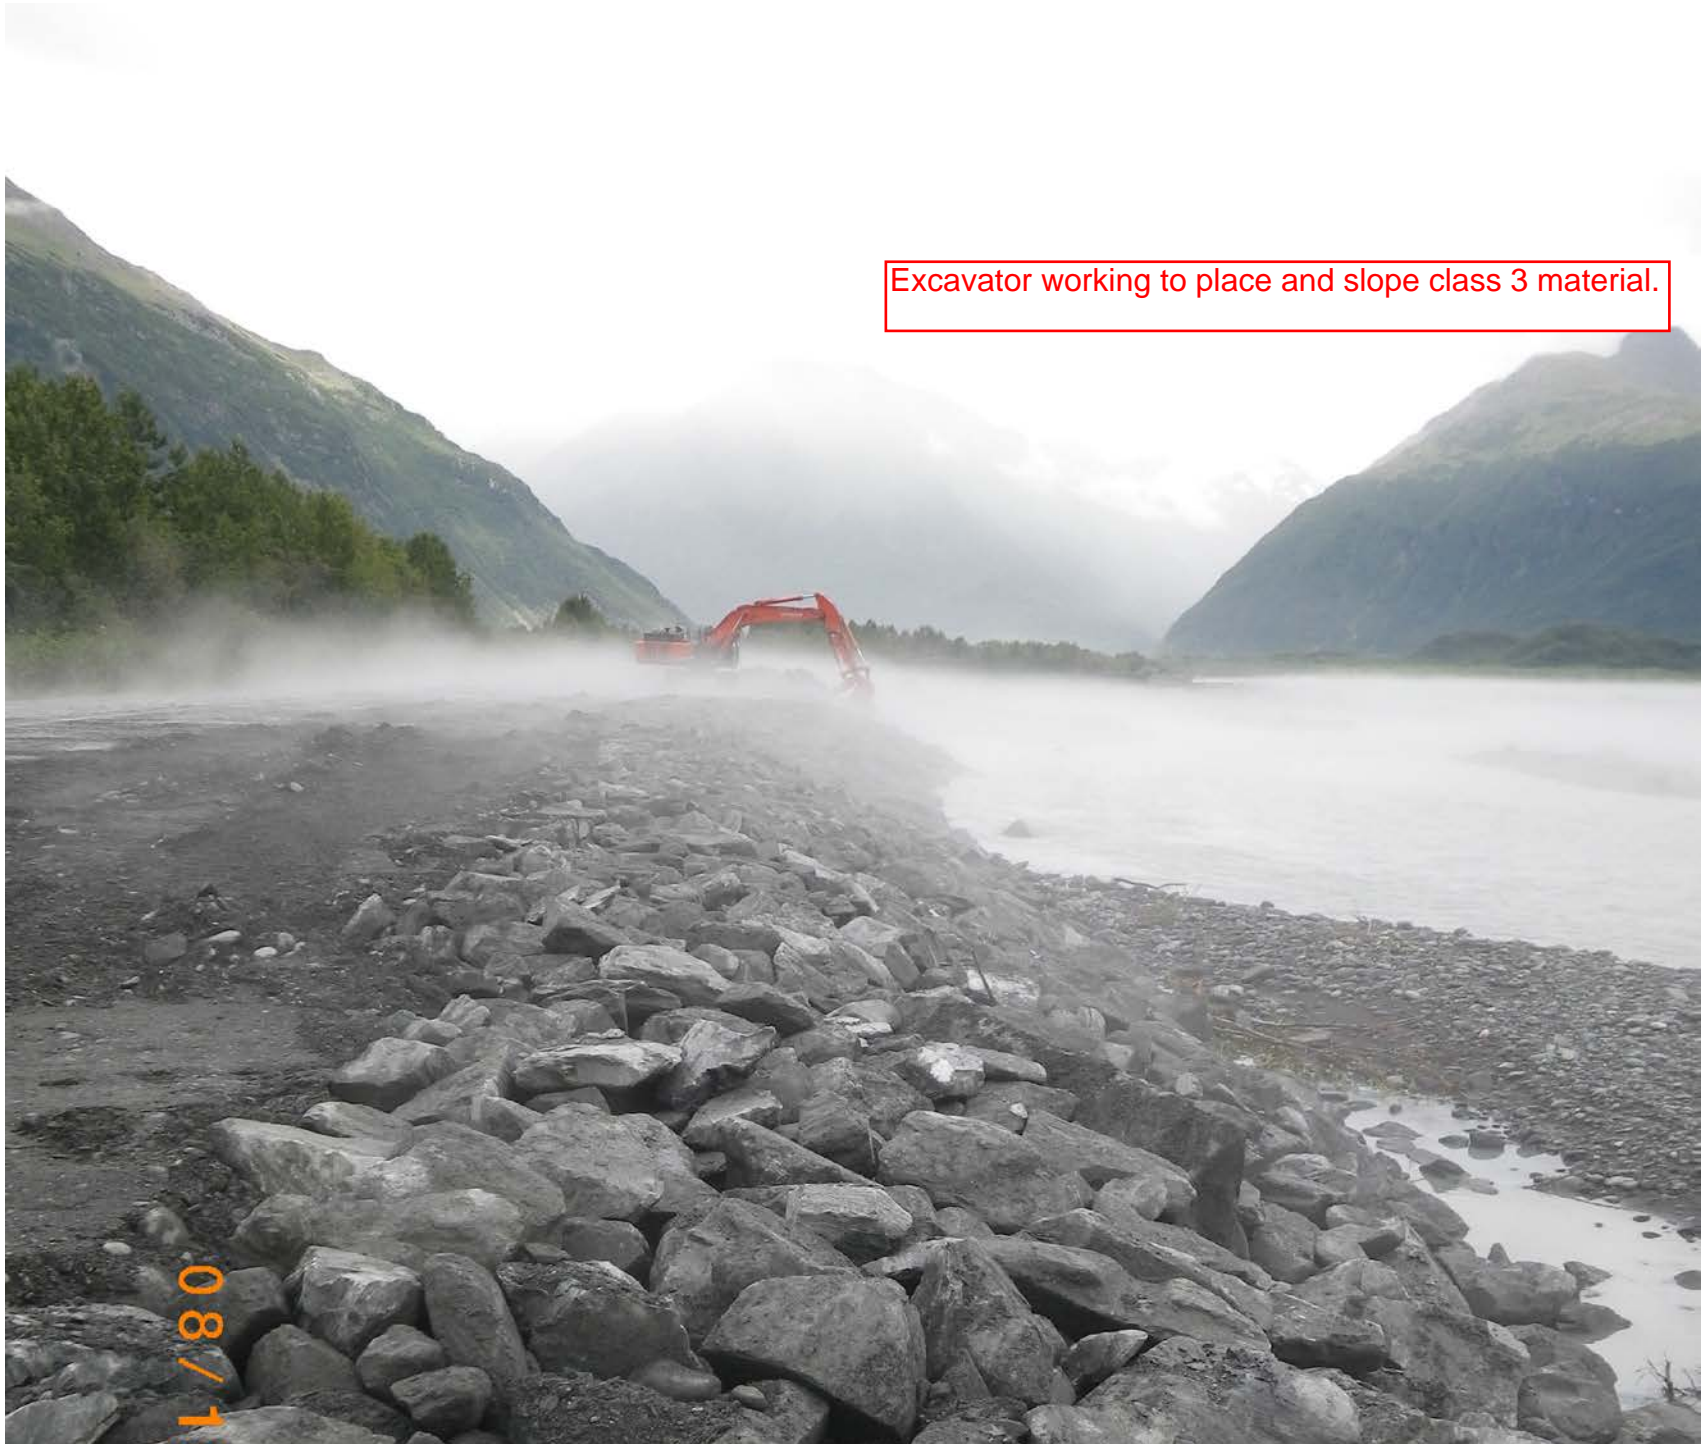
Excavator working to place and slope class 3 material.
