VALDEZ  
EGAN DRIVE  
ENHANCEMENT  
PROJECT -  
CIP  
# 310-1150-58000

STREETLIGHT  
LAYOUT

E101

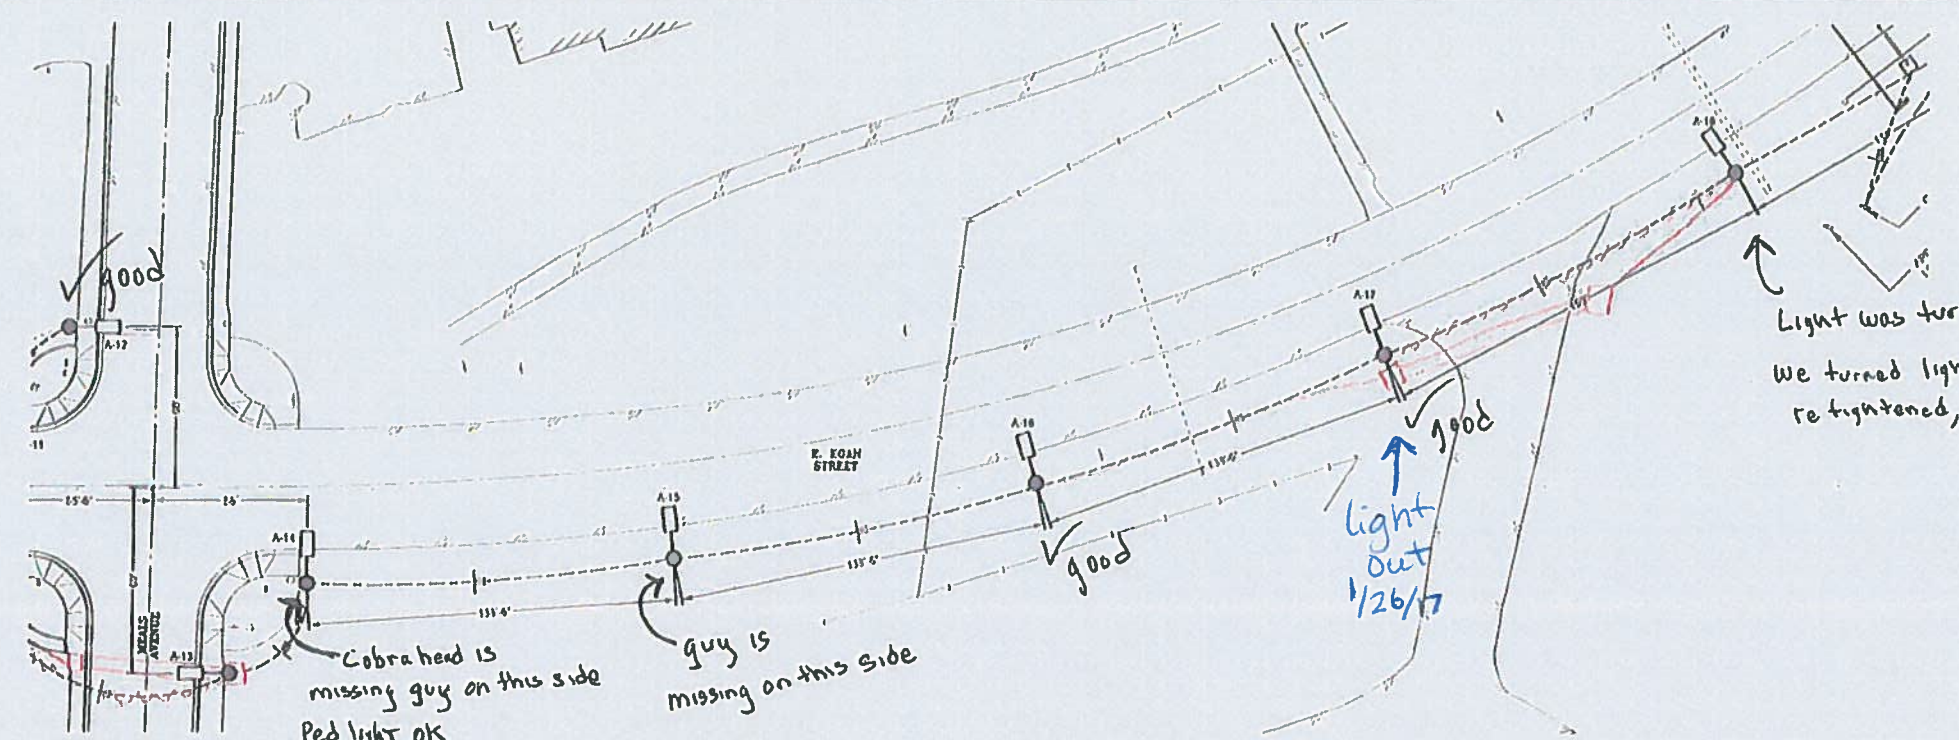
1  
E101

Light was turned on  
We turned light and  
re-tightened, good

light  
out  
1/26/17

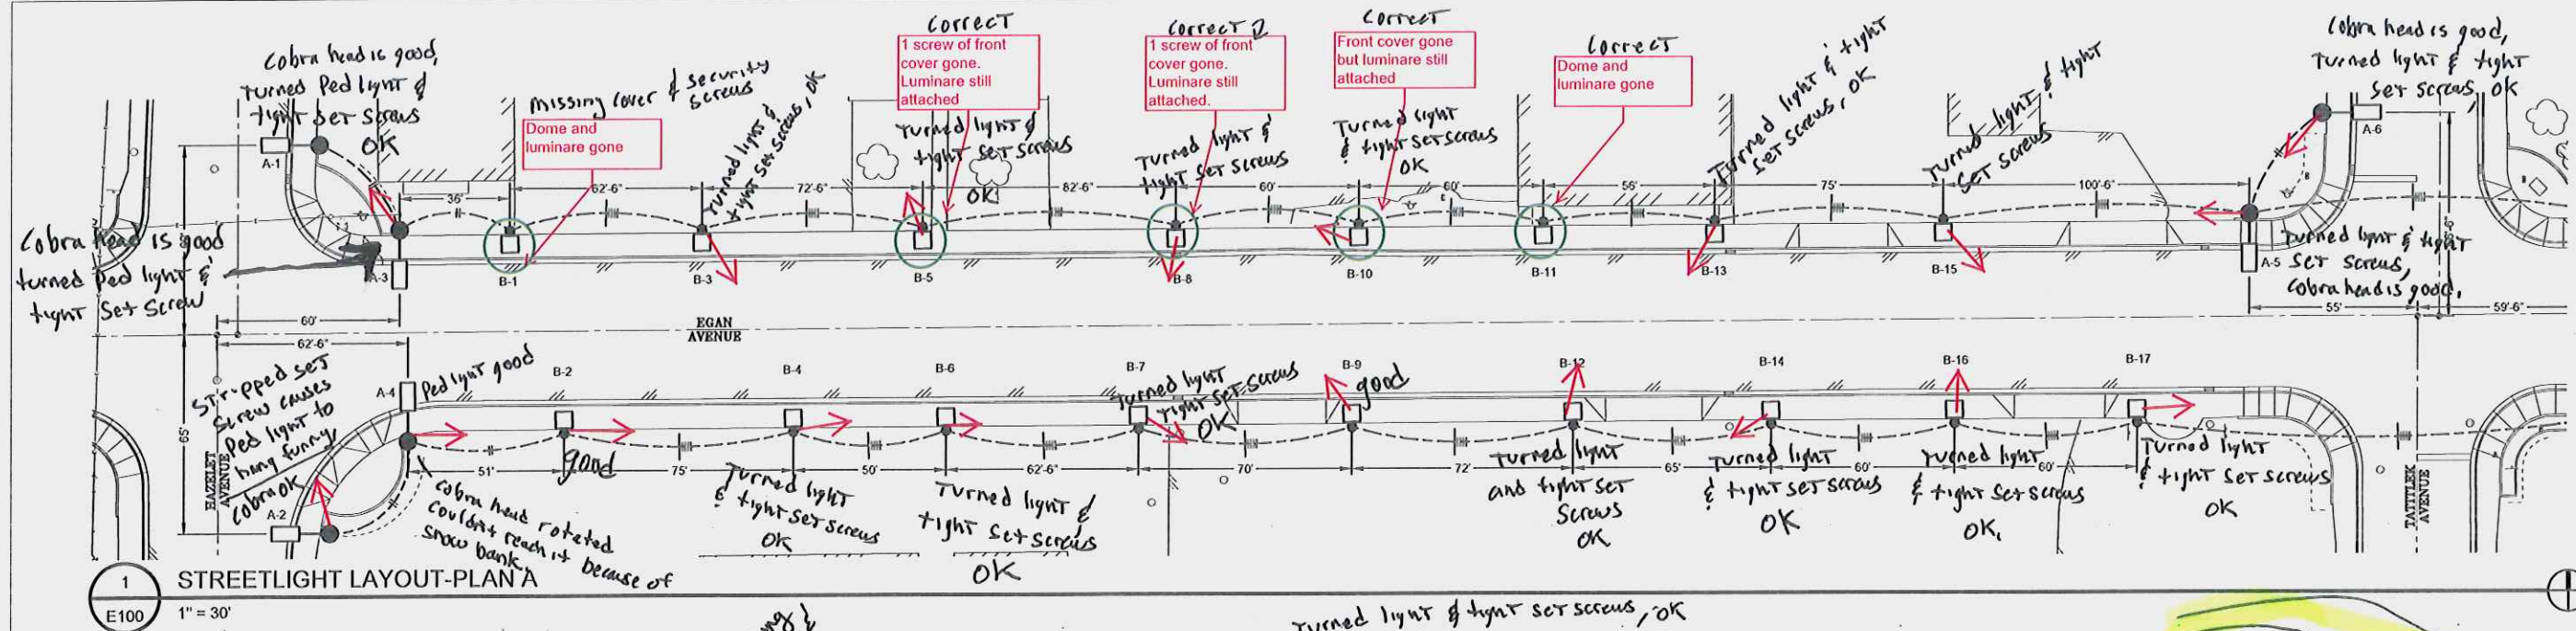
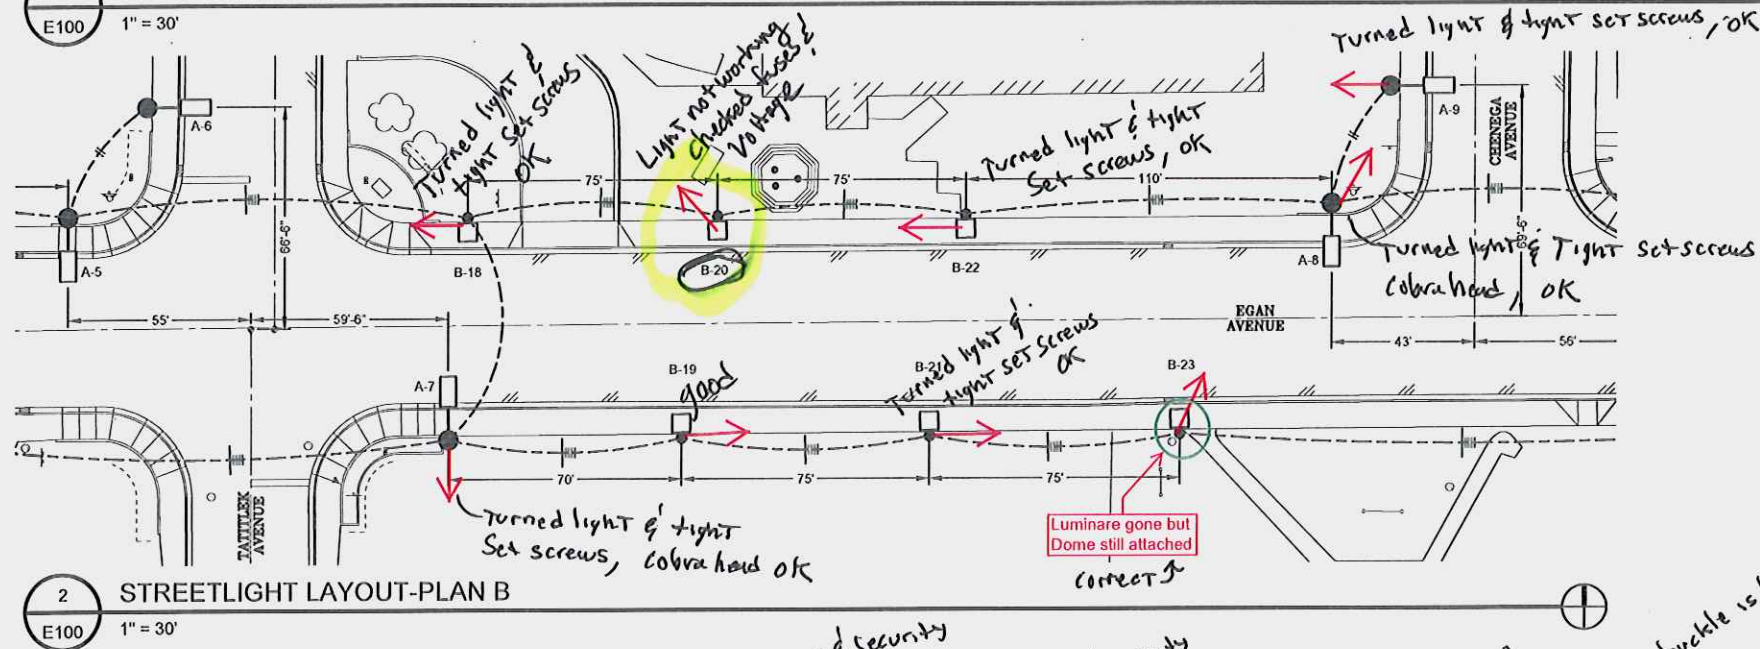
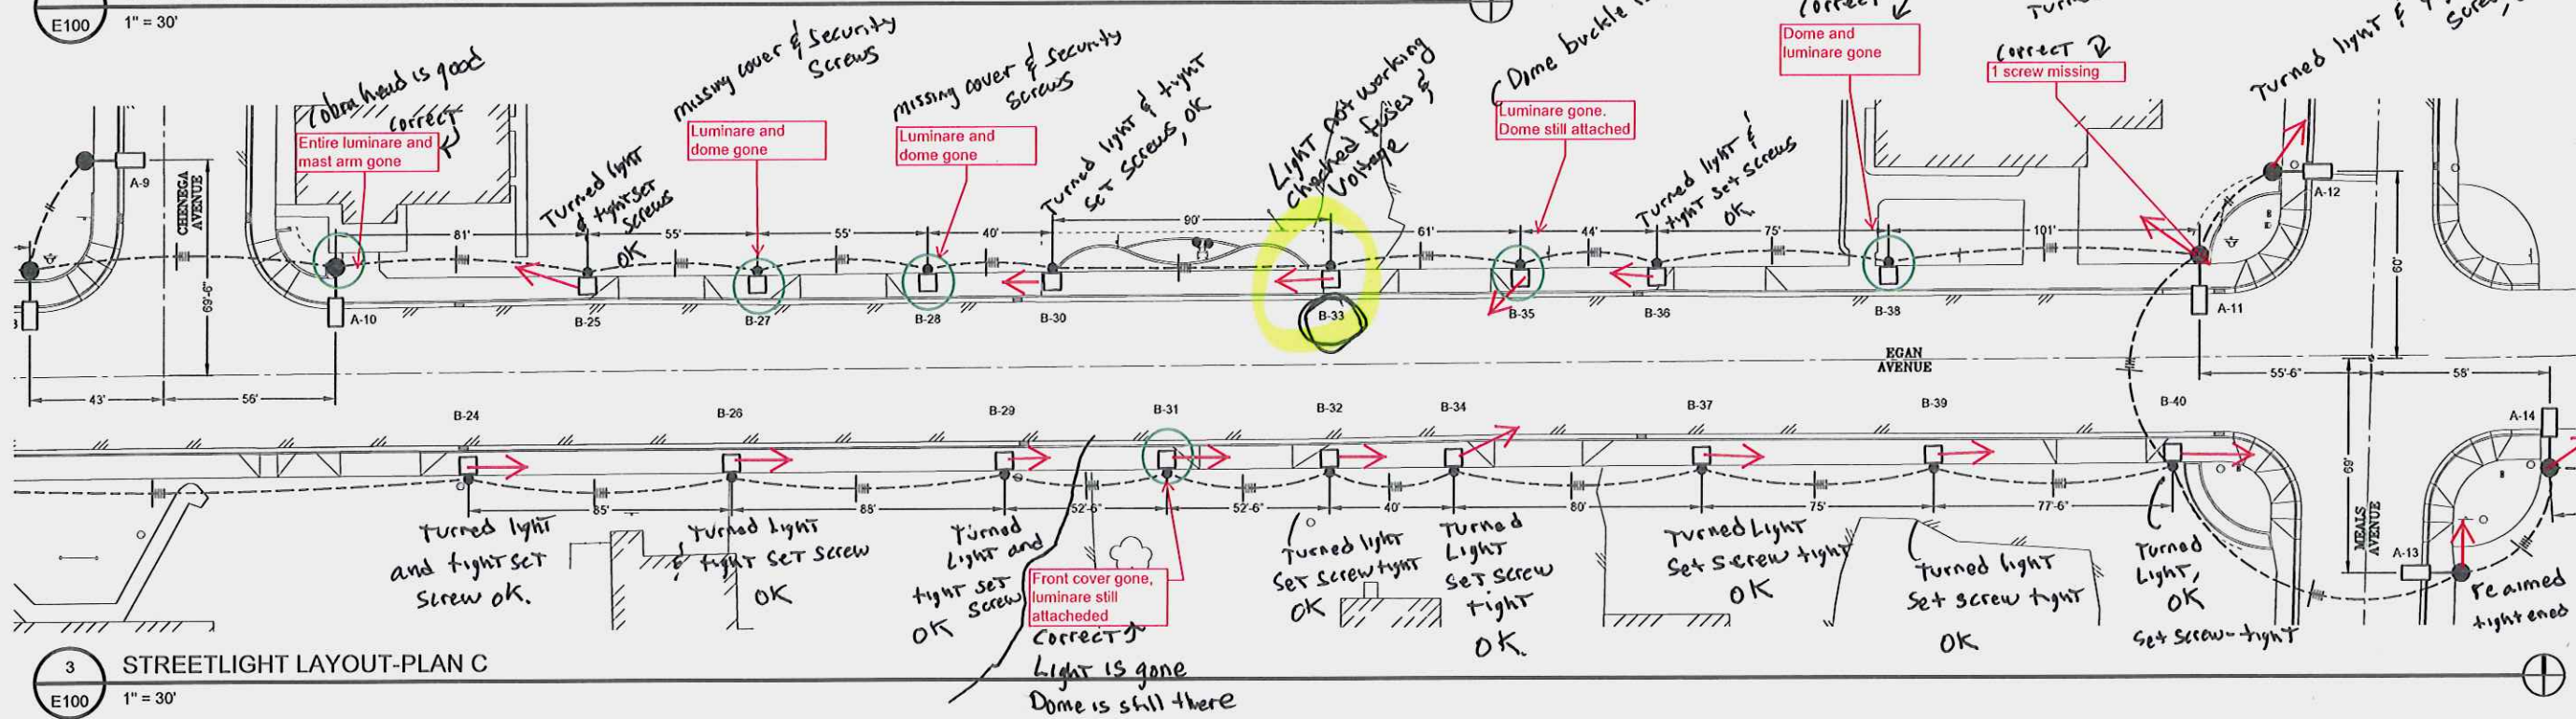
E100

NOTE: B-20  
B-33  
Lights not working

Reaimed Ped light and  
tightened set screw, Back set screw is  
stripped, may need  
new arm.

STREETLIGHT  
LAYOUT  
Reaimed Ped, re-tightened  
Set screws OK
