**RE: City of Valdez Animal Microbial IAQ Screening**

On the date of September 20<sup>th</sup> 2017 White Environmental Consultants (WEC) performed airborne and surface microbial fungal spore sampling within the Valdez Animal Shelter located at 276 Egan Avenue Valdez, Alaska. Brett O'Bray WEC's Board Certified Microbial Consultant performed onsite inspection, sampling and prepared this letter. Average temperature at the time of inspection within the structure was in the mid-seventies with a mean relative humidity of forty one percent. The inspection and sampling was performed in the fall on a cloudy day. Airborne and surface microbial sampling was performed at the request of our client to determine the type and extent of fungal spore content in relation to indoor air quality and suspect contamination within the structure.

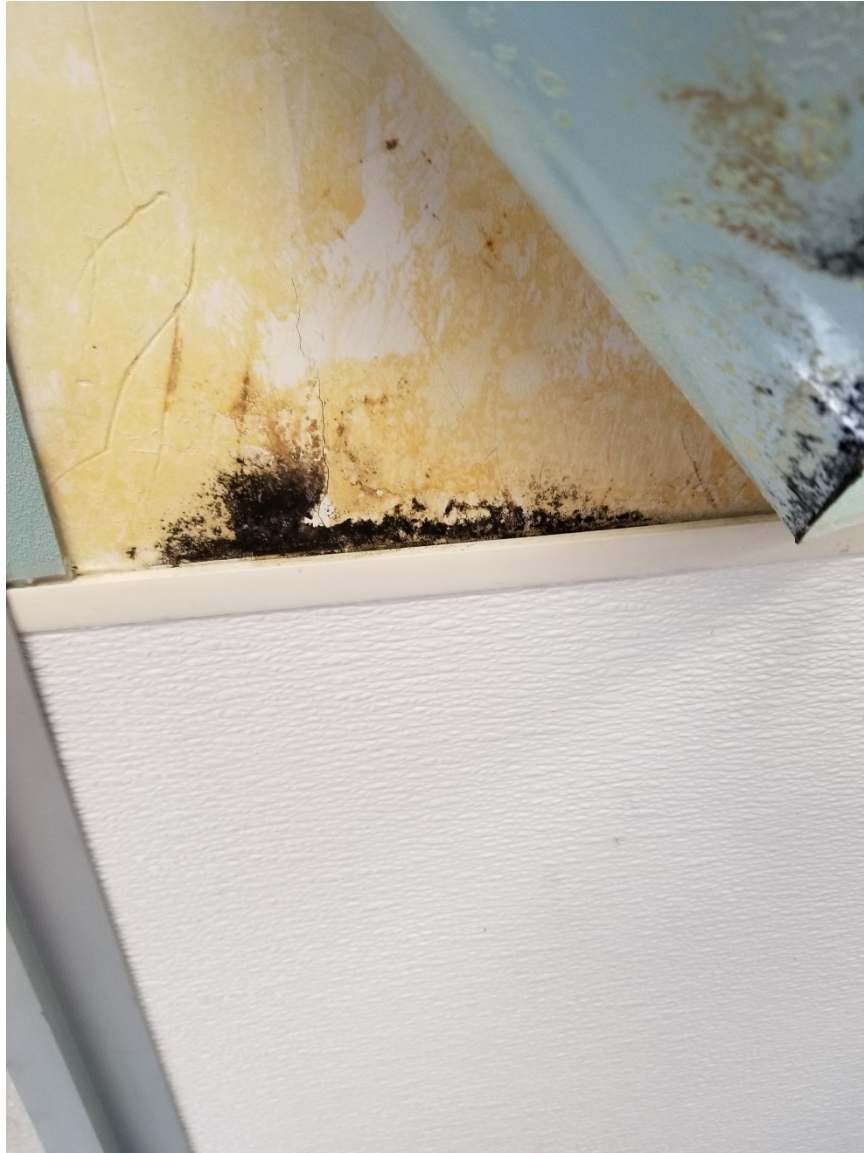
Visual inspection at the top and base of the Mylar Wainscot found visible suspect moisture behind the finishing material. The building was refurbished in 2005. After removing all interior finishes in the area where the kennel is now located, CMU block walls were furred out and gypsum wall systems were installed with the above-mentioned Mylar wainscot attached to the exterior. No curved cove is installed at the base of the system and the top of the wainscot does not extend up the wall far enough so that moisture, when personnel are cleaning the kennels, allows for moisture to wick into the wall system top and bottom. Coupled with drains that are level with the poured concrete floor and the wall systems themselves consisting of gypsum the design is not conducive to its proposed and current use.

Mold growth on wall system and Mylar wainscot located at the top seam, typical design throughout the kennel

Sample ID #	Collection Date	Sample Description	Sample Location	<u>Results</u> Mold Growth
T-001	09/20/2017	Tape Lift	Top of wainscot from wall	ASP/PEN +5
T-002	09/20/2017	Tape Lift	Base of wainscot from wall	ASP/PEN +5

It should be assumed based on visual and laboratory analysis that the perimeter walls of the kennel from the top of the wainscot to the base of the wall system have mold content on and or within the wall systems and the Mylar wainscot. It is recommended to remove the wall system from the and wainscot from the top of the wainscot to the ground level. The future design should account for the excessive use of moisture in this area, and put back of materials should incorporate moisture resistant products coupled with a design not to allow moisture to wick into it. The concrete floor should be floated to allow for proper drainage from the everyday discharge of water.

- Remove all gypsum board in the kennel from affected areas to access foundation and CMU block wall.
  - Remove contamination found at the time of inspection on the structural joists, and clean all surfaces within the contained area.

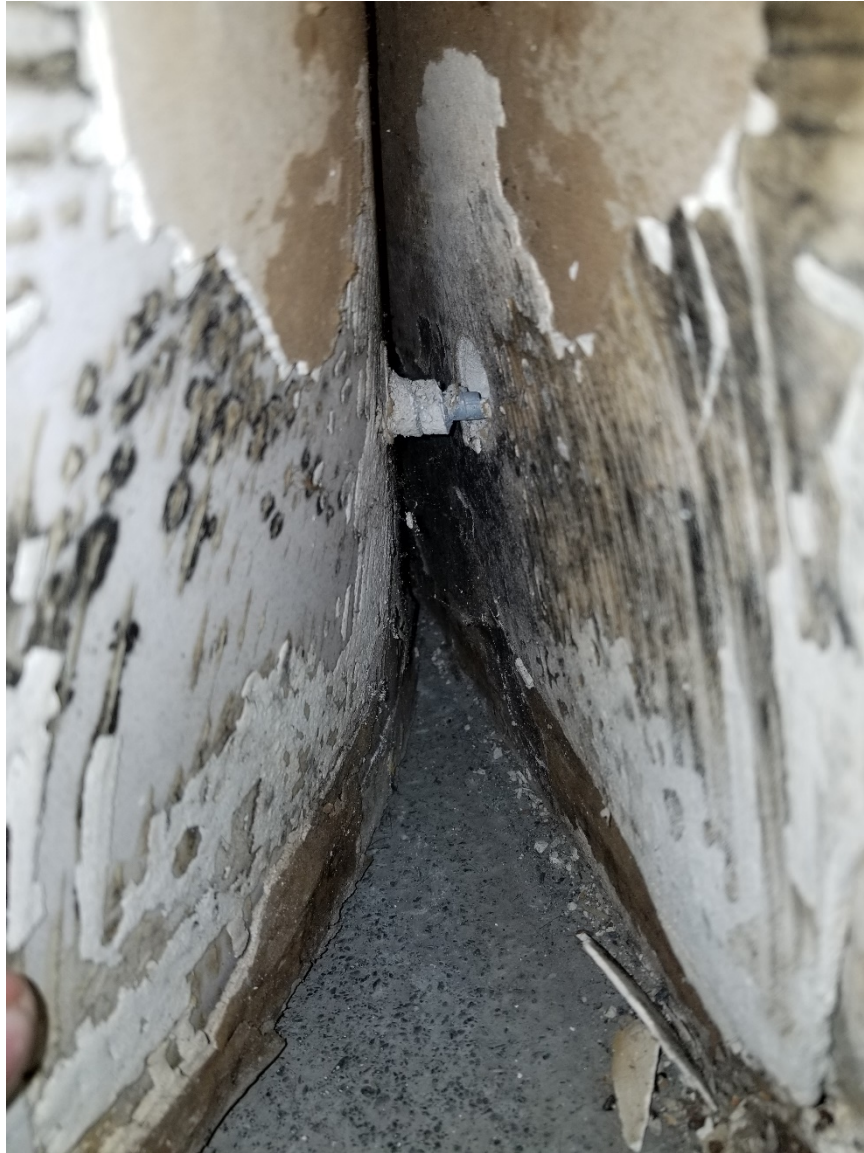
WEC was informed by our client, The City of Valdez, that the head of the shelter had discovered suspect microbial growth behind Mylar wainscot that exists in the dog kennel of the facility. All wall systems were inspected at suspect locations of water intrusion within the kennel area. WEC tested all of the suspect surface and surrounding areas of the kennel with a G.E. Survey master Moisture Meter. The GE Protimeter Surveymaster is used for moisture measurement in buildings. Excessive moisture in buildings will lead to decay and deterioration of components and decorative finishes. Testing within the area of concern(kennel) found the materials to be positive for moisture content at the base of the wall systems at the time of inspection.

Mold growth on wall system and base of wainscot
