MEMORANDUM

TO: Rob Comstock
FROM: Anna Ferntheil, E.I. through Brad Melocik, P.E.
DATE: November 5, 2018
PROJECT: City of Valdez Pavement Management Plan 2018

Valdez Pavement Management Plan

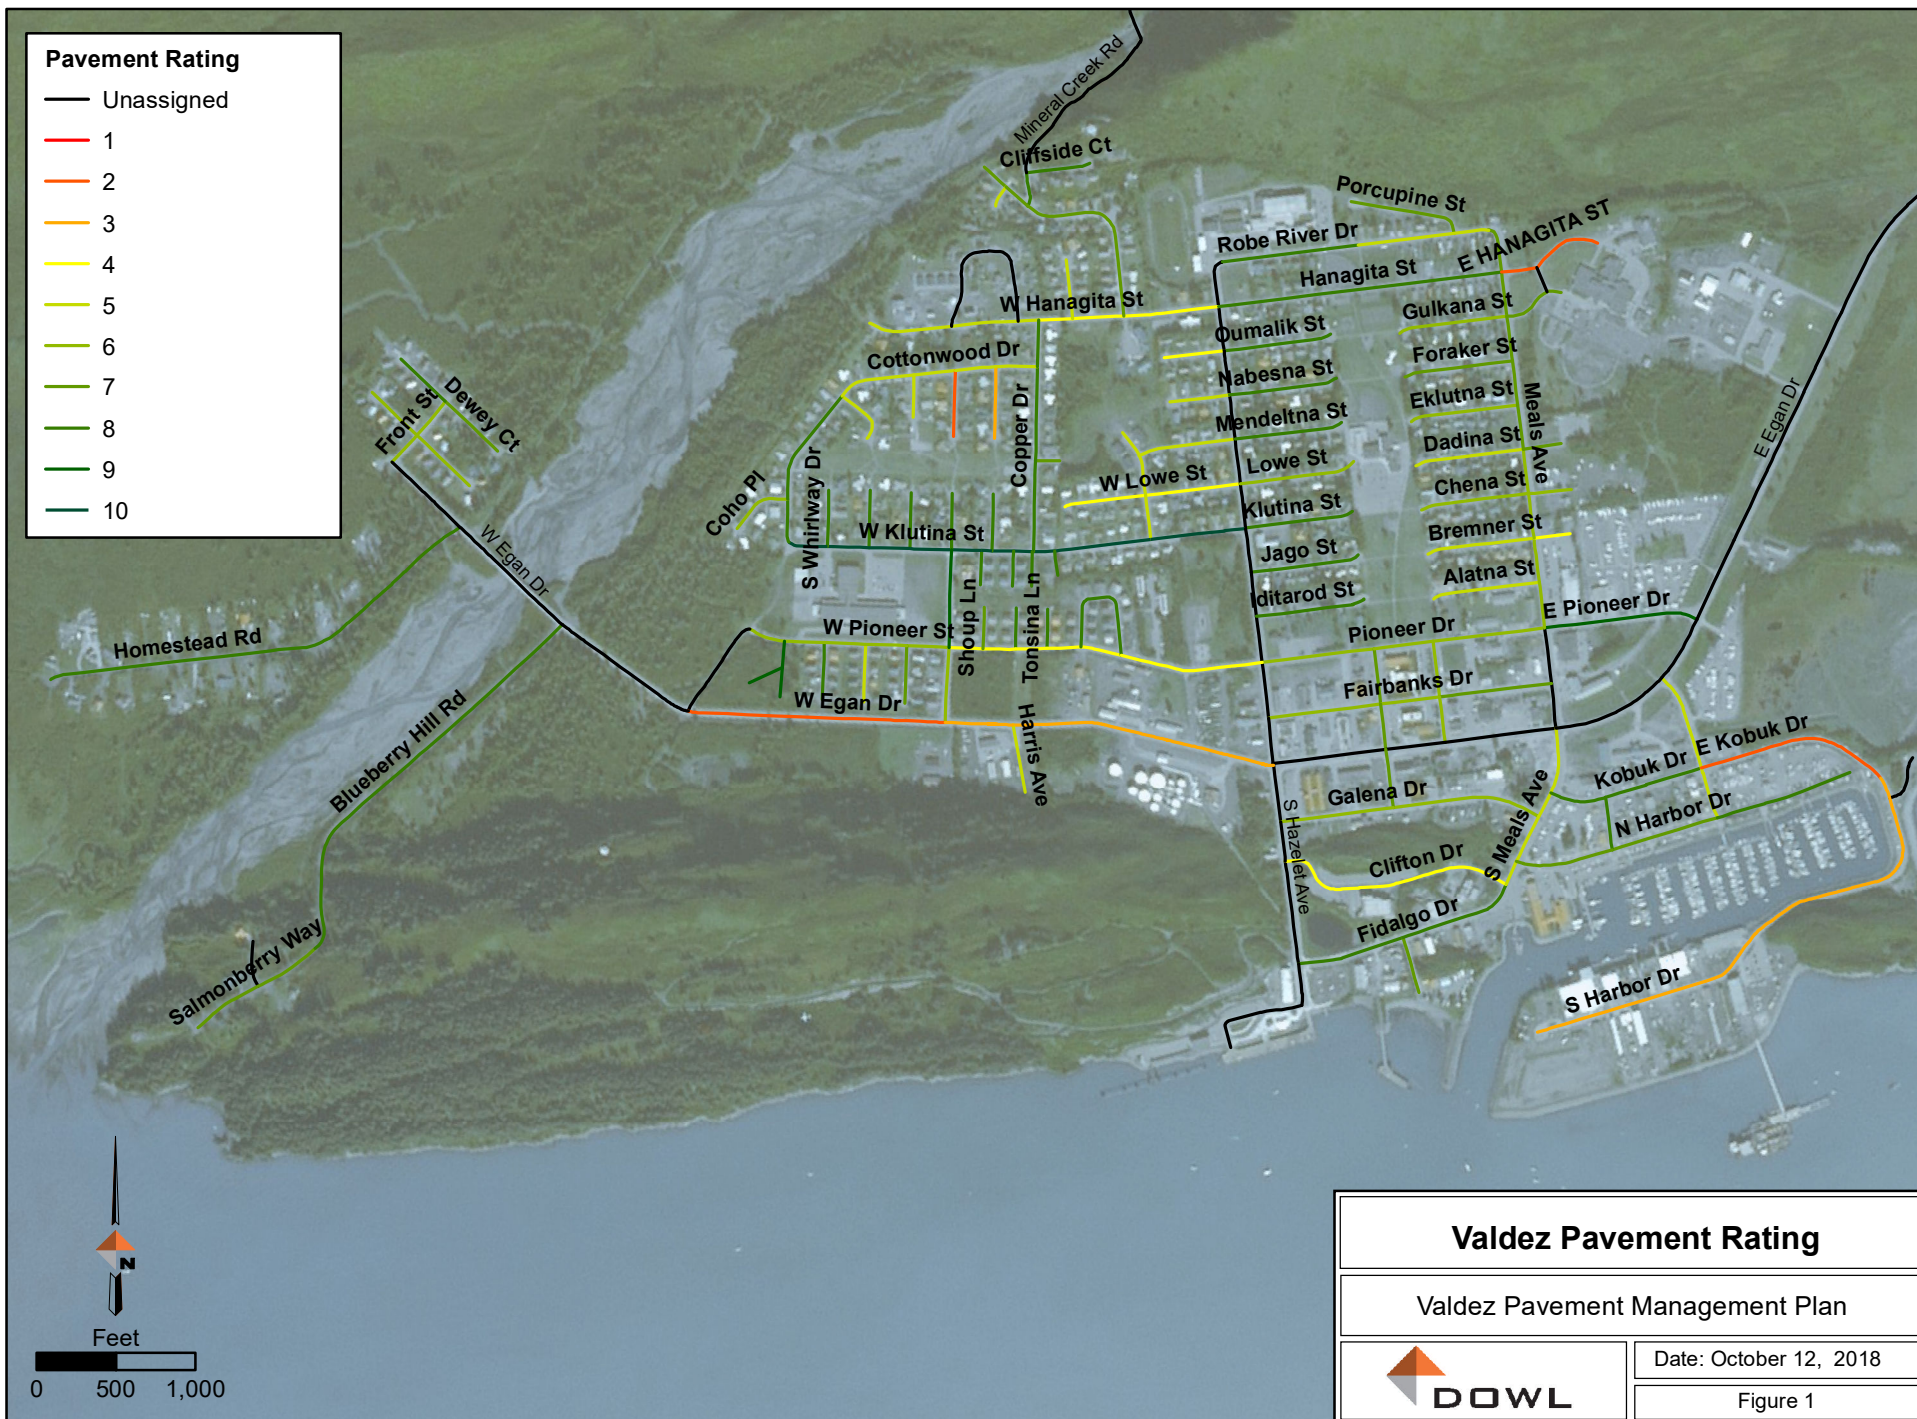
Hanagita (Figure 1; Table 1, Page 1)

While the new section of Hanagita outside the high school is a new road surface, the pavement matrix is highly segregated. Segregated pavement allows water to enter the pavement and subgrade and can lead to a shortened service life of the road. A seal coat or similar surface treatment is recommended in this section. An emulsion provider should be consulted to determine what product best meets the needs of this road section

- Intersection of Clark Street and West Pioneer Drive (Figure 1)
- The end of the Shoup Lane cul-de-sac (Figure 1)
- Intersection of W. Lowe Street and Pacific Avenue (Figure 1)
- Intersection of Mineral Creek Road and Mineral Creek Drive (Figure 1)
- Intersection of Fairbanks Drive and Tatitlek Ave (Figure 1)
- Intersection of Fairbanks Drive and Chenega Ave (Figure 1)

- The storm drain on Lowe from Hazlet to Mendeltna is shallow and freezes during the winter. (Figure 1)
- There is a French drain installed on Mineral Creek that does not connect to the storm drain system. The size of the French drain is inadequate to hold the amount of water it collects. (Figure 1)
- Water pools on the north end of Shoup. This pooling has caused significant pavement damage. (Figure 1)

The freezing and thawing of water can lead to significant problems for pavement. It is recommended that drainage is improved in these problem areas.

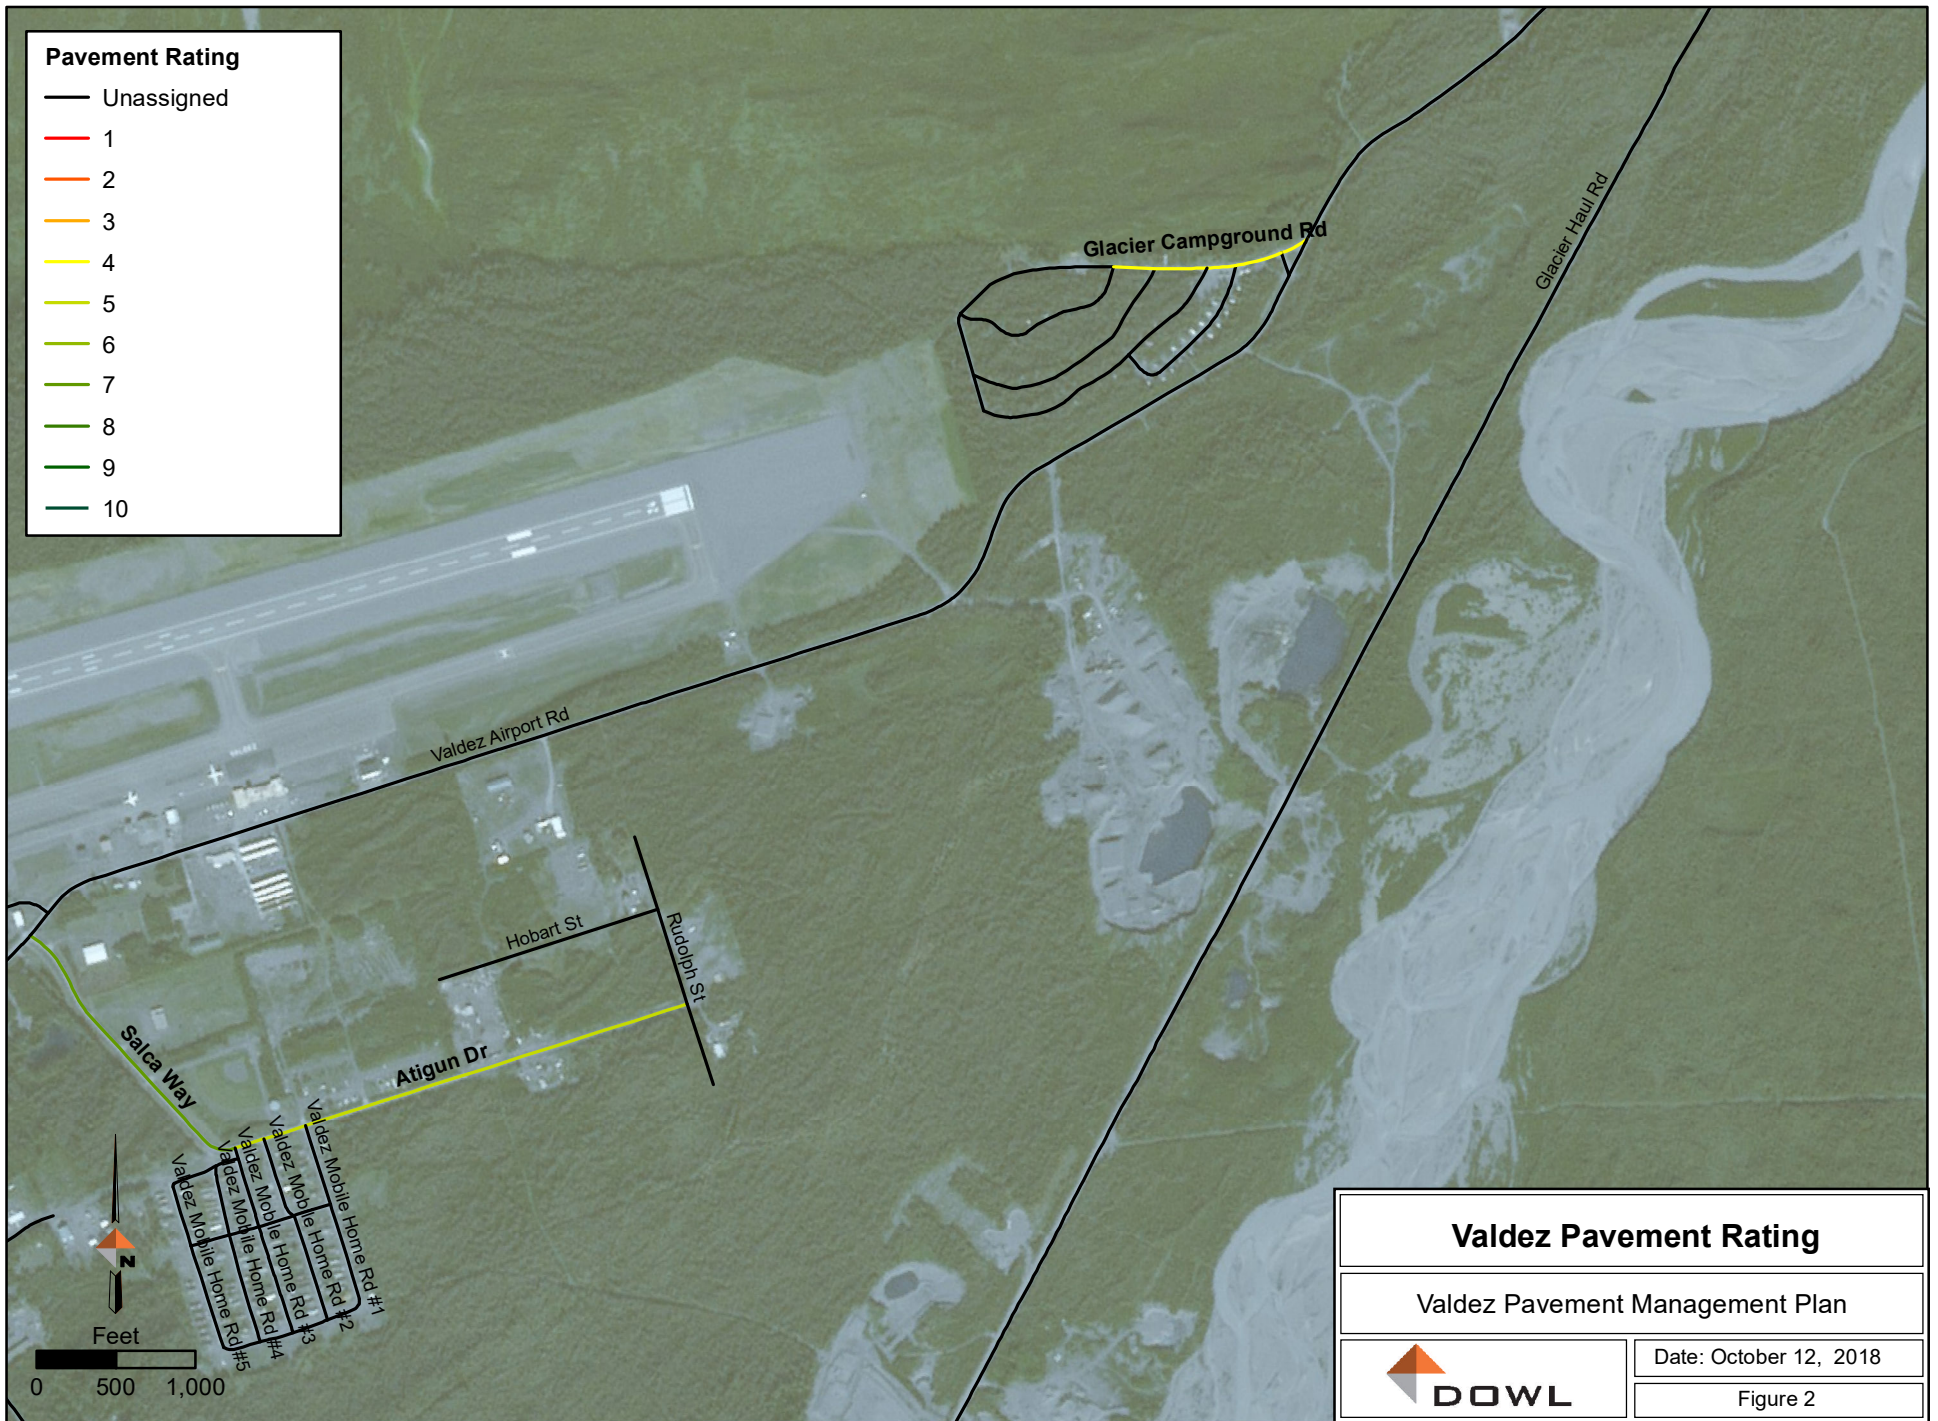
- Intersection of Chitna Ave and Kobuk Drive (Figure 1)
- Intersection of Airport Road and Salcha Way (Figure 2)
- Intersection of Salcha Way and Atigun Dr (Figure 2)
- Intersection of Robe Lane and Raven Drive (Figure 3)

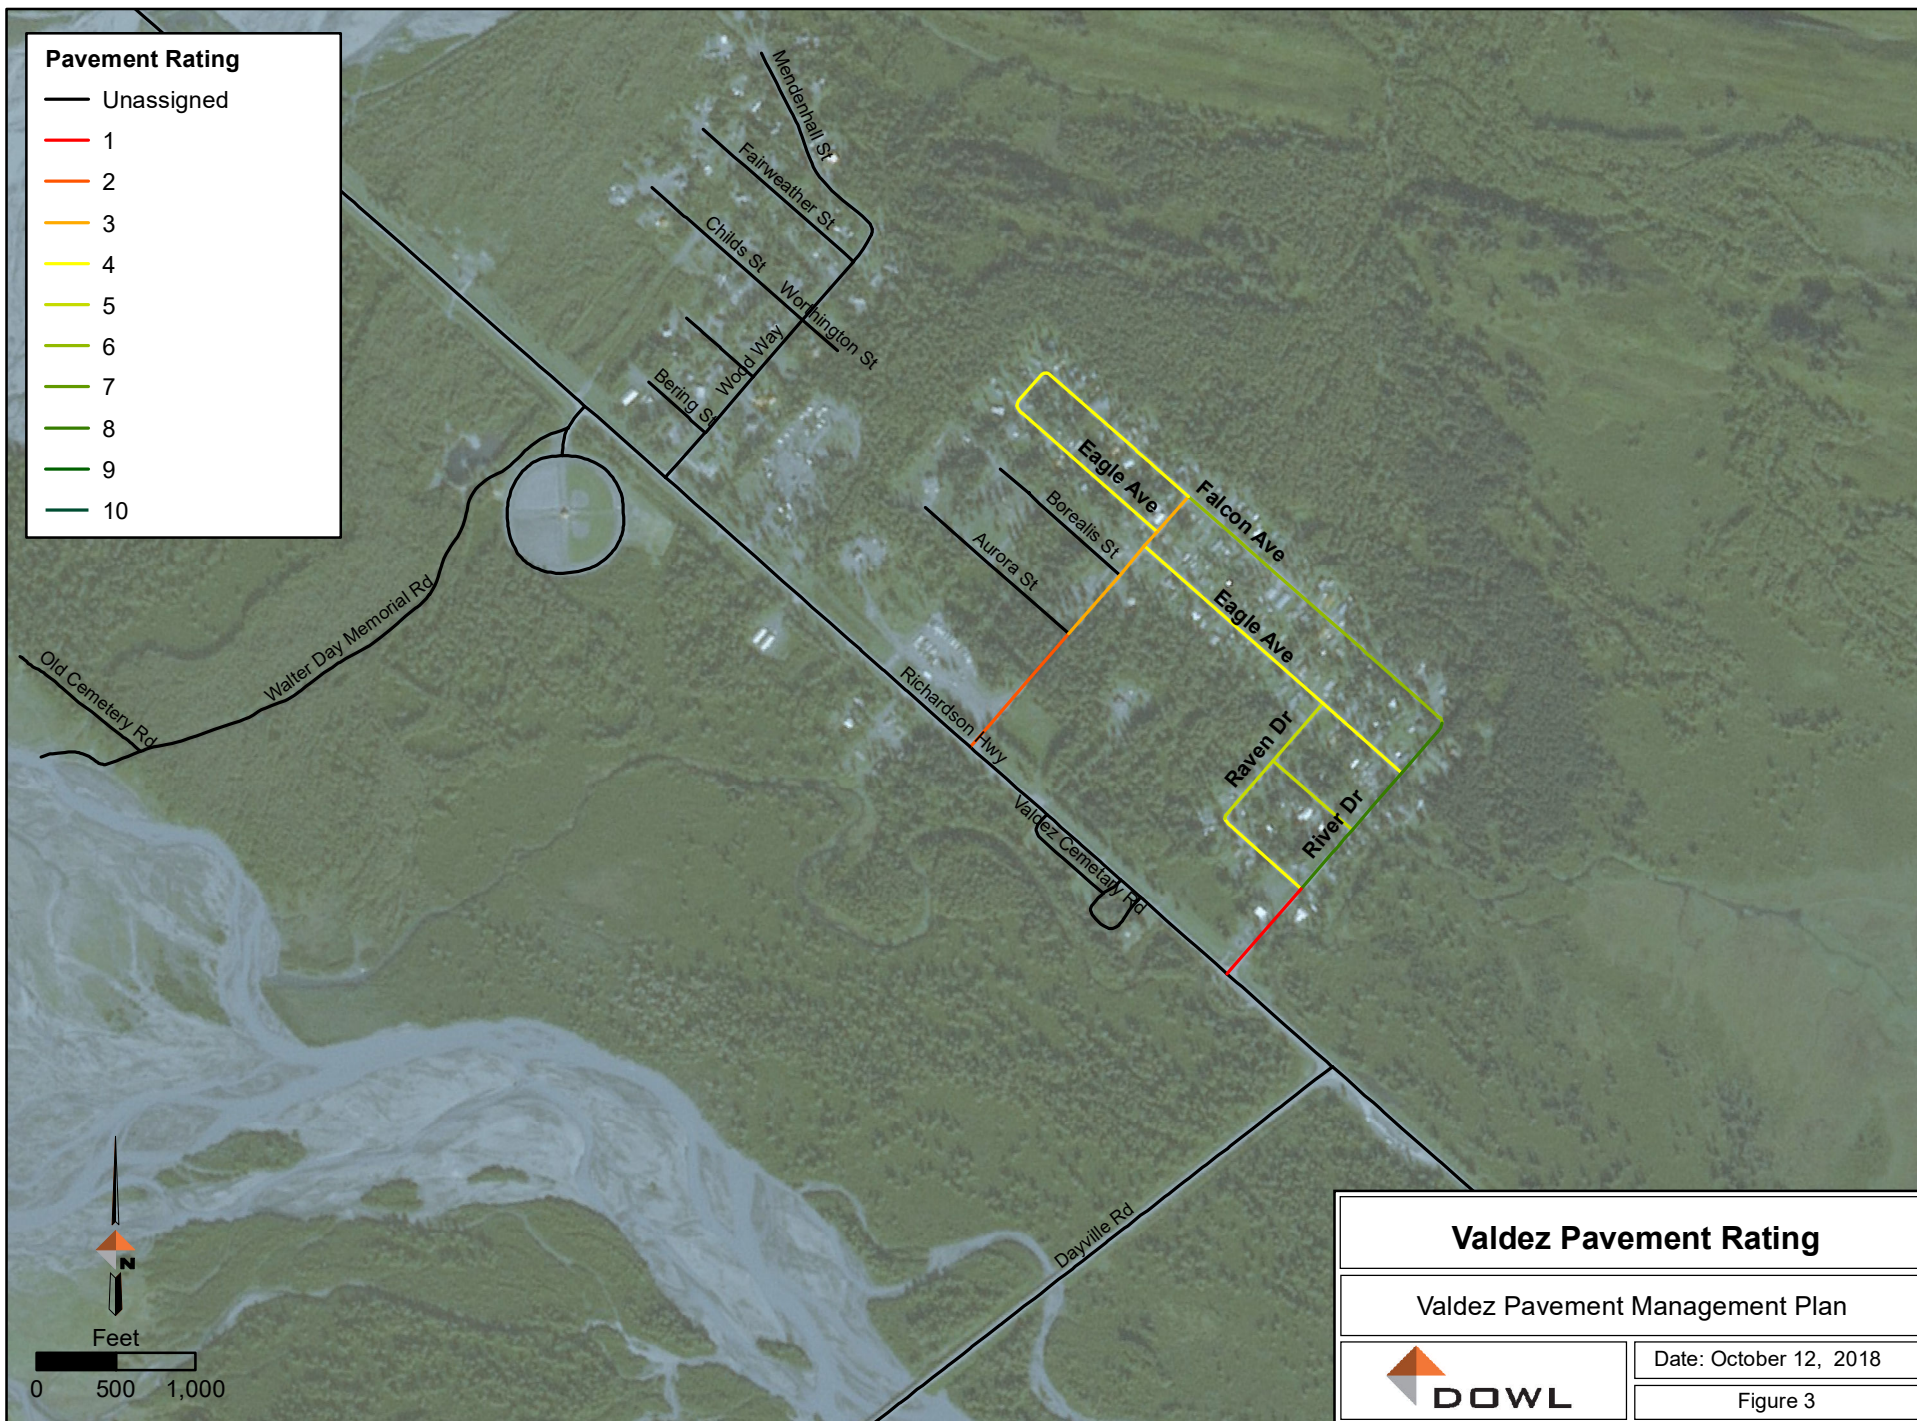
Robe River Subdivision (Figure 3; Table 1, Page 10 & 11)

In general, the pavement in this subdivision is in poor condition. While the ratings reflect this, a significant cause of the damage appears to be due to unsuitable drainage and subgrade failure. Common issues in this area include settling utility trenches, failing shoulders, extensive patching, and severe alligator cracking.

In many areas, the ditches that were constructed when the subdivision was put in have been filled in with soil. Additionally, many culvert inlets and outlets appeared to be buried or blocked. The standing water in this area caused by this inadequate drainage can contribute to pavement distress as it seeps into the road subgrade causing frost damage as the temperatures change. The standing water may also be weakening the subgrade and contributing to the shoulder failures.

Utility trenches were cut into the road after construction. Material and methods used to backfill the trenches likely varied from the original subgrade and may be due to compaction issues, a difference in material, or something else. Regardless of the cause, a long-term solution involves replacing the subgrade with material of uniform properties and compaction.

Some of these roads are rated in the 4 to 6 range. However, for satisfactory long-term service, the drainage and subgrade issues need to be addressed.
