US Army Corps of Engineers
Alaska District

Seward, Alaska, Planning Assistance to States Flood Risk Management

November 2011

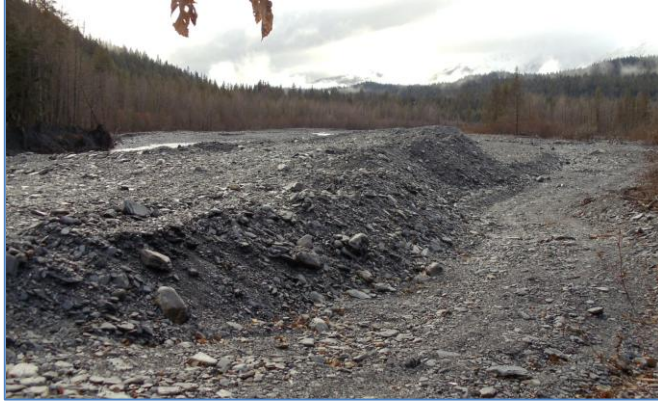
Photograph 1. Near the end of 1,400-foot non-engineered levee protecting Meridian Park and Bear Lake subdivisions (looking downstream)

9. The SBCFSA Board approved the use of gabion baskets at Kwechak Creek to extend the current embankment to 1,400 feet. The gabion baskets are understood to be a short-term solution to the flooding issues in the area.

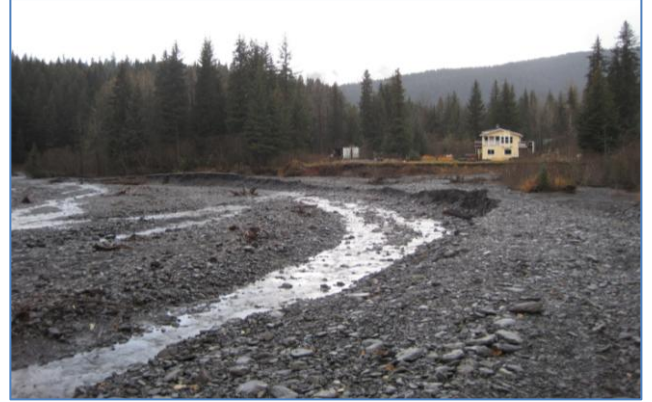
Photograph 2. Additional non-engineered levee farther downstream at Kwechak Creek (looking downstream)

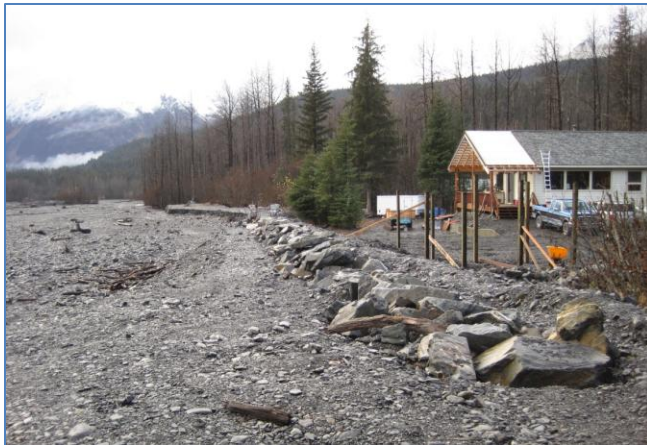
Photograph 3. Non-engineered levee with rock placed by homeowner in the Questa Woods subdivision (looking downstream)

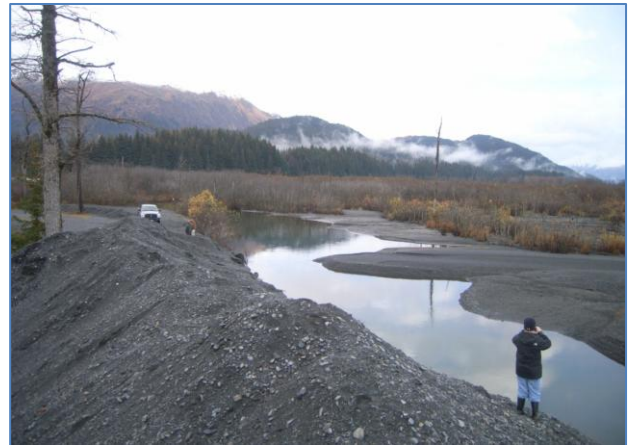
Photograph 4. Embankment constructed of river-run materials along Clear Creek near Salmon Creek confluence (looking upstream)

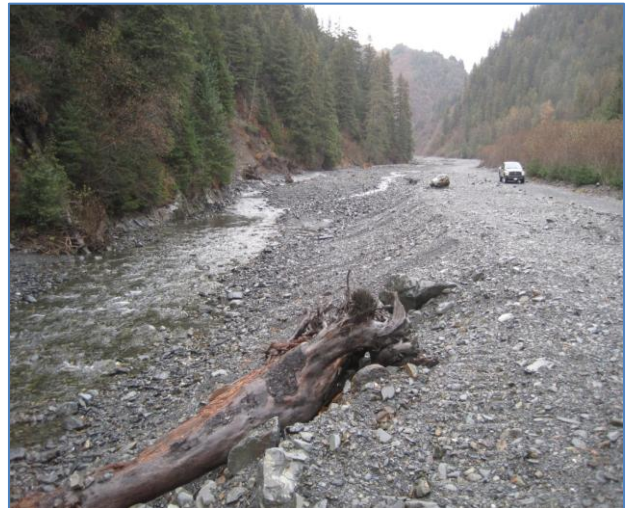
Photograph 5. Non-engineered levee along Box Canyon Creek (looking upstream)

Measures Implemented. The KPB maintains a 3,000-foot-long non-engineered levee on an emergency basis to mitigate floods on Box Canyon Creek (Photograph 5). An Individual Permit for maintenance of this structure was issued July 2011 and expires July 31, 2021.

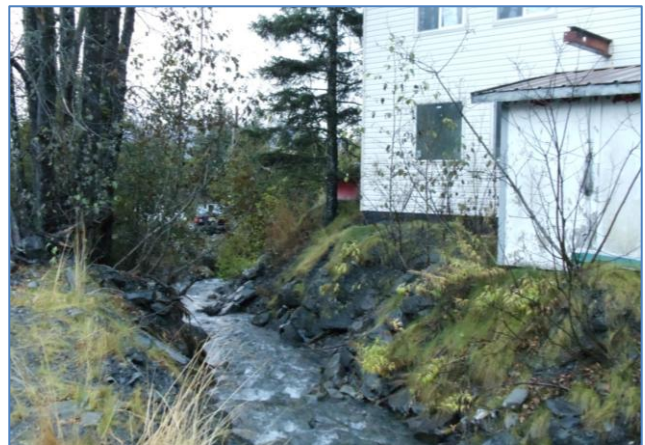
Measures Implemented. Sediment was cleared from the area shown in Photograph 6 by a homeowner after the 2006 flood. There were no other historical measures implemented for flood mitigation on Scheffler Creek at the time of this report.

Photograph 6. Close development along Scheffler Creek (looking downstream)

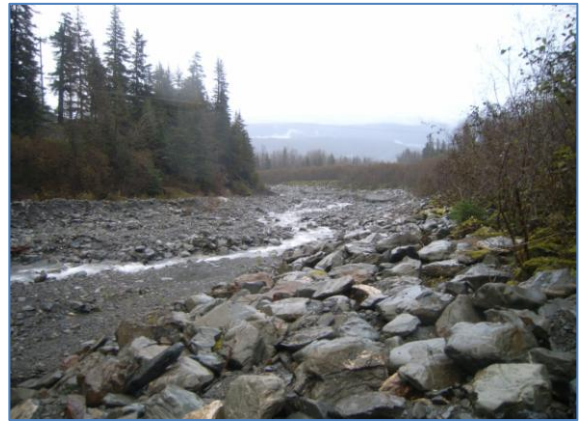
Photograph 7. Upper portion of NRCS Levee (looking downstream)

Measures Implemented. NRCS constructed a riprap protected 1,150-foot-long levee along the right channel bank at the apex of the fan that forces flow to the north, protecting homes and businesses (Photograph 7). The levee was constructed in December 1986 and continues to perform well under flood conditions. In September of 2011, the City of Seward completed extension of this levee to its intersection with the Seward Highway.

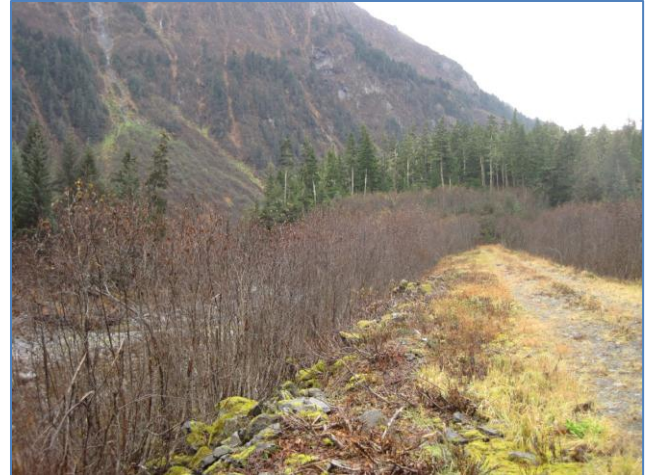
Photograph 8. Fourth of July Creek levee (looking downstream)

Measures Implemented. A flood control levee (Photograph 8) was built in 1982 to protect the prison, quarry, and the Seward Marine Industrial Center from flood waters. Flood waters during the 1986 flood

did not overtop the levee but caused erosion damage to the levee toe. In 1991, the city modified the existing levee to withstand the high-velocity flow generally experienced in this area. A Corps Section 205 Report in 1992 sited the repairs completed by the city and noted no further action.

The levee on Fourth of July Creek has functioned without incident since construction. Recommendations for maintenance for continued flood control are needed. Recent LiDAR in the area has shown the channel is aggrading.

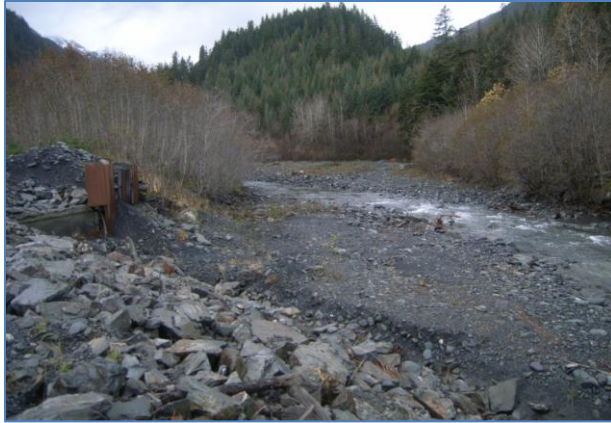
Measures Implemented. After the 1986 flood, the NRCS built a riprap protected levee on the south bank of the channel upstream of the bridge to entrain flow under the bridge opening, protecting most of the development on the fan including the wastewater plant. The levee has performed well despite the fact it has not been maintained since its construction (Photograph 9). The KPB has recently channelized the flow downstream of the Spruce Creek Bridge by pushing river-run material from the center of the active stream channel to either side to aid in conveyance (Photograph 10).

Photograph 9. NRCS constructed levee along Spruce Creek

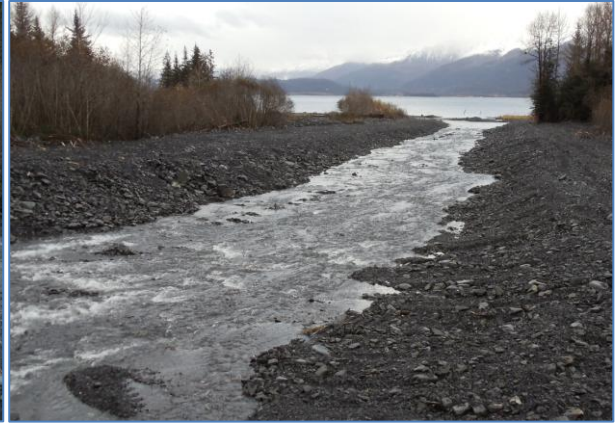
Photograph 10. Channelized Spruce Creek (looking downstream) to Resurrection Bay
