### STATE OF ALASKA NAVIGABILITY DETERMINATION

#### Valdez Glacier Stream

**Date of Determination:** April 6, 2017

The Valdez Glacier Stream is navigable for title purposes the entire length of the river from tide water to Unnamed Pro-Glacial Lake.

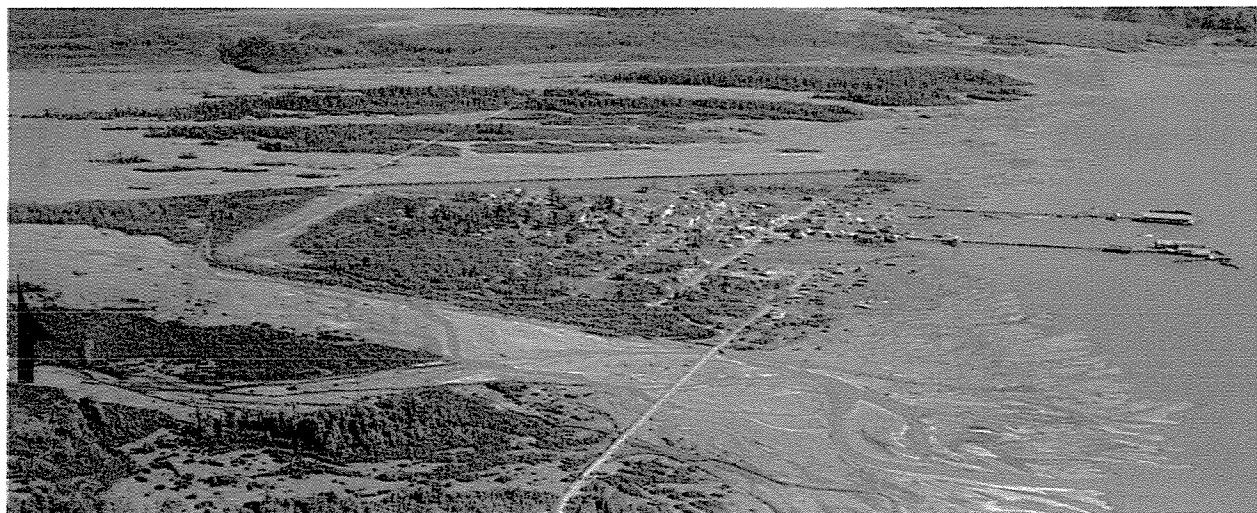
Figure 1. Valdez Glacier Stream. Crop of photo 3669, 1940, Source, Quantum Spatial.

1940: Artificial changes observed from the pre-statehood photographs are the Richardson Highway and a dike surrounding the entirety of Old Valdez. Portions of the dike surrounding Old Valdez are still in place. Much of the Richardson Highway in 1940 was on pilings and multiple bridges to allow the wide meandering flow of Valdez Glacier Stream flow to the ocean.

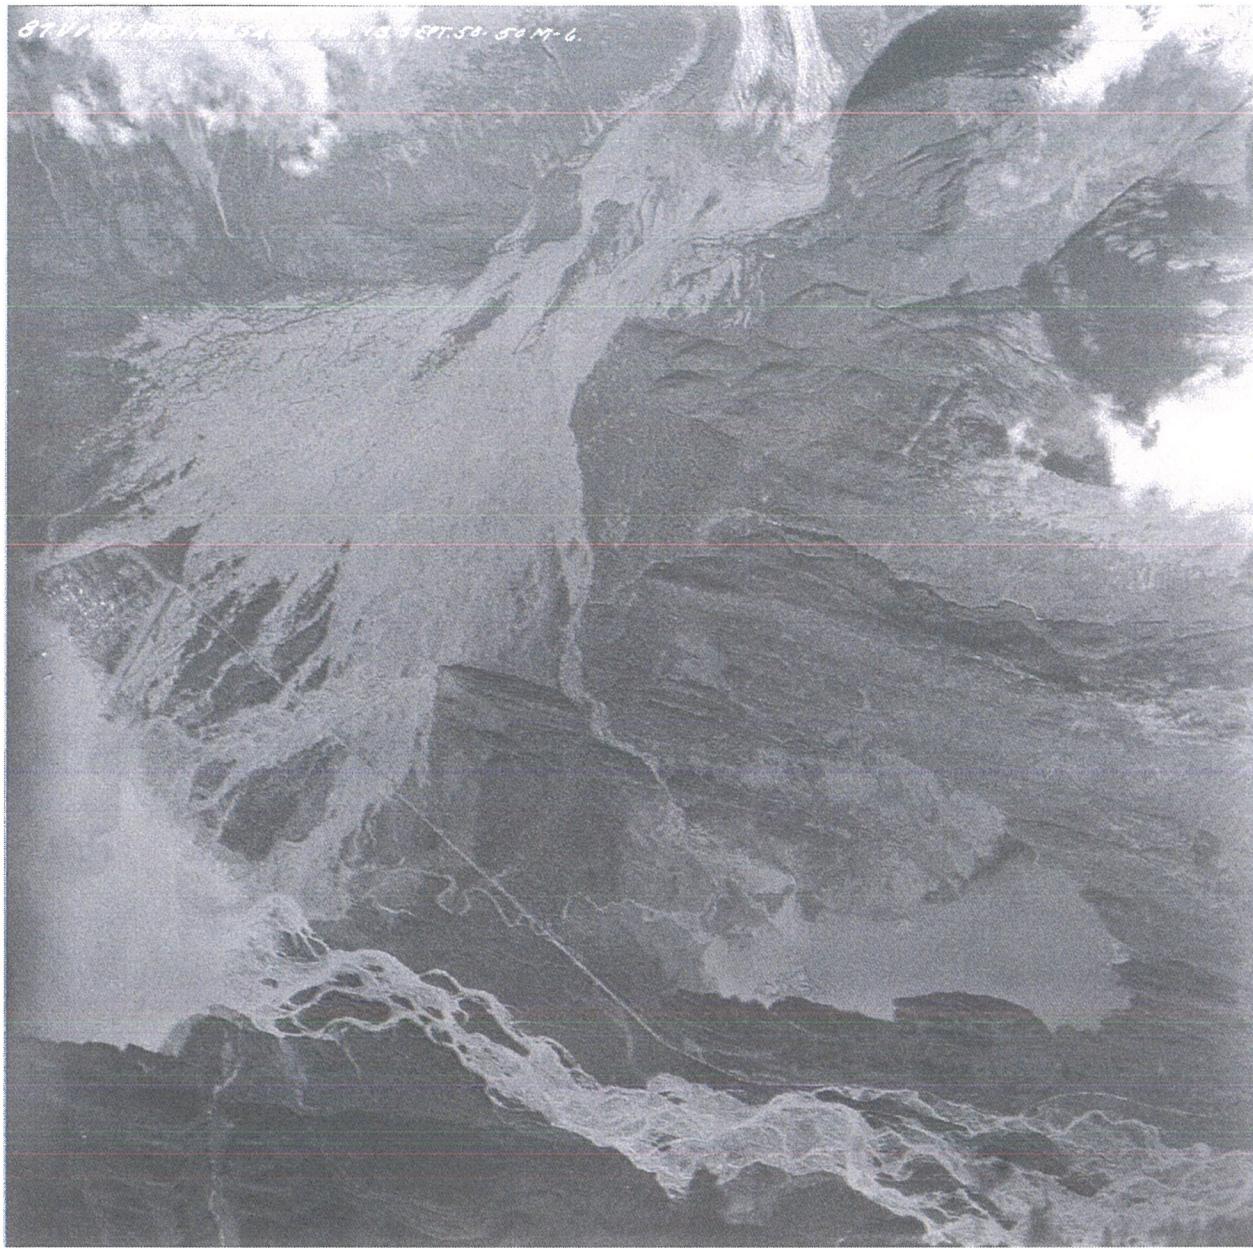
Figure 2. Valdez Glacier Stream. Crop of photo BM04540340087, September 13, 1950, downloaded from USGS Earth Explorer.

1950: The Valdez Glacier did not have a lake at its front in 1950. There were multiple locations of upwelling of meltwater and some indications of lateral melting; but overall the entire face of the glacier was releasing water. Leaving the area of the glacier there were two main channel areas one on the west side of the valley and another on the east. The west channel was entrenched and flowed to the west of Old Valdez. The east channel was entrenched from the glacier downstream to about river mile 3.5 (See Figure 2 and Figure 7).

Below the Richardson Highway west of Old Valdez the channel outside the Old Valdez dike was flowing strong. East of Old Valdez outside the dike the first few channels had clear water flowing in them while the last two bridges, the current location and the location near the levee had large amounts of water flowing through them. The channels below the current bridge location look remarkably similar to current conditions. The islands are in the same locations and many features in the 1950 photography can still be identified.

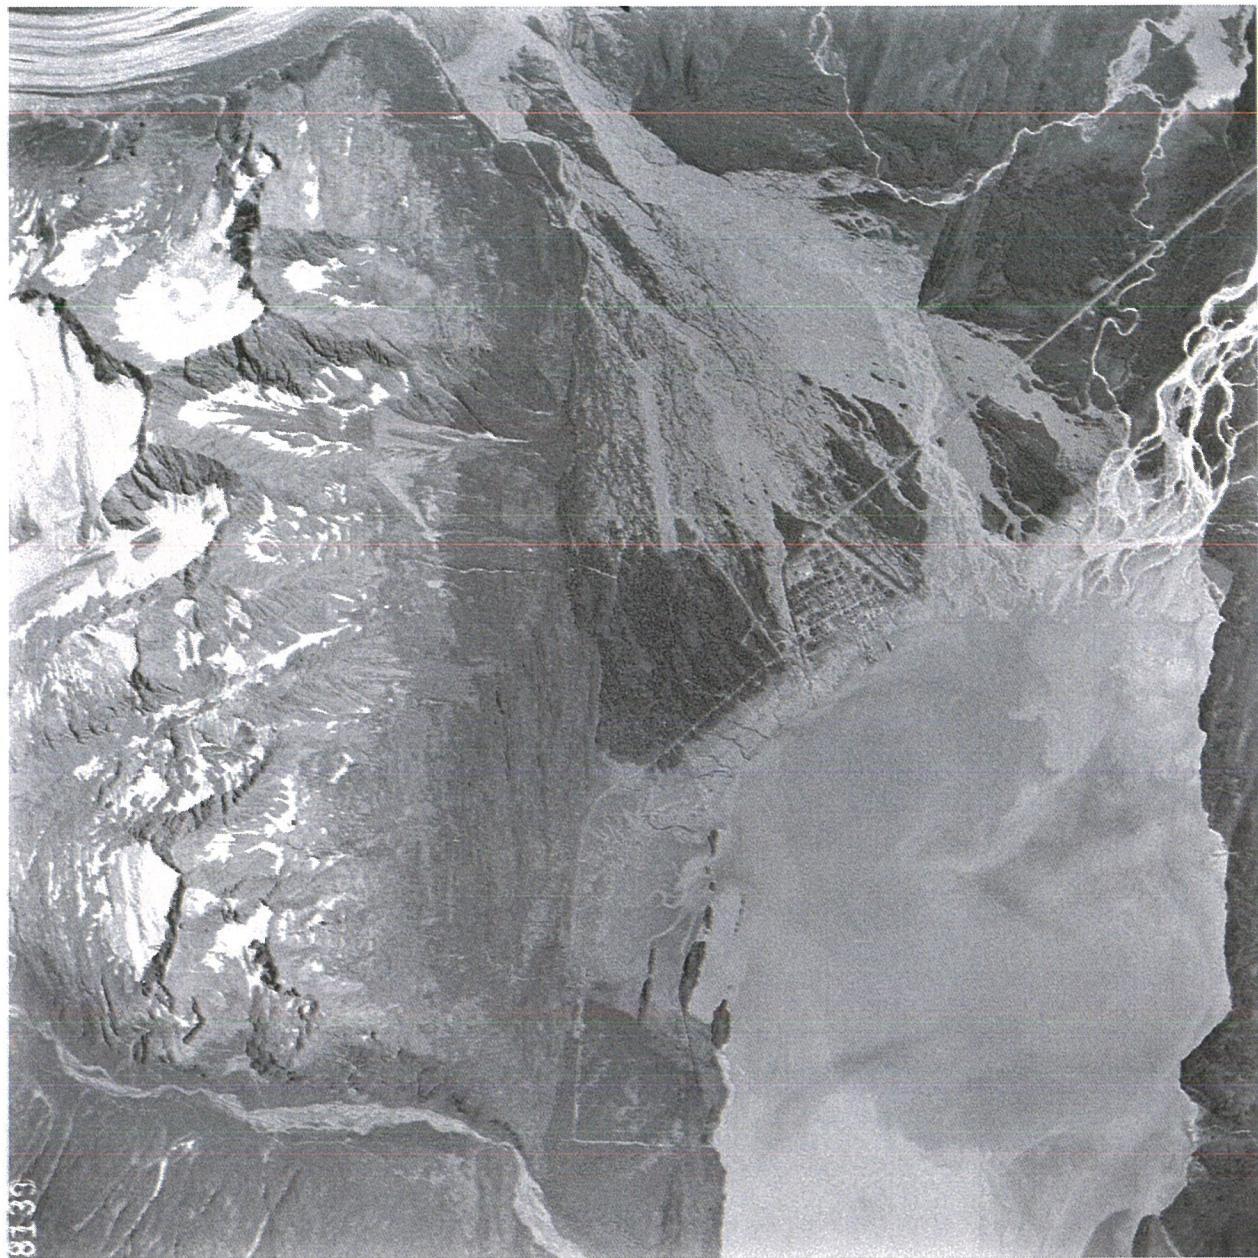
Figure 3. Valdez Glacier Stream. Crop of photo BM02310628139, July 29, 1957, downloaded from USGS Earth Explorer.

1957: The pro-glacial lake is forming at the front of the Valdez Glacier. There are still areas of upwelling and indications of lateral flow along the lower length of the glacier. The west valley channel has been abandoned in favor of the east valley channel. Visible plant growth is taking place in the abandoned west channel. The east channel has entrenched to and beyond the levee at US C & GS Knife (See Figure 3 and 7). In 1957 all water from Valdez Glacier was flowing under the Richardson Highway in the channel at the current bridge location. A levee extension and bridge removal appears to have been constructed between 1950 and 1957. There is no visible indication of gravel extraction in the east channels of Valdez Glacier Stream.

The single lane bridge from Old Valdez heading northwest was moved from Front Street and replaced by a bridge one block northeast on McKinley Street. Gravel mining in the now dry northeast channel of Valdez Glacier Stream appears to be taking place adjacent to Old Valdez. The airstrip has been moved from within the diked area of Old Valdez out to the North of town into the now dry bed of Valdez Glacier Stream.

Downstream of the Richardson Highway on the west side of Old Valdez, there is no flow from Valdez Glacier Stream, there is a small amount of clear water within the lower channels. On the East side of Old Valdez the river looks very much the same as it did in 1950 and to current conditions.

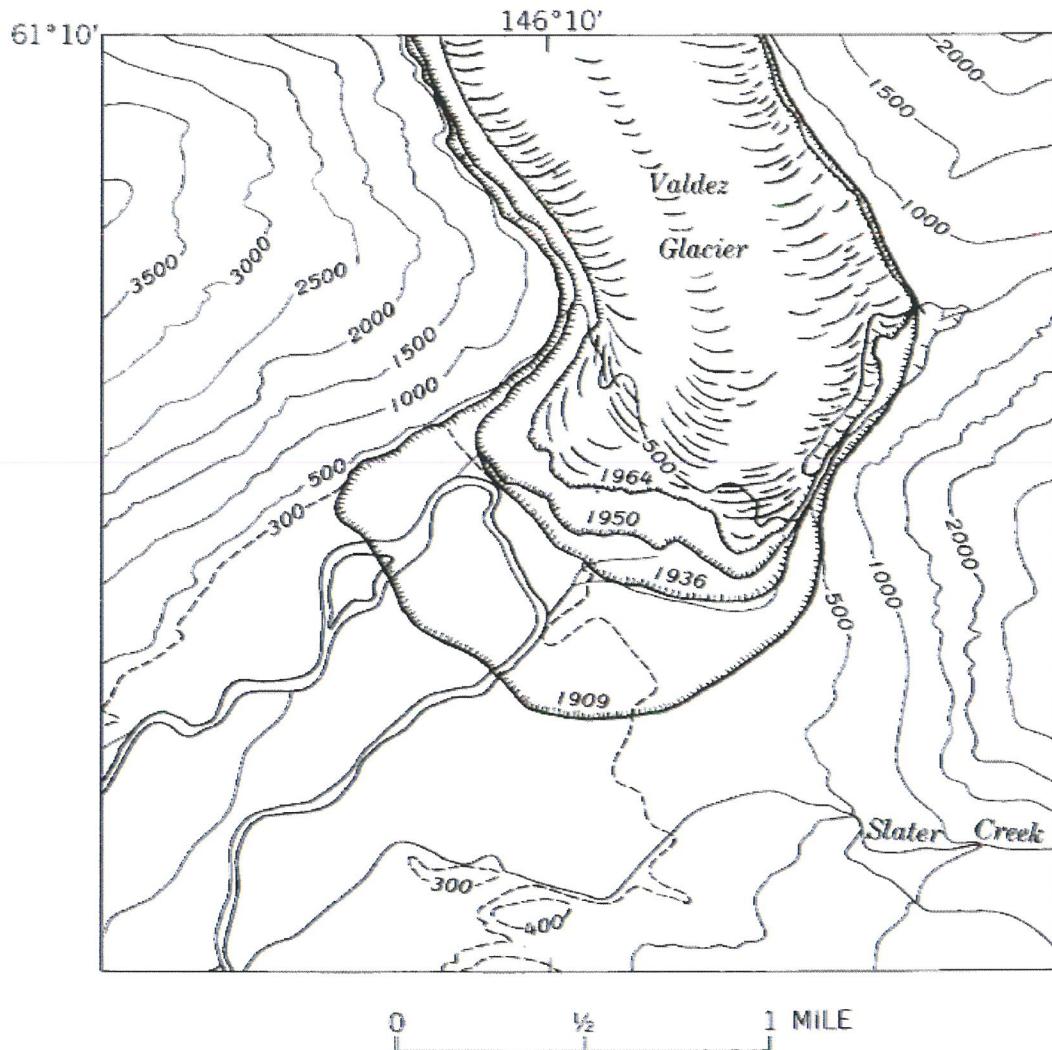
**3.—Recorded positions of the terminus of Valdez Glacier since 1909.**

Figure 4. Valdez Glacier terminus positions, from USGS Professional Paper 542 C.<sup>11</sup>

The USGS engaged in intensive study of this earthquake and much information is available regarding conditions after the event. One such piece of information is the recorded positions of the terminus of Valdez Glacier since 1909, presented here as Figure 4. Unfortunately, the forming pro-glacial lake is not presented in this graphic.

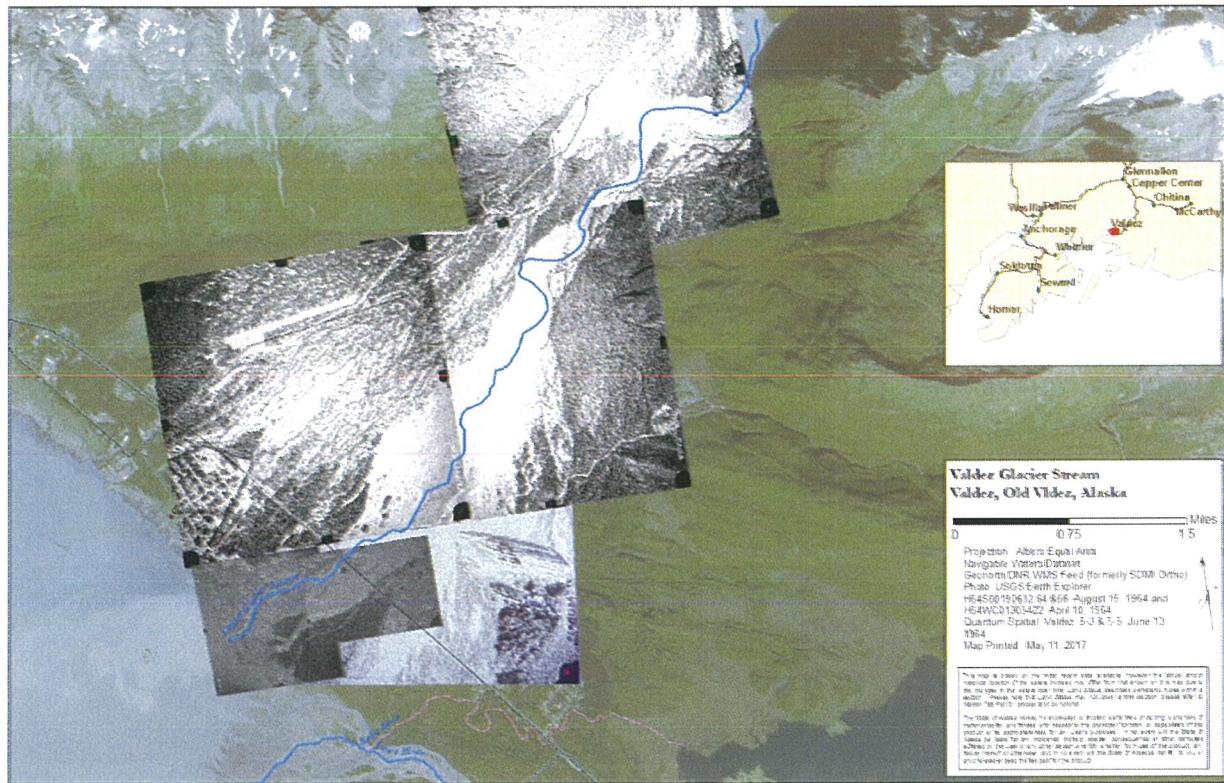
Figure 5. Valdez Glacier Stream. Georeferenced Photos H64S001906329, H64S001906364 and H64S001906366, August 15, 1964 and H64WC01305422, April 10, 1964, downloaded from USGS Earth Explorer.

Explorer. The photos reviewed were taken on April 10, with snow coverage; and on August 15. The August photography did not cover the area of the Richardson Highway and the mouth of Valdez Glacier Stream, so the April 10 photography was utilized.

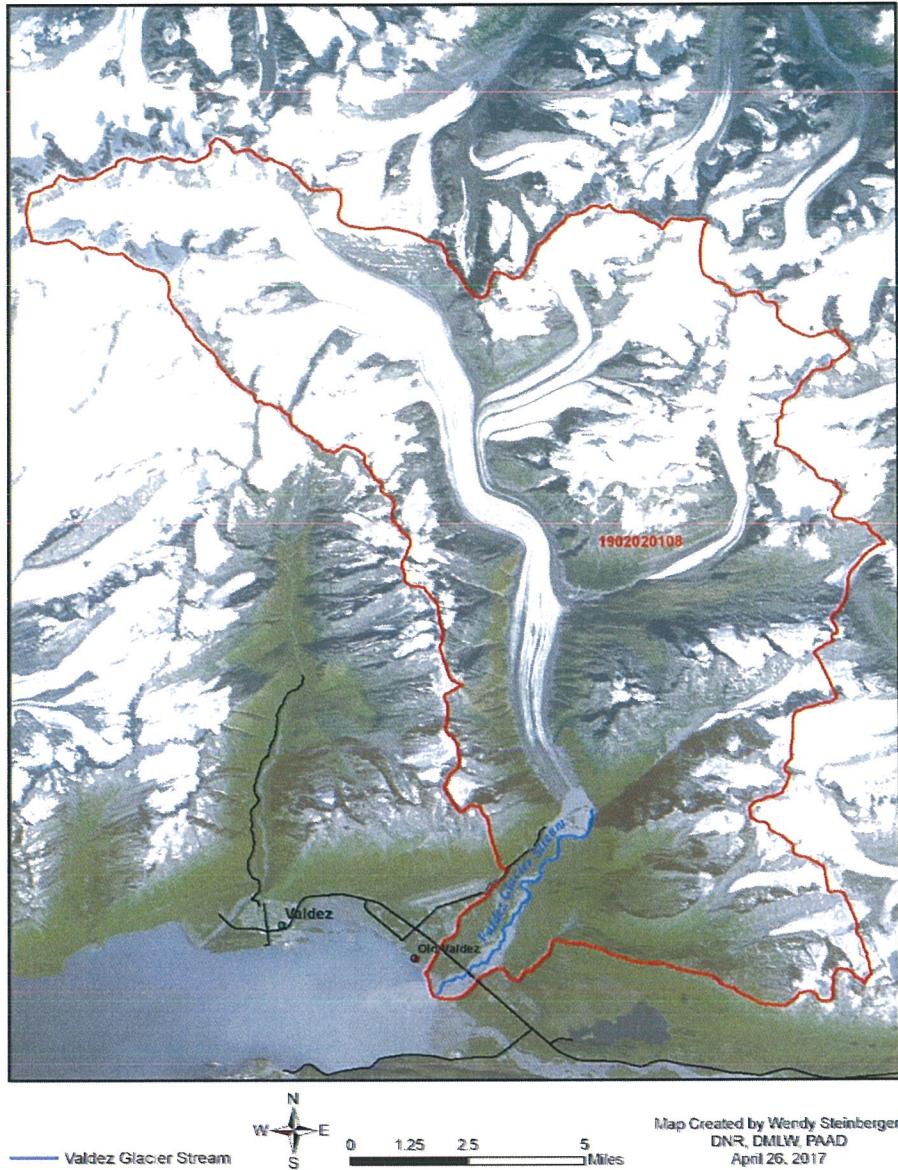
Figure 6. Valdez Glacier Stream basin area delineated by the HUC 10 boundary (HUC 1902020108).

The Valdez Glacier Stream originates at the Valdez Glacier Lake, a proglacial lake at the terminus of the Valdez Glacier. The basin area is 159.7 square miles as delineated by the HUC 10 boundary (HUC 1902020108). The Valdez Glacier and several small glaciers dominate the land coverage within the basin and total 76 square miles (Figure 6). The Valdez Glacier Stream runs 6.3 miles from the Valdez Glacier Lake (207 ft elevation) to the Port Valdez inlet with an average stream gradient of 32.9 feet per mile.

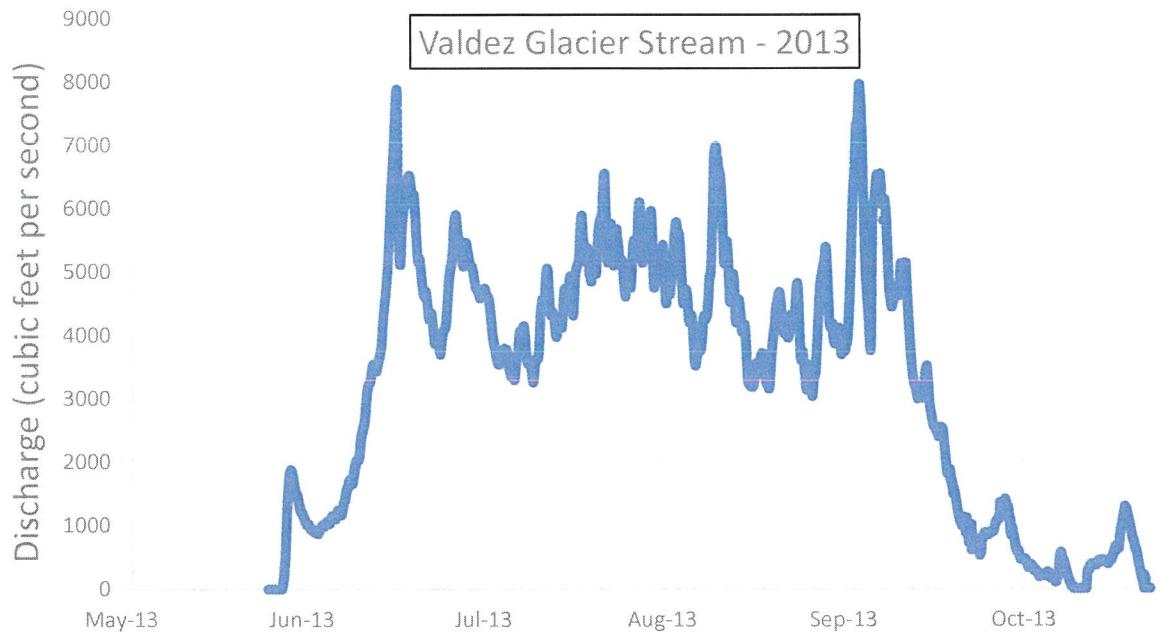
Figure 7. Valdez Glacier Stream 2013 estimated discharge (15-min intervals) from the outlet of the Valdez Glacier Lake. Period of record from May 23 to October 28 2013.

A discharge time series was estimated from May 23 to October 28 2013. Flow increased sharply from late May reaching a peak flow on June 16 of 7887 cfs which was only exceeded by a later peak flow of 7969 cfs on September 4 (Figure 7). On a monthly basis, mean daily flow was greatest in July (4640 cfs) and lowest in October (405 cfs; Table 1). The flow regime of Valdez Glacier Stream is typical for glacier streams where flow remains high throughout the summer months due to glacial melt.

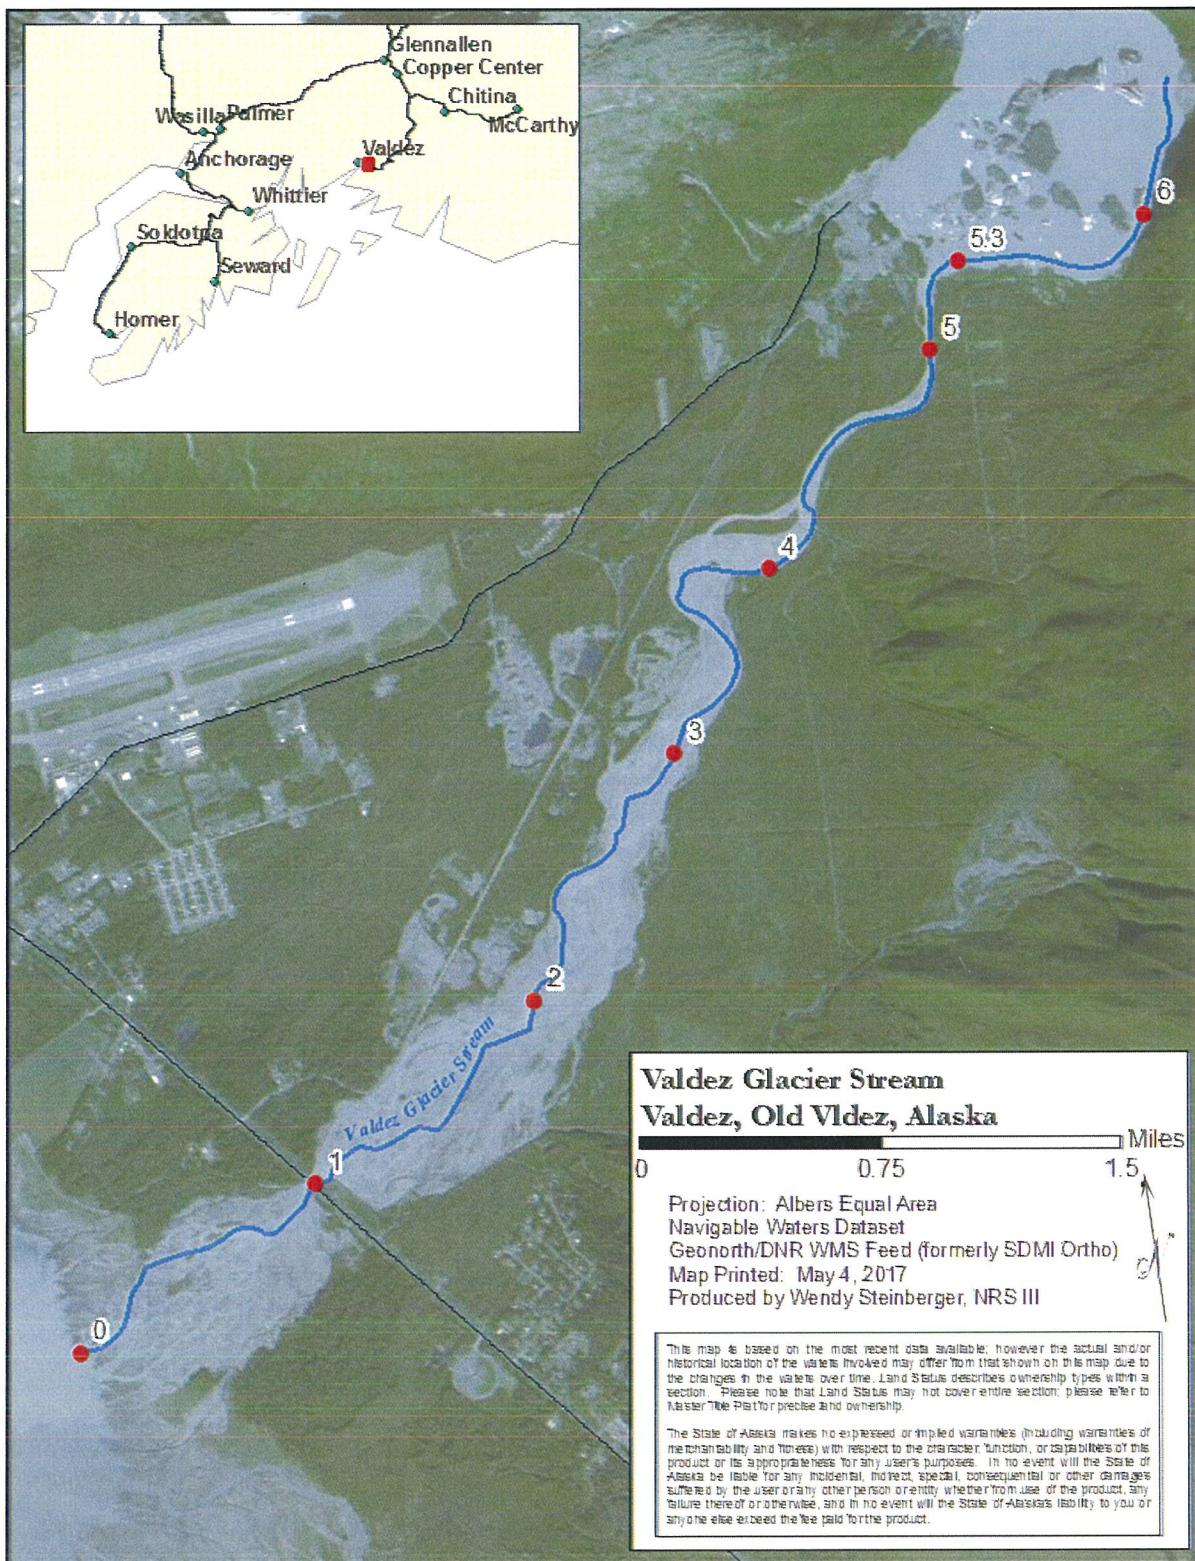
Figure 7. Valdez Glacier Stream Determination Map

Summary of the navigability determination is summarized within Figure 5, below. While the extent of tidal influence is undetermined, the State holds the tidally influenced submerged lands based upon the Submerged Lands Act of 1953.

The Valdez Glacier Stream is determined navigable from the outlet of the unnamed pro-glacial lake, within Section 29, Township 8 South, Range 5 West, Copper River Meridian.
