# City of Valdez

## RISK MANAGEMENT REPORT 12219A

May 24, 2019

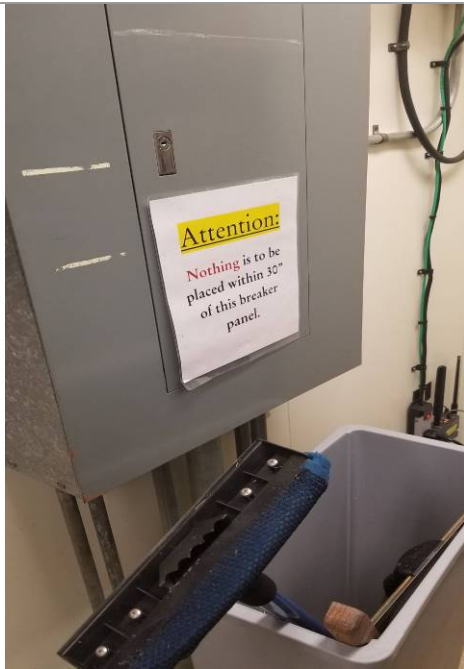
**01-12219A: Civic Center, Police Station, Fire Station;** Relocate obstructions away from electrical panel for easy access in the event of an emergency. Allow for a minimum of 30 inches of clearance around the electrical panel. In addition, keep electrical panels shut when not in use.

No.	Recommendation (Location)	Date of Completion	State Corrective Action Taken or Describe Plan For Future Action
01-12219A	<b>Civic Center; Police Station; Fire Station:</b> Relocate objects at least 30 inches away from electrical panel for clearance and easy accessibility.		
02-12219A	<b>Civic Center (Theater):</b> Replace batteries and lightbulbs in non-functioning emergency lights to ensure emergency lighting activates in the event of a power outage.		
03-12219A	<b>Civic Center; Library:</b> Purchase new eyewash solutions. Discard all expired eyewash solutions.

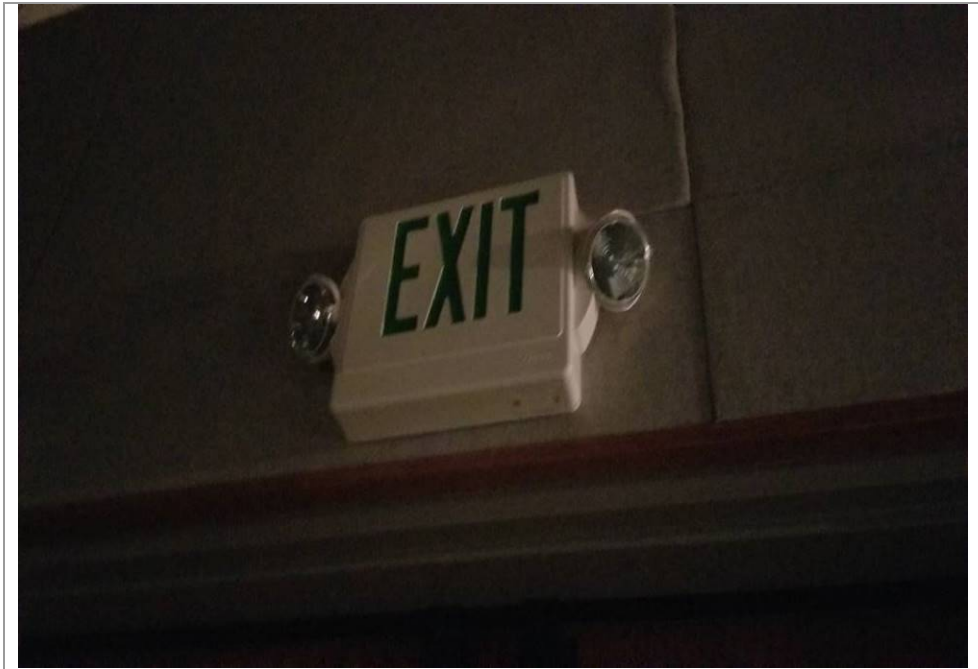
**02-12219A: Civic Center (Theater);** Replace batteries and lightbulbs to ensure emergency lighting activates in the event of a power outage.

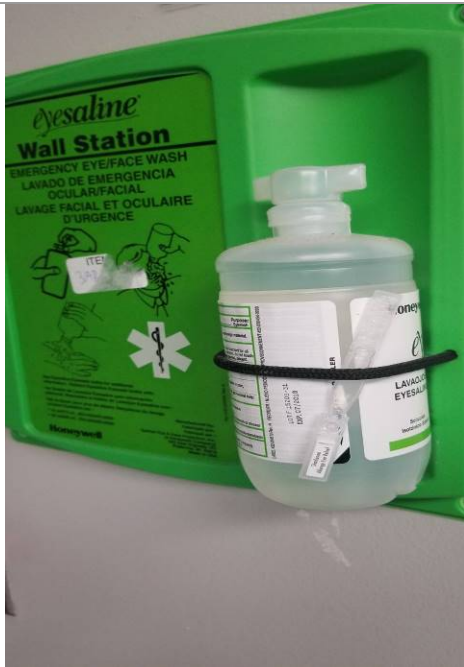
**03-12219A: Civic Center (Kitchen, Janitor Closet);** Expired eyewash solution. Recommend purchasing new eyewash solution.

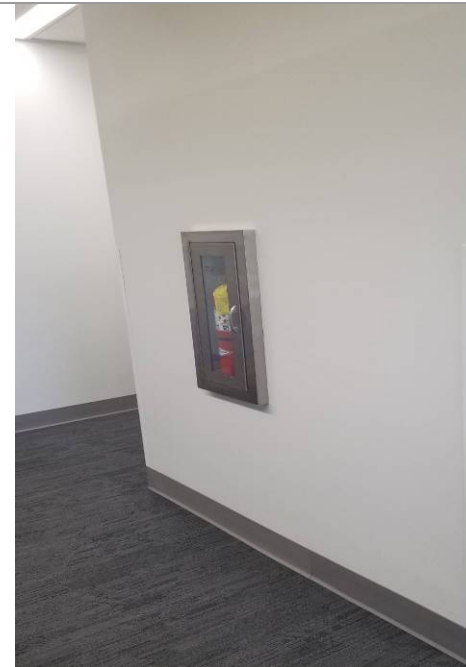
**04-12219A: Civic Center, Library;** Place fire extinguisher signs above fire extinguisher to help identify location.

No.	Recommendation (Location)	Date of Completion	State Corrective Action Taken or Describe Plan For Future Action
04-12219A	<b>Civic Center; Library:</b> Purchase fire extinguisher signs and place above fire extinguishers to help identify location.		
05-12219A	<b>Rec Center (Boiler Room):</b> Replace missing electrical covers on electrical switch.		
06-12219A	<b>Rec Center; Fire Station:</b> Repair broken electrical outlet to avoid arc flash, an electrical short, and live electrical exposure to employees and general public.		
07-12219A	<b>Rec Center:</b> Highlight the tripping hazard on both sides of the step with fluorescent safety tape or paint.		
08-12219A	<b>Hospital:</b> Excellent new self-testing exit signs installed throughout facility. Continue the good work!		
09-12219A	<b>Police Station:</b> Replace broken electrical outlet to avoid arc flash, an electrical short, and live electrical exposure to employees and general public.

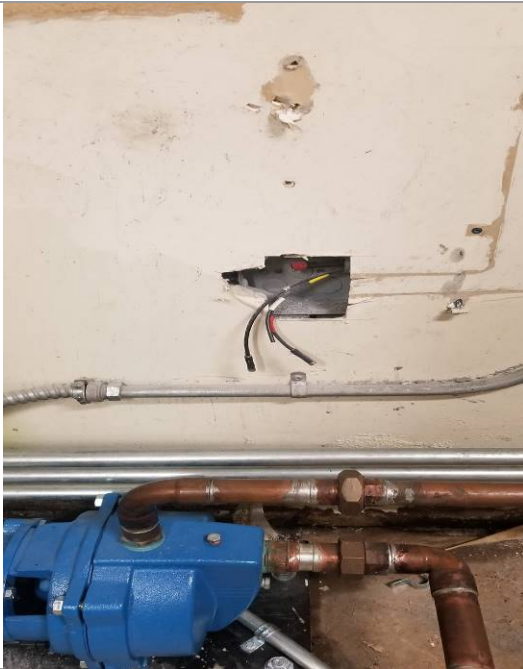
**05-12219A: Rec Center (Boiler Room);** Replace missing electrical cover to prevent exposure to live electrical wires.

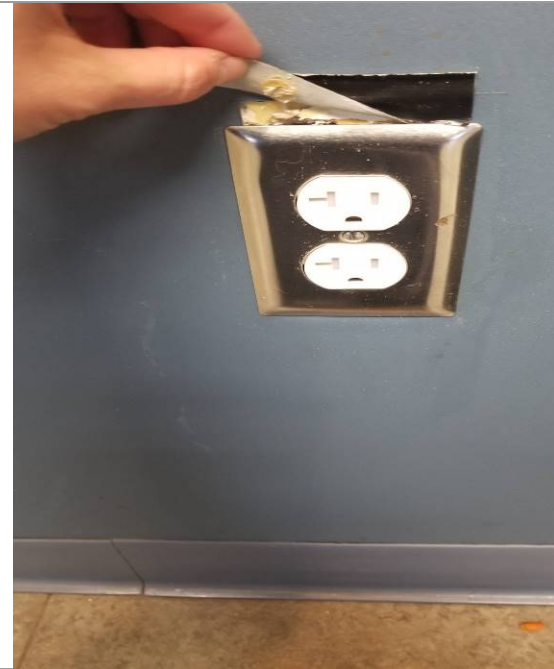
**06-12219A: Rec Center, Fire Station;** Repair broken electrical outlet cover to avoid arc flash, an electrical short, and live electrical exposure to employees and general public..

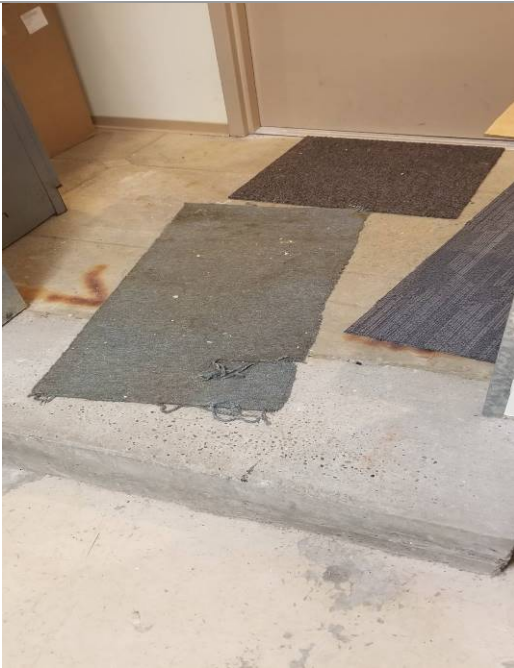
**07-12219A: Rec Center;** Highlight the step on both sides with safety tape or fluorescent paint to minimize potential for tripping hazard and injury.

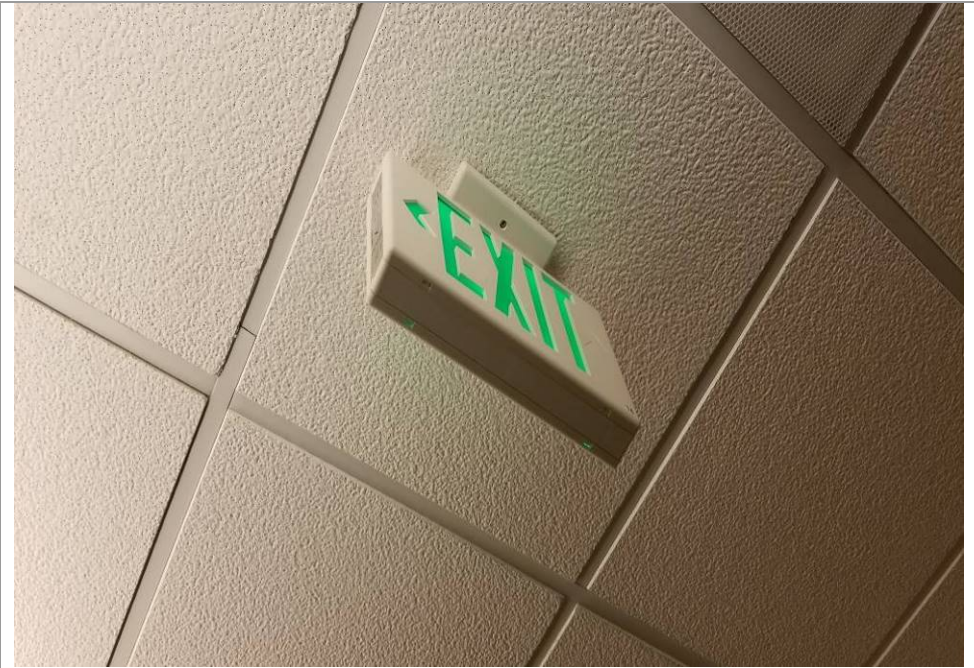
**08-12219A: Hospital;** Excellent new self-testing exit signs installed throughout the facility. Continue the good work!

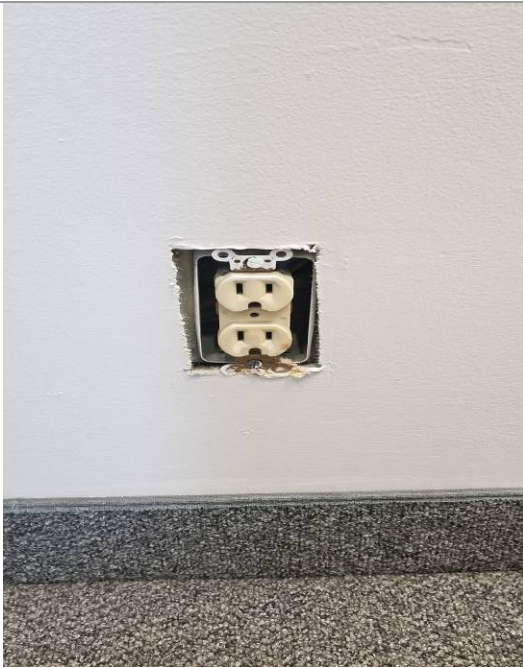
**09-12219A: Police Station (Stairwell);** Replace broken electrical outlet cover to avoid arc flash, an electrical short, and live electrical exposure to employees.

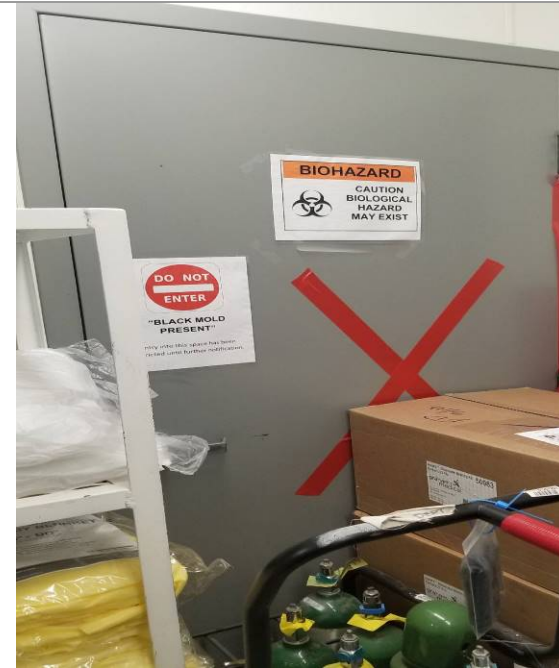
**10-12219A: Fire Station (Throughout Building);** The building was inspected 3 years ago and diagnosed with a severe type of black mold. As indicated by the picture, certain areas have been quarantined due to black mold. Staff continue to work around the quarantined areas and state they feel sick after a day of work. During my inspection at this facility, I immediately experienced a headache that dissipated after I left. On May 6, 2019, the Valdez city council voted no on a proposal to relocate and construct a new fire station.

Recommend revisiting remediation plan(s) for current quarantined mold areas within building.

10-12219A	<b>Fire Station (Throughout Building):</b> Black mold throughout building was detected 3 years ago. Areas have been quarantined, however employees continue to experience sick symptoms after a day of work. Recommend revisiting remediation plan(s) for current quarantined mold areas within building.		
11-12219A	<b>Fire Station:</b> Exit doors are missing exit signs. Hang visible emergency exit sign over appropriate exit doors (two) to avoid confusion in the event of an emergency. Exit signs should be illuminated to a surface value of at least five foot-candles (54 lux) by a reliable light source and be distinctive in color.

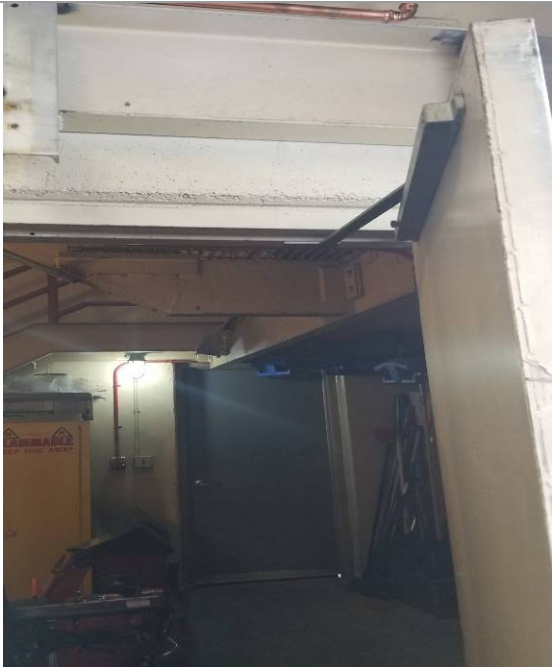
**11-12219A: Fire Station;** Exit doors are missing exit signs. Install appropriate exit signs above both doors. Exit signs should be illuminated to a surface value of at least five foot-candles (54 lux) by a reliable light source and be distinctive in color.

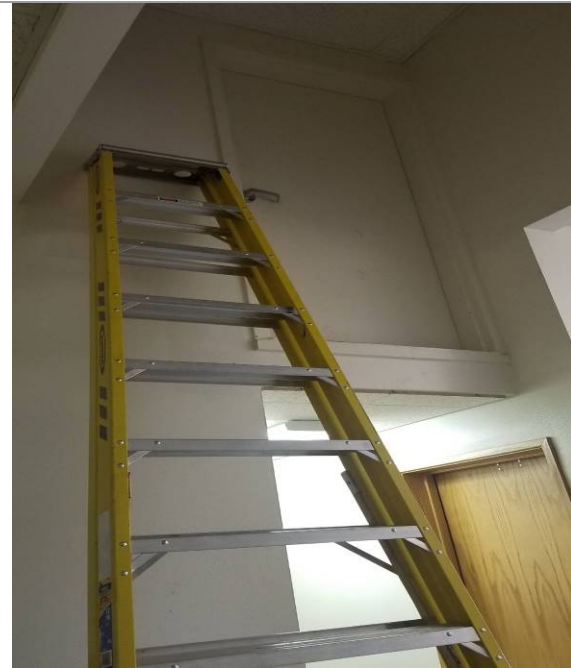
**12-12219A: Airport;** Improper means of entry into air handler room. Recommend installing pull-down staircase. Additionally, door should be marked to identify air handler room for authorized personnel only, and marked as not an exit.

No.	Recommendation (Location)	Date of Completion	State Corrective Action Taken or Describe Plan For Future Action
12-12219A	<b>Airport:</b> Install pull-down staircase to air handler room. Additionally, door should be marked to identify air handler room for authorized personnel only, and marked as not an exit on both sides.		
13-12219A	<b>Shooting Range:</b> Develop a policy for users to sign-in and, or sign a waiver and statement of understanding of general range rules to keep on file. Additionally, install general range rules at shooting range visible enough for all users to read.  Lastly, I recommend eliminating the hazard by selling the property to a local third party e.g., a gun club.		
14-12219A	<b>Shooting Range:</b> Install shooting range rules instructing users to only shoot at authorized targets (no exploding, glass, cans, or other items considered trash targets).

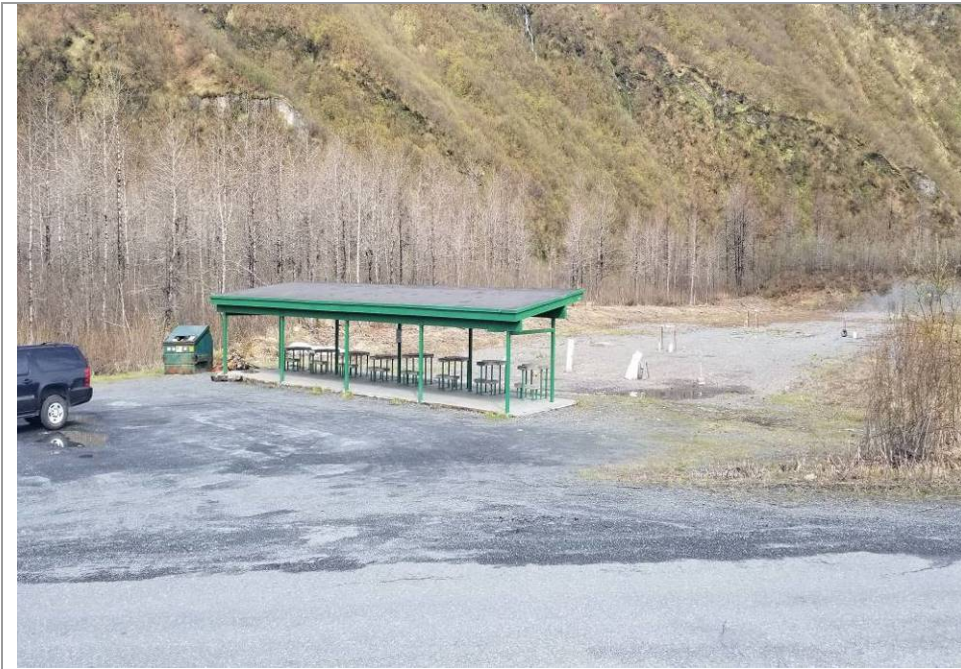
**13-12219A: Shooting range;** Recommend users to sign-in prior to use and/or have users sign a waiver and statement of understanding of general range rules to keep on file. Additionally, install general safety range rules signs visible enough for all users to read, not posted in the line of fire.

Additionally, I recommend eliminating the hazard by selling the property to a local third party e.g., a gun club.

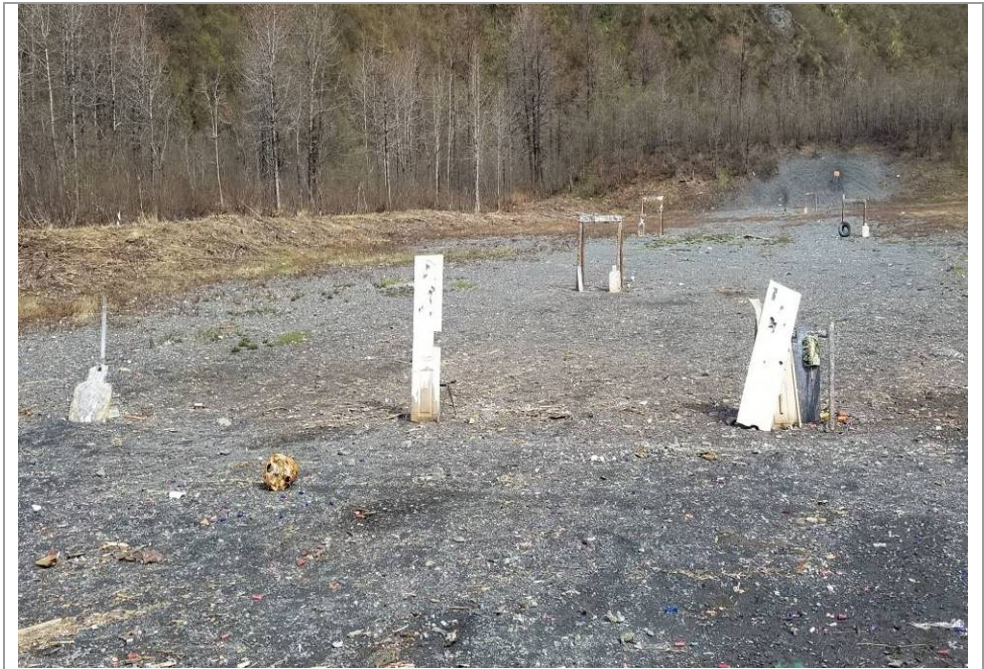
**14-12219A: Shooting range;** I was informed users often bring non-designated targets to the range to shoot; microwaves, tv's, etc. Recommend installing shooting range rule signs large enough for all users to read instructing users to only shoot at authorized targets (no exploding, glass, cans or other items considered trash targets).
