# CITY OF VALDEZ

## VCT CAUSEWAY REPAIRS

VALDEZ, ALASKA  
FEBRUARY 2021

COVER SHEET & DRAWING INDEX

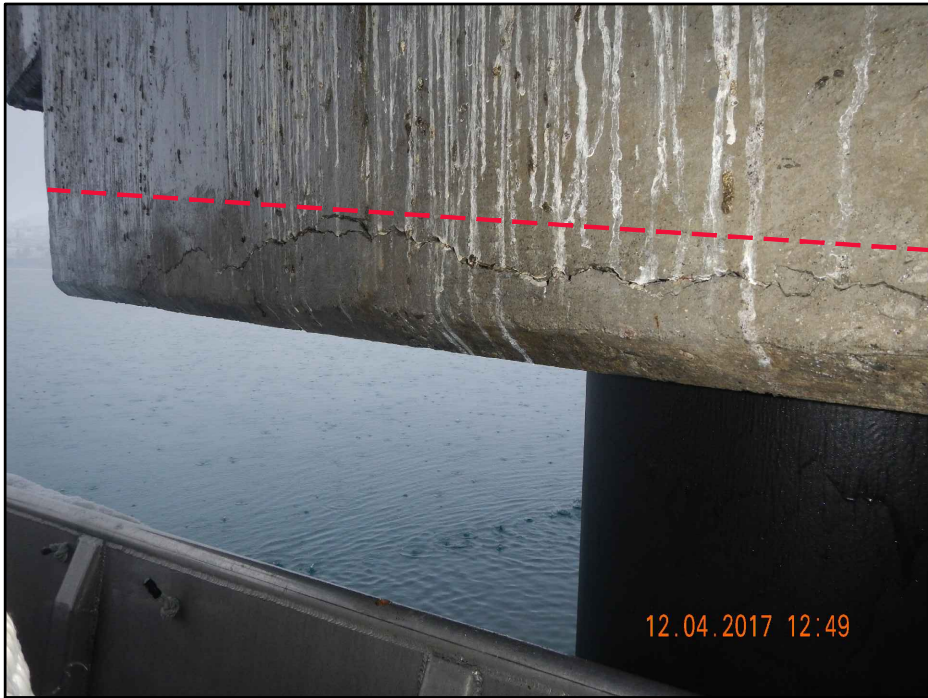
TYPICAL BOTTOM CORNER - CLOSED CORROSION SPALL

PILE CAP DEFICIENCY TABLE				
PILE CAP BENT #	# OF DEFICIENT CORNERS	TOTAL CORNER DEFECT LENGTH (FT)	OTHER DEFECTS	OTHER DEFECT SIZE (SF)
6	2	8	(2) SPALL AREAS OF VARIOUS SIZES	0.9
9	1	4	(1) SPALL AREA	4.3
23	2	11	(2) SPALL AREAS OF VARIOUS SIZES & HONEYCOMBING	22.5
25	1	2		0
28	1	6		0
39	0	0	(8) SMALL LOCALIZED OPEN SPALLS	2.7
41	1	4	(1) SPALL AREA	0.2
42	0	0	(2) SPALL AREAS OF VARIOUS SIZES	2.8

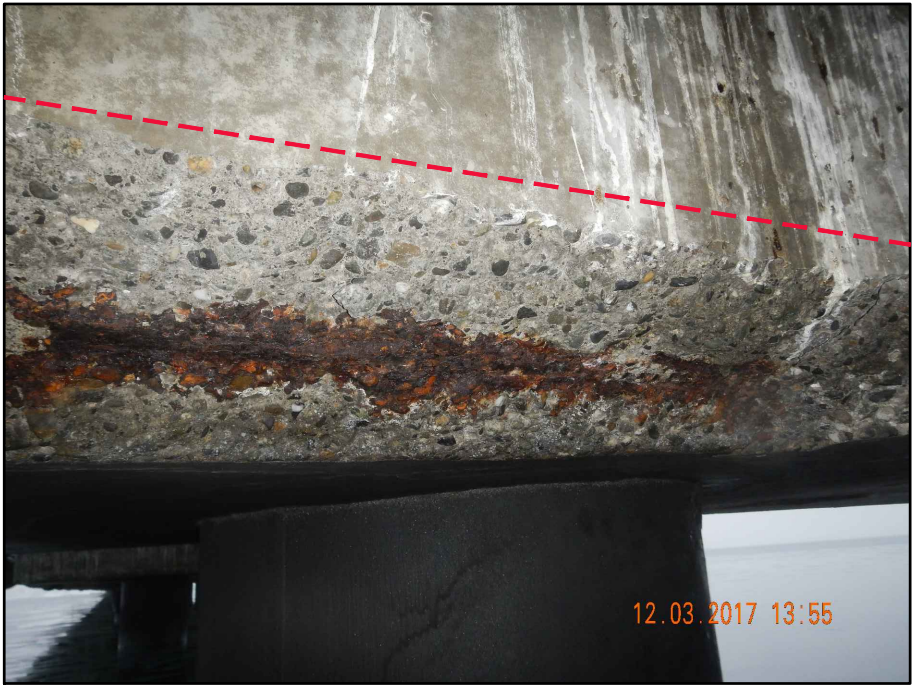
TYPICAL BOTTOM CORNER - OPEN CORROSION SPALL

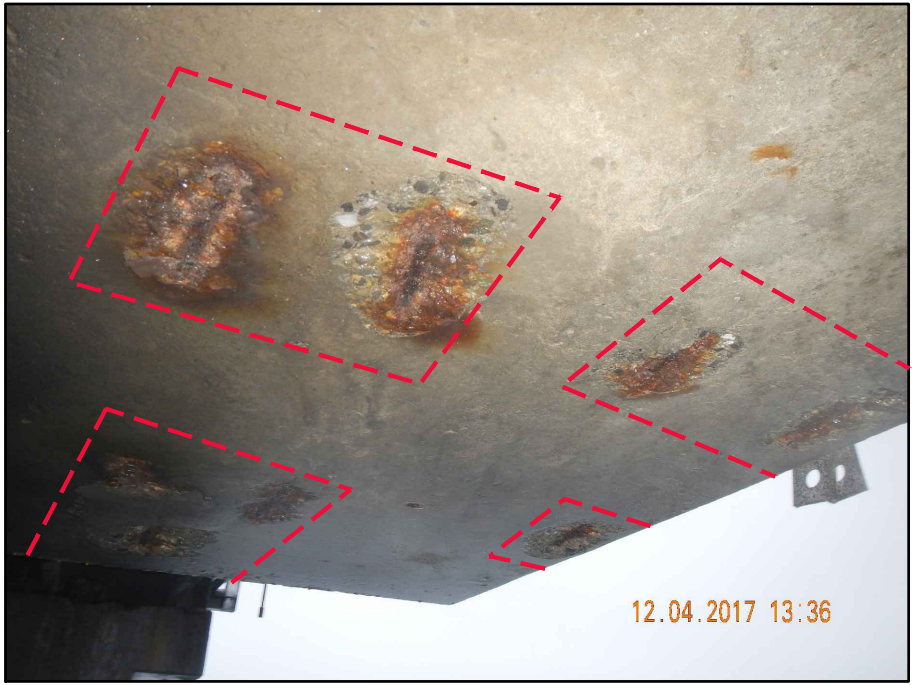
TYPICAL BOTTOM SURFACE - CORROSION SPALL

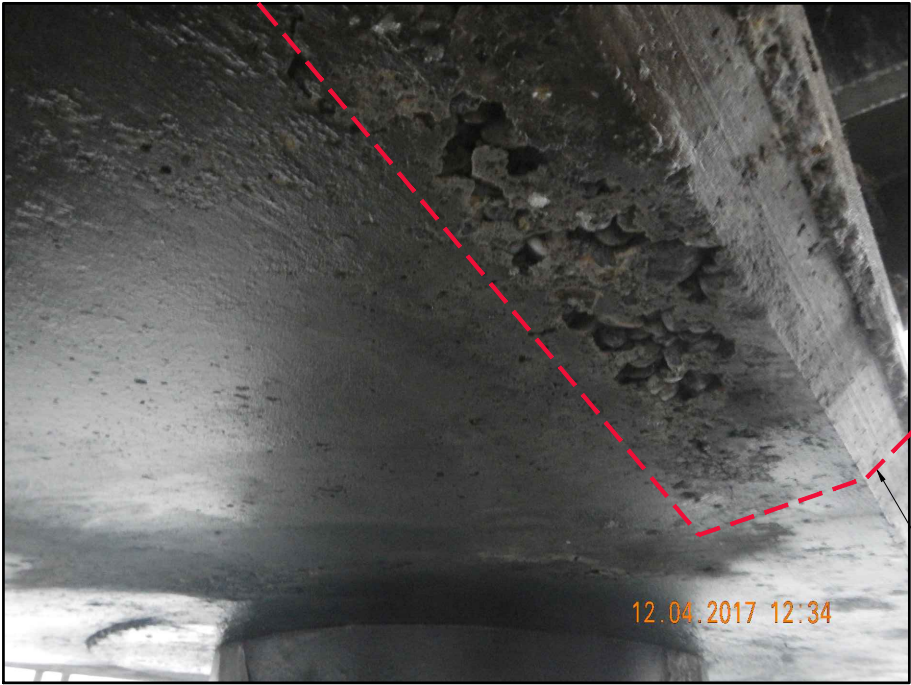
TYPICAL BOTTOM SURFACE - CONCRETE HONEYCOMB

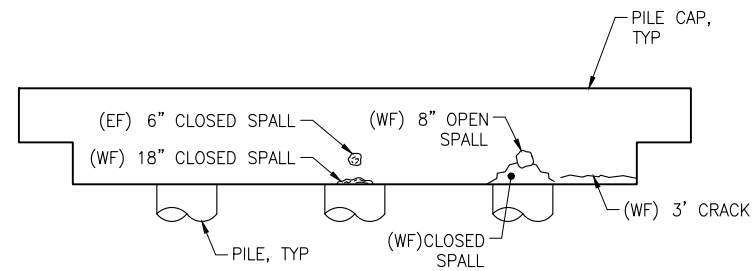
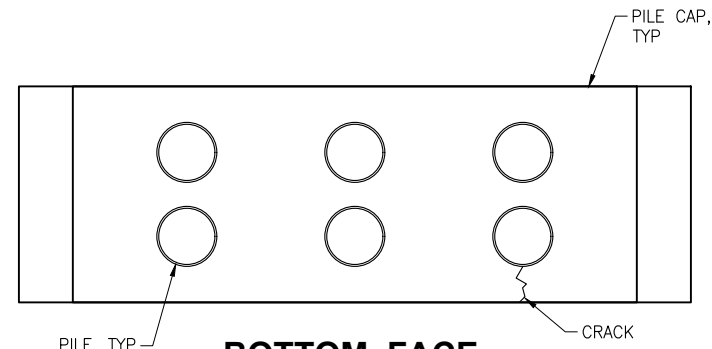
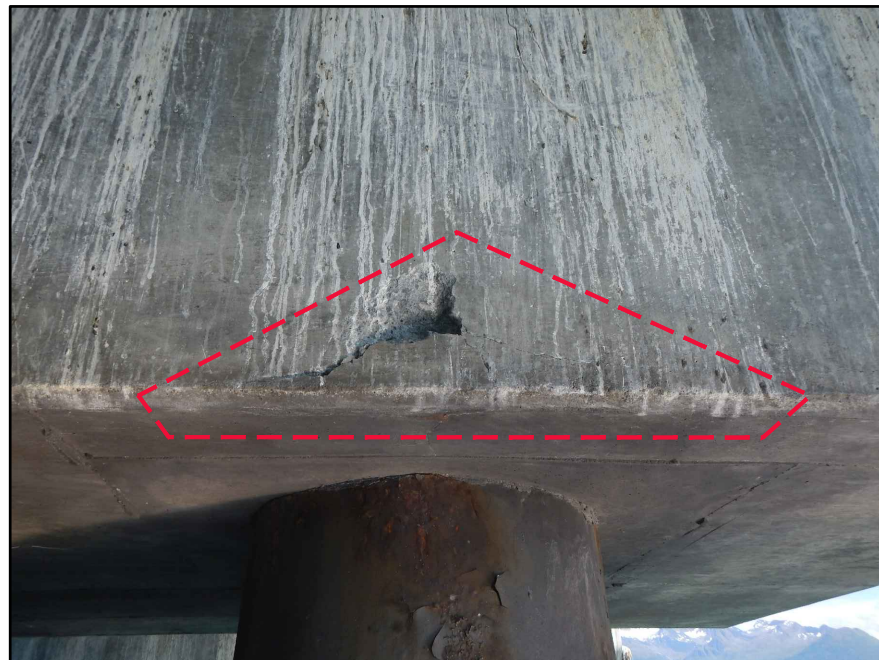
**ELEVATION**

**BOTTOM FACE**

**PILE CAP BENT # 6**  
**EXISTING CONDITION**

1. ITEMS NOTED (EF) REFER TO DEFICIENCIES FOUND ON THE EAST FACE OF THE PILE CAP, (WF) REFERS TO DEFICIENCIES FOUND ON THE WEST FACE.
2. ALL DEFICIENCIES NOTED SHALL BE REPAIRED ACCORDING TO THE STANDARD DETAILS ON SHEET 8, UNLESS OTHERWISE APPROVED.
3. DEFICIENCY EXTENTS SHOWN ARE APPROXIMATE FIELD MEASUREMENTS. ACTUAL DEMOLITION AND REPAIR DEPTHS AND WIDTHS SHALL BE FIELD DETERMINED USING THE BASIS DEFINED IN THE CONCRETE REMOVAL SPECIFICATIONS.

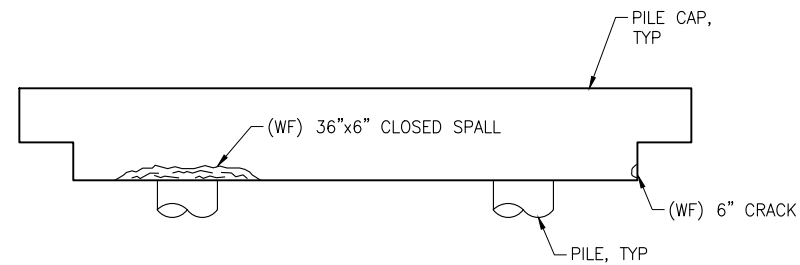
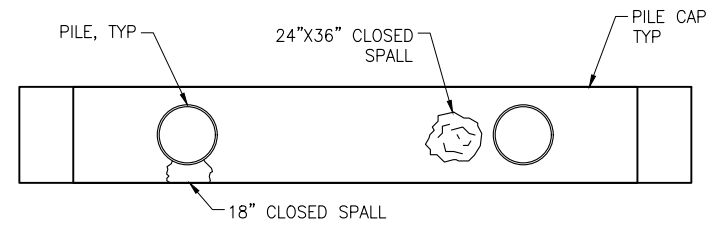
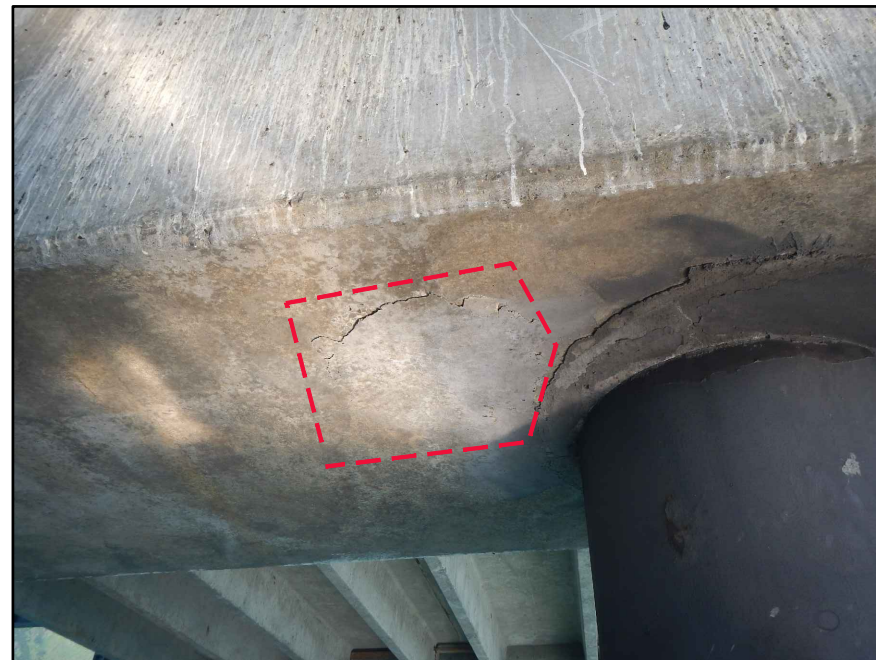
**ELEVATION**

**BOTTOM FACE**

**PILE CAP BENT # 9**  
**EXISTING CONDITION**

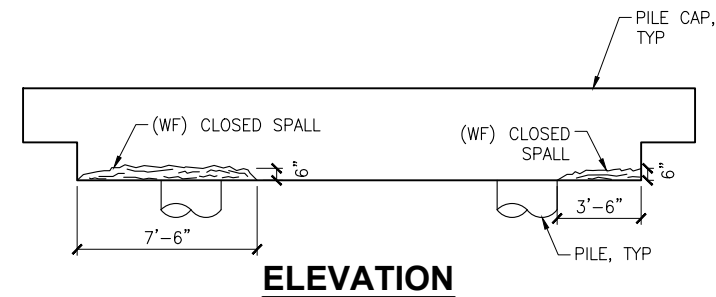
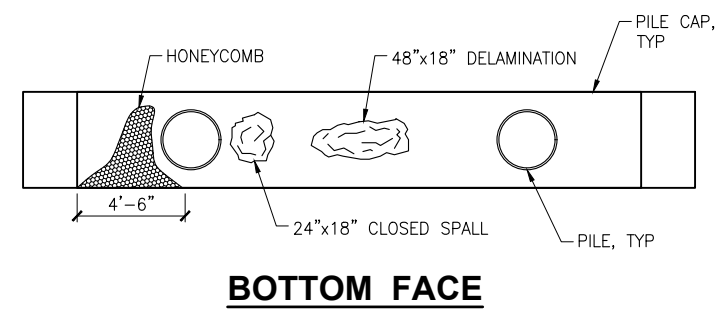
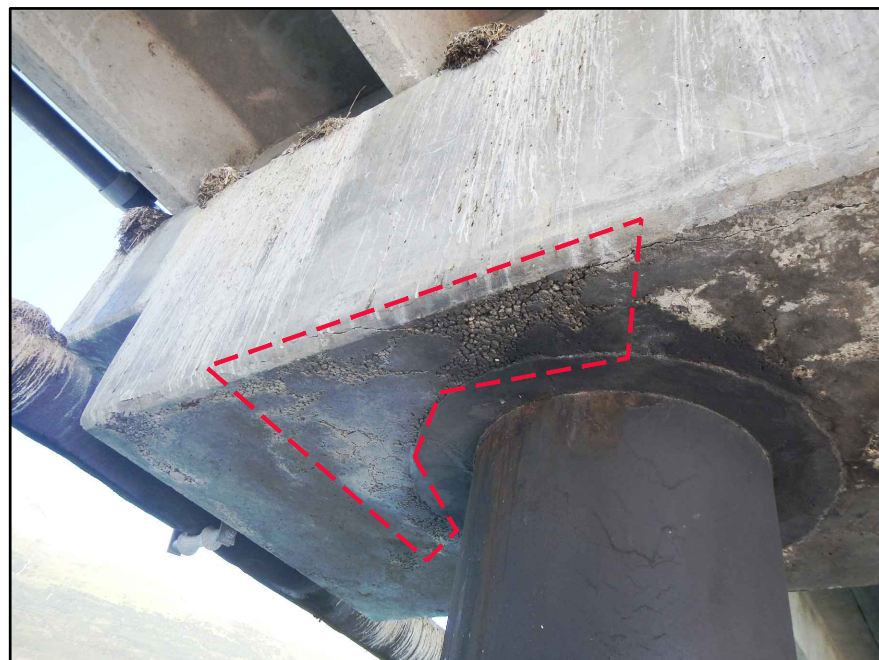
**PILE CAP BENT # 23**  
**EXISTING CONDITION**  
NTS

- NOTE:**
1. ITEMS NOTED (EF) REFER TO DEFICIENCIES FOUND ON THE EAST FACE OF THE PILE CAP, (WF) REFERS TO DEFICIENCIES FOUND ON THE WEST FACE.
  2. ALL DEFICIENCIES NOTED SHALL BE REPAIRED ACCORDING TO THE STANDARD DETAILS ON SHEET 8, UNLESS OTHERWISE APPROVED.
  3. DEFICIENCY EXTENTS SHOWN ARE APPROXIMATE FIELD MEASUREMENTS. ACTUAL DEMOLITION AND REPAIR DEPTHS AND WIDTHS SHALL BE FIELD DETERMINED USING THE BASIS DEFINED IN THE CONCRETE REMOVAL SPECIFICATIONS.

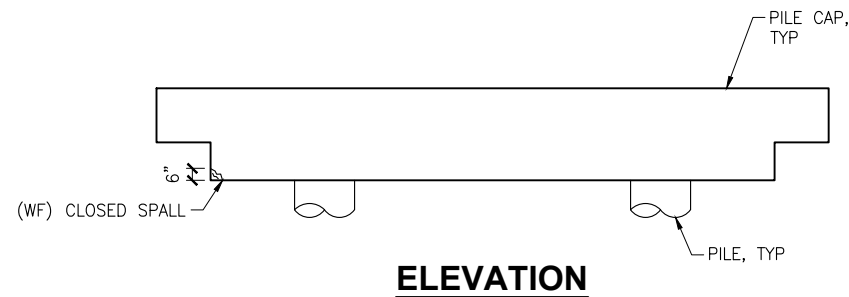
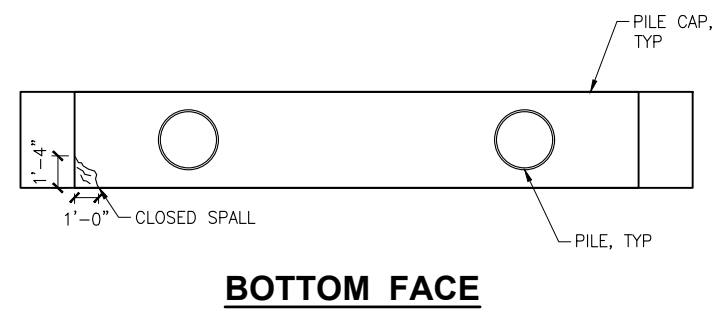
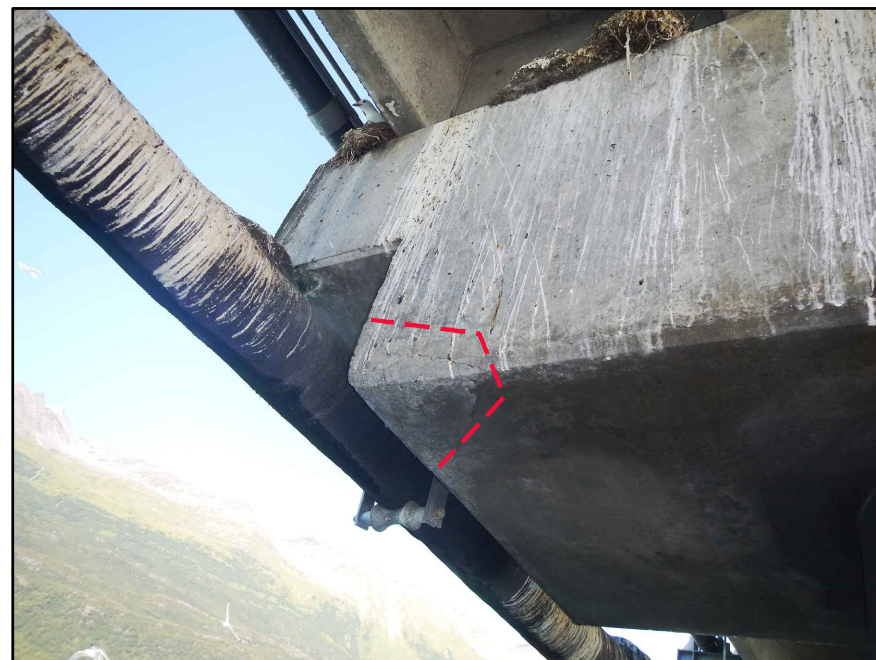
**PILE CAP BENT # 25**  
**EXISTING CONDITION**  
NTS

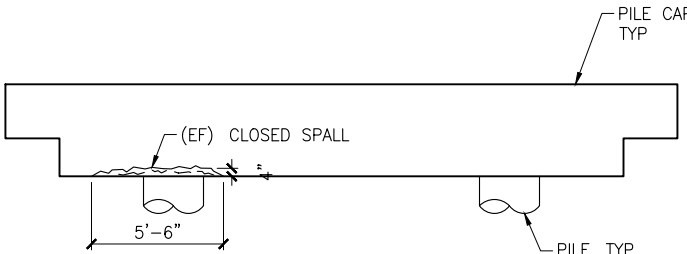
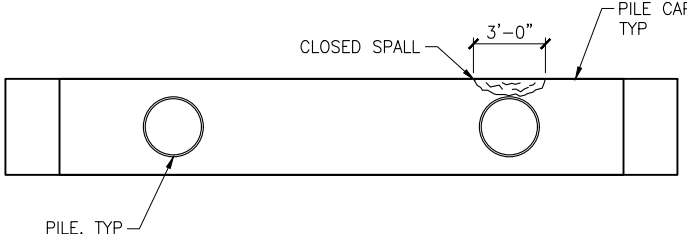
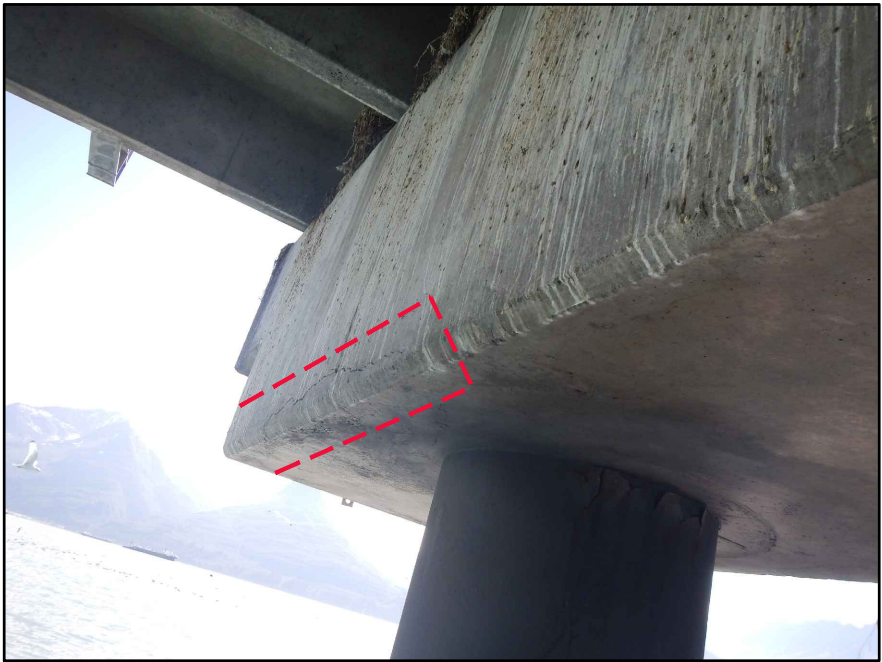
ELEVATION

BOTTOM FACE

PILE CAP BENT # 28  
EXISTING CONDITION

- NOTE:**
1. ITEMS NOTED (EF) REFER TO DEFICIENCIES FOUND ON THE EAST FACE OF THE PILE CAP, (WF) REFERS TO DEFICIENCIES FOUND ON THE WEST FACE.
  2. ALL DEFICIENCIES NOTED SHALL BE REPAIRED ACCORDING TO THE STANDARD DETAILS ON SHEET 8, UNLESS OTHERWISE APPROVED.
  3. DEFICIENCY EXTENTS SHOWN ARE APPROXIMATE FIELD MEASUREMENTS. ACTUAL DEMOLITION AND REPAIR DEPTHS AND WIDTHS SHALL BE FIELD DETERMINED USING THE BASIS DEFINED IN THE CONCRETE REMOVAL SPECIFICATIONS.

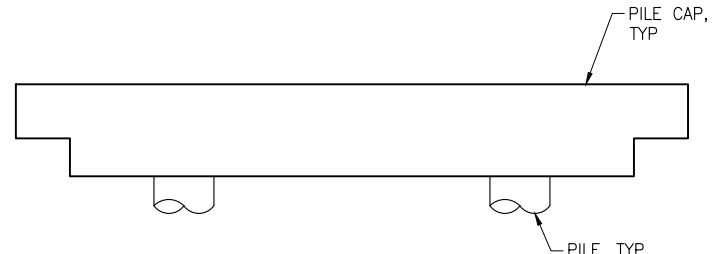
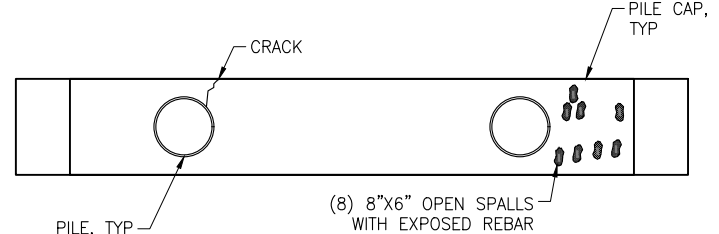
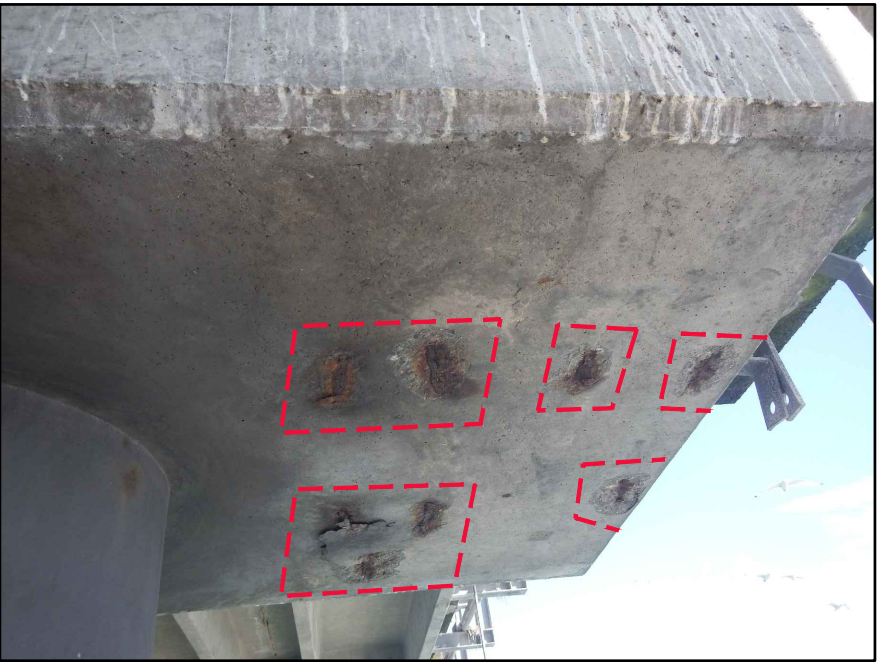
ELEVATION

BOTTOM FACE

PILE CAP BENT # 39  
EXISTING CONDITION

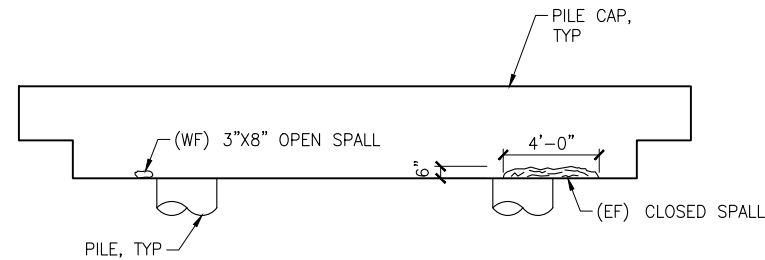
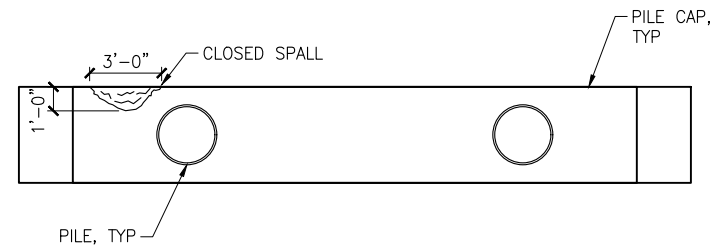
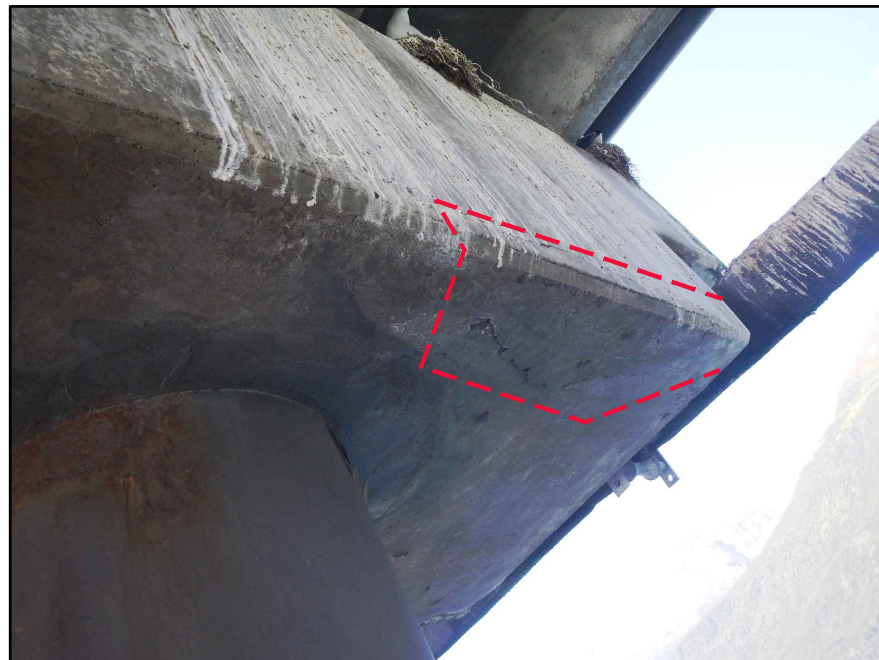
**ELEVATION**

**BOTTOM FACE**

**PILE CAP BENT # 41  
EXISTING CONDITION**

1. ITEMS NOTED (EF) REFER TO DEFICIENCIES FOUND ON THE EAST FACE OF THE PILE CAP, (WF) REFERS TO DEFICIENCIES FOUND ON THE WEST FACE.
2. ALL DEFICIENCIES NOTED SHALL BE REPAIRED ACCORDING TO THE STANDARD DETAILS ON SHEET 8, UNLESS OTHERWISE APPROVED.
3. DEFICIENCY EXTENTS SHOWN ARE APPROXIMATE FIELD MEASUREMENTS. ACTUAL DEMOLITION AND REPAIR DEPTHS AND WIDTHS SHALL BE FIELD DETERMINED USING THE BASIS DEFINED IN THE CONCRETE REMOVAL SPECIFICATIONS.

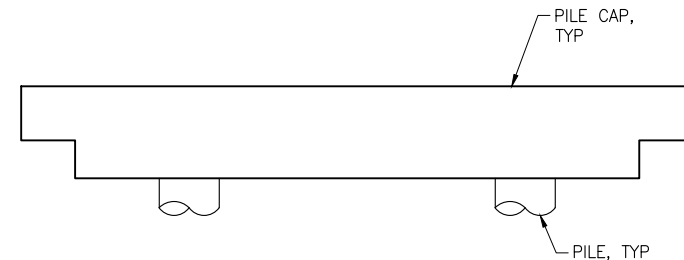
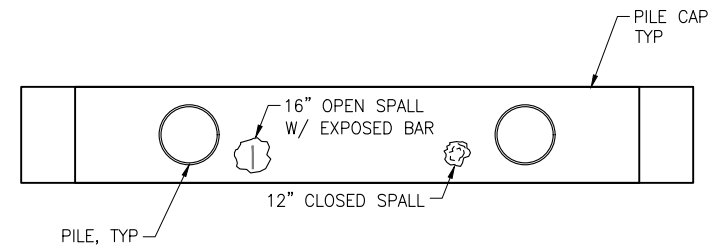
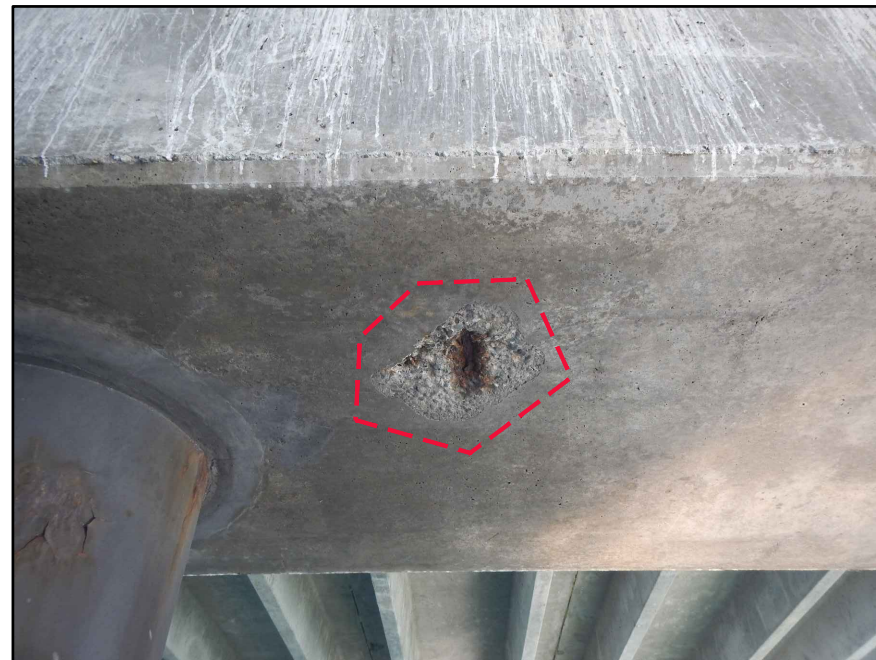
**ELEVATION**

**BOTTOM FACE**

**PILE CAP BENT # 42  
EXISTING CONDITION**

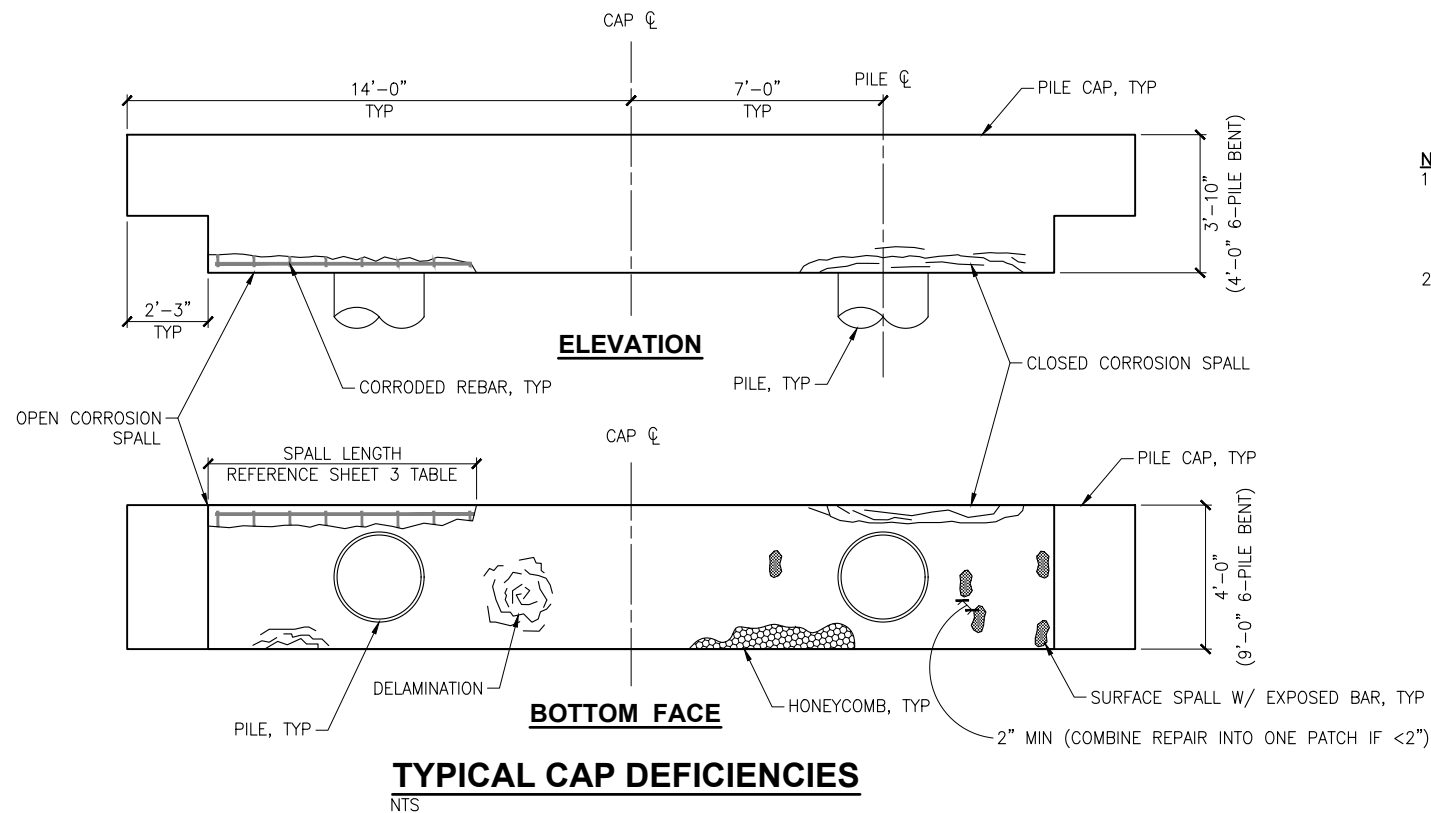
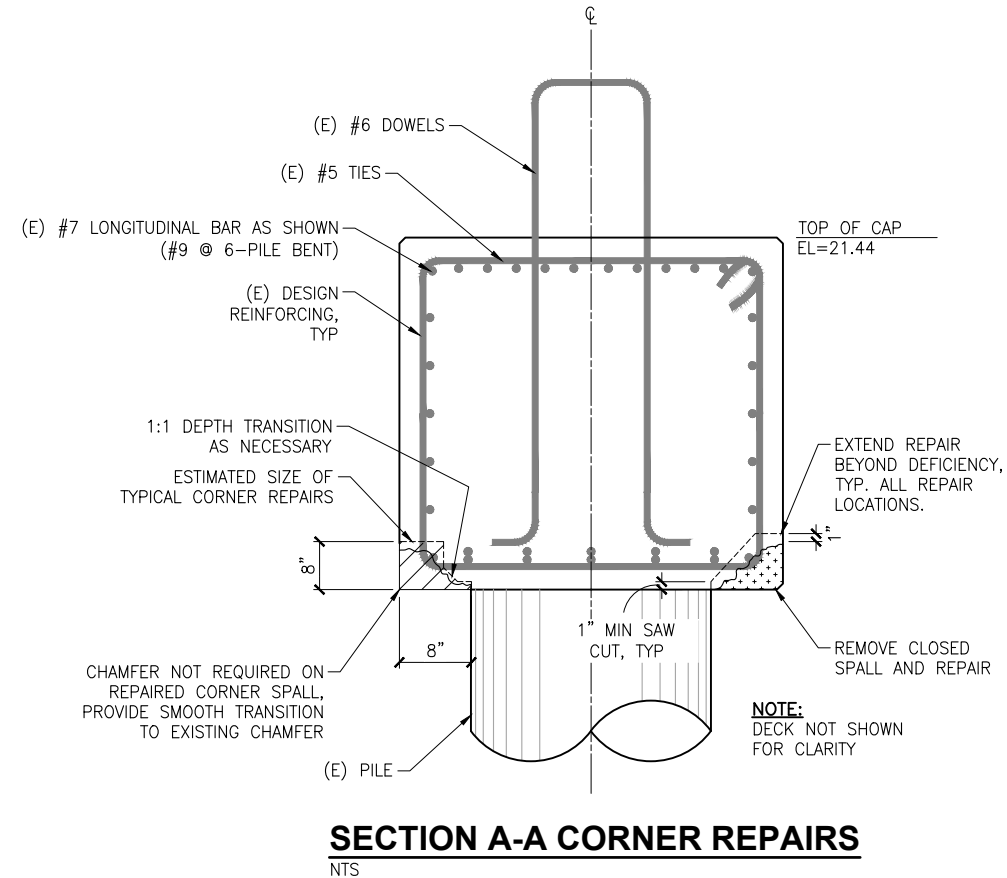
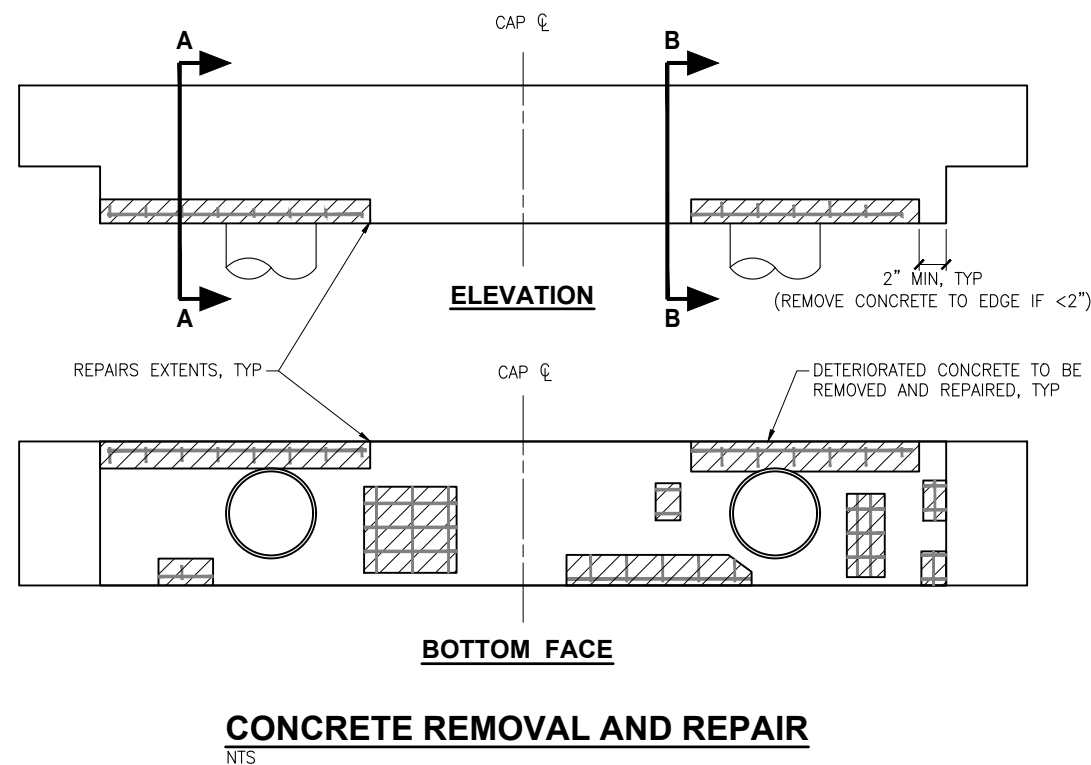
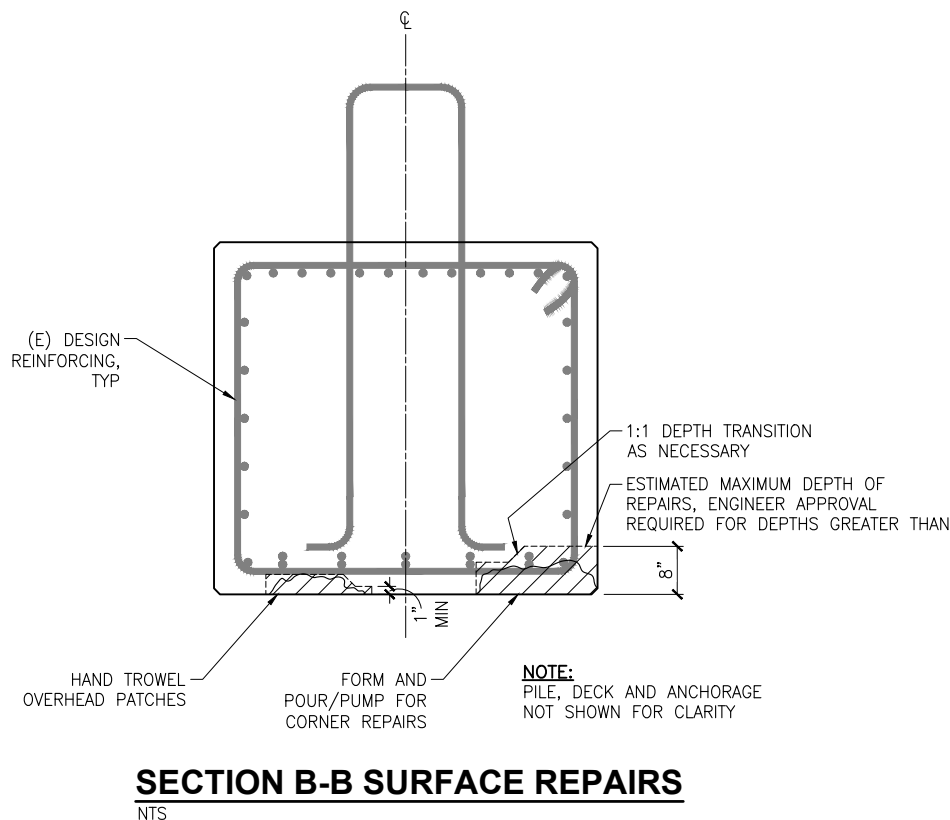
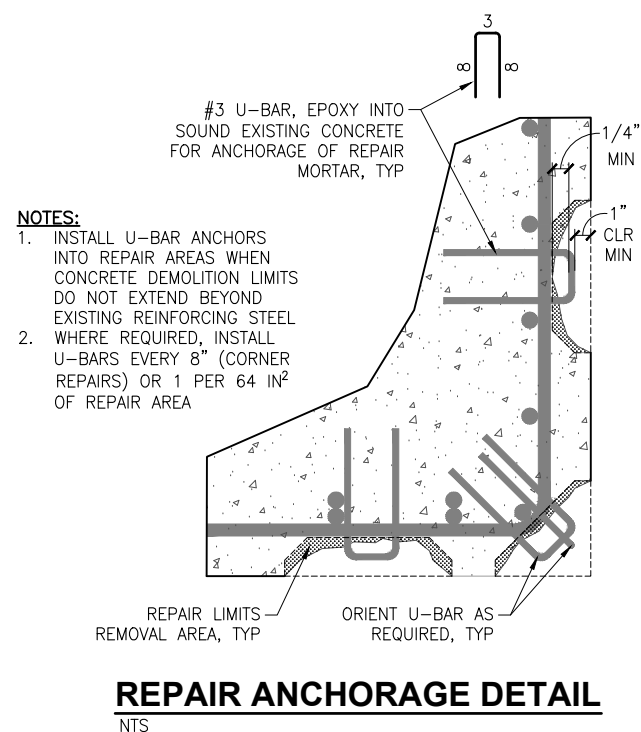
**NOTE:**  
1. DEFICIENCY EXTENTS SHOWN ARE APPROXIMATE FIELD MEASUREMENTS. ACTUAL DEMOLITION AND REPAIR DEPTHS AND WIDTHS SHALL BE FIELD DETERMINED USING THE BASIS DEFINED IN THE CONCRETE REMOVAL SPECIFICATIONS.  
2. TYPICAL CAP SHOWN IS PROVIDED TO REPRESENT ALL ANTICIPATED DEFECTS REQUIRING REPAIR.

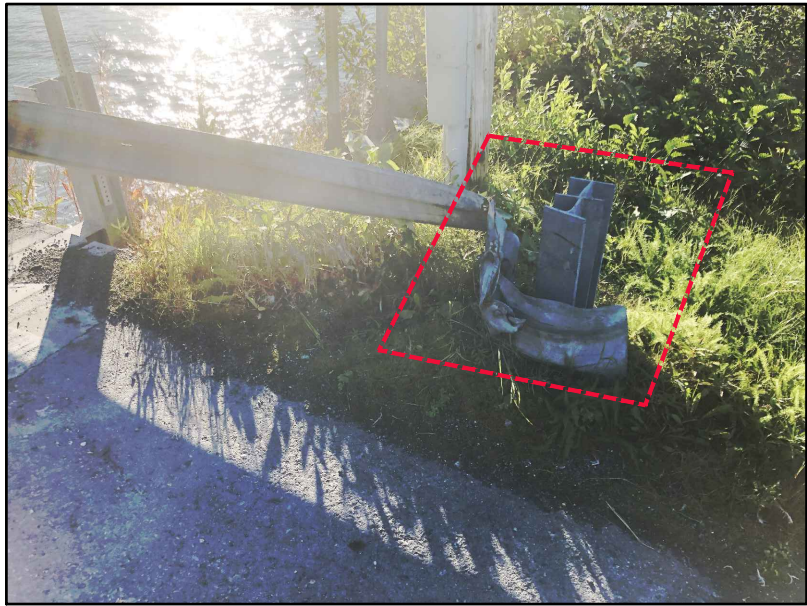
**FLARED END TERMINAL DAMAGE  
ON WEST APPROACH**

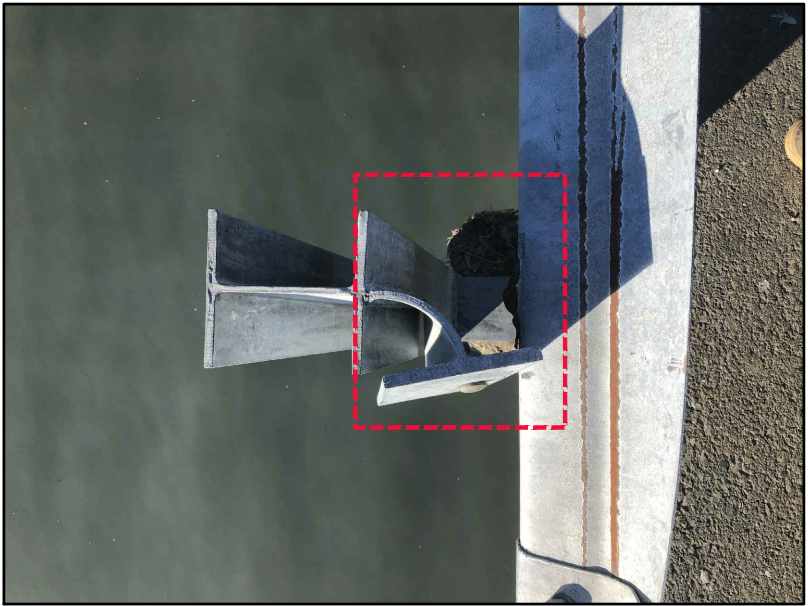
**TYPICAL WT DAMAGE ON POST**

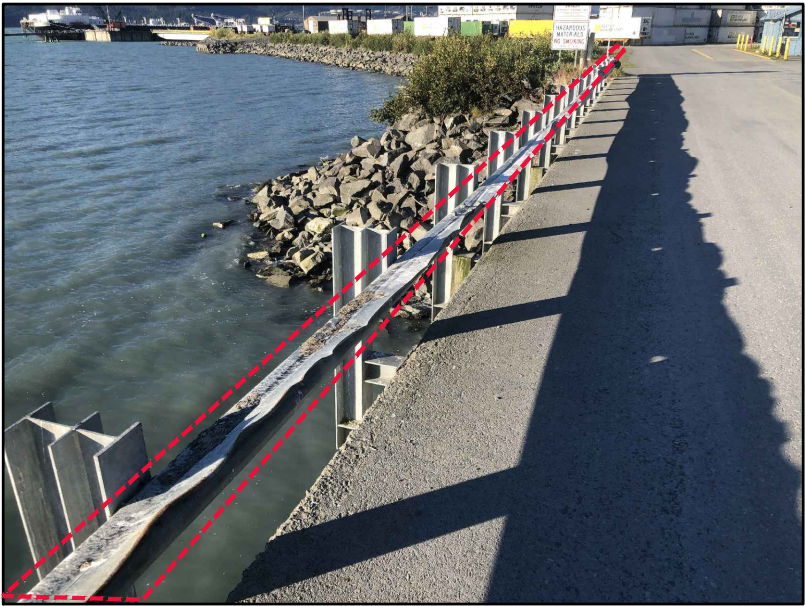
**TYPICAL RAIL DAMAGE**

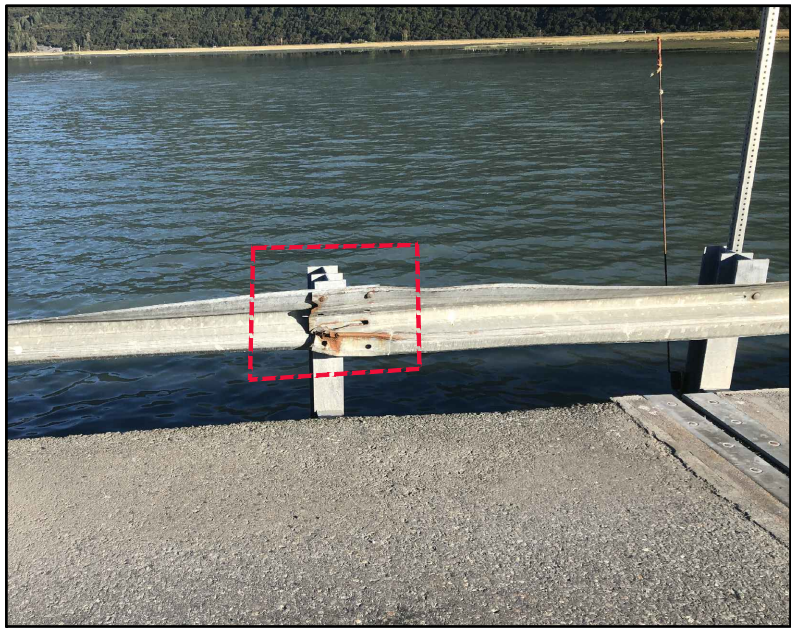
**SPLICE DAMAGE AT EXPANSION JOINT**

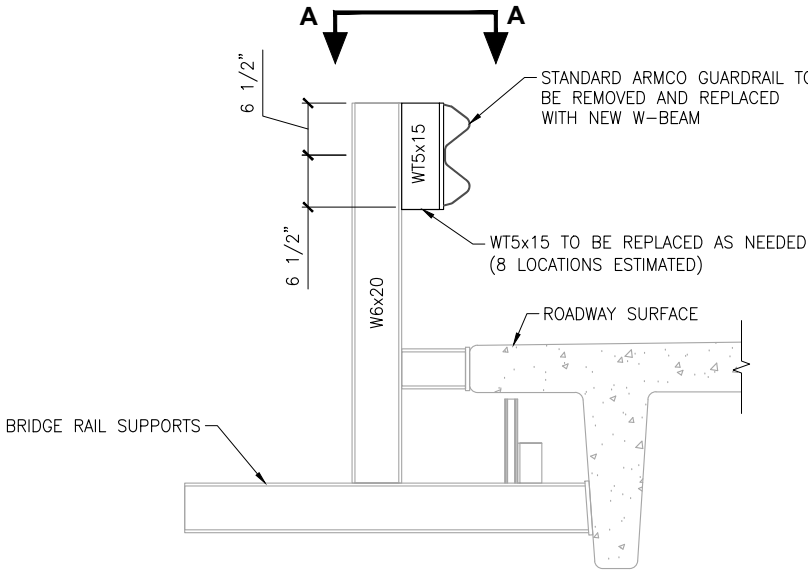
**SIDE VIEW**

**EXISTING GUARDRAIL - REPAIR DETAILS**  
NTS

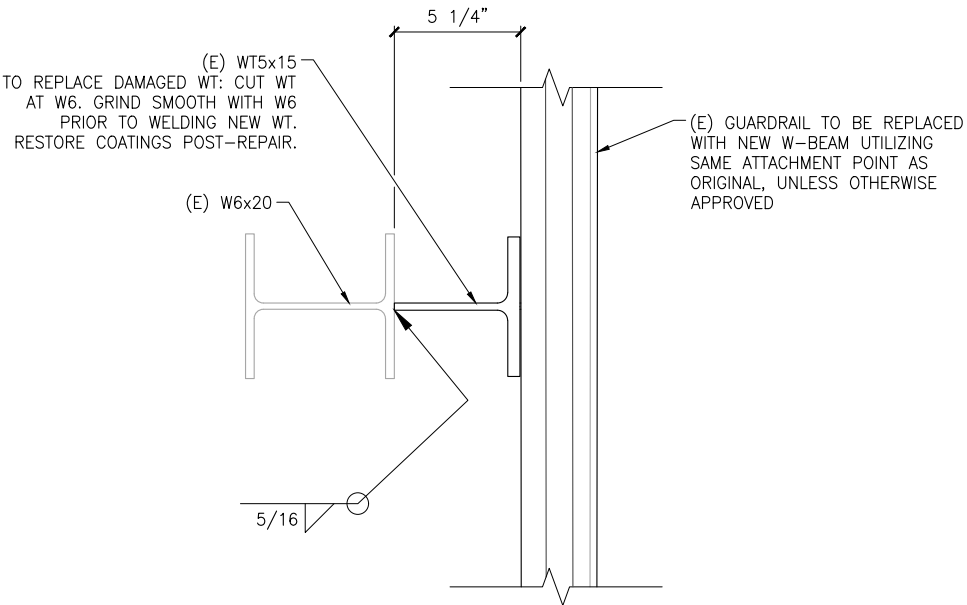
**SECTION A-A**  
NTS
