Typical failure stage 1.

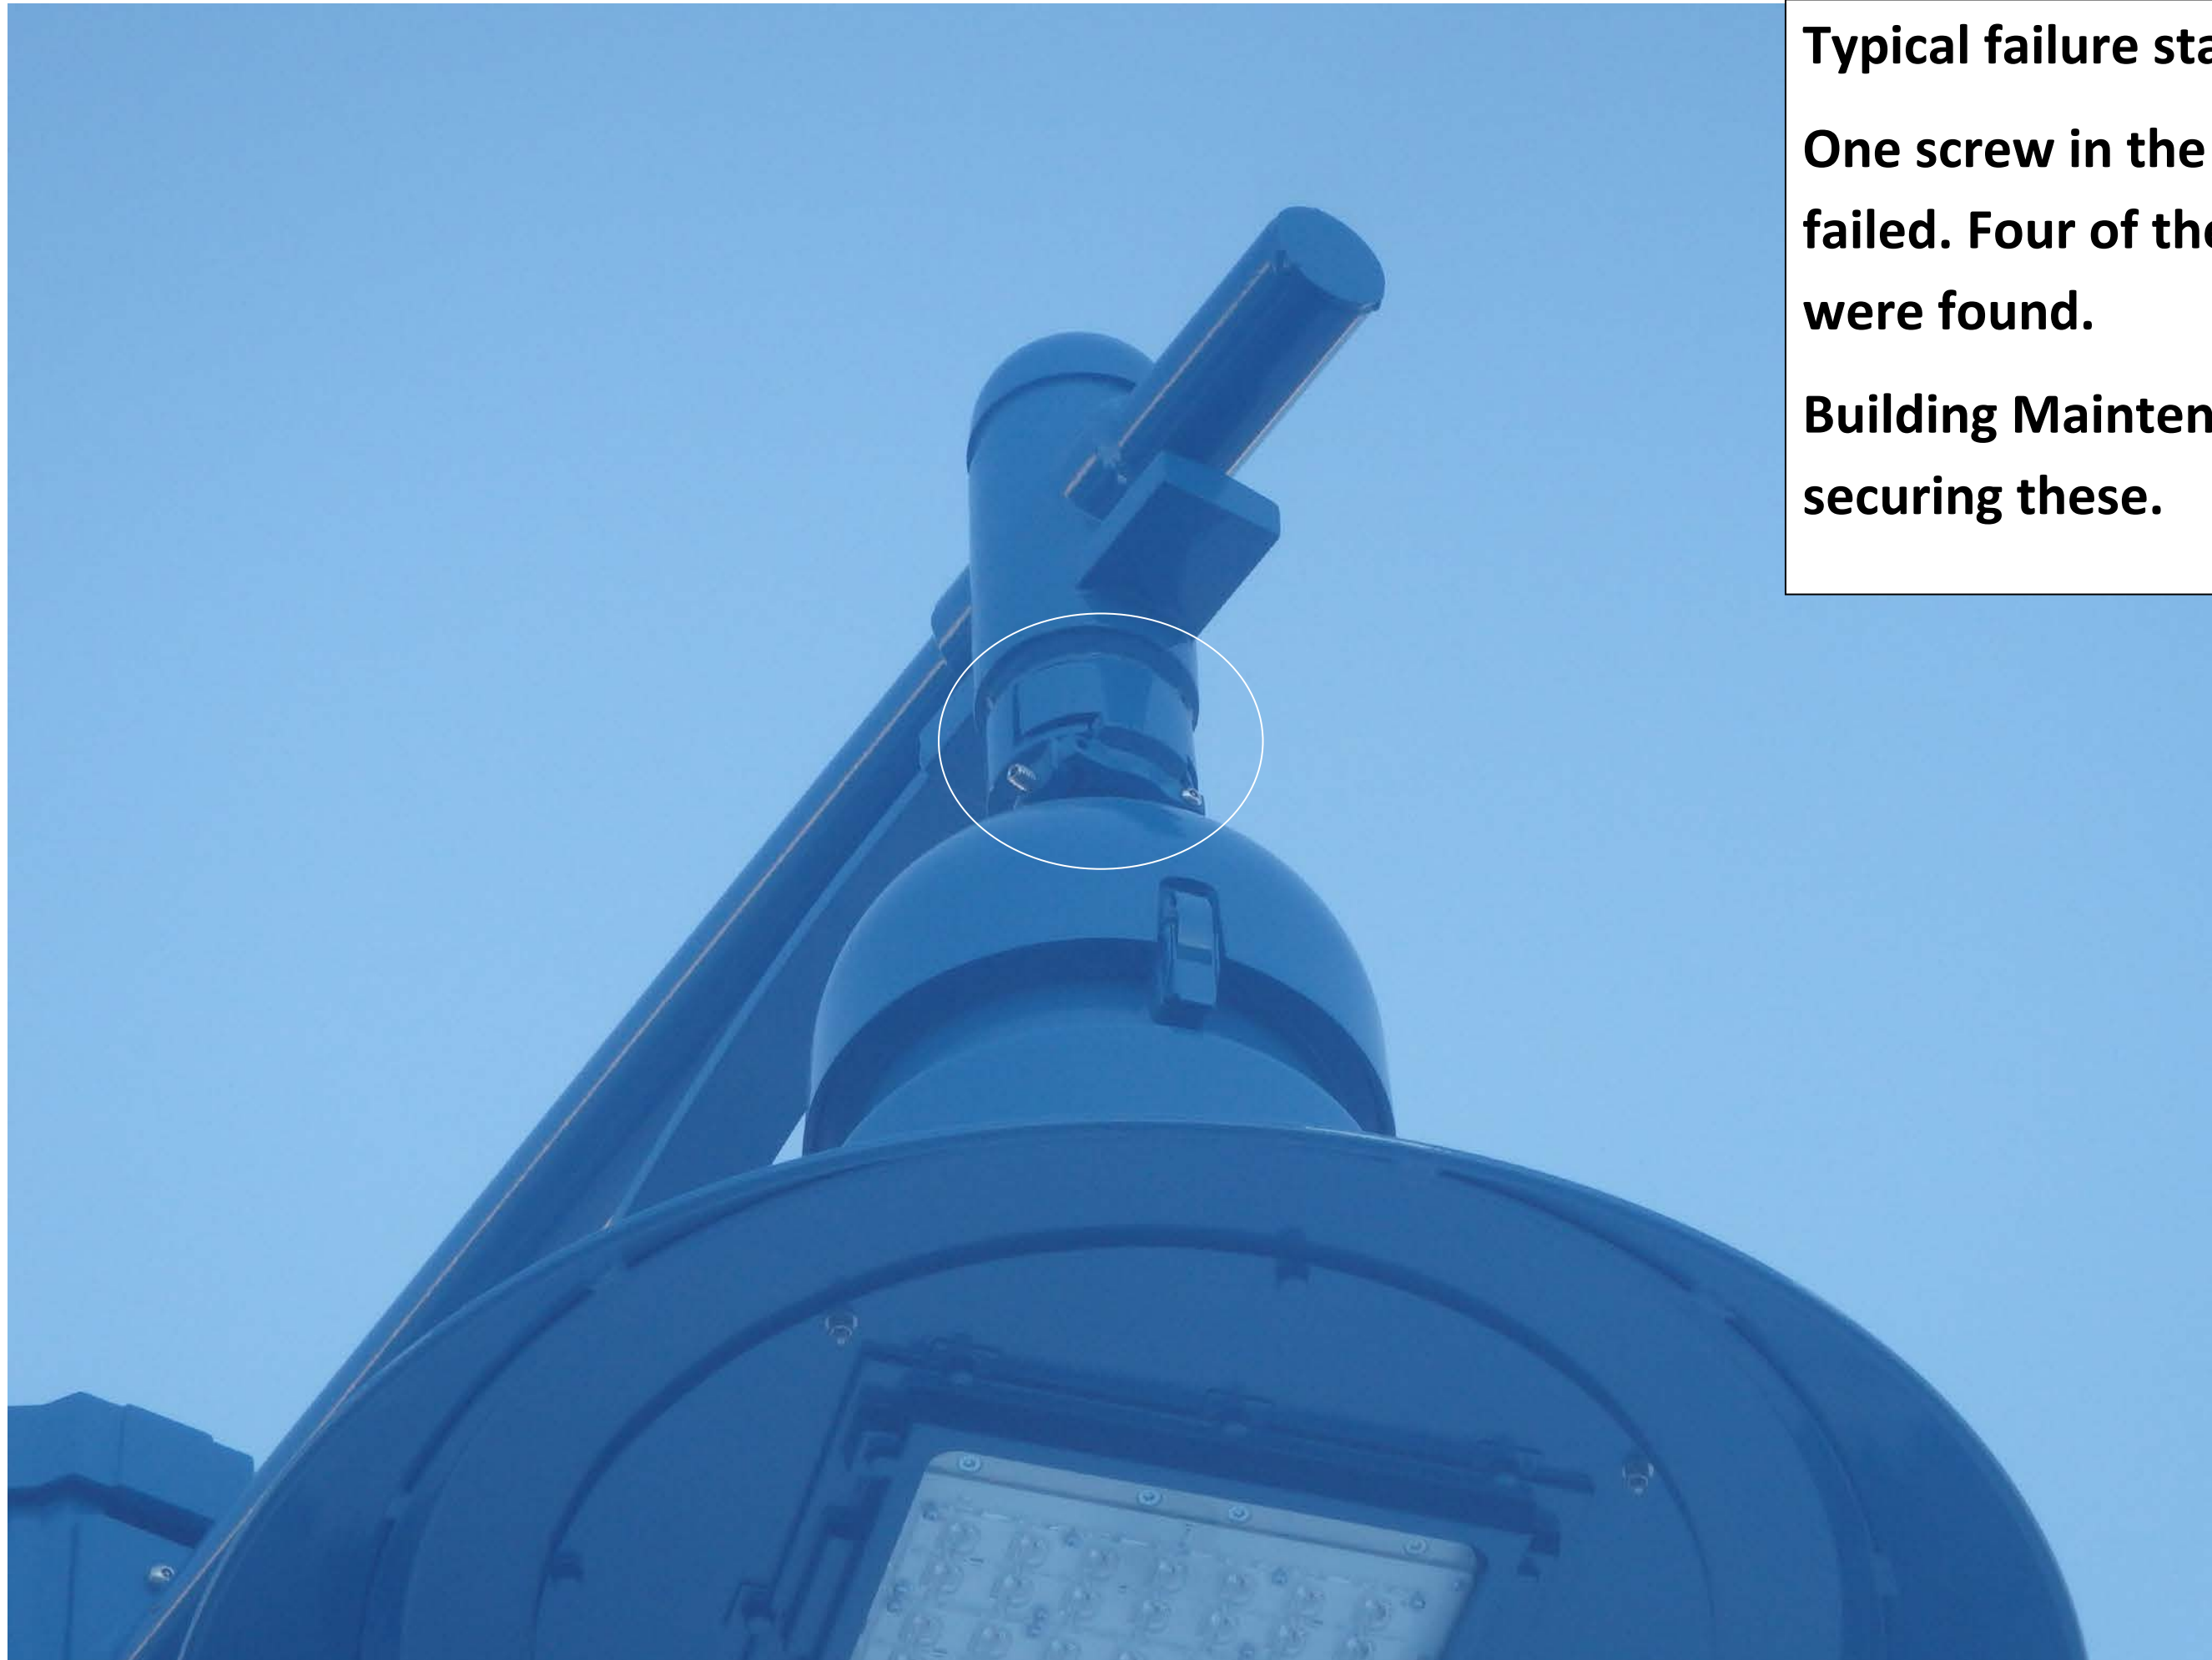
One screw in the front has failed. Four of these cases were found.

Building Maintenance is securing these.

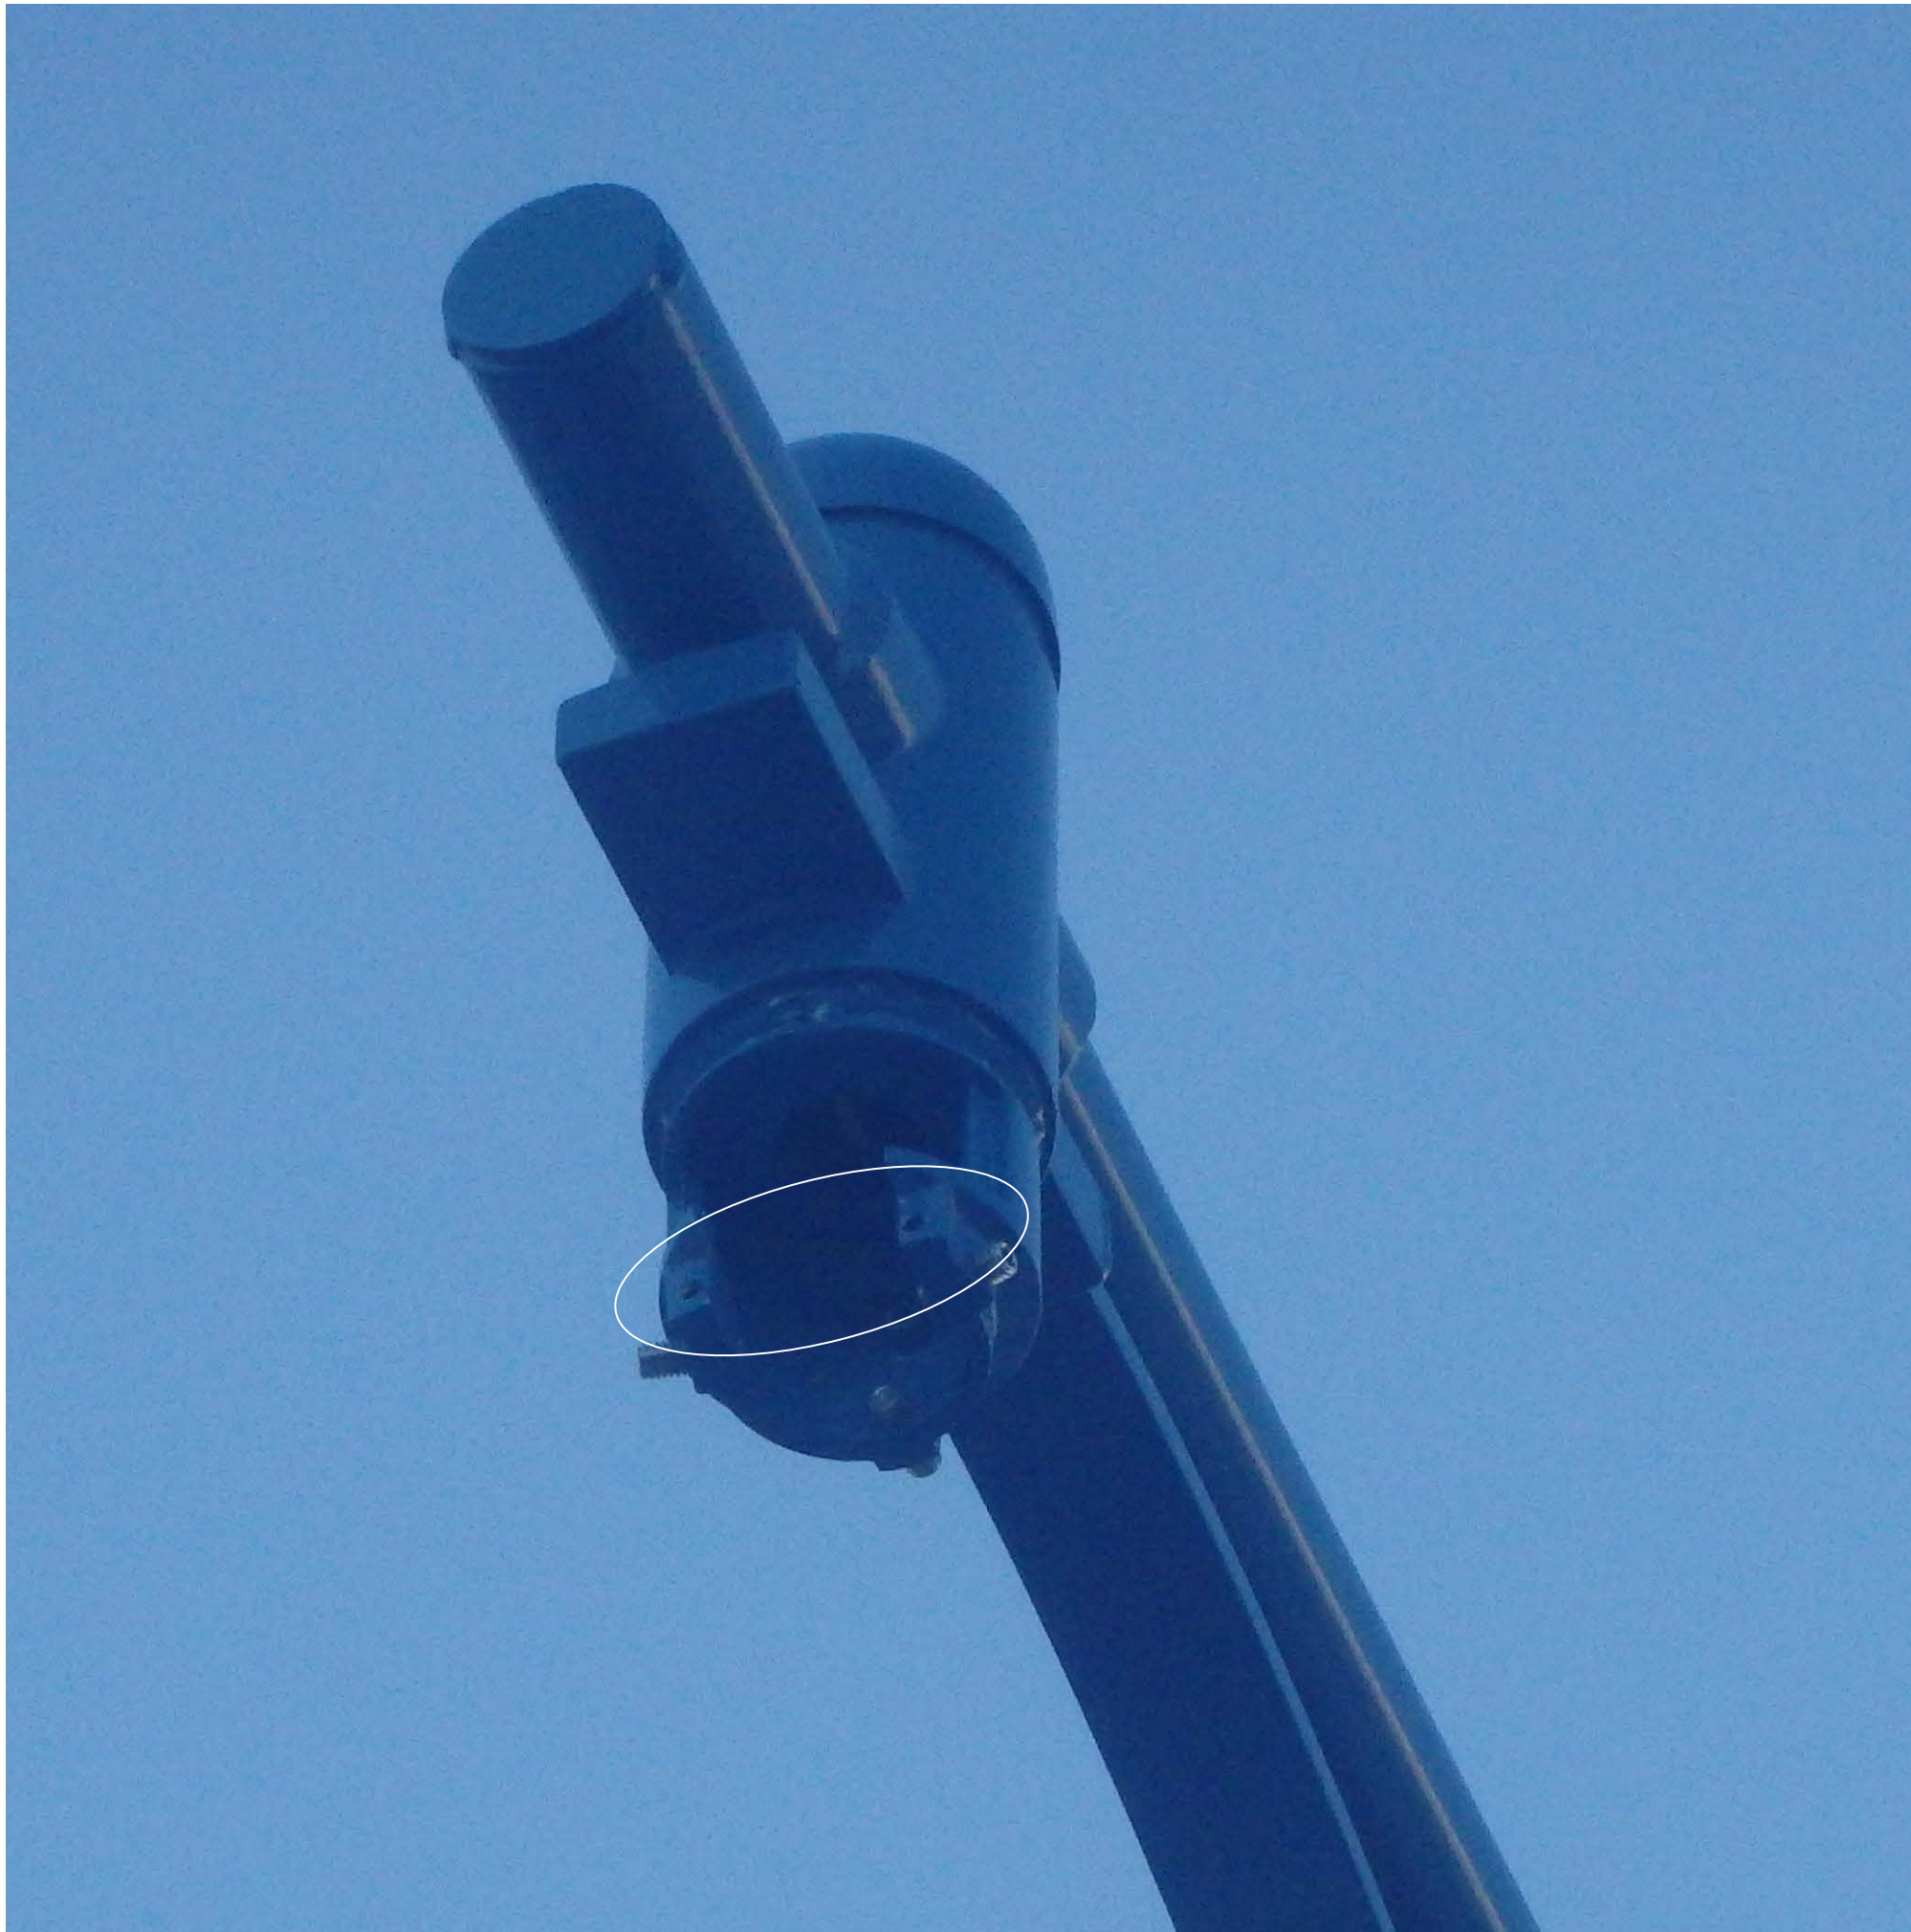
Typical Failure Stage 3.

Both screws released from the front cover and the light fixture fell out. Five of the eight lights failed because of this issue.

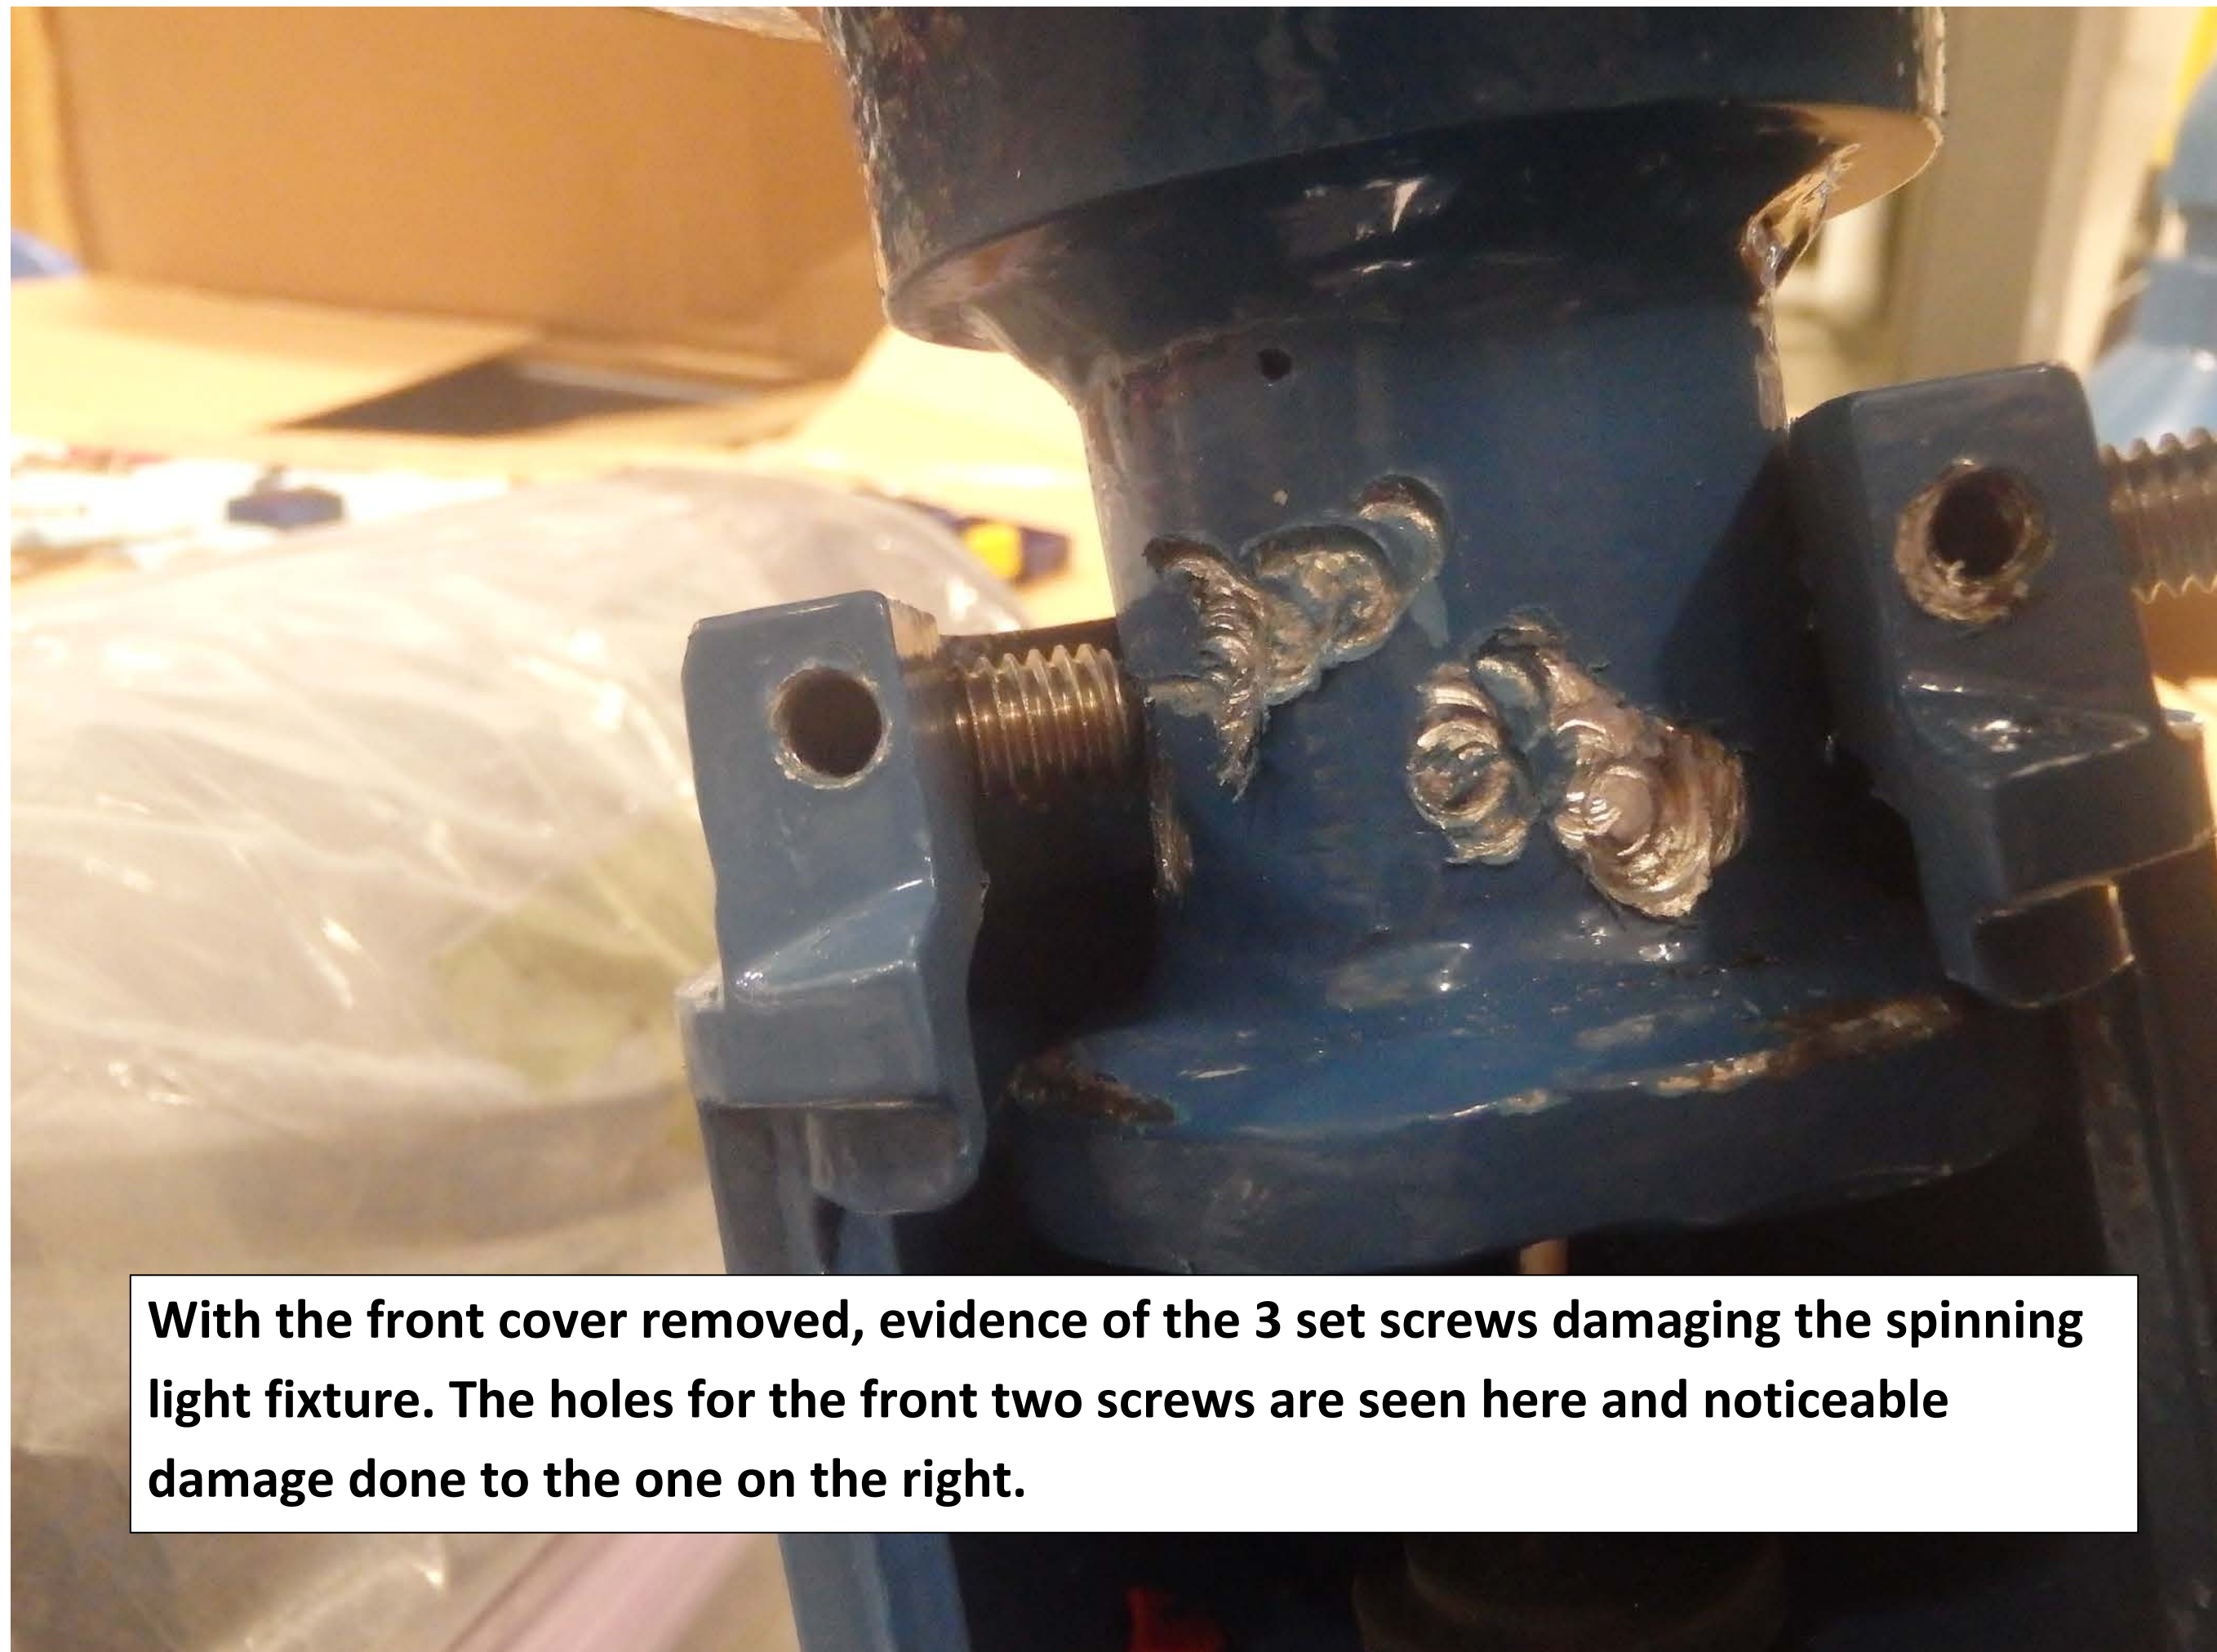
With the front cover removed, evidence of the 3 set screws damaging the spinning light fixture. The holes for the front two screws are seen here and noticeable damage done to the one on the right.

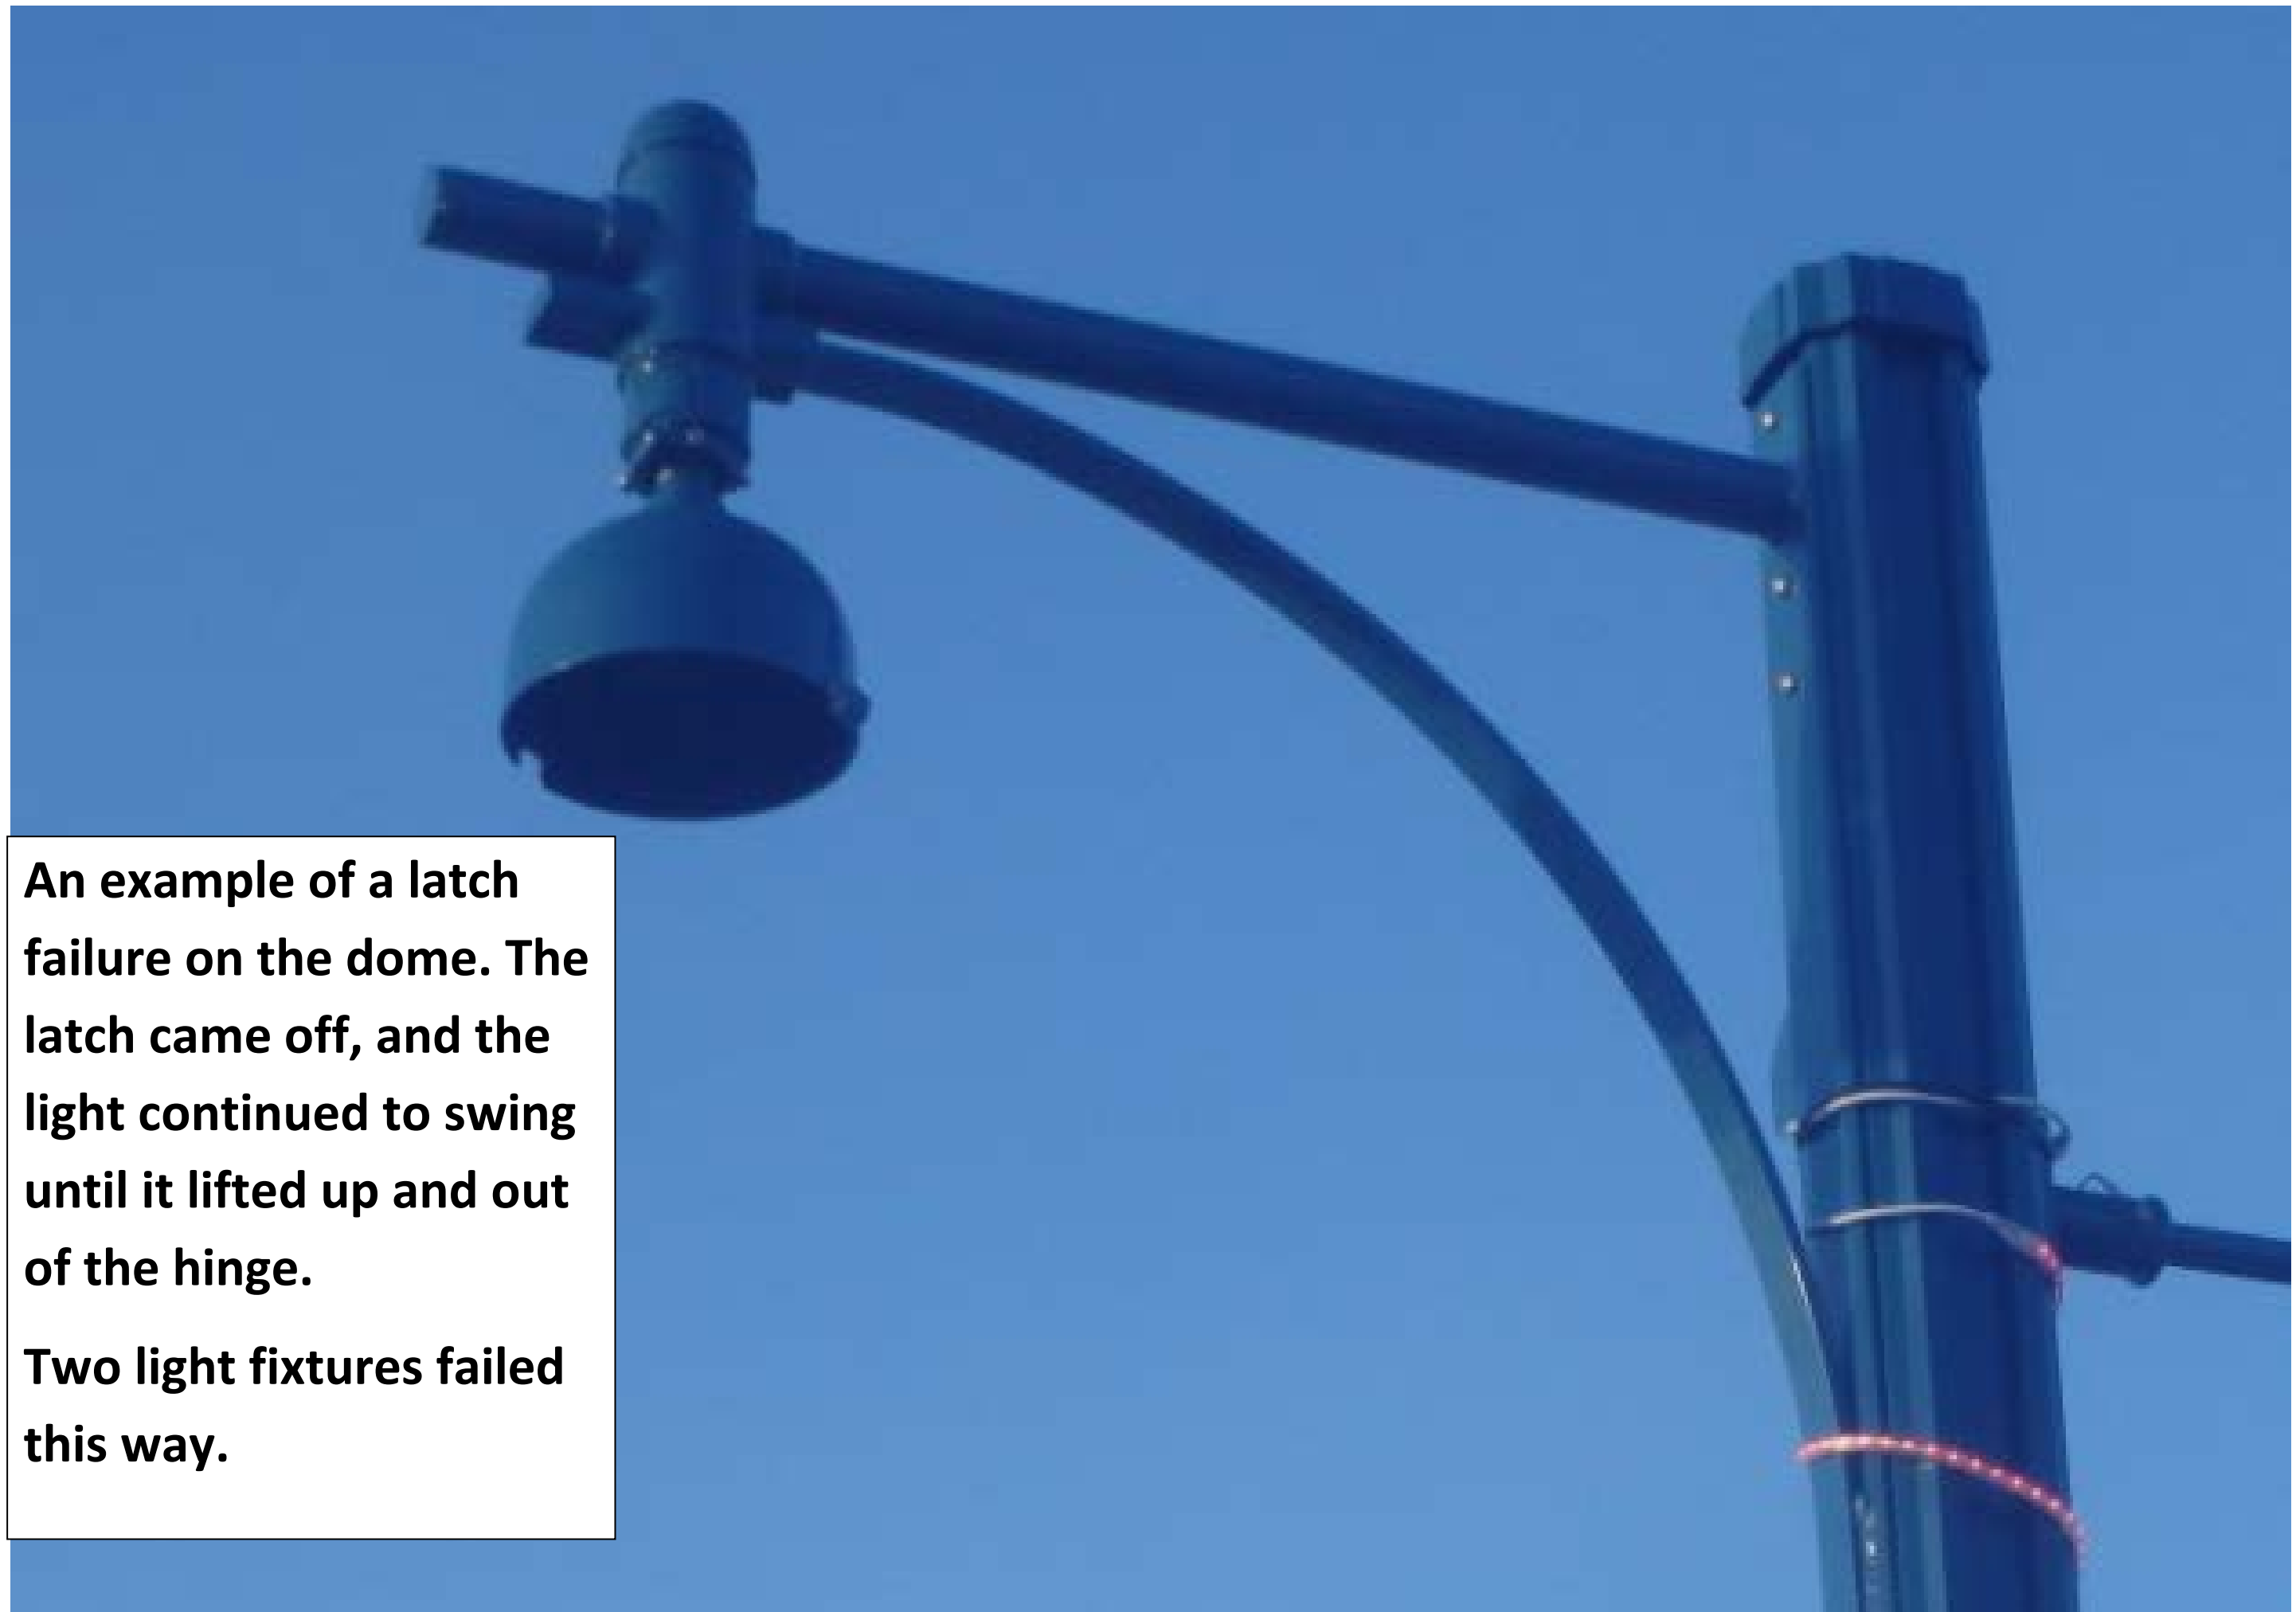
An example of a latch failure on the dome. The latch came off, and the light continued to swing until it lifted up and out of the hinge.

Two light fixtures failed this way.

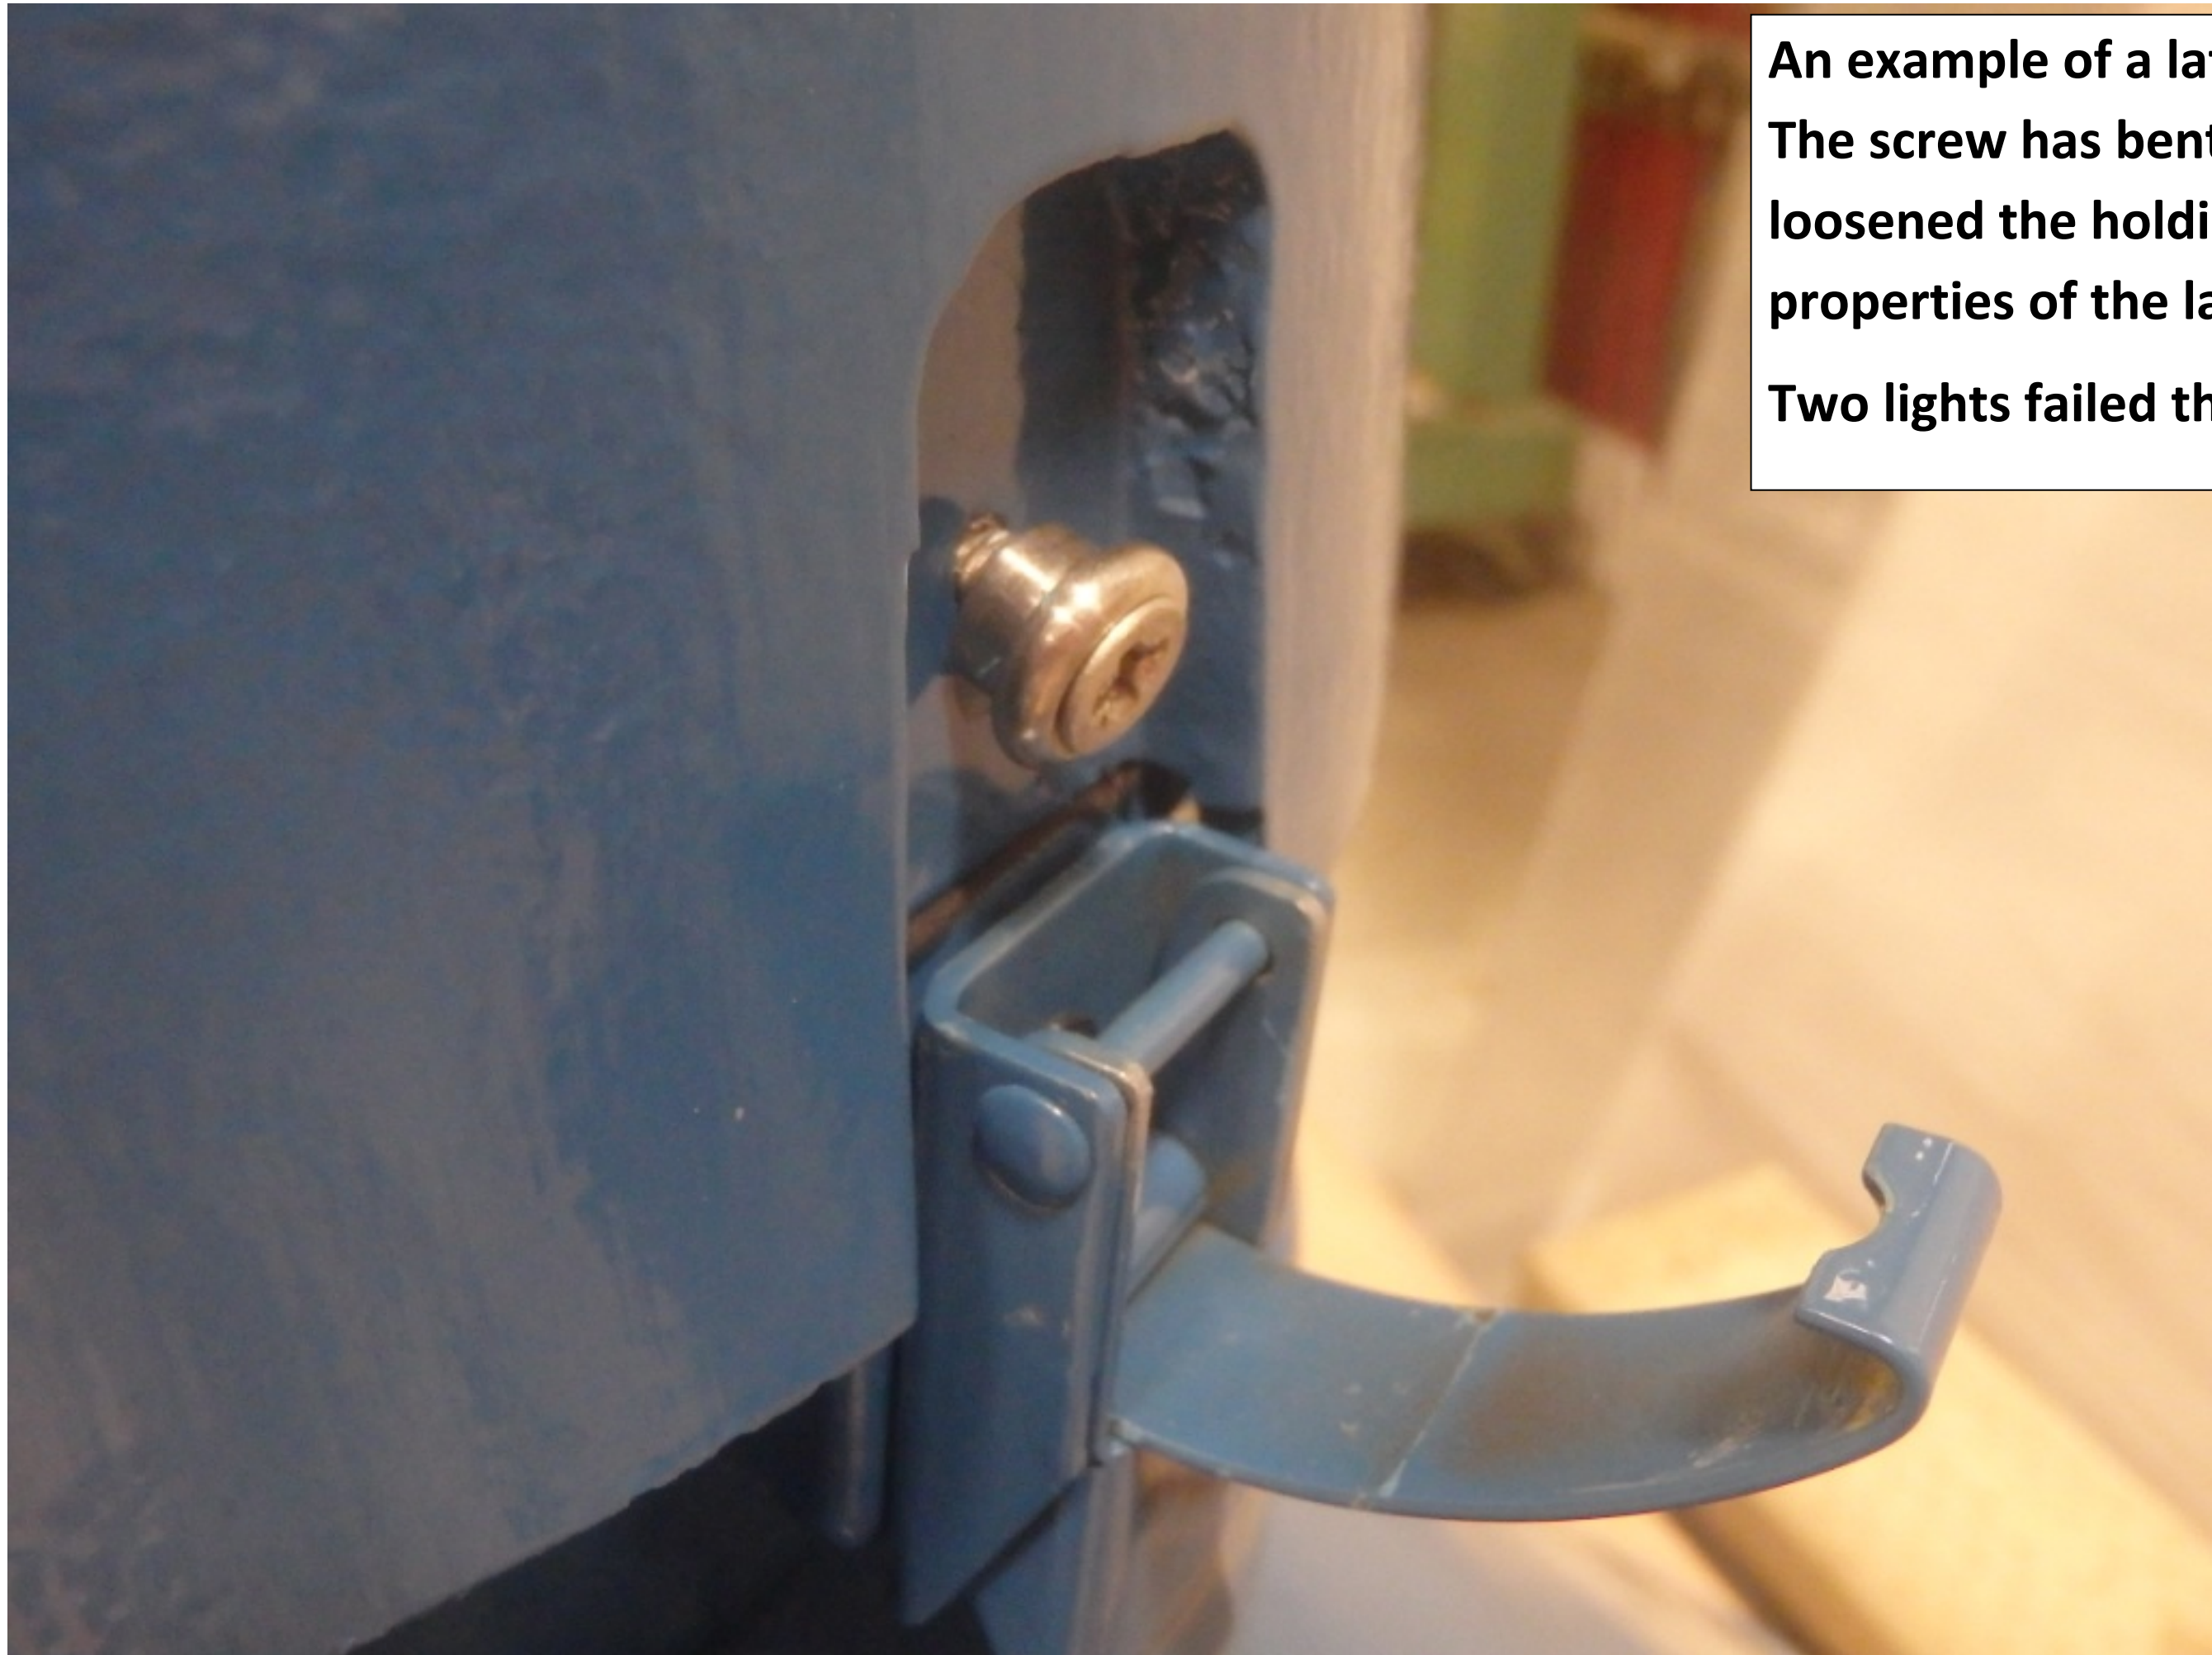
**An example of a latch failure.
The screw has bent which
loosened the holding
properties of the latch.
Two lights failed this way.**

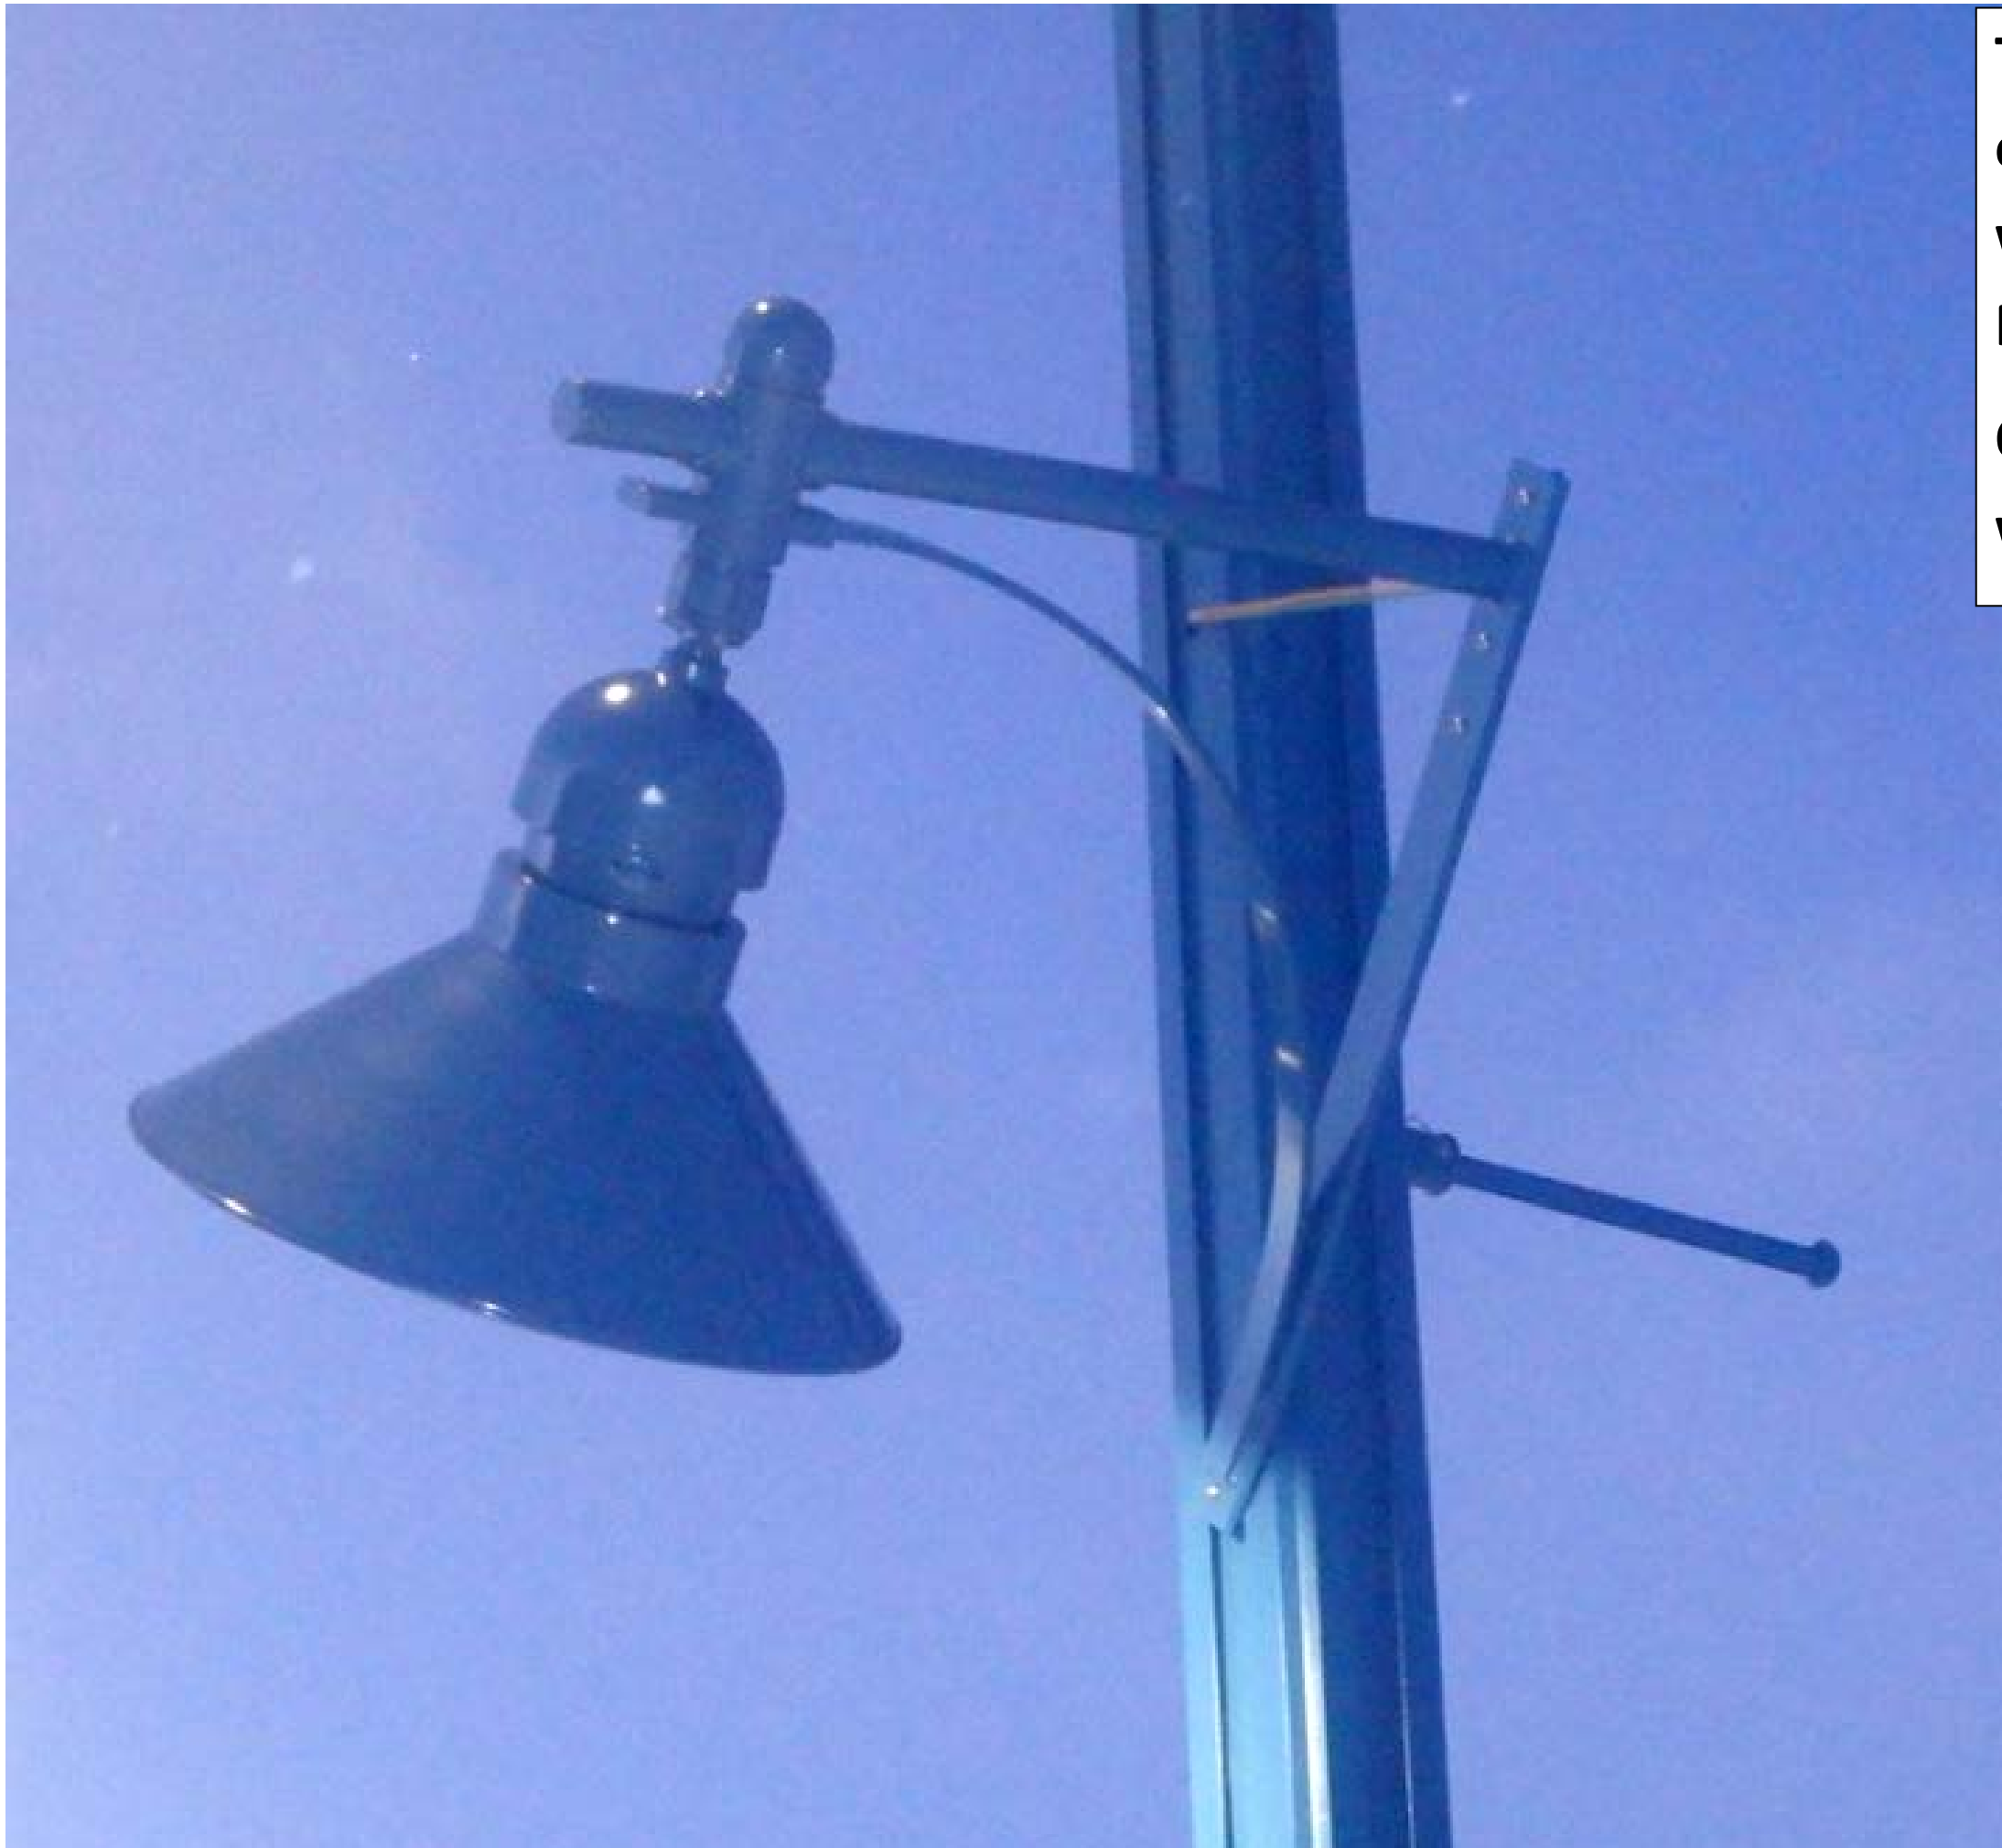
The mast arm being held by 1 of the 4 securing points. Light was removed by Building Maintenance.

Only one light failed this way.
