Typical failure stage 1.

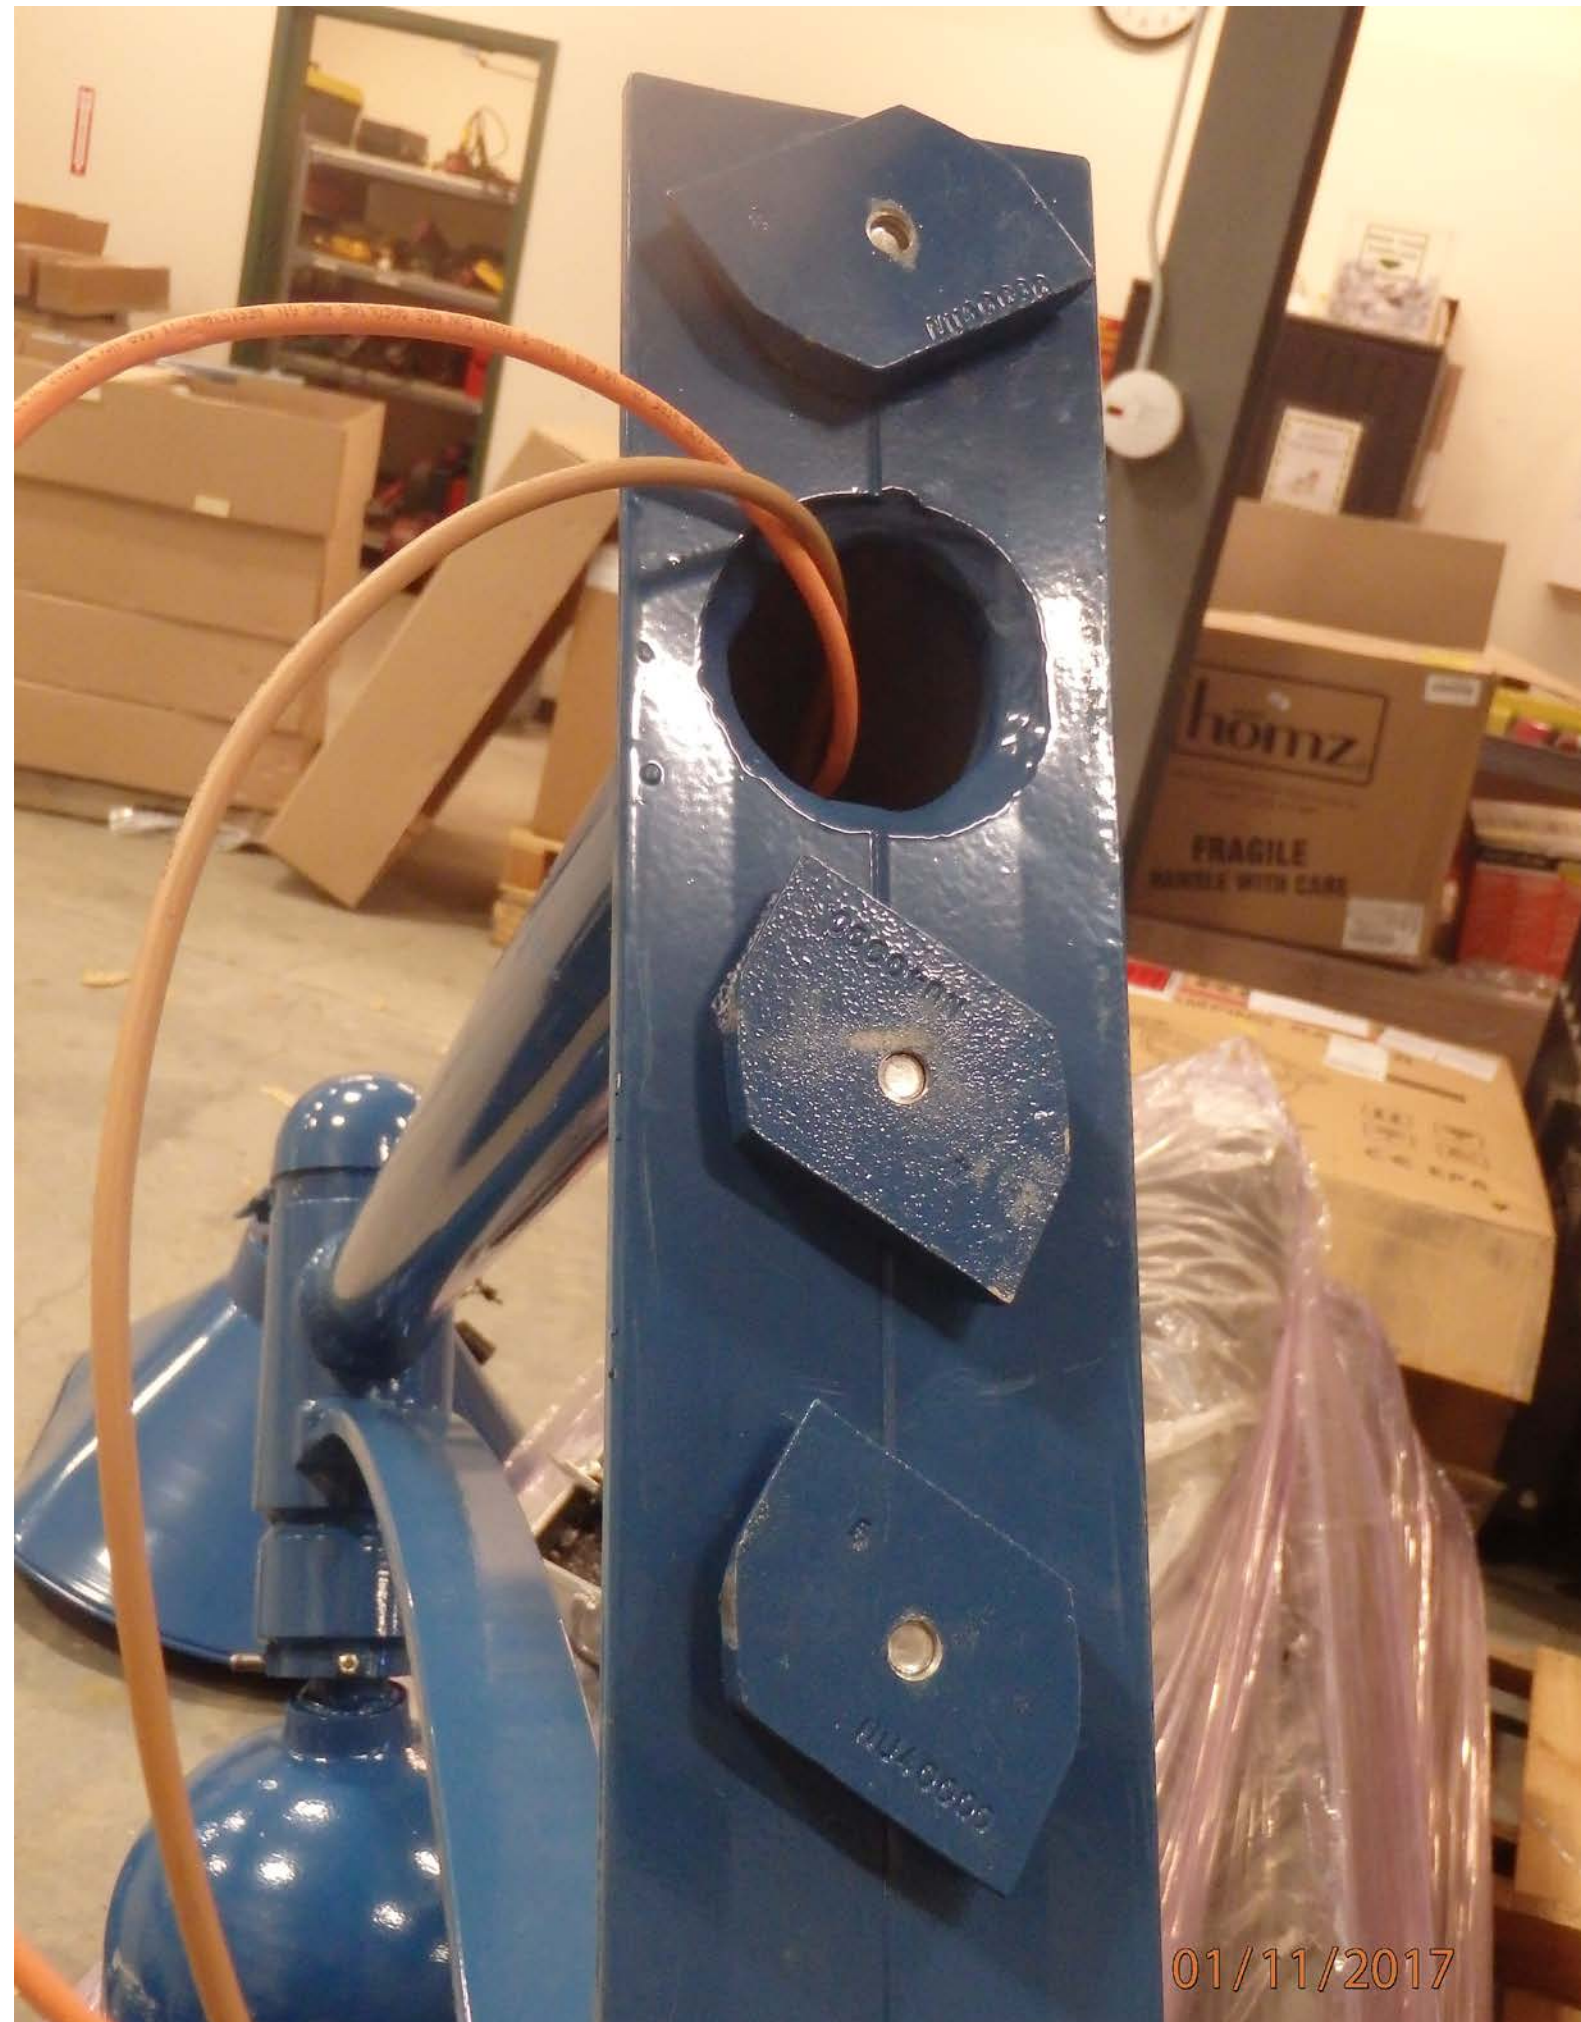
A view behind the mast arm that failed. These are rotated and locked into the pole. During the storm a few were loosened, rotated, and subsequently came off the pole.

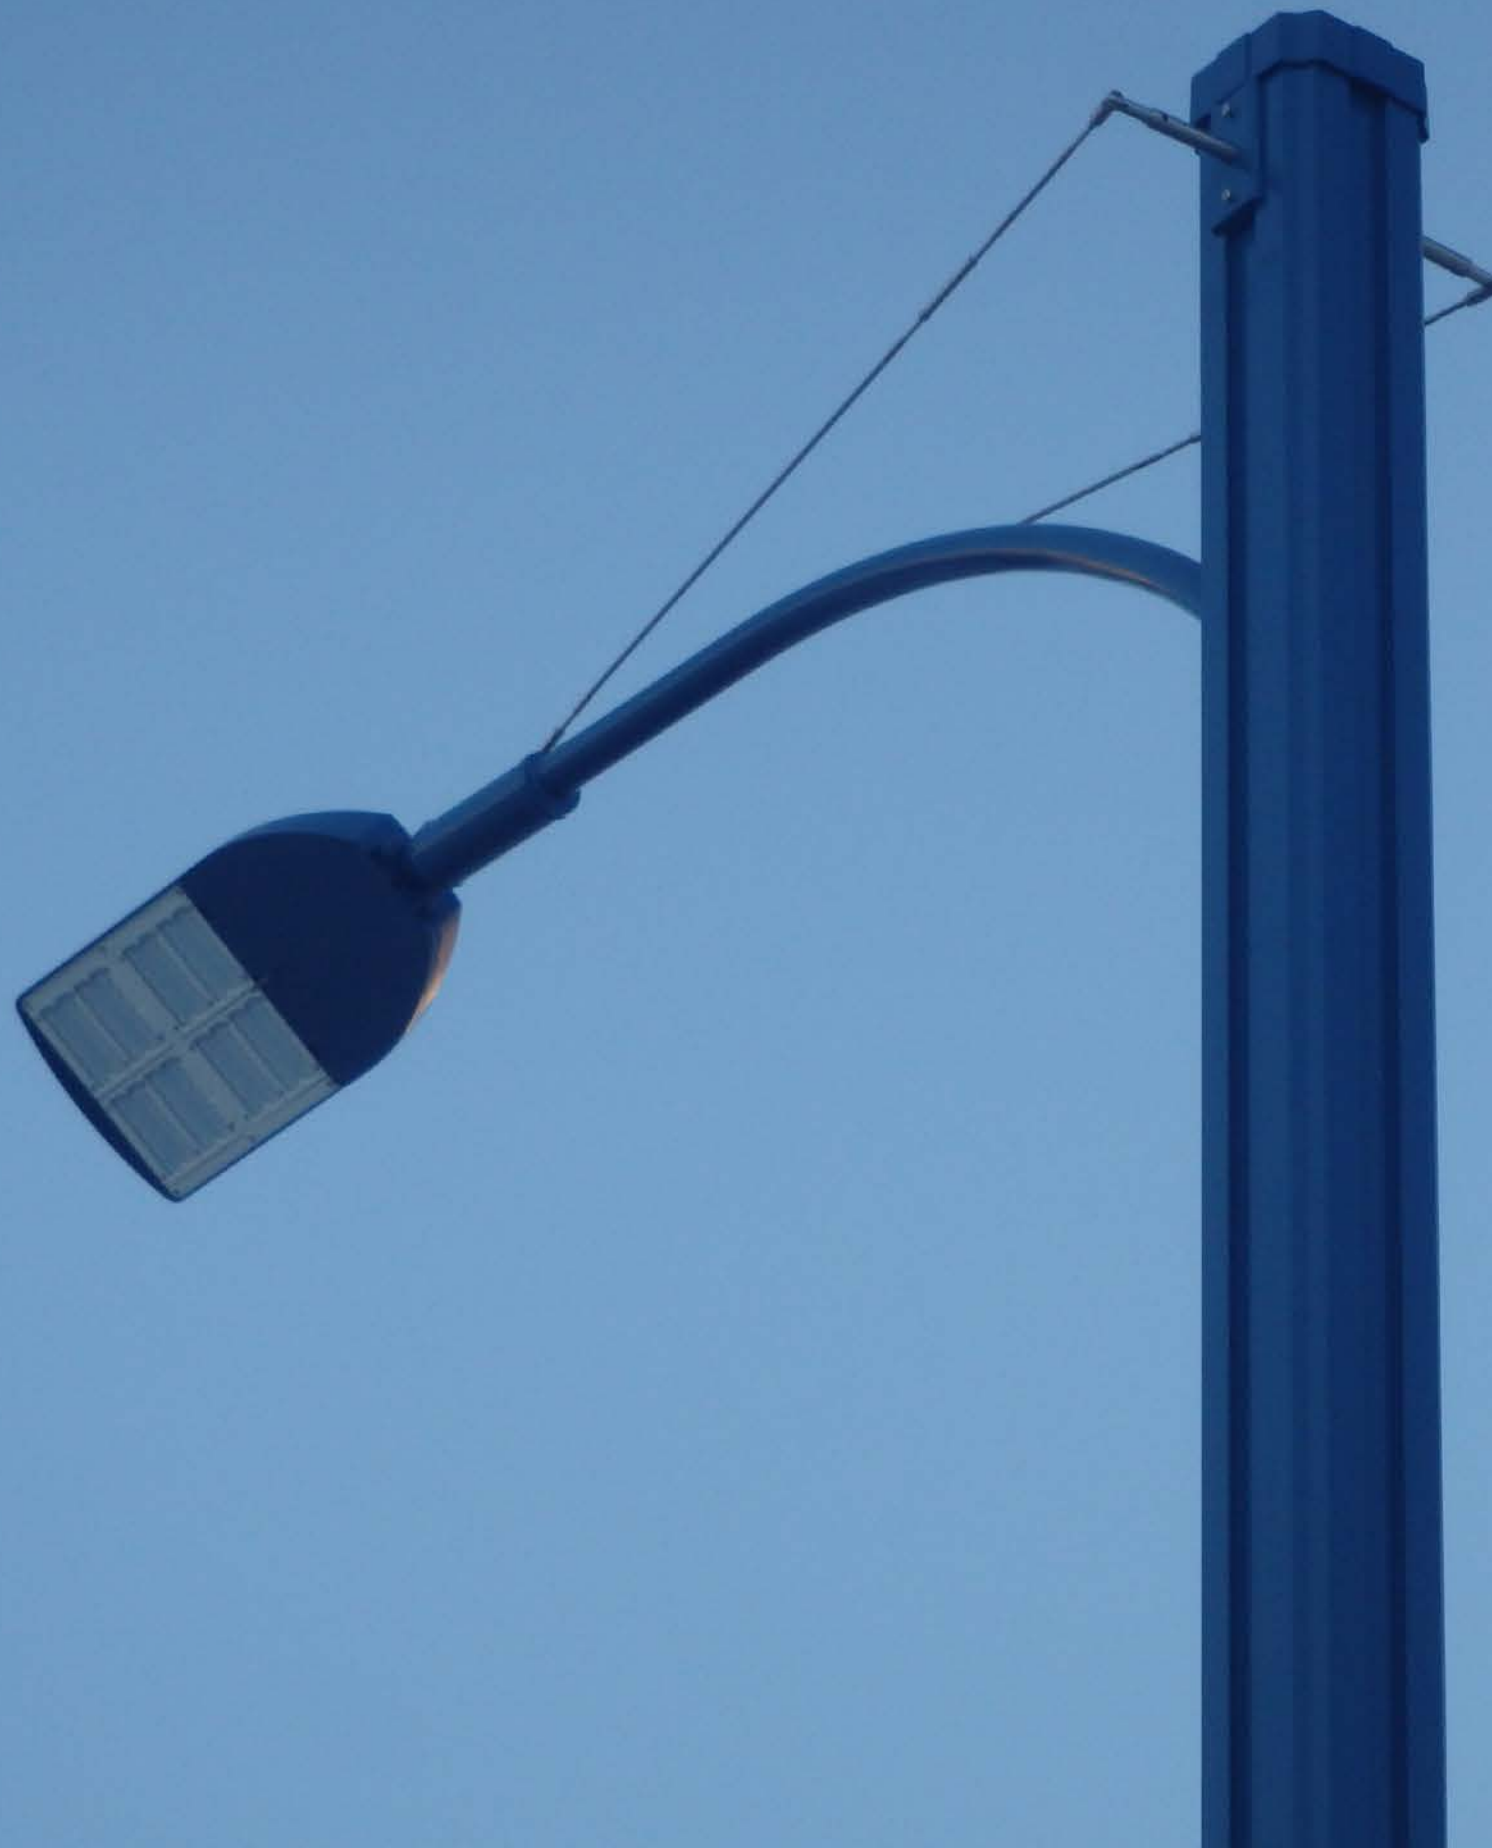
**Located on the backside of
the arch.**

**30' light fixture failure.
Mast arm and light have
rotated about 45 degrees.
Only one of these failed in
this way.**

**30' light support failure.
Securing wire from the
light to pole broke. Only
one of these has failed.**
