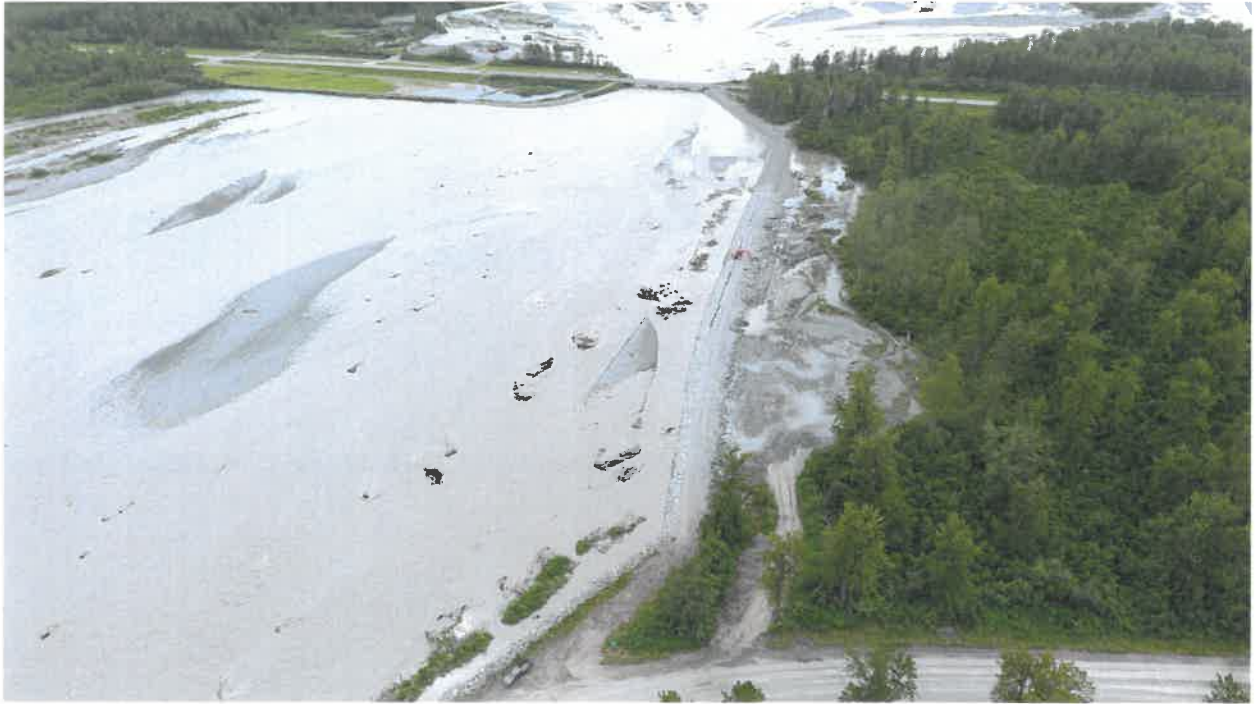
Photo taken during the outburst flood and how it prevented a repeat of the previous year's flooding.

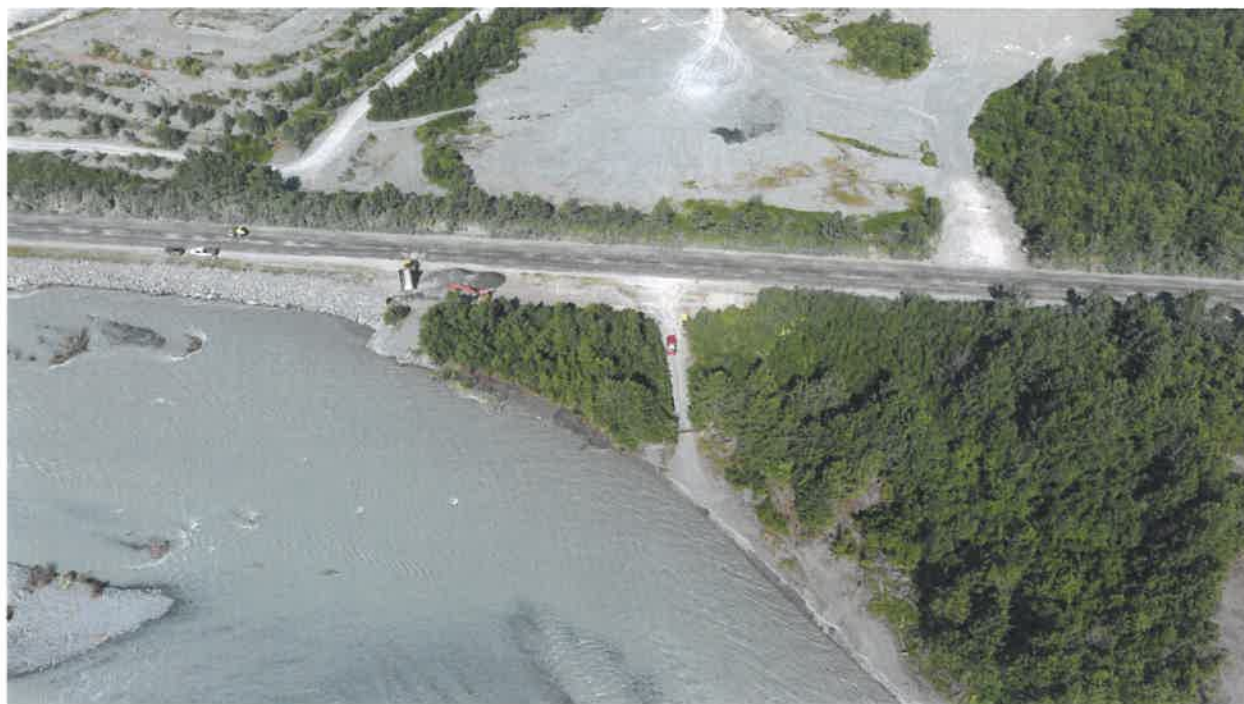
Here's a photo of the start of the 700' long ditch we excavated and filled with riprap across from the landfill. The river is currently right next to it and may even expose the buried rock this fall.
