# **City of Valdez**

## **Meeting Agenda - Final**

**Work Session (Preliminary Space Planning for the Former Fire  
Station 1)**

Capital Facilities will discuss options for the utilization of the soon-to-be vacated fire station. Discussion will walk through available alternatives, rough order of magnitude costs, and context within the greater Citywide long range Capital Improvement Plan.

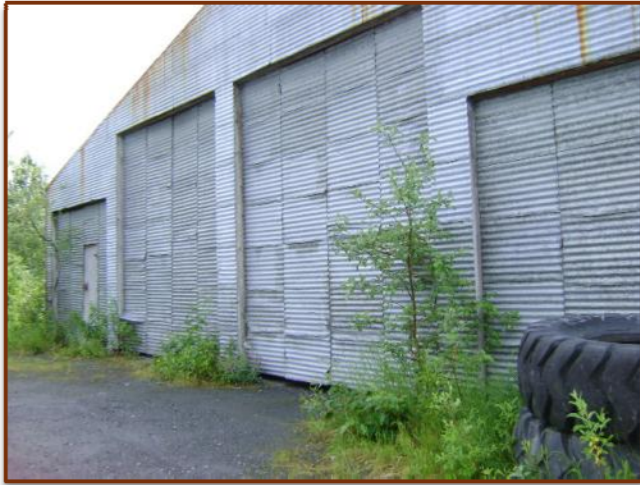
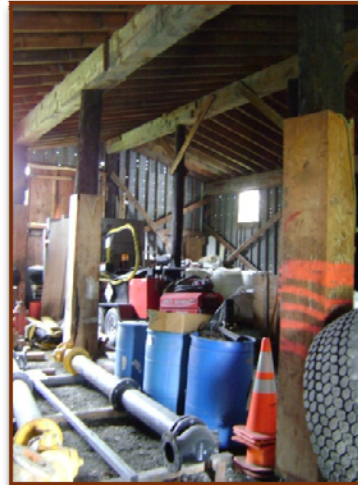
### **1. Hanagita Warehouse – Evaluated as Poor**

The Hanagita Warehouse is part of the Public Works Department that provides the department with critical storage of equipment needed to perform necessary services. Presently, the warehouse is beyond its serviceable life and needs to be replaced with a facility about 1.5 times its size. The cost to replace this facility is approximately \$2.2 million.

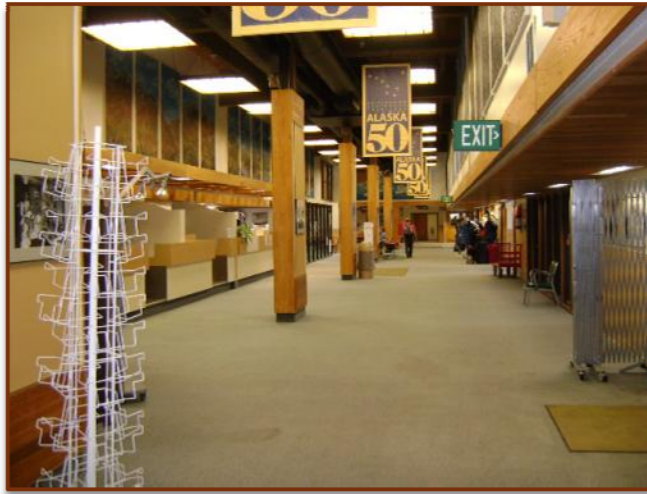
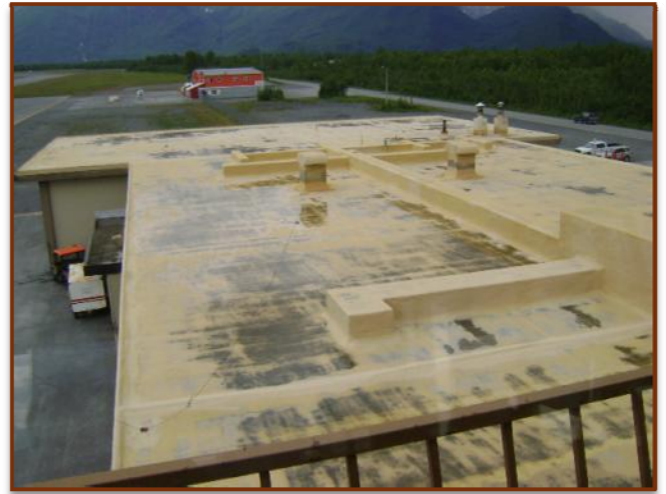
## 5. Airport – Evaluated as Adequate

The Airport is part of the Ports & Harbor Department and currently also houses the Capital Facilities Engineering Department. Upgrades are needed to bring the facility up to code. The roofing and fire alarm system need to be replaced. Interior finishes need to be replaced. Energy consumption could be reduced by upgrading the insulation in the roof & exterior walls, addressing inefficient lighting, environmental control and ventilation system issues. Total estimated cost of these items is \$8.9 million.

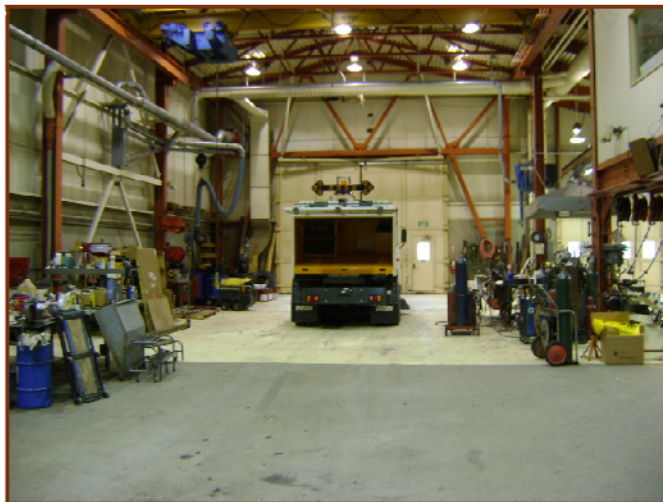
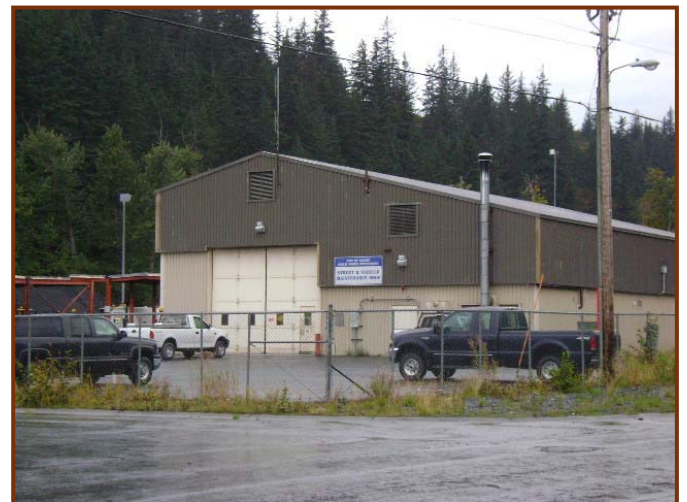
## 6. Public Works – Evaluated as Adequate

Public Works complex includes Office/Vehicle Shop, Sand Storage Building, Storage Building, and Covered Vehicle Equipment Area. The office area needs ventilation separation from the shop building; currently the air contaminants from the repair shop are

leaking into the office causing indoor air quality in the office that is uninhabitable. The office area also needs better acoustic separation from the shop. The office area is on the second floor and no disabled access is currently available. The estimated cost to address the Office and Vehicle Shop is \$900,000

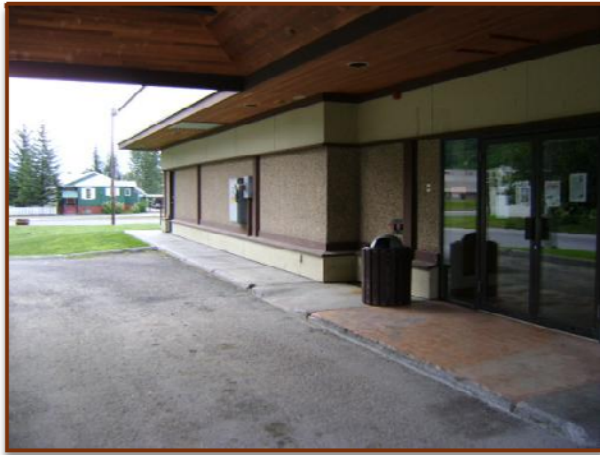
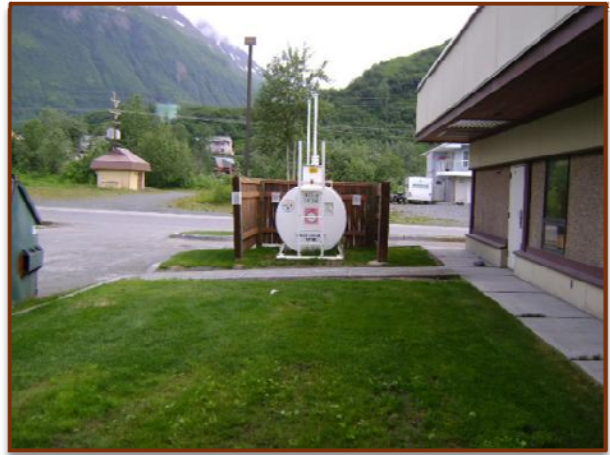
### 8. Teen Center –Evaluated as Adequate

The Teen Center operates under the Parks, Recreation & Cultural Services Department. It provides community recreation and services for all ages. Energy efficiency upgrades need to be made to the lighting and control. Also, the windows currently allow high levels of air infiltration and should be replaced. The heating and ventilation system needs evaluation commissioning. The roof and worn out finishes like carpet, paint and ceilings needs replacement. Total estimated cost of these items is \$1.3 million.

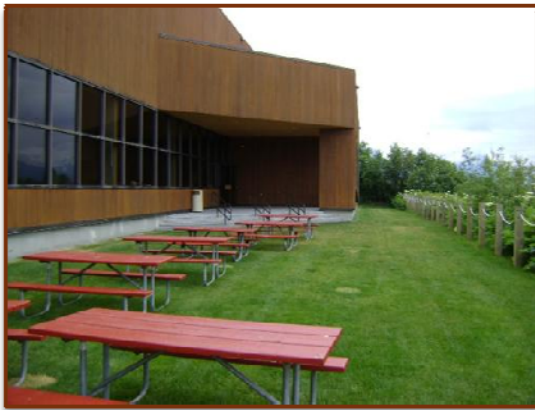
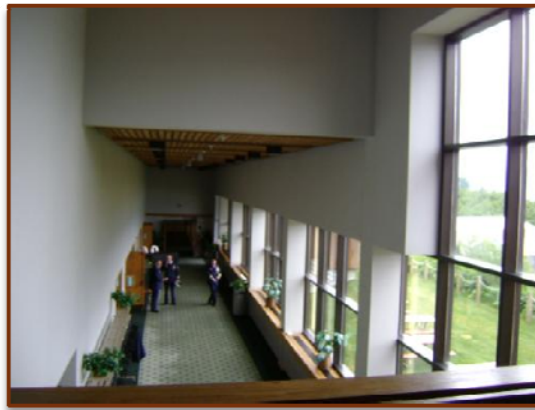
### 9. Civic Center – Evaluated as Adequate

The Civic Center operates under the Parks, Recreation & Cultural Services Department providing civic and cultural services. The current facility is in good shape; a routine finish maintenance schedule should be prepared to accommodate finishes that will eventually need to be replaced. The roof and ventilation system should be evaluated and commissioned. The fire alarm needs repair/replacement. Mechanical valves are leaking and should be evaluated. The sprinkler system is in need of repair. These items cost an estimated total of \$2.1 million.

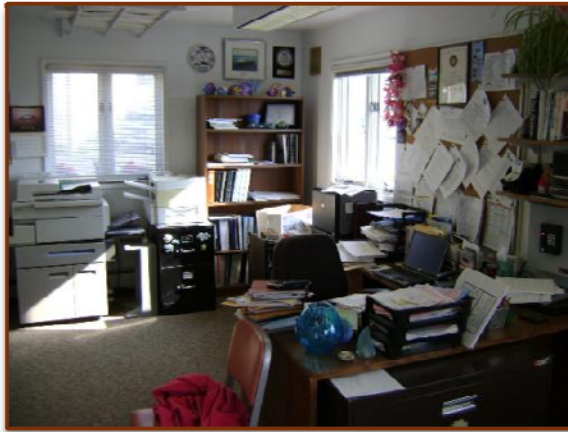
## 10. Port Administration – Evaluated as Adequate

The Port Administration is part of the Ports & Harbor Department and manages the Valdez Container Terminal, Kelsey Dock and Airport Building. The lighting is inefficient and needs upgrading to include high-quality optics and control. The ventilation system needs evaluation and the heating system needs commissioning. Environmental control would provide energy efficiency and fresh paint and carpet would improve aesthetics. The estimated cost of these items is \$100,000.

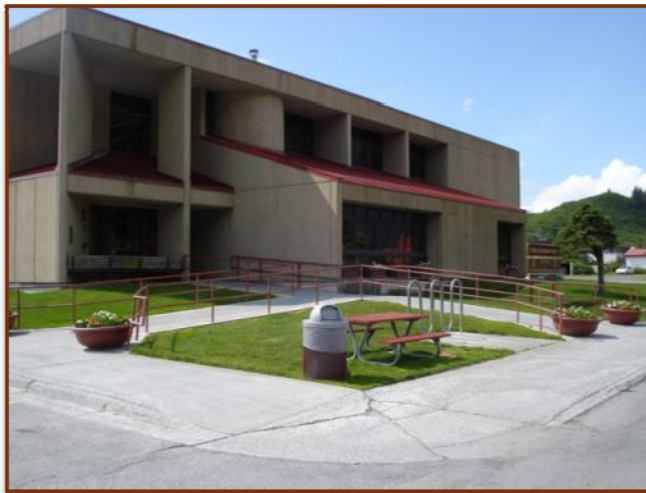
## 11. Library – Evaluated as Adequate

The Library is part of the Parks, Recreation & Cultural Services Department. It is a consortium library combining public and library media resources. The overall facility is in good condition. Repairs should be made to the roof and leaks showing at the walls. Estimated total cost for these items is \$500,000.

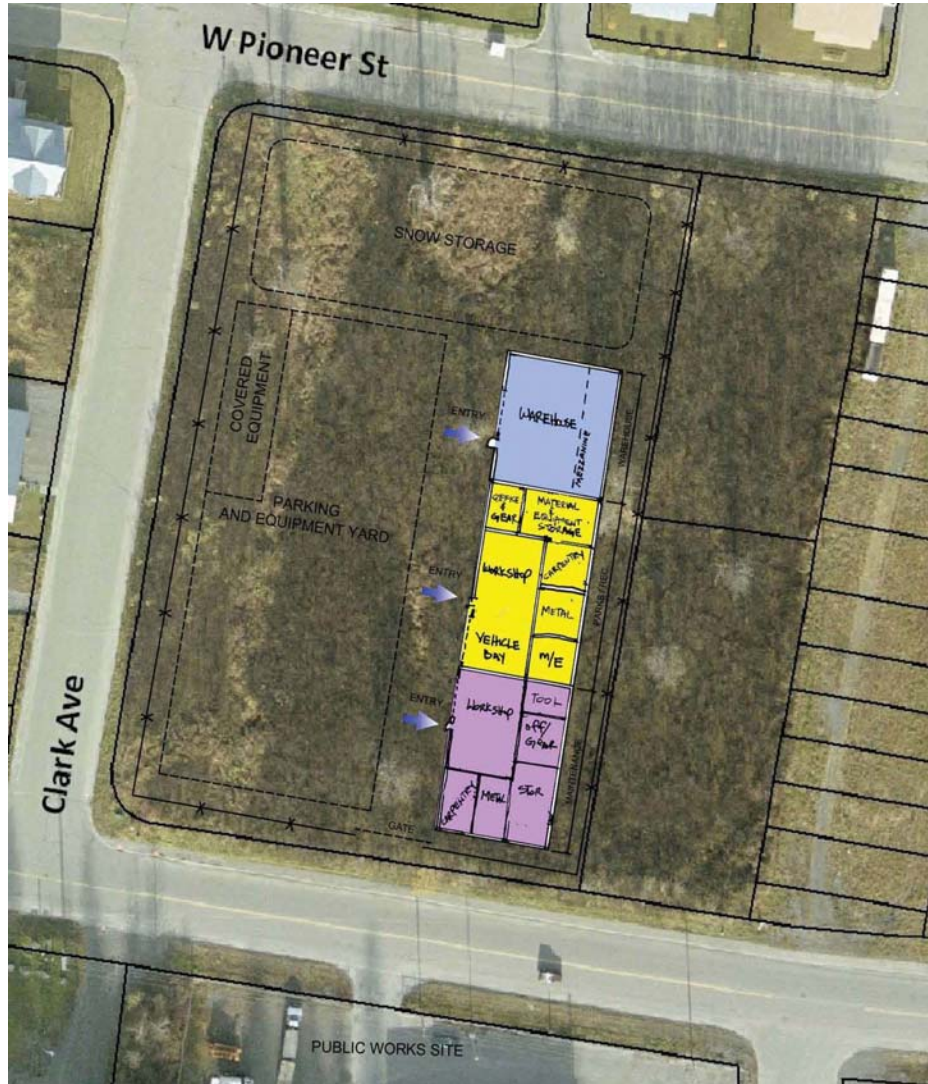
Site & Floor Plan – Issue 1A

Project scope includes:

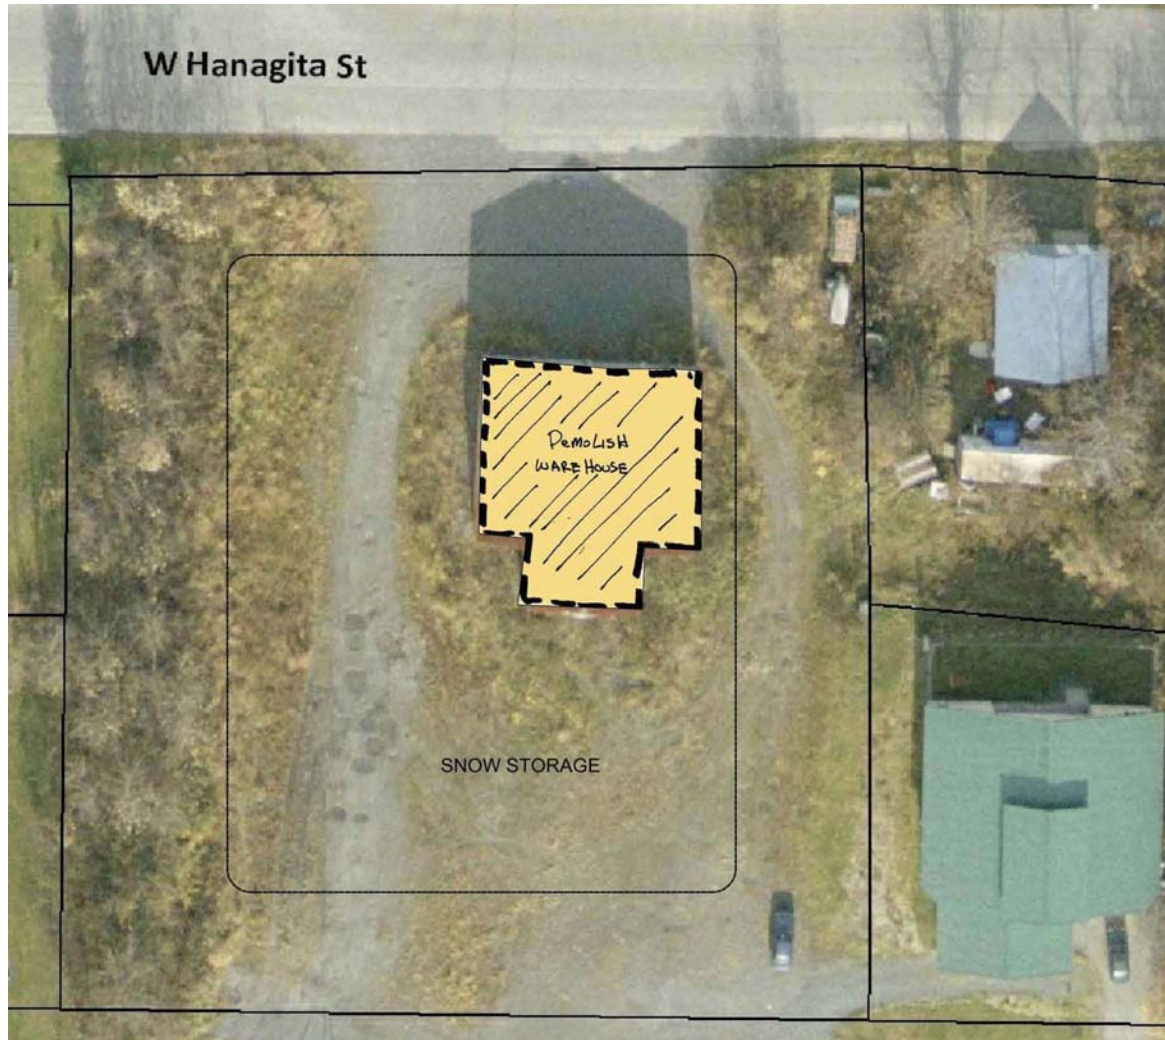
Site Plan – Issue 1A

Project scope includes:

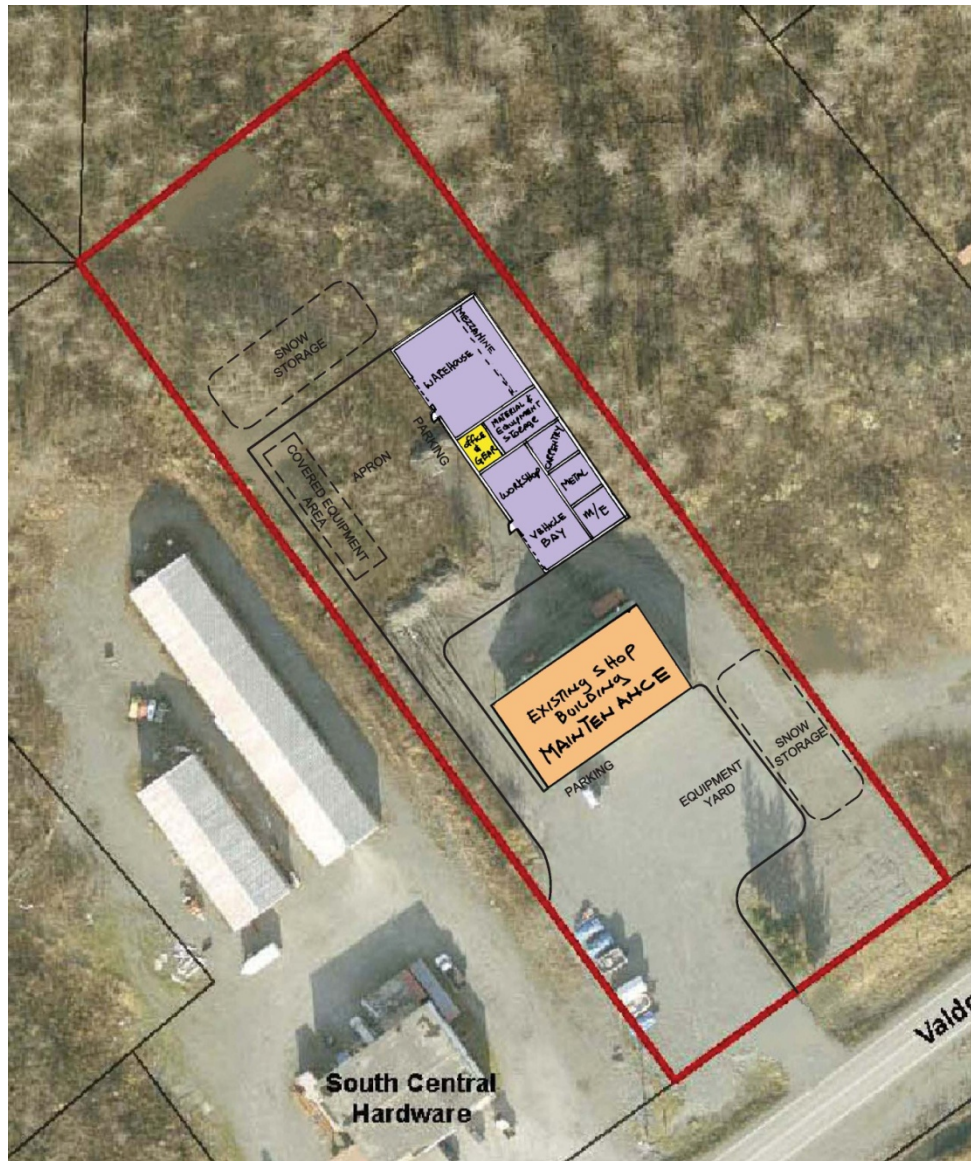
Site & Floor Plan – Issue 1B

Project scope includes:

**Issue 1B (continued)** - also includes the scope identified for the “Shop Building” and Hanagita Warehouse building identified in Issue 1A. This main difference between Issue 1A and 1B is that 1B is utilizing the opportunity of purchasing an existing building.

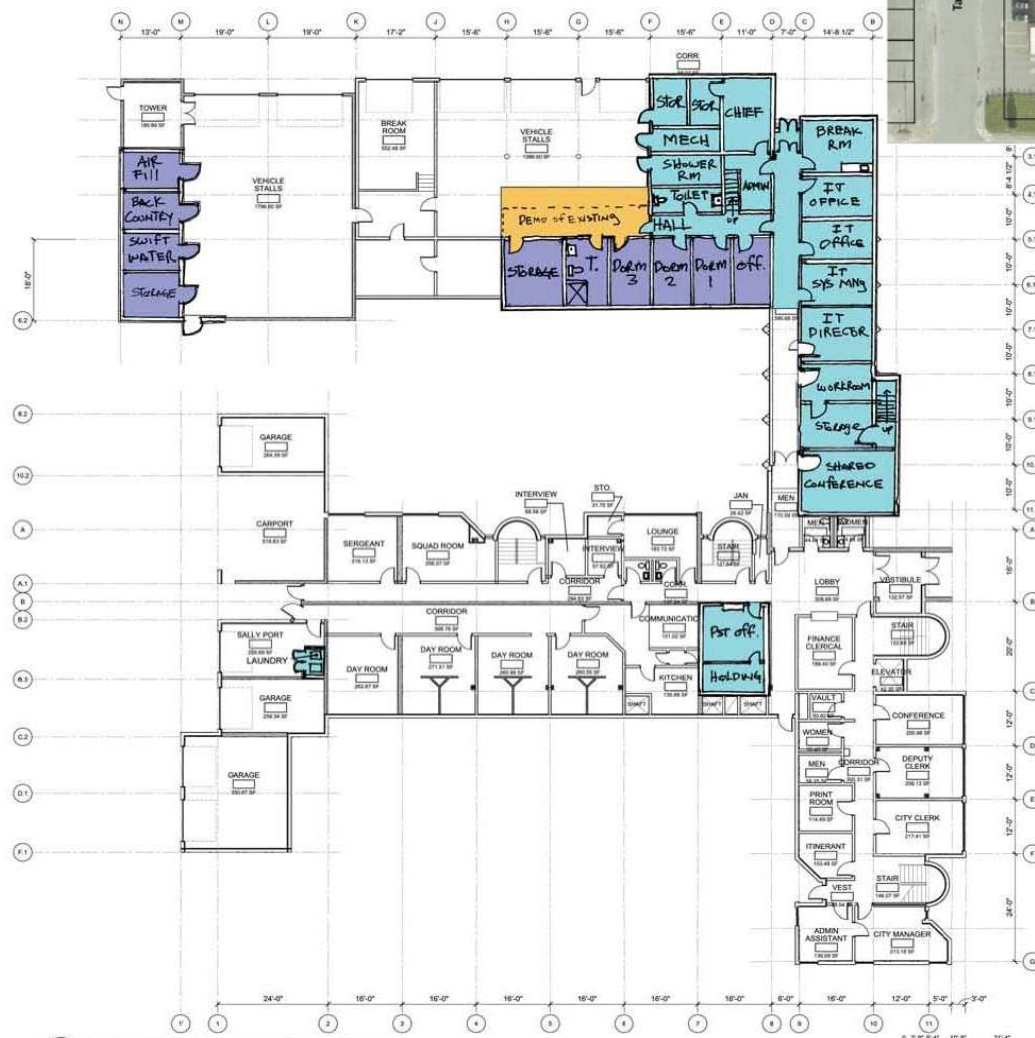
Floor Plan Level 1 – Issue 2A

1. Remodel 1,600 sf of the existing City Hall for IT program and shared conference room.
2. Remodel 1,900 sf of the Fire Station to accommodate Storage and Ancillary needs.
3. Provide addition of 1384 sf for Fire Station Office, Dorm Rooms and Storage needs.
4. Remodel Police area to provide Juvenile Holding area and Laundry Room.
5. Remodel and reallocation of space from Vehicle Stalls will make room for larger apparatus vehicles.
6. Reallocation of space in the remodel of the North part of City Hall will free up space for Administration and Clerk Dept. to accommodate Conference space and Itinerant Office space.
7. Demolish existing Dorm and Toilet for additional Storage area for Fire Dept.
8. Move Office from Training Room making it more dedicated program space.

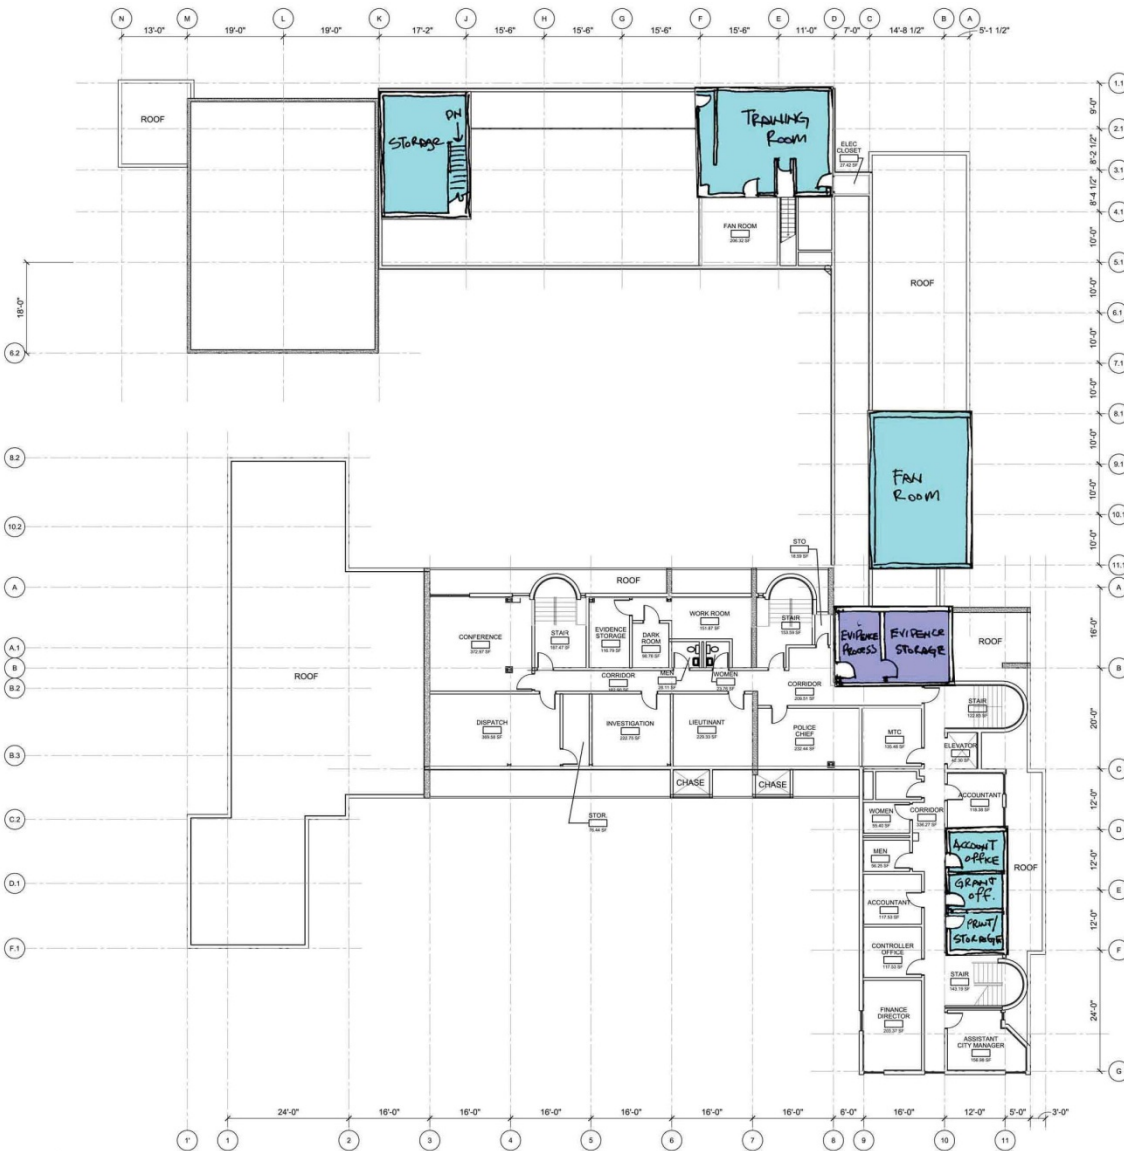
Floor Plan Level 2– Issue 2A

9. Provide new Fan Room in existing space.
10. Provide remodel for Finance to accommodate privacy issues.
11. Infill 2-story volume at Entry Lobby for Evidence Processing and Storage for the Police Dept.

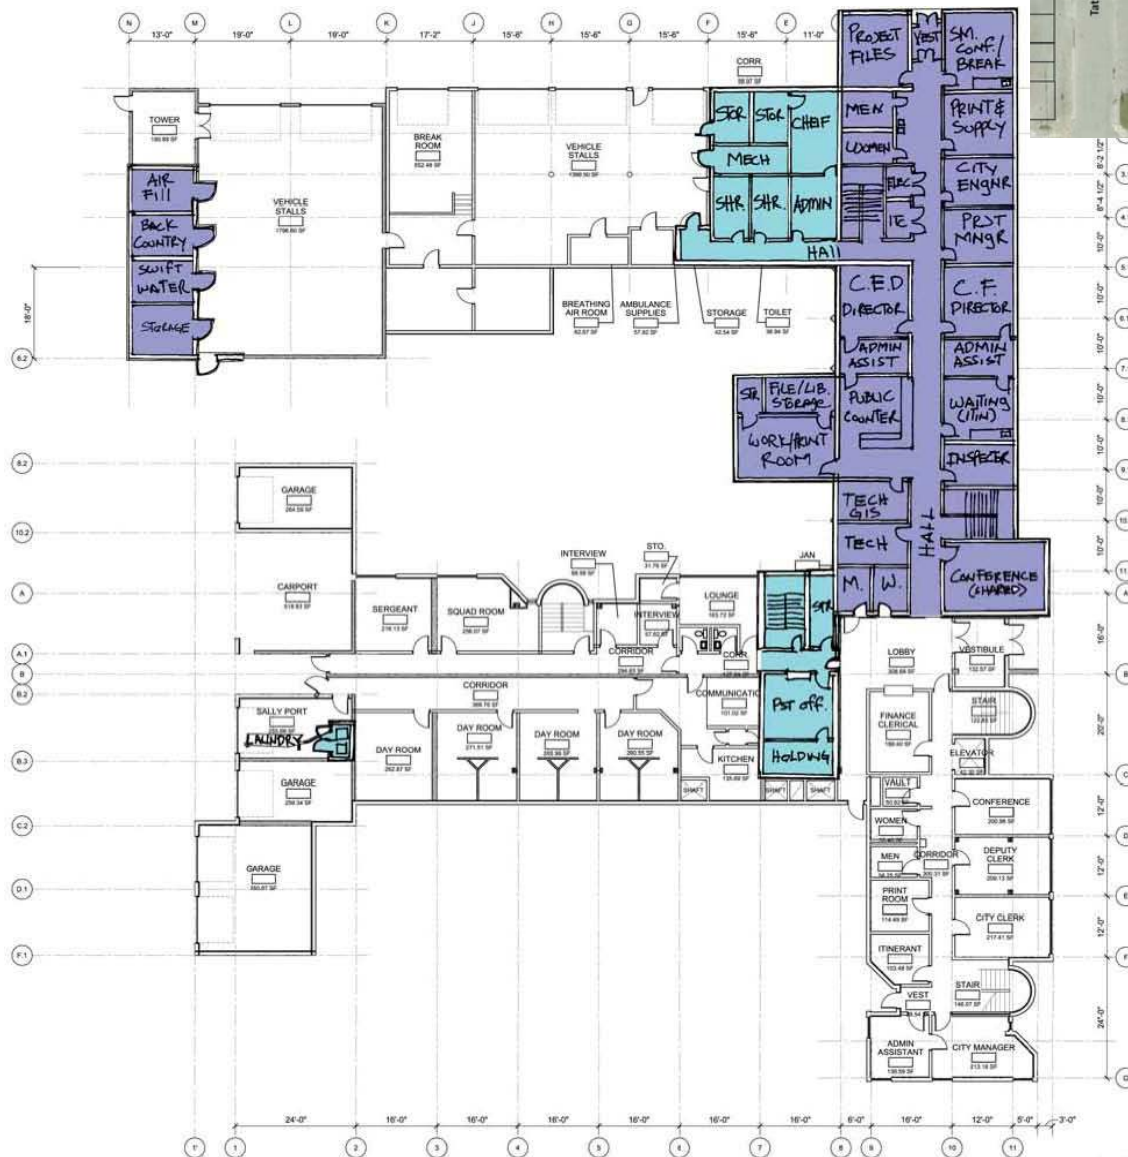
Floor Plan Level 1 – Issue 2B

1. Demolish “Old City Hall” and build a 9,728 sf, two-story addition.
2. Addition includes complete program for Community and Economic Development, Capital Facilities and IT.
3. Remodel Fire Department to allow for large vehicles in the Vehicle Stalls and to optimize Office, Storage and Shower configurations.
4. Remodel Police area for inclusion of Juvenile Holding Area and Laundry facility.
5. Reallocation of space in the remodel of North part of City Hall will free up space for Administration and Clerk Dept. and accommodate Conference and Itinerant Office space.

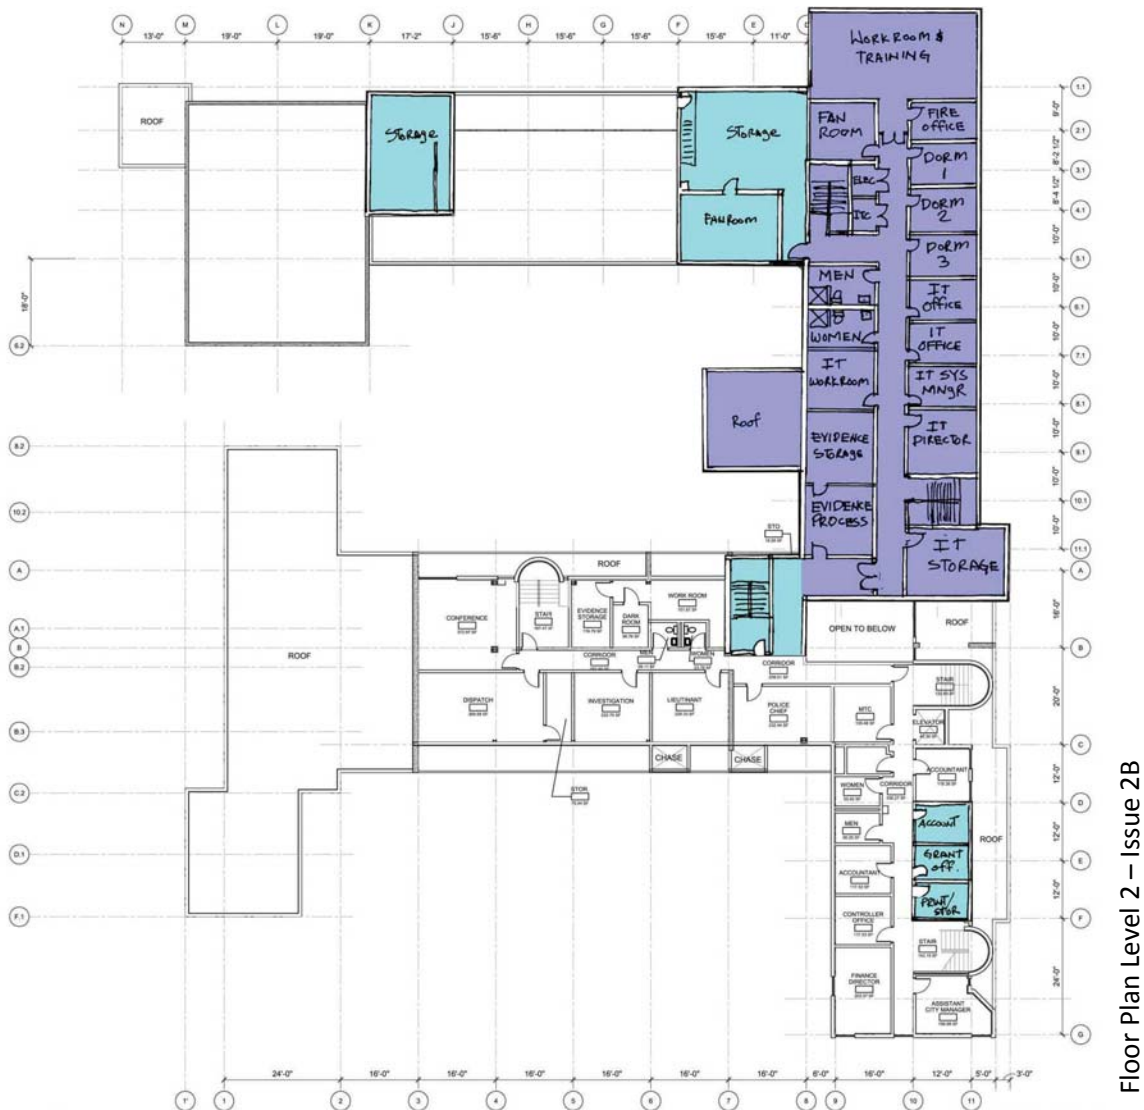
Floor Plan Level 2 – Issue 2B

6. Addition on Level 2 includes IT, Fire and Police Areas.
7. Remodel Fire for Storage Needs.
8. Remodel Finance.

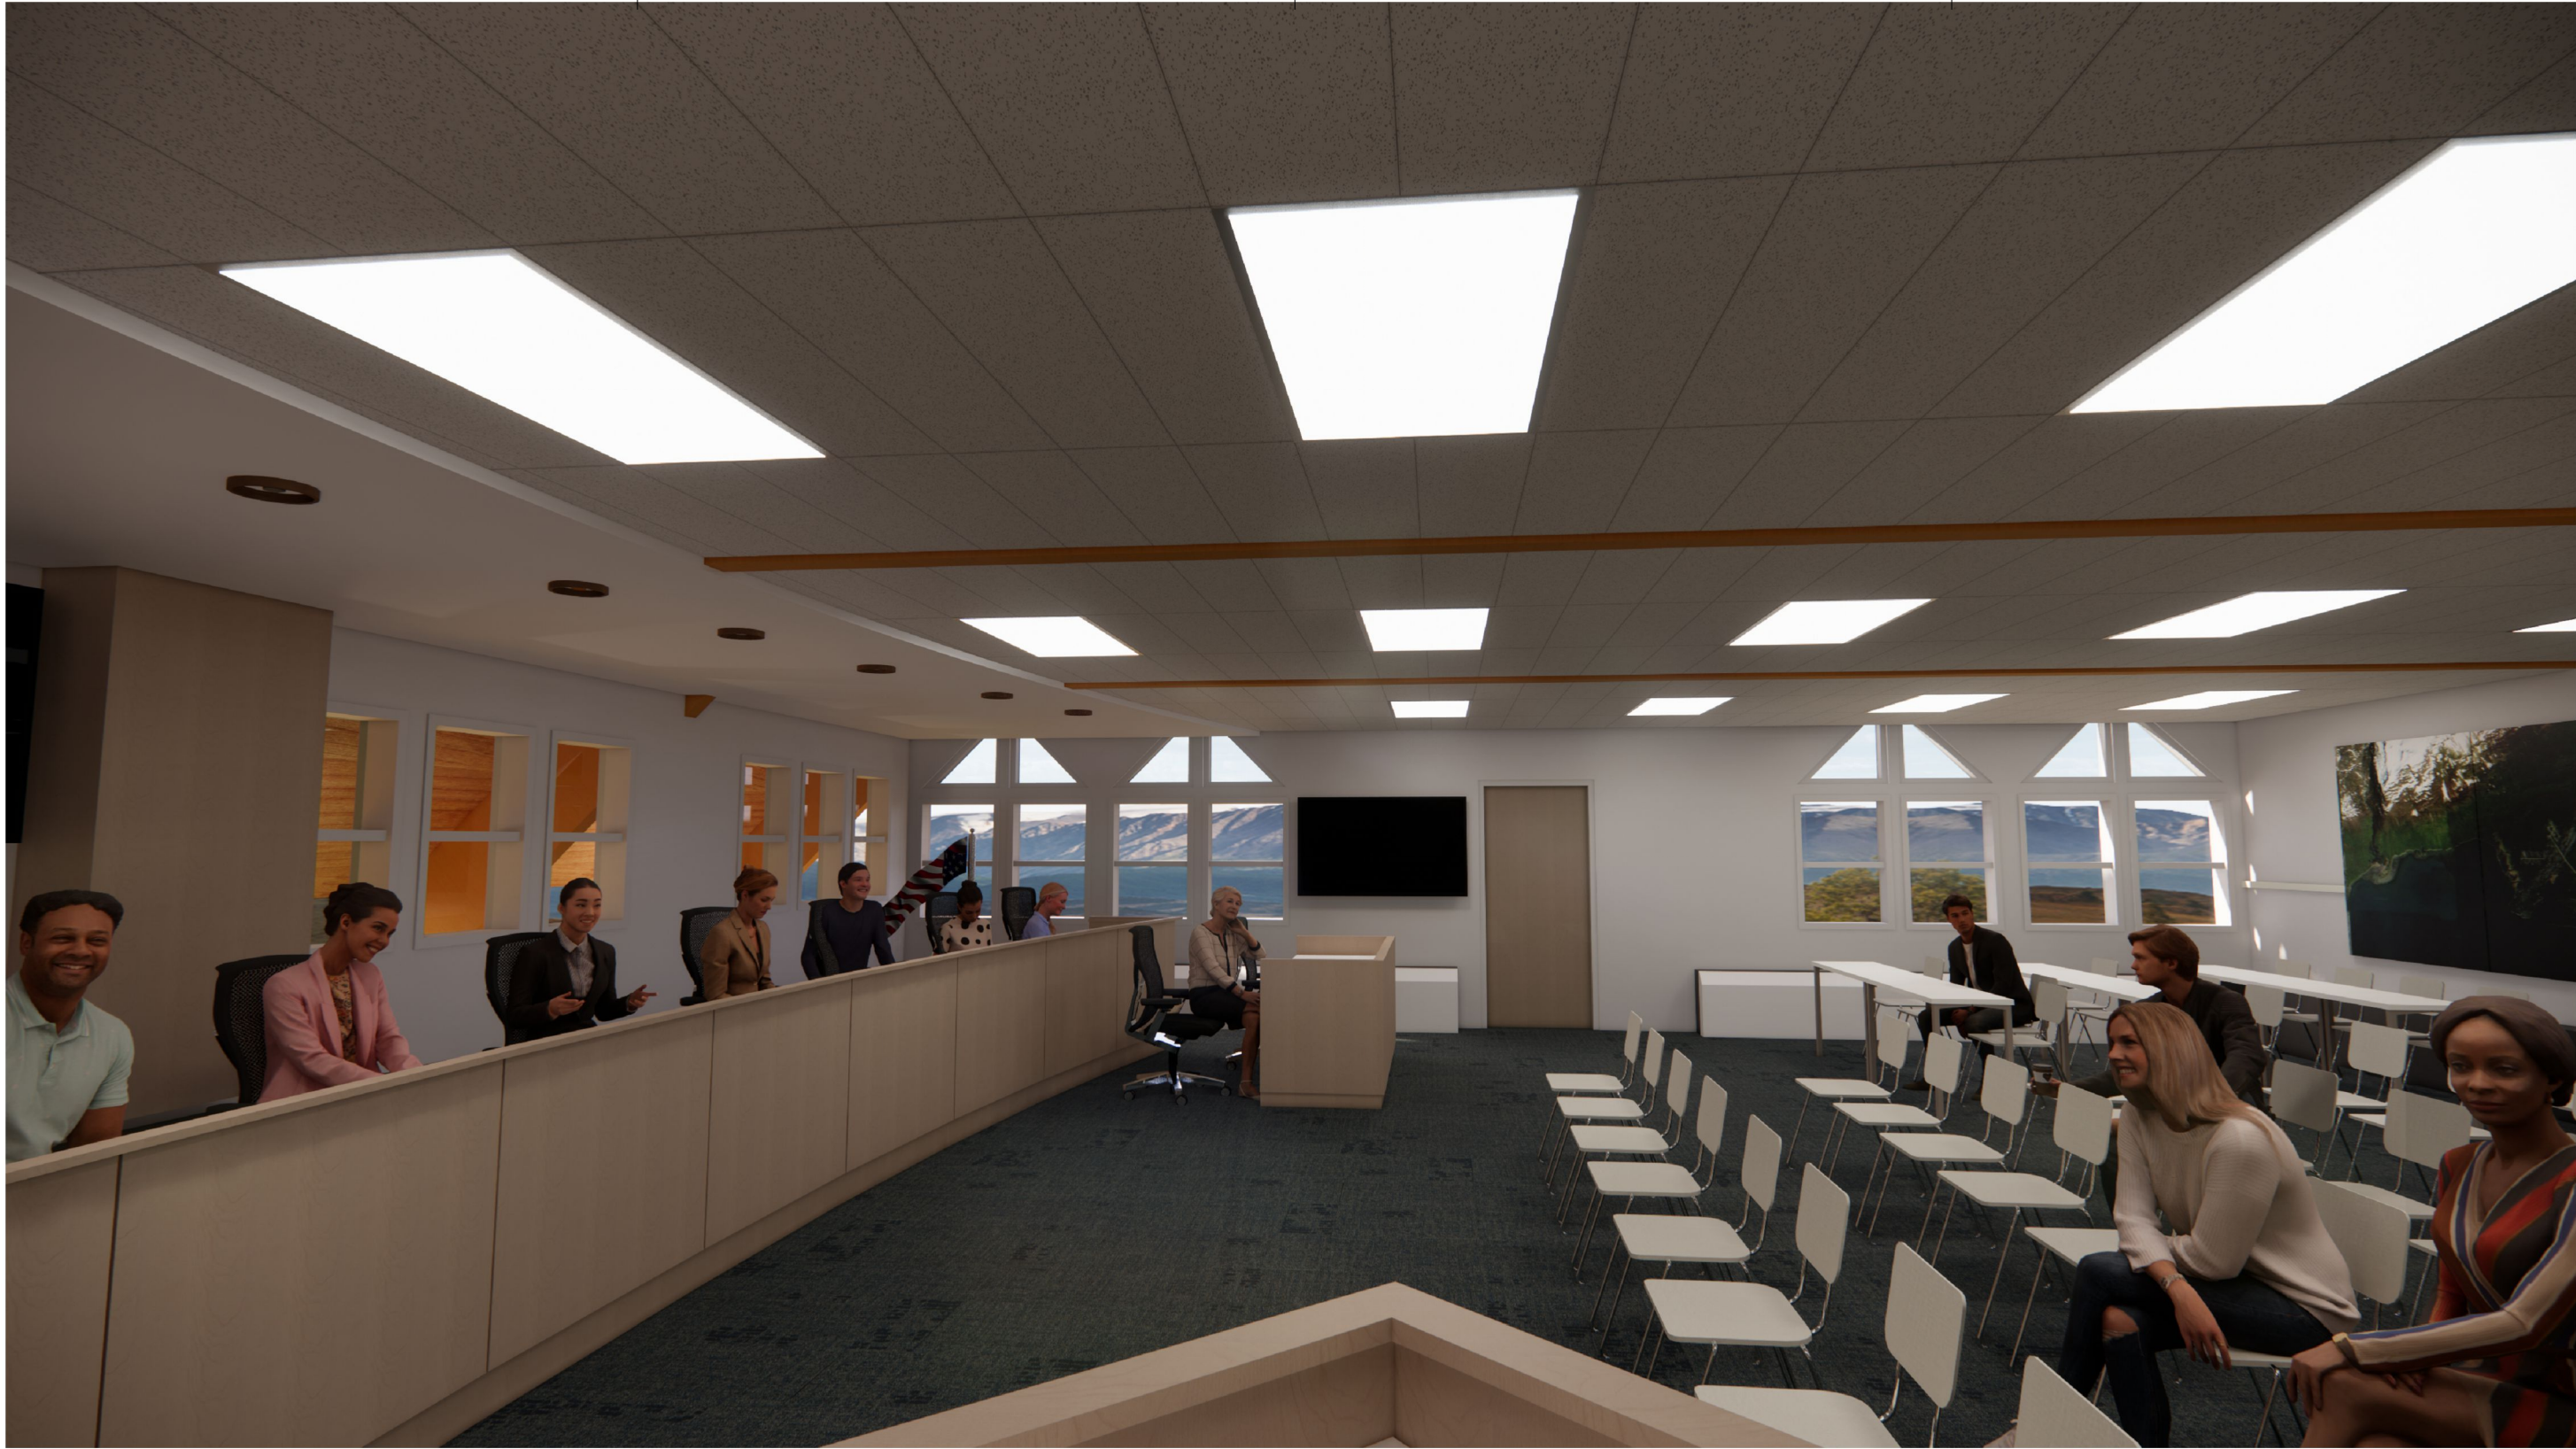
**A9.1**

SHEET CONTENTS  
PERSPECTIVE

- Replacement of the dais which will provide increased distance and workspace between council member seats
- Replacement of damaged and stained carpet
- Creation of a barrier wall between the kitchen and meeting room
- New chairs and dedicated seating for staff
- New podium (ADA compliant)
- New aerial maps (current maps are out of date)
- Replacement of audio system/technical upgrades
