# **City of Valdez – Radio Infrastructure Upgrade Audit**

City of Valdez – Site Visit Audit/Report Performed by: Trevor Empey - Program Manager Patrick Goodyear, P.E. - Sr. Electrical Engineer Dale Browning, P. E. - Sr. Civil/Structural Engineer

**Prepared for** The City of Valdez Nathan Duval – Assistant City Manager

December 17, 2021

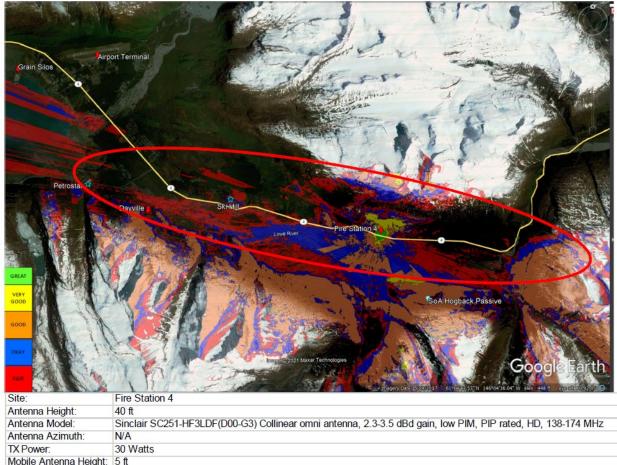
Because of the height (approximately 40 feet), of the existing Fire Station 4 antenna it does not provide sufficient coverage of this corridor. Additionally, there is terrain to the Northwest that blocks the coverage in that direction.

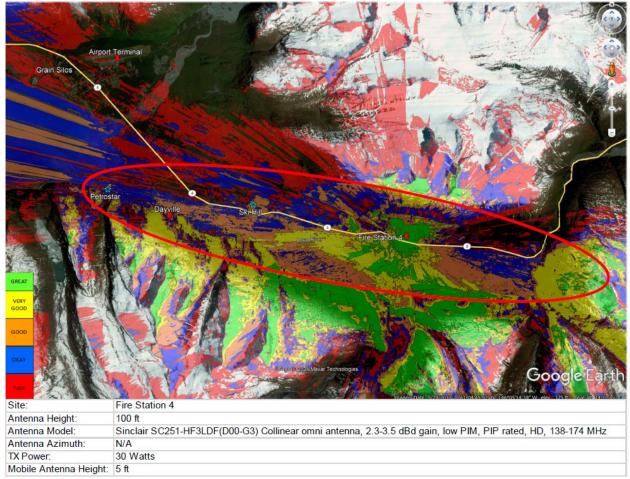
The following shows expected coverage from a Fire Station 4 antenna positioned at height of 100 feet. The coverage is moderately better than the same antenna located at a height of 40 feet.

Due to the radiation pattern of omnidirectional antennas; most of the energy is radiated outward in a donut shape with little downward output. A possible approach to improve coverage is to move the antenna away from the intended area of coverage and place it in the largest part of the "donut."

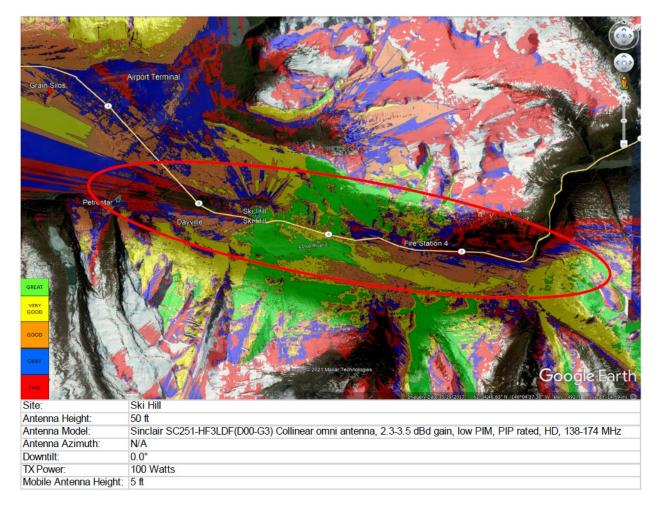
This shows the expected coverage from an omnidirectional antenna located at 50 feet at the top of the Ski Hill location. This is the best coverage of the four scenarios shown in the Exhibits.

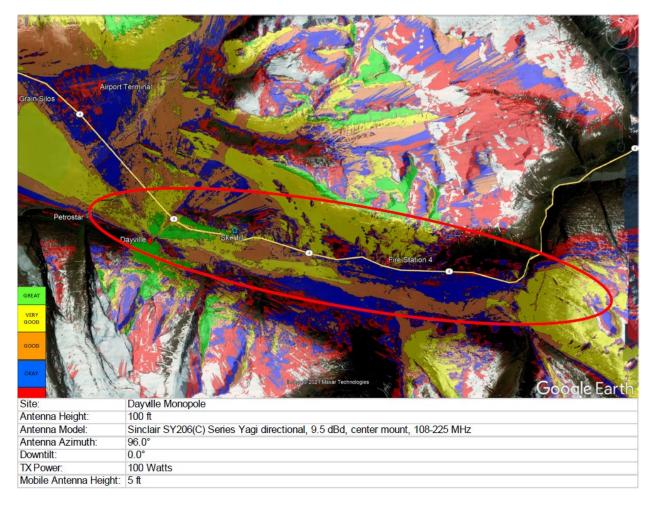
A possible and less expensive option may be to collocate a yagi antenna on the Crown Castle monopole located on the TAPS Access Road just South of Dayville Road<sup>2</sup>. This is a 100 ft monopole that hosts AT&T Wireless. The following shows the expected coverage from a yagi antenna mounted at 100 feet and pointed on an azimuth of 96°. This orientates the antenna through the 10 Mile corridor.

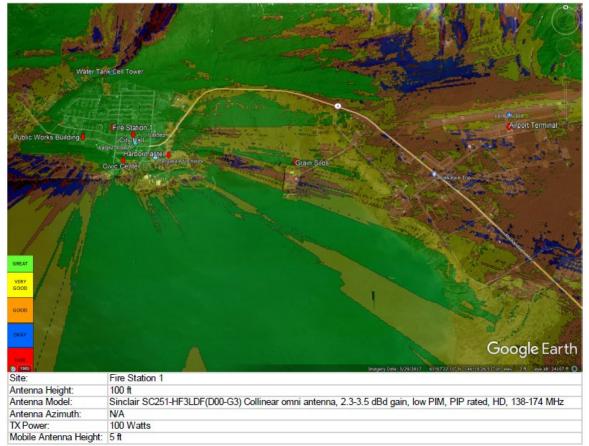
During the site visit constructing a new tower at Fire Station 1 was discussed. This could be to support a redundant or emergency dispatch center should something happen to the one located at City Hall. Below shows the expected coverage of an omnidirectional antenna at 100 ft located at Fire Station 1. It could also be used to start a development of an open based system (non-Motorola) for growth and eventual transition from the existing dispatch system.
