# Gilson Middle School

## CPVC Plastic Piping Failure Analysis

## GEORGE H. GILSON MIDDLE SCHOOL CPVC PIPING FAILURE ANALYSIS

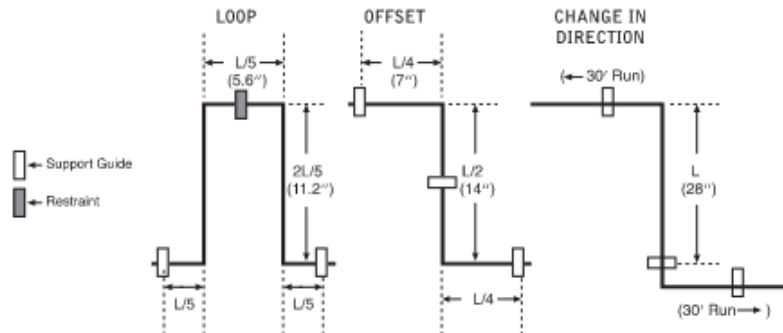
Nominal Dia., In.	20'	40'	60'	80'	100'
1/2	16	23	28	32	36
3/4	19	29	33	38	43
1	22	31	38	44	49
1 1/4	24	34	42	48	54
1 1/2	26	37	45	52	59
2	30	42	52	60	67

Example: Tubing Size = 1/2" Length of run = 60' L = 28" (from table)

Failure to compensate for expansion and contraction caused by temperature change may result in system failure and property damage.
