VALDEZ  
EGAN DRIVE  
ENHANCEMENT  
PROJECT -  
CIP  
# 310-1150-58000

STREETLIGHT  
LAYOUT

E101

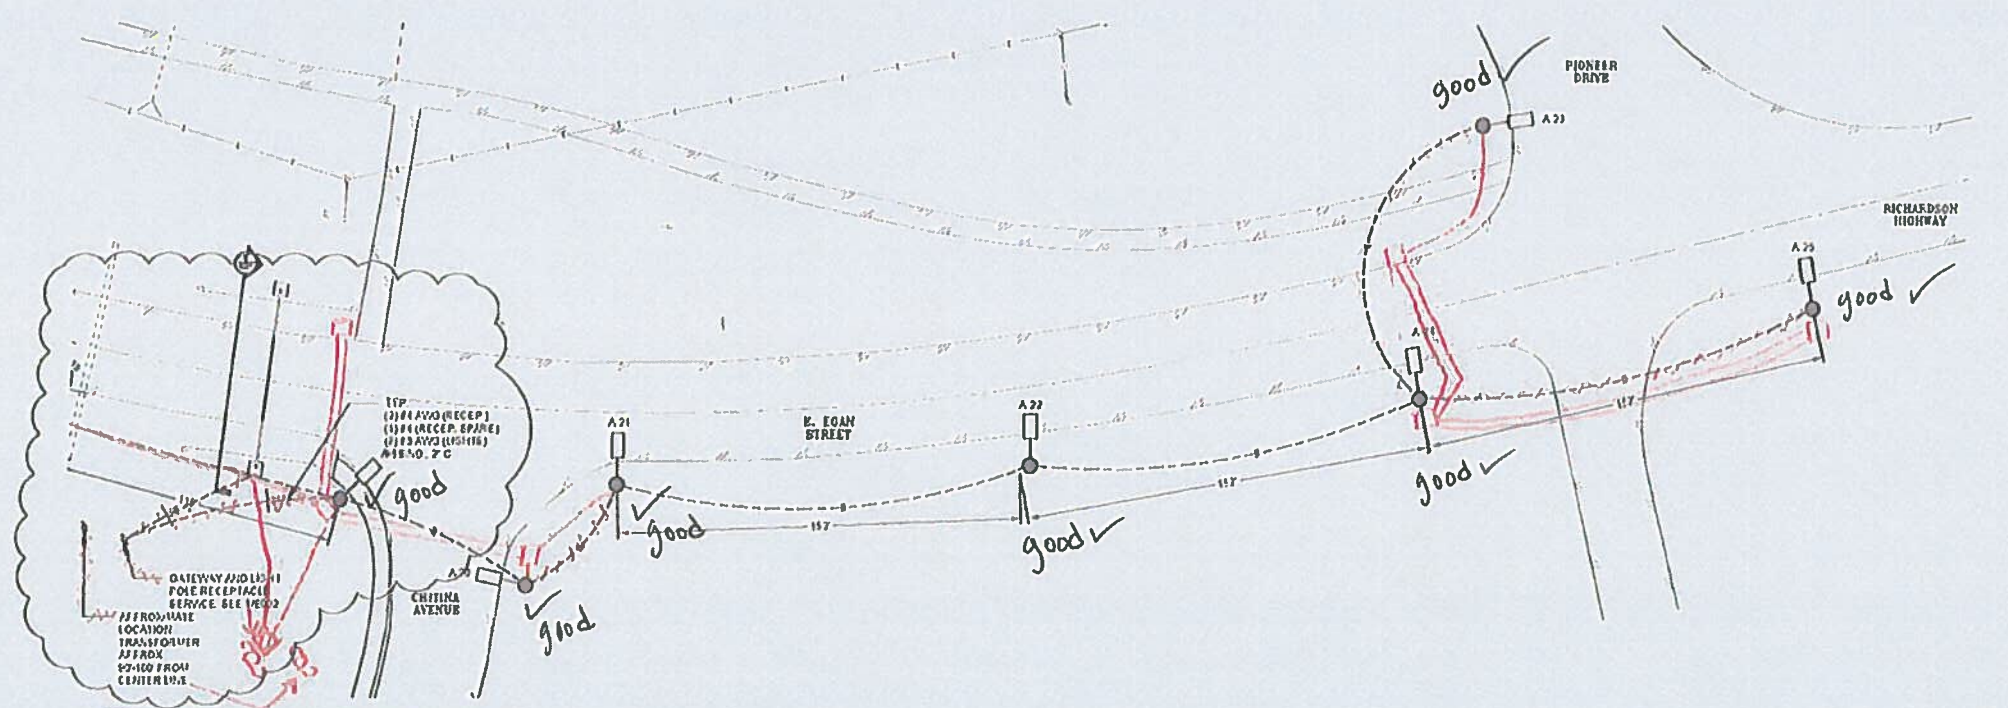
2  
E101

light  
out  
1/26/17

## STREETLIGHT LAYOUT - SECTION E

Light was turned on  
We turned light and  
re-tightened, good
