**Subject: Existing Fire Station 1 Assessment**

Attached find Structural and Mechanical evaluations, completed by consulting engineers, PND Engineers and RSA Engineers respectively, documenting conditions at the existing Fire Station 1 at 212 Chenega Avenue. Additionally, below are a short list of known and reported fire and building code and regulatory deficiencies present at the Station. These findings add to known deficiencies relative to both overall condition and specific occupancies of the structure.

## FEMA-154 Data Collection Form

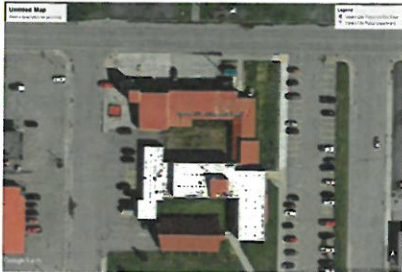
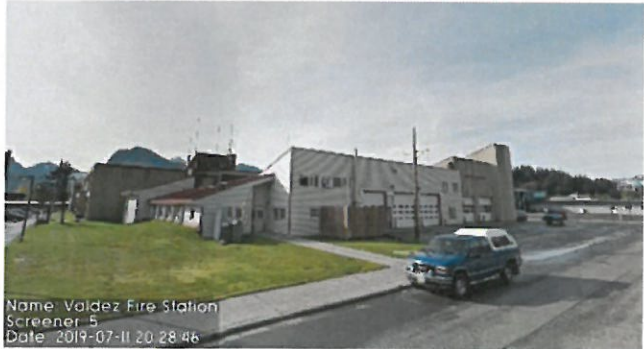
| | <p>Address: 212 Chenega Street<br/> Zip: 99686<br/> Other Identifiers:<br/> No Stories: 2<br/> Year Built: 1966<br/> Screener: 5<br/> Date: None<br/> Total Floor Area (sq. ft.): 10000</p> <p>Building Name: <b>Valdez Fire Station</b><br/> Use: None</p> |
| <p style="font-size: small;">Name: Valdez Fire Station<br/> Screener: 5<br/> Date: 2019-07-11 20:28:46</p> | |
