# VALDEZ GLACIER STREAM EAST ACCESS STUDY

## ACCESS STUDY ASLS 79-116

APRIL 2022

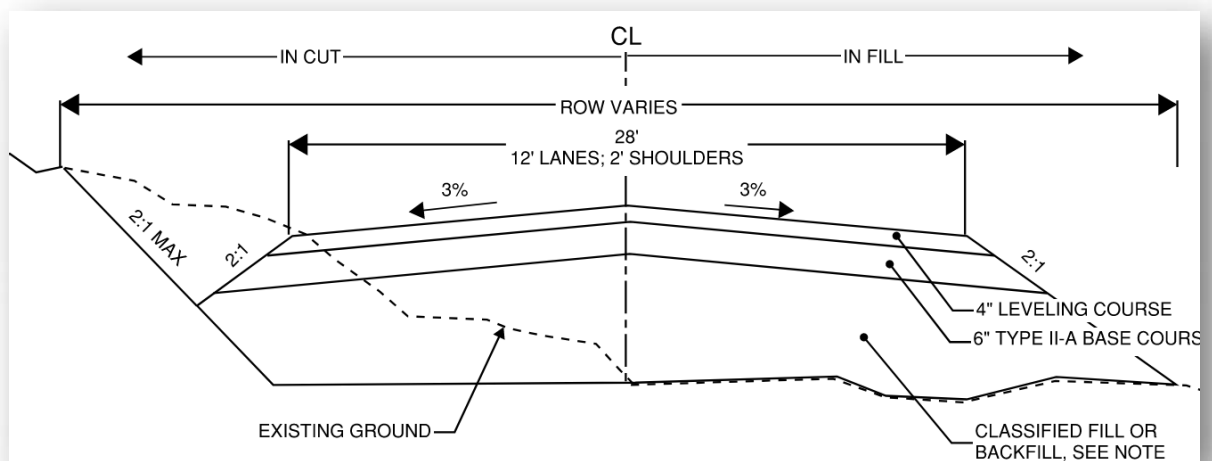
Figure 5 - Design Typical Section for the proposed access roads used for cost estimating

Each alternative is based on the same typical section (see Figure ) to enable direct comparisons between alternatives. Basic standards include:

- 12-foot lanes
- 2-foot shoulders
- 2-foot-tall embankment prism
- Gravel surfacing
- 4" leveling course
- 6" type II-a base course
- 60' wide, cleared right-of-way

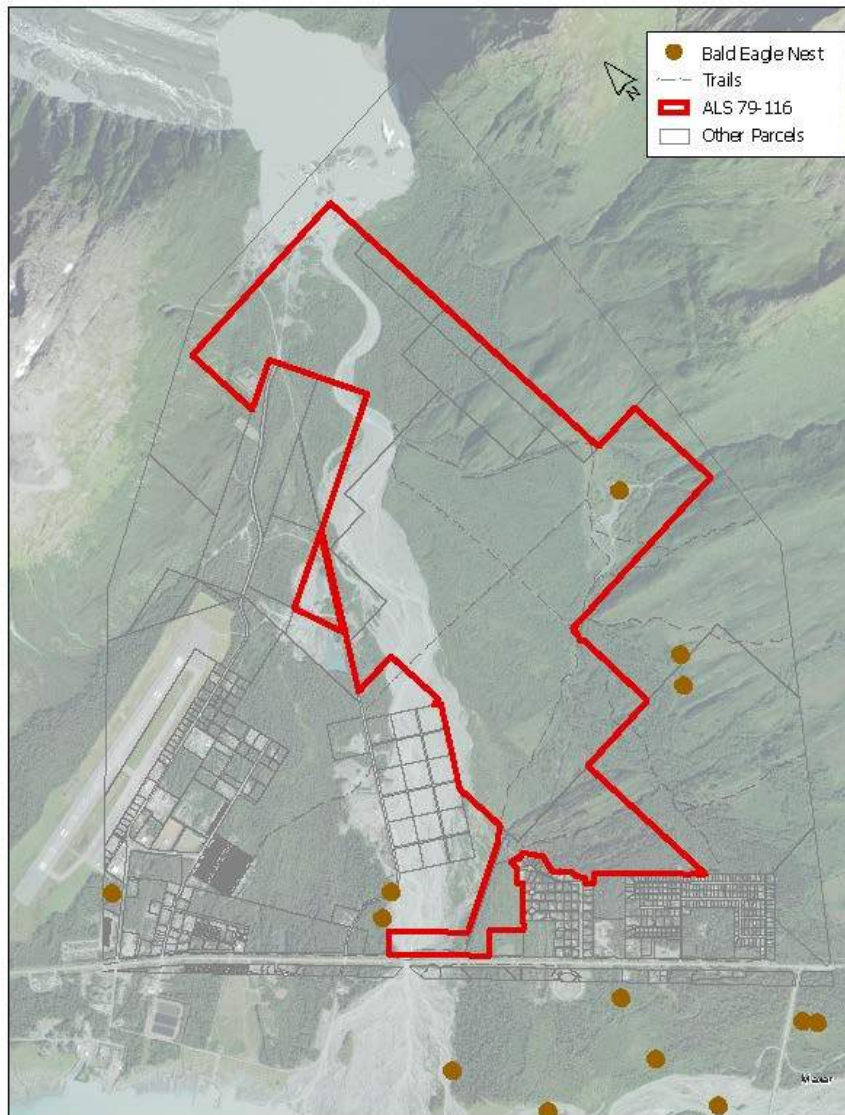
Figure 5 - Figure 6 – Study Area with Eagle Nests Indicated  
ammunition may have resulted in lead contamination in the vicinity.

The property includes flood zones of Valdez Glacier Stream (zone AE), Corbin Creek (zone A) and Slater Creek (zone A). Valdez Glacier Stream is braided, and channels can rapidly migrate location. Valdez Glacier Ice Dam Lake, upstream of Valdez Glacier Stream, is susceptible to glacial outbursts which subsequently lead to downstream flood events (USACE, 2021).

Other environmental considerations that will affect development approaches include the presence of Bald Eagle nests on the property, which are federally protected. There are three bald eagle nests along the east side of the property and two bald eagle nests at the southeast corner.

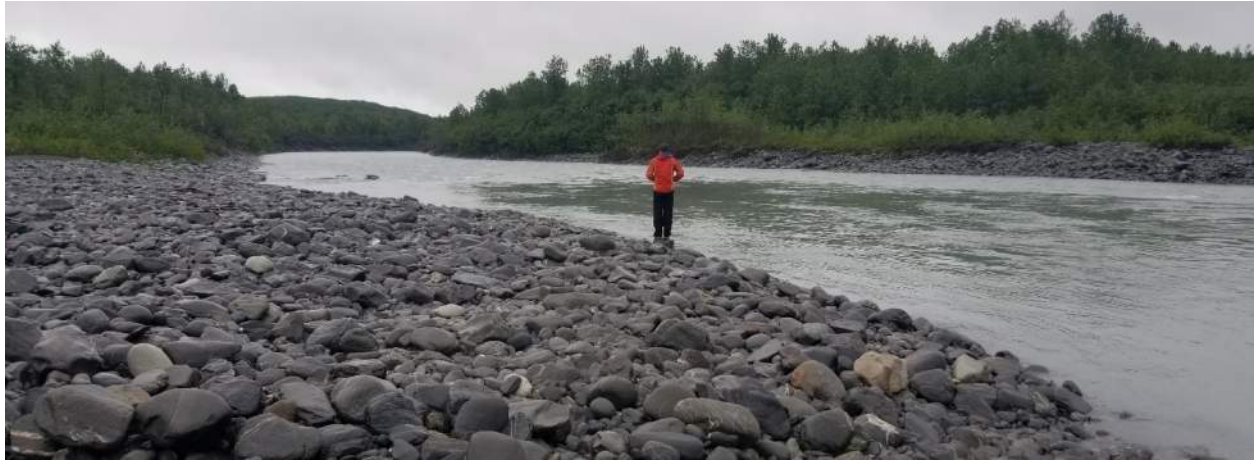
Figure 8 - Downstream view of Valdez Glacier Stream looking towards a potential bridge location

Valdez Glacier Stream is a meandering waterway that will likely change its watercourse in the future. Regardless of a bridge location, the bridge will require maintenance and monitoring to ensure changes in the stream do not undermine or erode any structural supports.

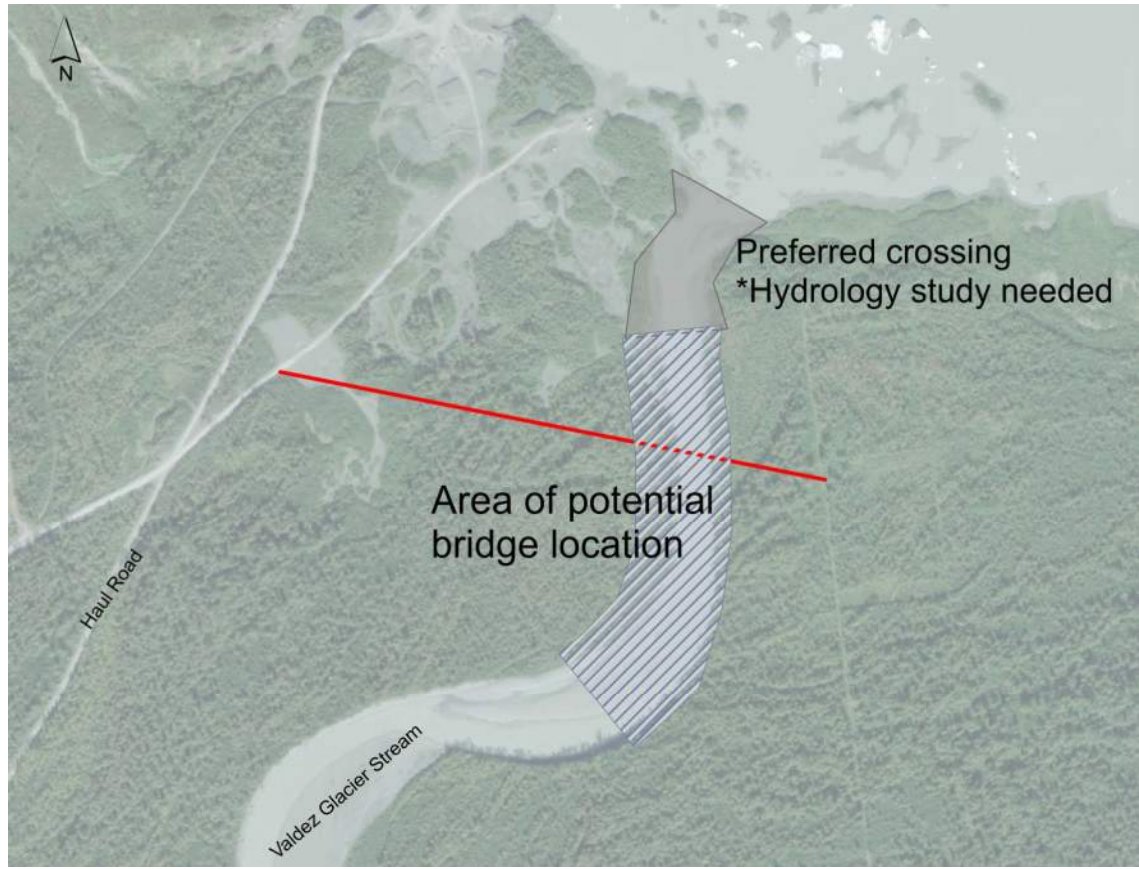
Figure 9 - Alternative 1 – North Bridge Access

**Description:** The north access alternative extends east from Haul Road and crosses Valdez Glacier Stream approximately 1/4-mile downstream from Valdez Glacier Lake. This alternative is the shortest, but it includes the largest stream crossing which requires a 200-foot-long bridge to cross Valdez Glacier Stream. The road terminates at the northwest corner of parcel A-1 where an easement extends south along the west side of the parcel.

There are two options for a bridge over Valdez Glacier Stream:

- Single lane bridge, 18 feet wide
- Two-lane bridge, 32 feet wide

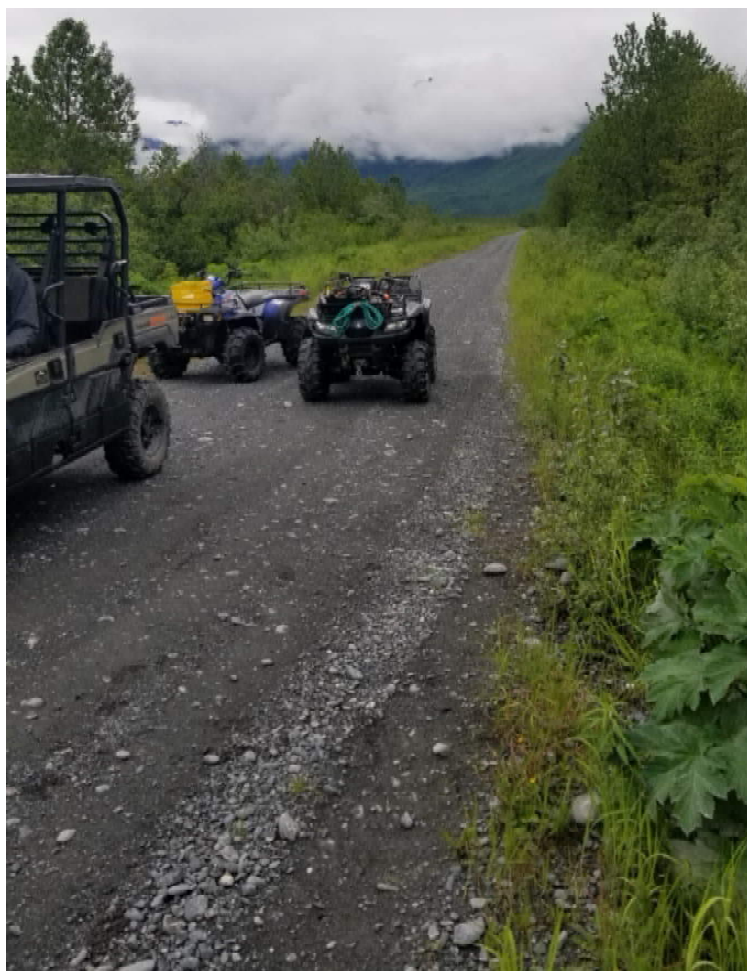
Figure 10 - Looking northeast along the levee

This alternative takes advantage of the levee as a base for road construction, which reduces overall construction costs. It may also help snow removal as the prevailing winds travel down Valdez Glacier Stream and may blow the elevated levee/road surface clear.

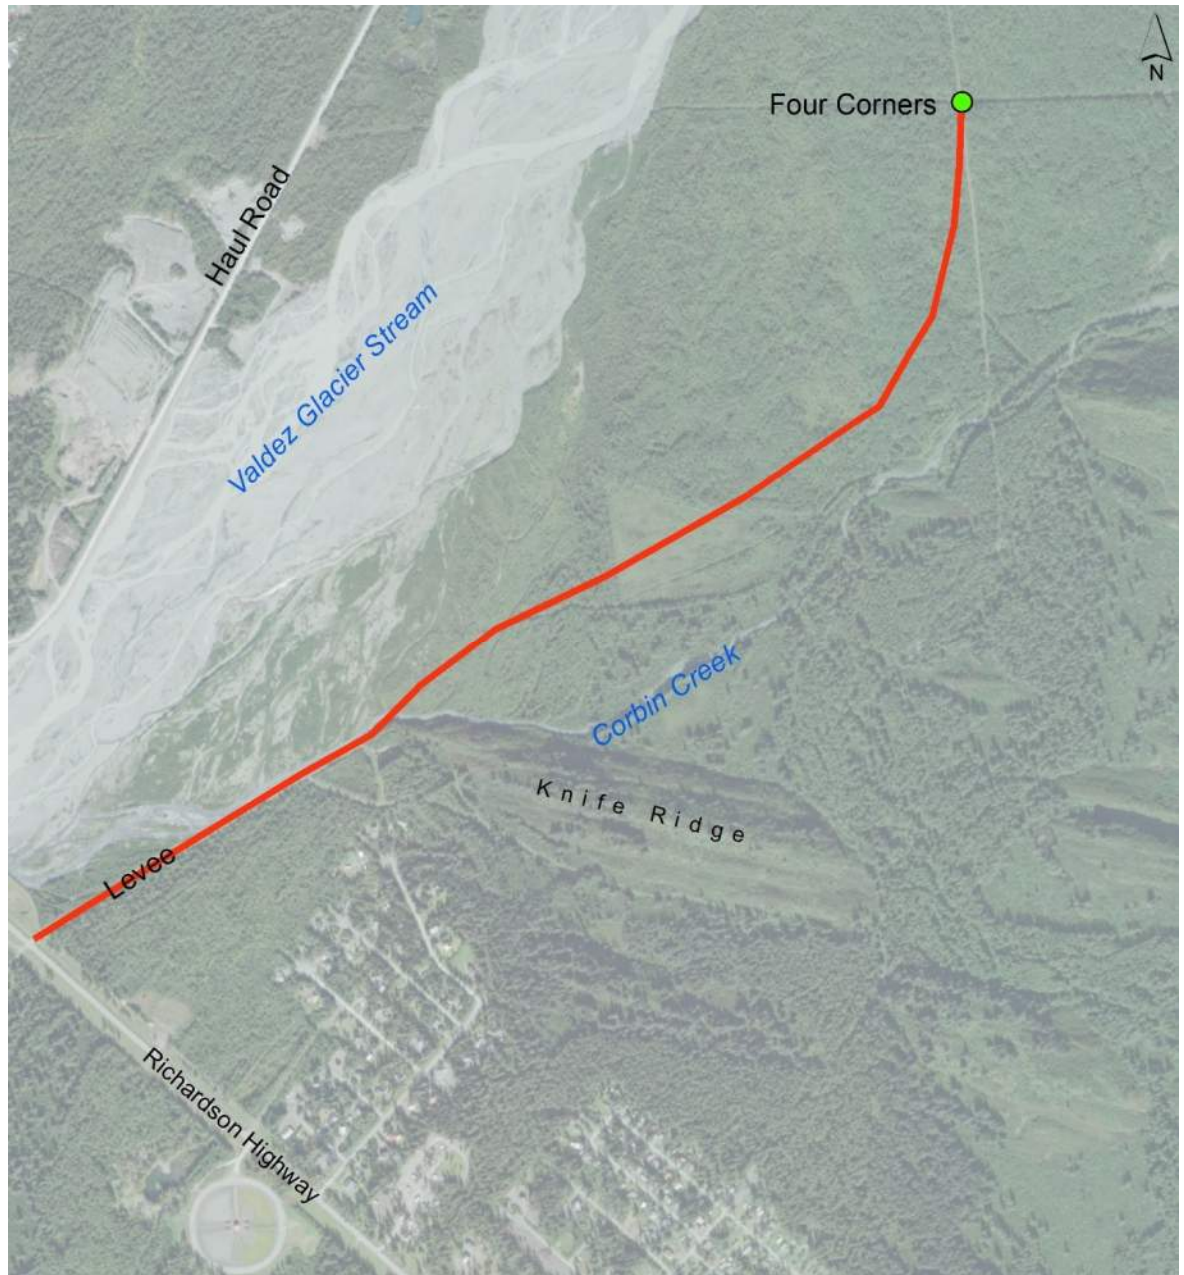
Figure 11 - Alternative 2A - Levee

**Description:** The levee access alternative begins at the Richardson Highway where the Valdez Glacier Stream levee meets the road and continues northeast along the top of the levee. A series of culverts across Corbin Creek at the north end of the levee bring the road into the flats east of Valdez Glacier Stream. The road continues northeast towards Four Corners.

This alternative crosses Zone A and Zone AE floodplains and is partially below the Base Flood Elevation. There is risk of erosion from Valdez Glacier Stream, particularly near the mouth of Corbin Creek.

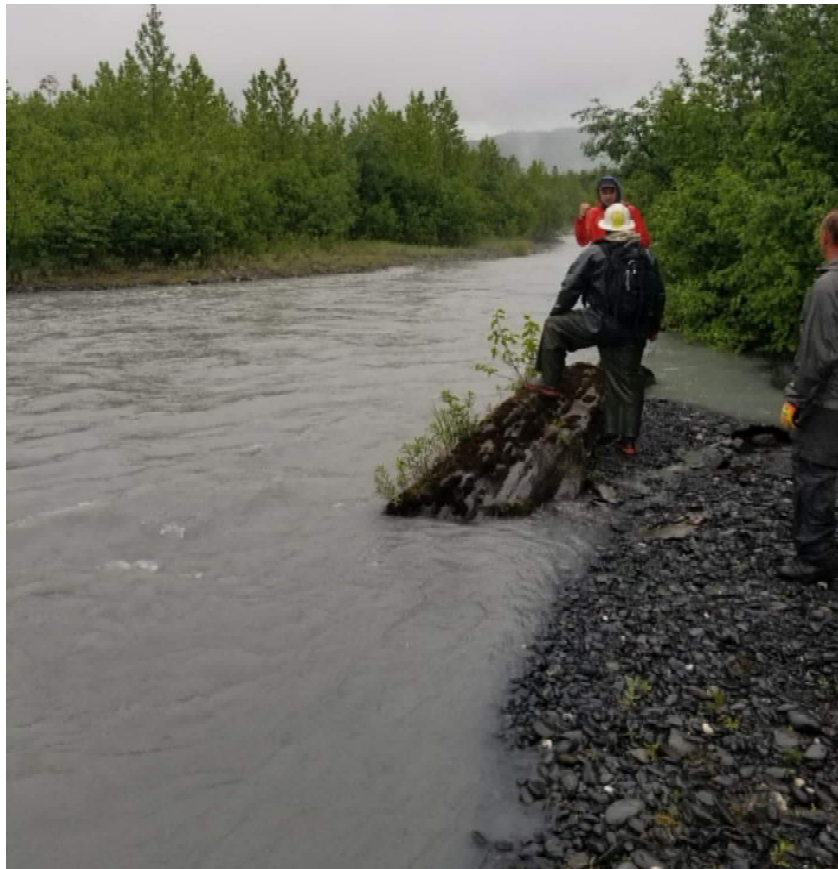
Figure 12 - Potential Corbin Creek crossing location for alternatives 2A and 2B; view is to the northeast looking upstream

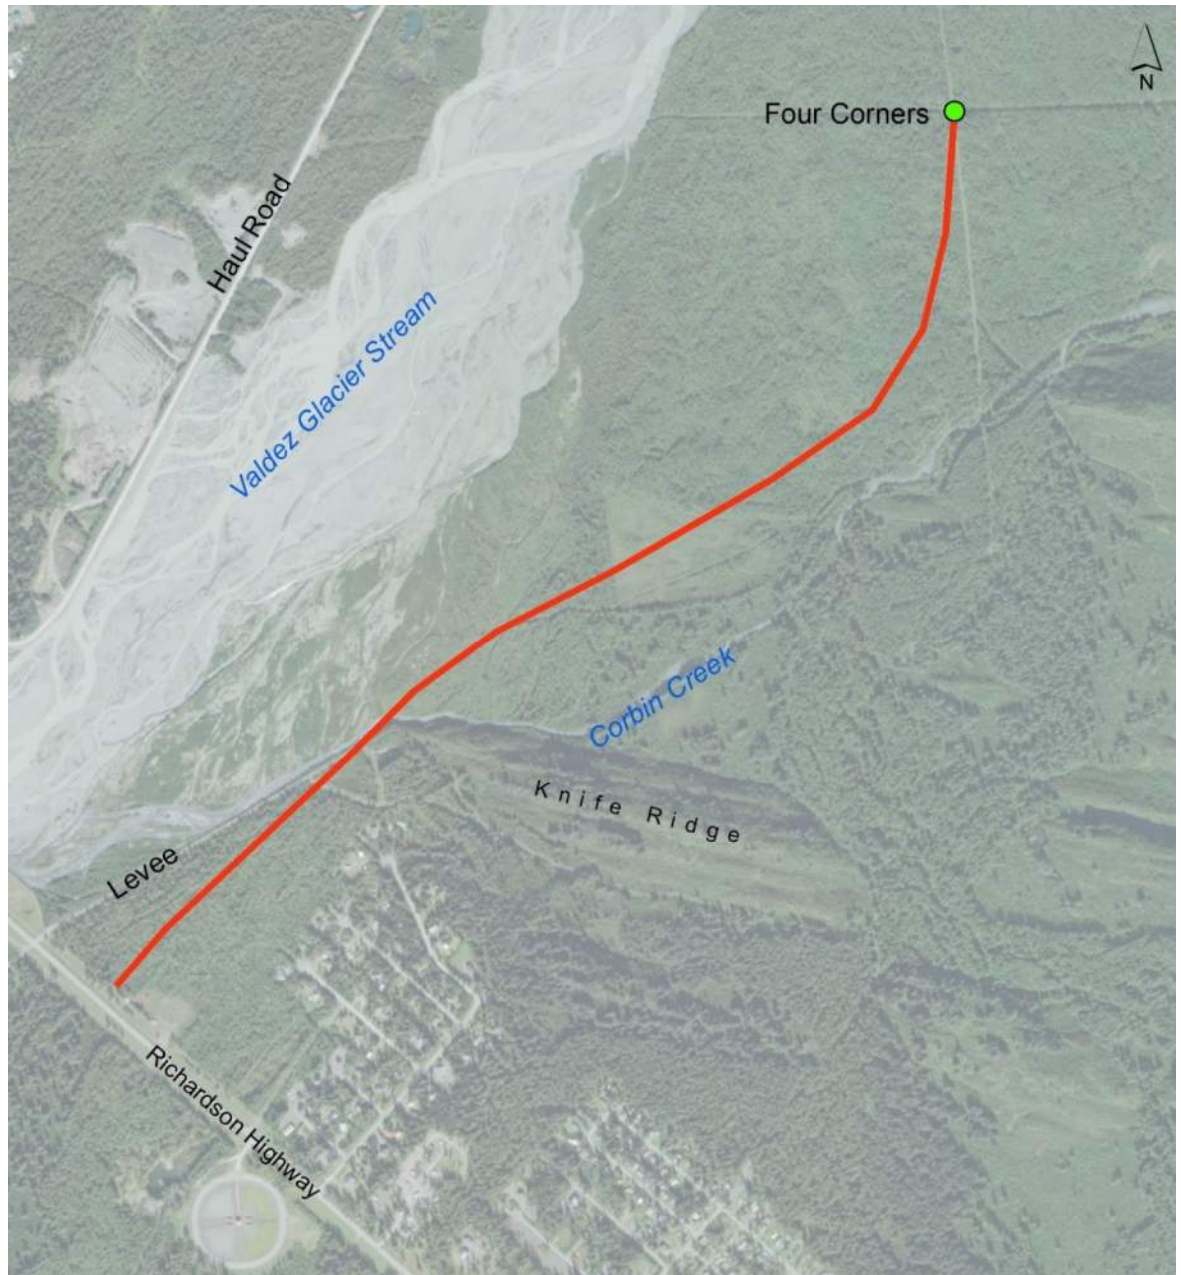
Figure 13 - Alternative 2B – Richardson Highway

This alternative crosses Zones A and AE floodplains and is partially below the Base Flood Elevation. There is a risk of erosion from Valdez Glacier Stream, particularly near the mouth of Corbin Creek.

This alternative comes within 300 feet of private residential property in the Corbin Creek Subdivision. A vegetation buffer between the road and the subdivision would remain.

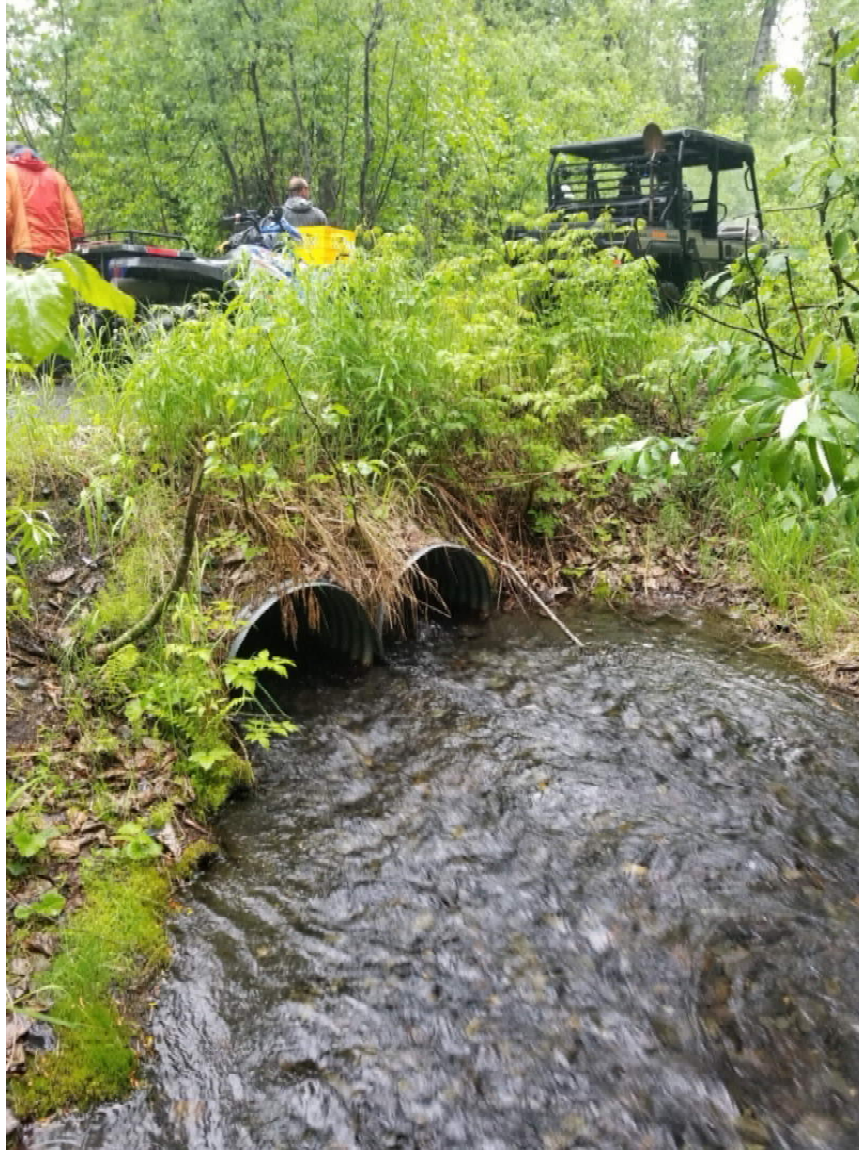
Figure 14 – Old Corbin Creek crossing east of Knife Ridge

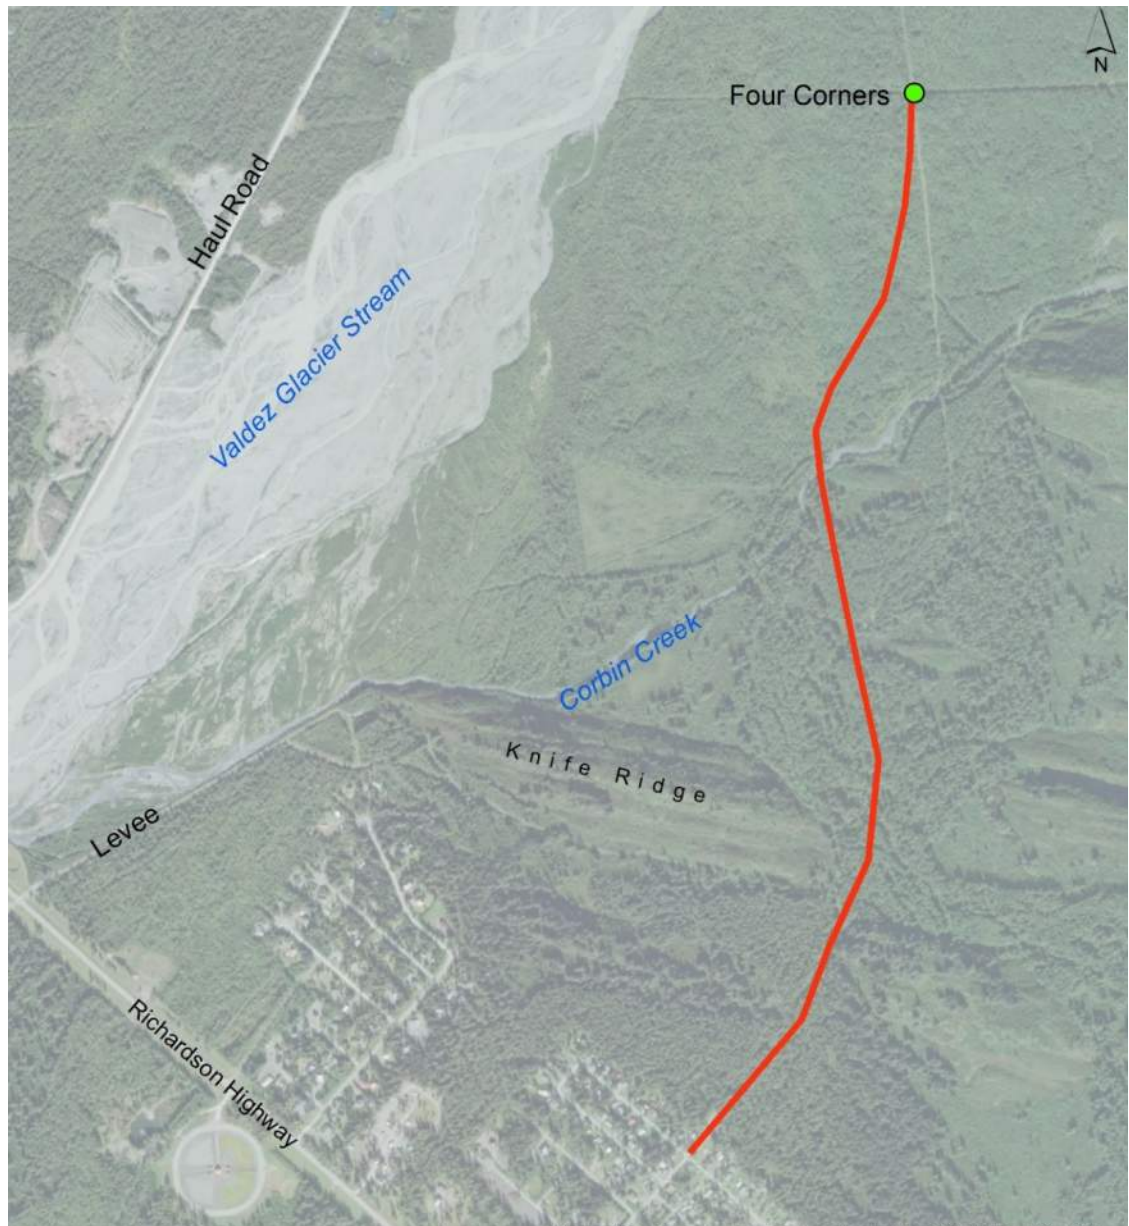
Figure 15 - Alternative 3 - Robe River Subdivision

**Description:** This alternative begins at the north end of Dylen Drive in the Robe River Subdivision. The route closely follows the proposed roadway in the Corbin Creek Subdivision master plan by extending north/northeast from the subdivision and passes around the east end of Knife Ridge before turning north. The route crosses Corbin Creek and connects to the same route as proposed under alternatives 2A and 2B before ending at Four Corners.

This route crosses through Floodplain Zone A at the proposed Corbin Creek crossing. This route crosses the fewest flood-prone areas of all alternatives.

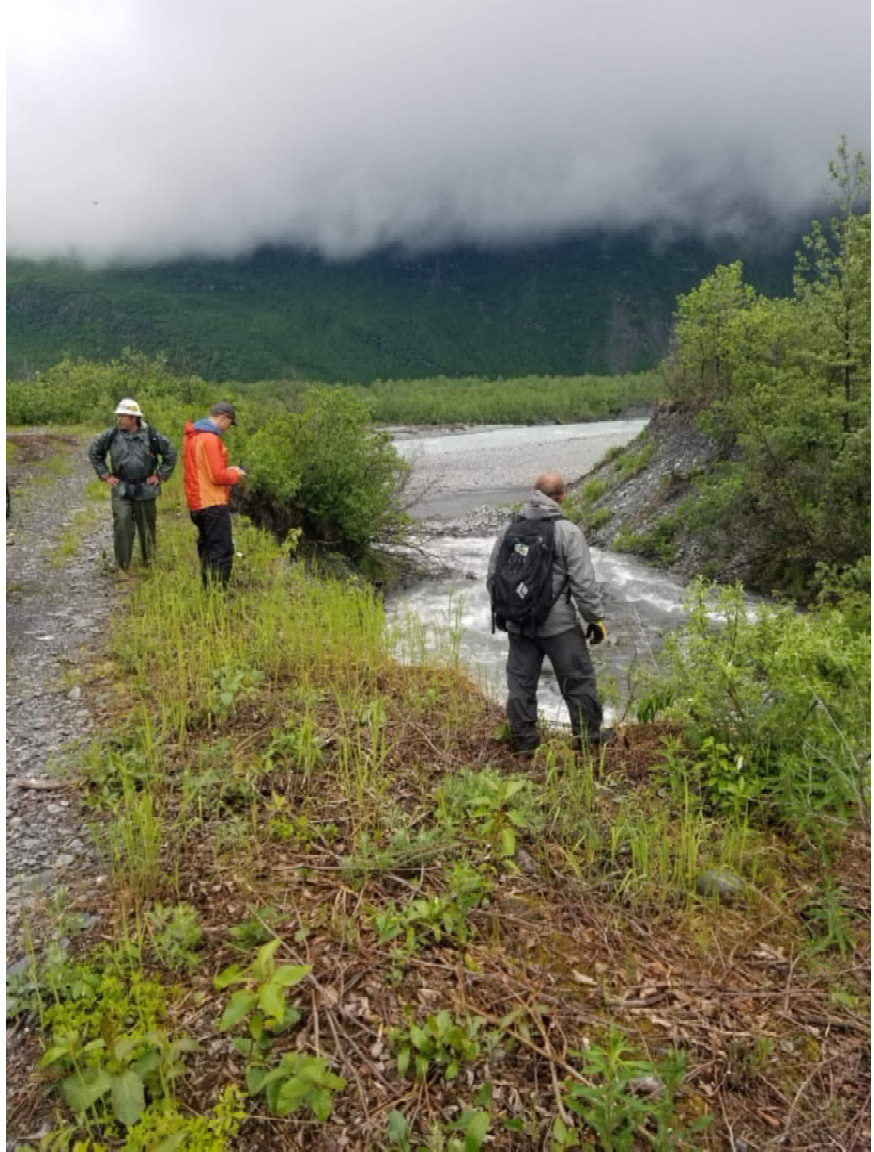
Figure 16 – Slater Creek is a significant drainage to cross; view looking west towards the confluence with Valdez Glacier Stream

Valdez Glacier Stream is eroding the east bank of the channel considerably and is creeping towards Slater Creek. This will likely present a significant erosion issue for the proposed route and would likely require a dike for protection. More detailed surveying, hydrology, and geotechnical analyses are needed.

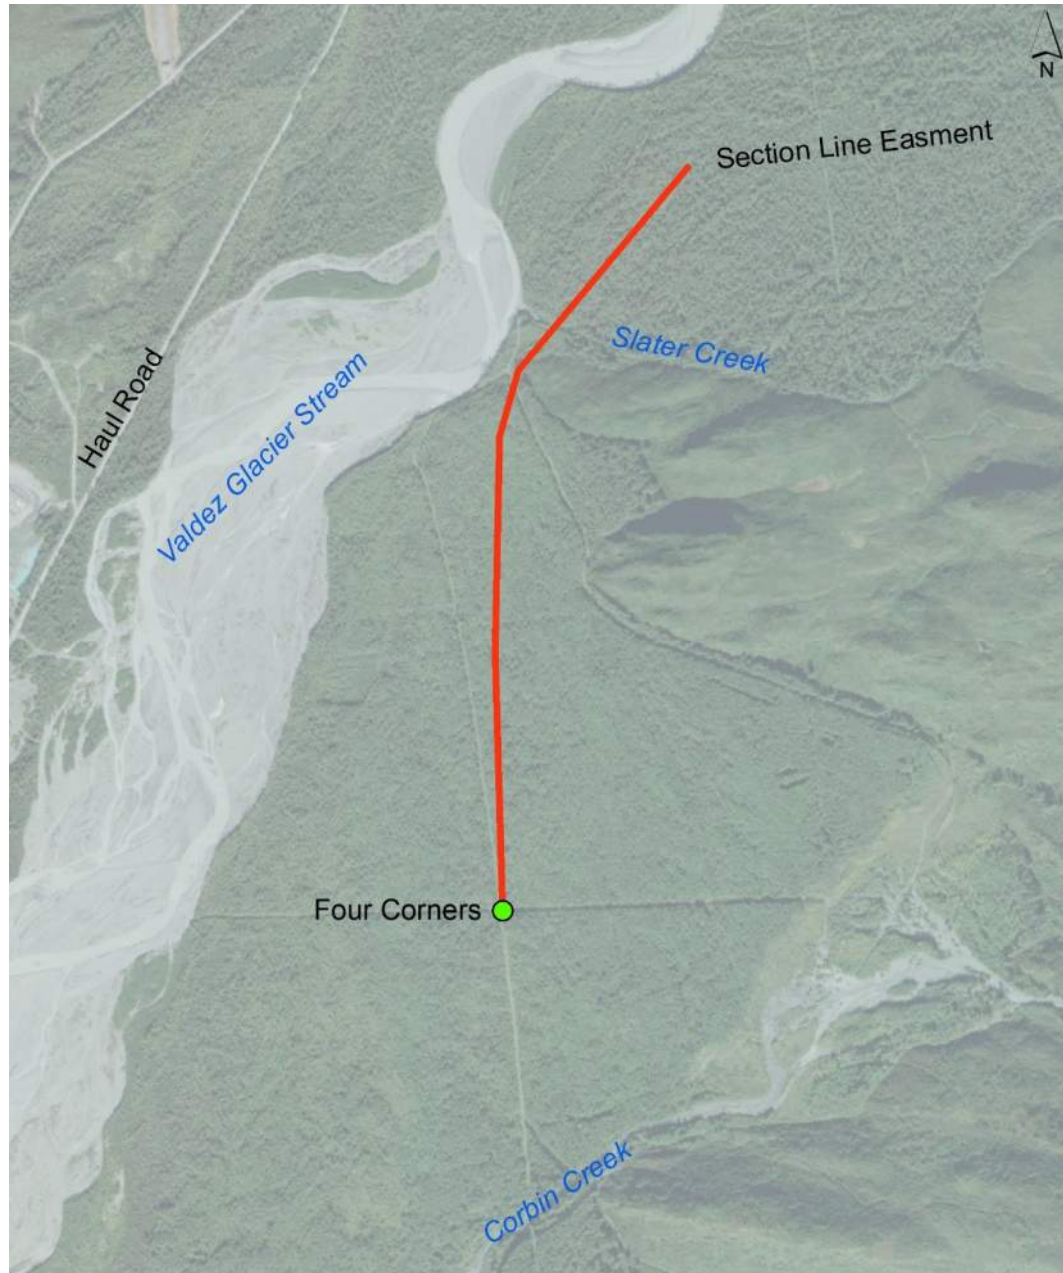
Figure 17 – Additive Alternative – Four Corners North

The route crosses flat terrain from Four Corners and extends around the west end of a large ridge before turning northeast. Slater Creek is the only significant stream crossing. However, Slater Creek is deeply incised into the terrain near the proposed crossing and would require a hydrology study to determine the best crossing location and size of crossing structure (bridge v. culverts).

The proposed route crosses Zone A flood potential along Slater Creek.

**Northern extension (Figure 17) estimated construction cost:** \$1,031,000
