**CHANGE ORDER**  
**CITY OF VALDEZ**

**DATE ISSUED:** 1/31/17  
**CHANGE ORDER NO.** 009  
**COST CODE NO.** 310-1150-58000  
310-1140-58000  
**PROJECT NO.** 15-310-1150, -1140  
**CONTRACT NO.** 1234

**PROJECT: 2016 City Streets (Egan and Pioneer)**

Change Order No. 9  
 Prosser Dagg Construction Company  
 Project: 2016 City Streets (Egan and Pioneer)  
 January 31, 2017

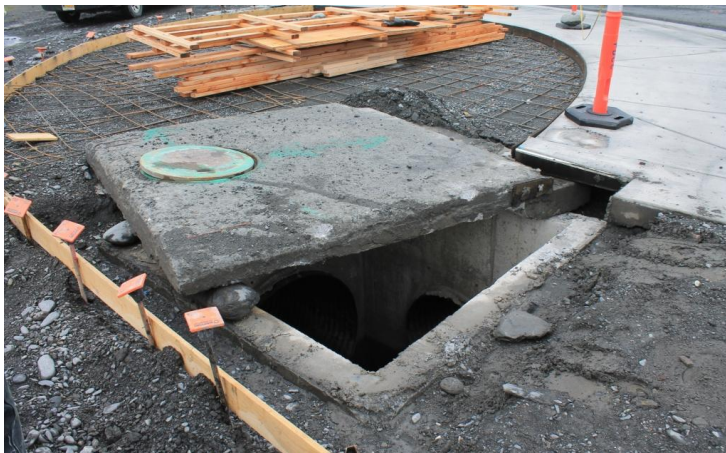
**10. Storm Drain Vault Lid Removal, SE corner of Meals and Egan**

At the south east corner of Meals and Egan, there was a storm drain vault in the plaza that the plans called to remain. This vault lid was about 5'x7', in very poor condition, sloped the wrong direction of the new plaza, and was uneven which would have caused a lip in the new plaza. This would have been a trip hazard and a snow removal obstacle that could end up nicking and damaging the surrounding new plaza.

- The old lid was very thin and the reinforcing was showing through. The new lid would need to be structurally supportive due to the heavy equipment running over it. A structural lid like this required IBC structural inspection of the shoring, the pour and the curing requirements.
- The new lid could be poured with the rest of plaza thus hiding the lid inside the decorative plaza.
- The safety measures and traffic control devices that would be required while the empty vault is exposed.

In order to replace the lid the City had to consider several factors.

Considering the benefits to the public, the snow removal equipment, the longevity of the new plaza, and the aesthetics, the City decided to move forward on a T&M basis to replace the lid. After submission of the T&M paperwork, the City's Inspector was able to reduce the cost further with credits that were due to the City.
