**Tax Year 2024
Real Property Assessment Appeal
City of Valdez
Office of the City Clerk**

Appeal Number 19

Property ID Number:	7010-005-002-0	NOTE: A SEPARATE FORM IS REQUIRED FOR EACH PARCEL.
Property Owner:	Jaranda and Josh	
Legal Description:	lot 2, block 5, Black Gold #1, lot size 10000 SF	
Physical Address of Property:	616 S. Waterfall

Attached is a full home inspection report for 616 S. waterfall. Highlighted in the 164-page report you will find several repairs on the home that negatively affect the homes value. In my appeal I wrote that the home value should be dropped by \$100,000 based on the repairs outlined in the report. The costliest repairs include.

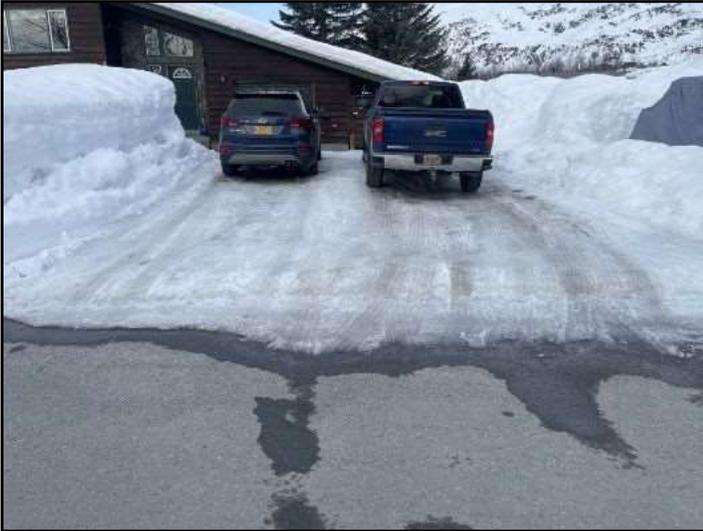
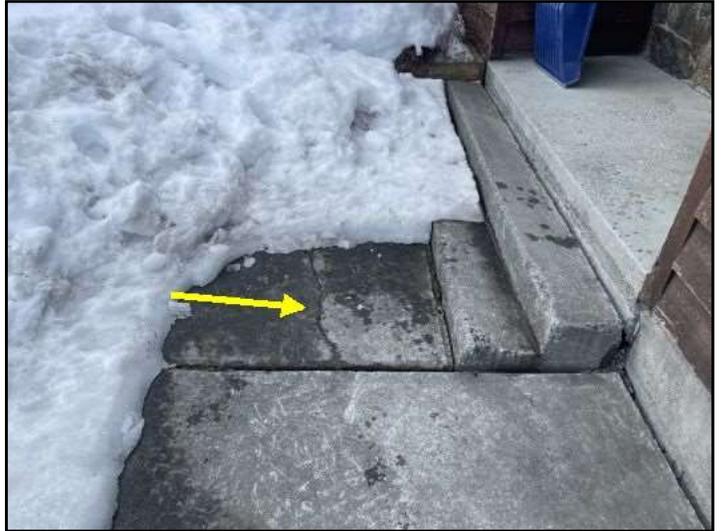
1. Driveway and Walkway Condition

- Snow covered; not fully inspected.
- Crack in concrete noted. Recommend sealing and monitoring crack for any further movement.

Crack in walk way noted.

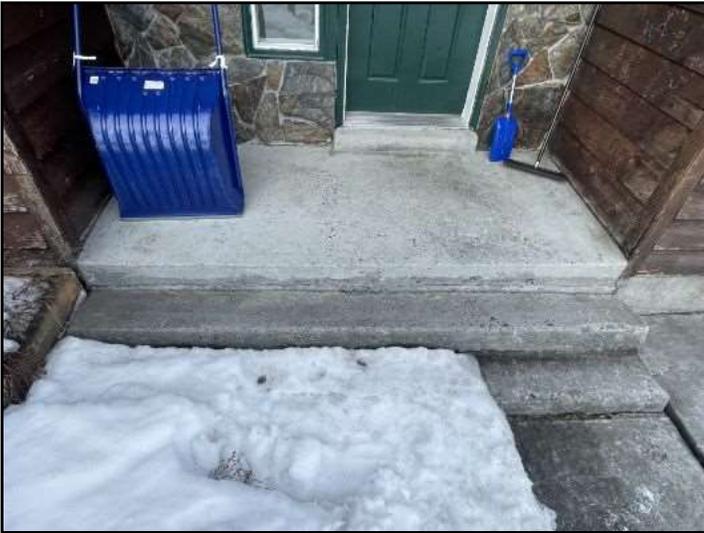
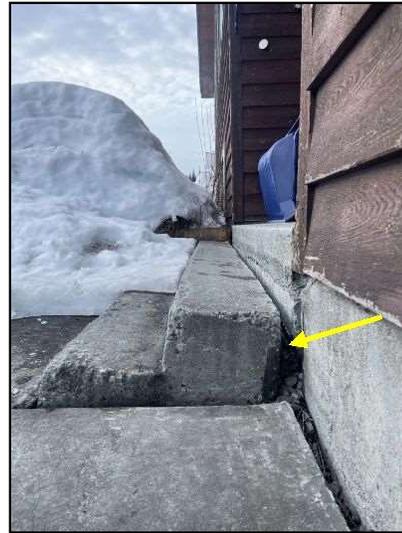
4. Front Entrance

- Front steps have sunken and are uneven. This can be a tripping hazard. Recommend a qualified contractor to evaluate for repair or replacement.

Front step to entrance has sunken and not level.

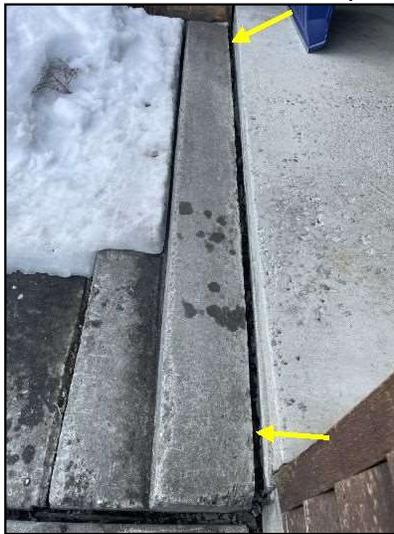
Gap between front entrance and front steps.

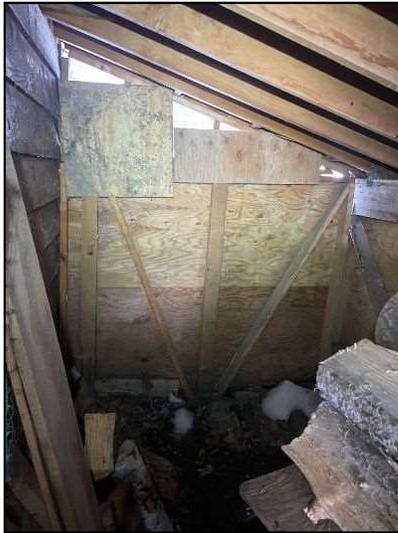
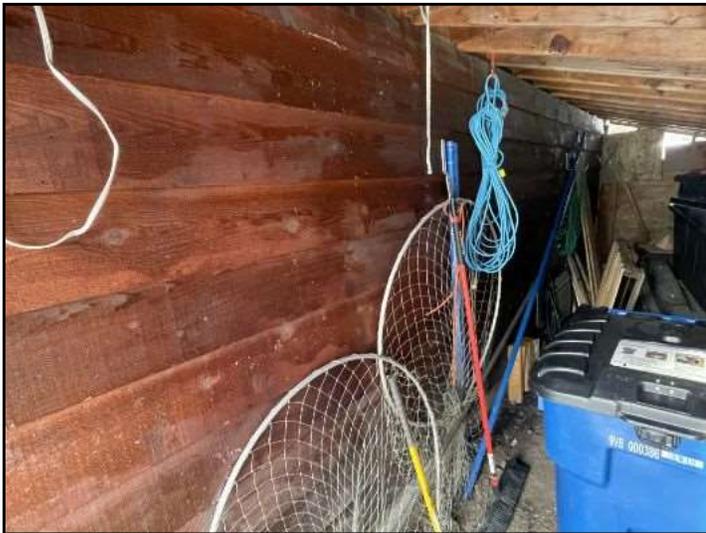
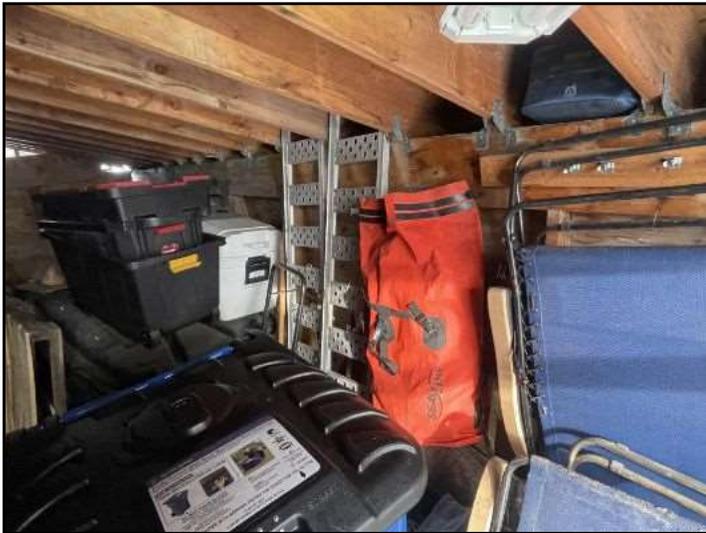
5. Extension Storage

- With the snow and ice covering the extensions support system. The inspector can not fully inspect how the condition is of the foundation. With information from the owners and how the extension roof was tied in to the homes roofing system incorrectly. I suggest a qualified contractor to evaluate the support system's foundation for any repair or replacement. The weight of the snow and ice from the roof may not be distrusting is correctly and causing stress cracks in the home's drywall.

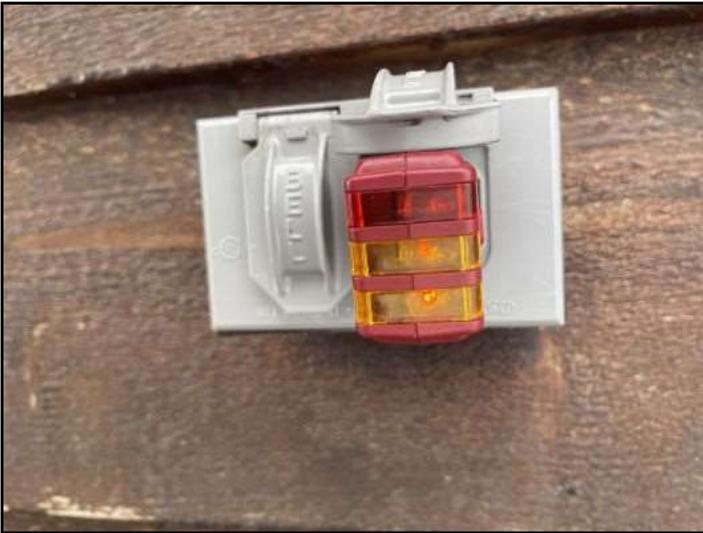
6. Grounds Electrical

- Exterior outlet had burn marks on outlet. Recommend licensed electrician to evaluate for repair or replacement.
- Extension cord pulled through garage wall to be used in the storage area. Recommend removing extension cord and installing more permanent outlet in storage area.

Burn marks noted when testing exterior outlet.

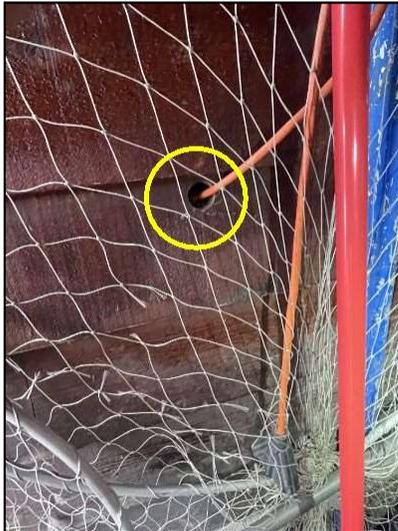
Extension cord pulled through wall in garage to use outside.

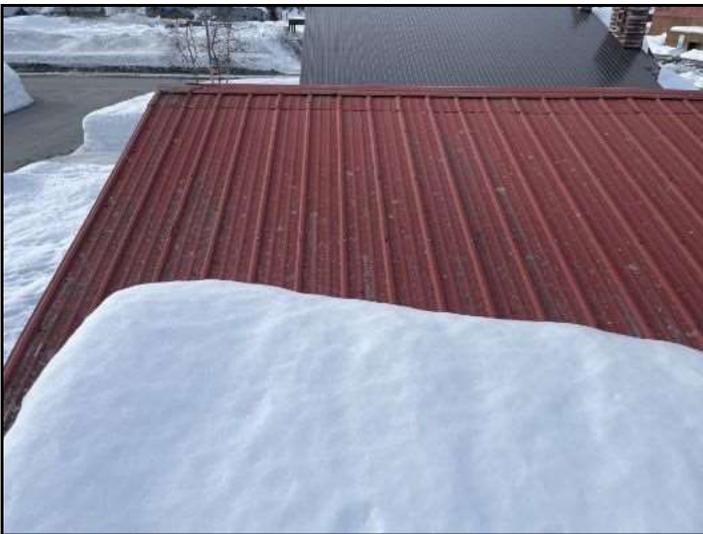
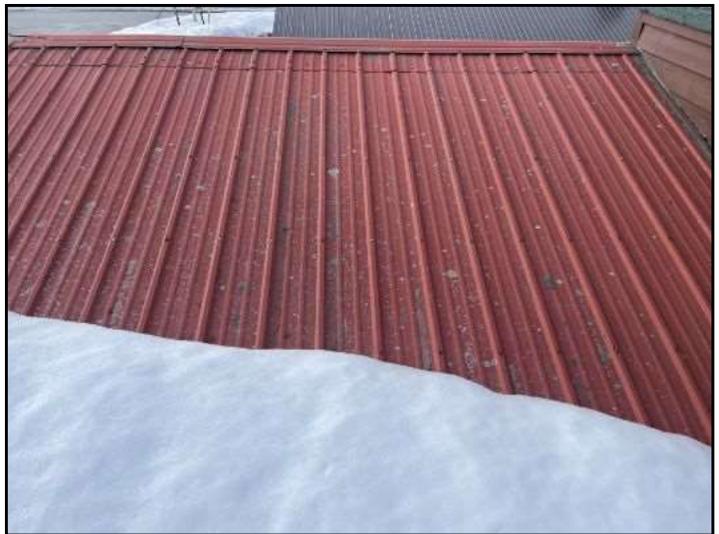
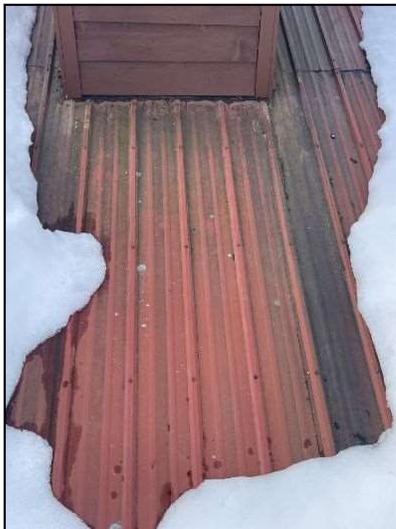
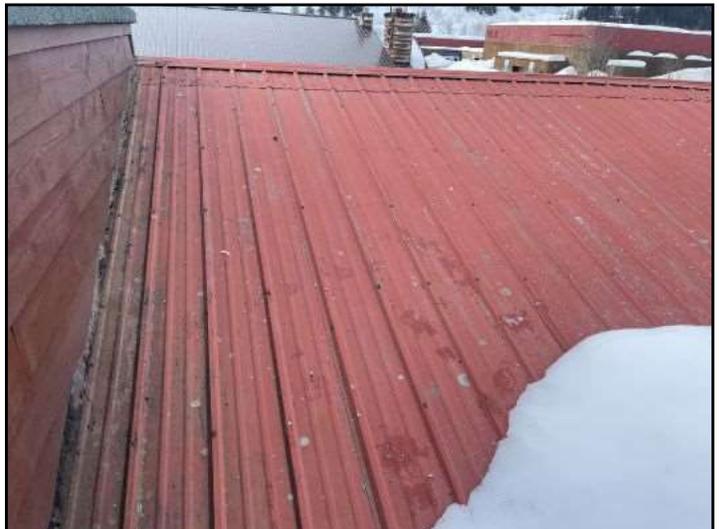
1. Roof Condition

- Partially snow covered, not fully inspected.
- Note that experts recommend that any roof over 10 years old receive a roof certification by a local roofing specialist.
- Serviceability of roof is questionable; it should be evaluated and repaired as necessary by a professional roofing contractor.
- Moisture intrusion in multiple spots in roofing material of the storage extension fascia. Recommend a qualified roofer to evaluate for repair or replacement.
- Ridge cap damaged at the edge of roof. Recommend a qualified roofer to evaluate for repair or replacement.
- Multiple roofing screws applied to roof. Recommend a qualified roofer to evaluate roofing screws for repair or replacement.

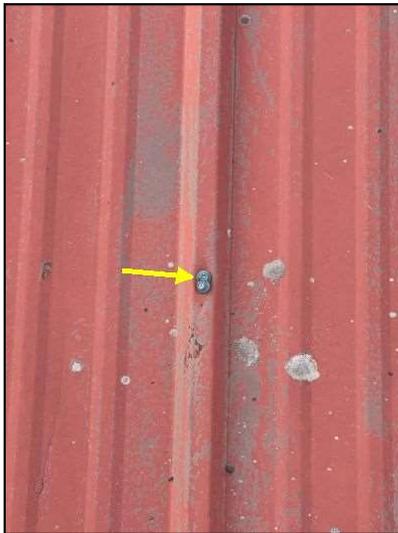
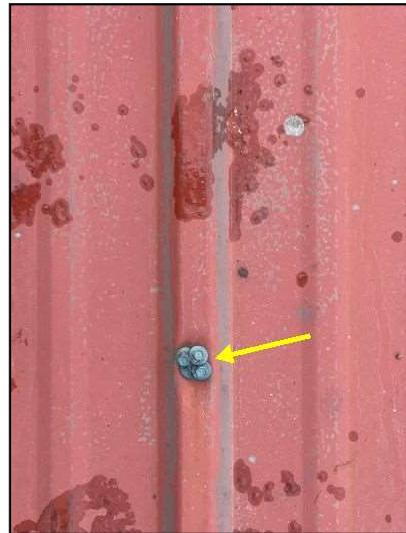
Multiple hold down screws placed in roofing material.

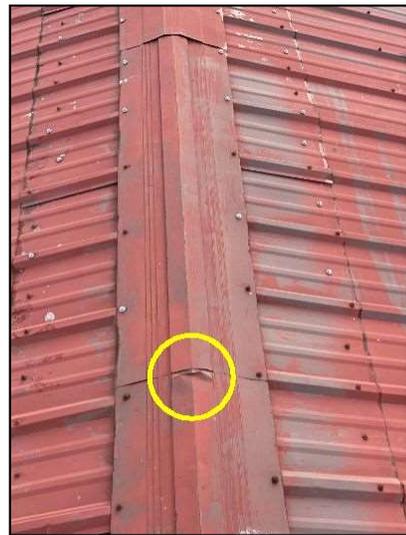
Ridge roofing material bent.

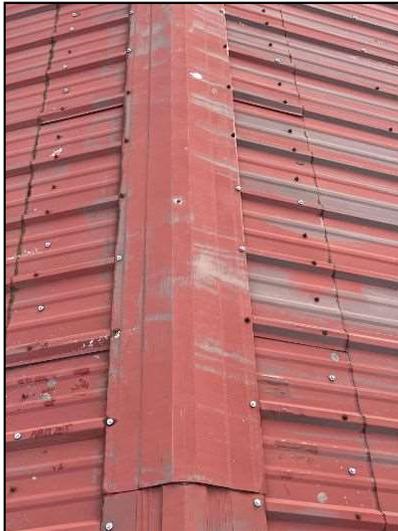
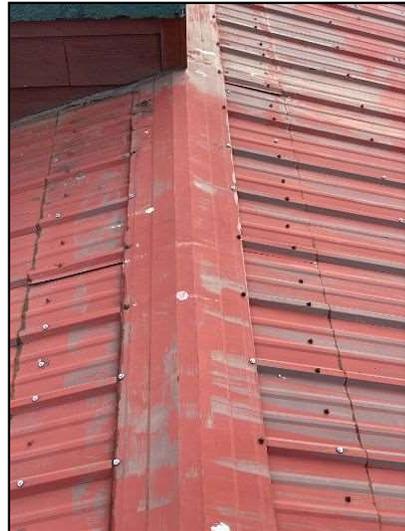
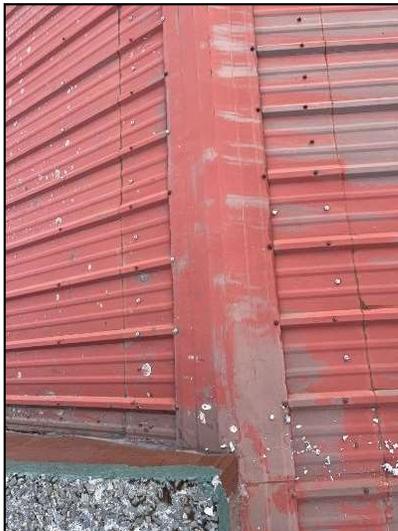
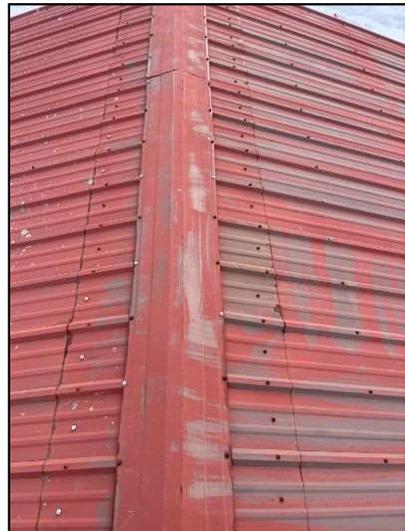
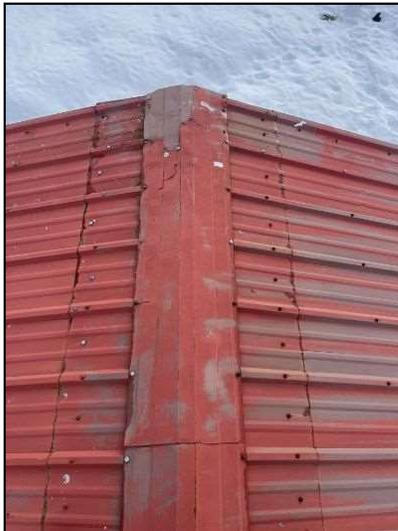
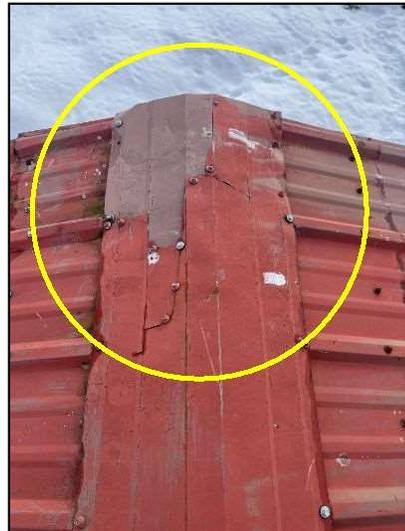
Ridge roofing edge damaged.

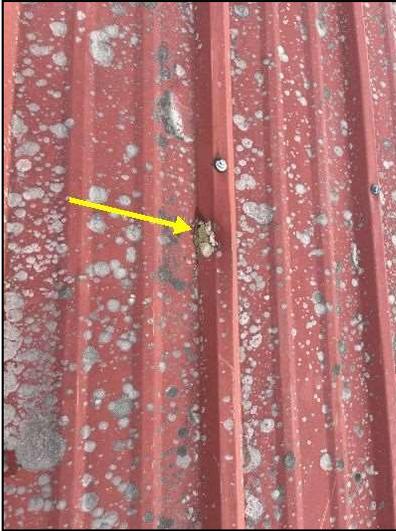
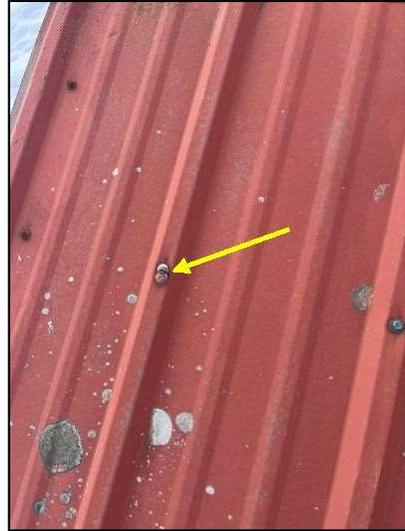
Dent noted in roofing material.

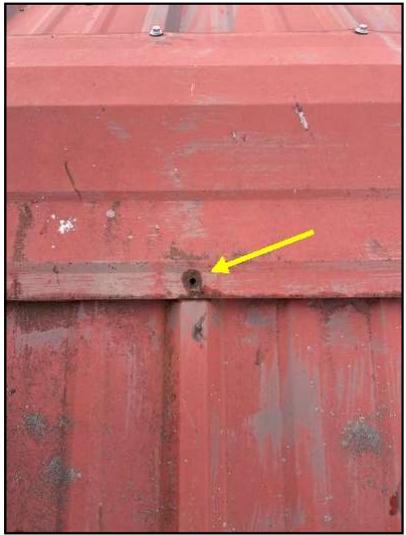
Missing roofing screw noted.

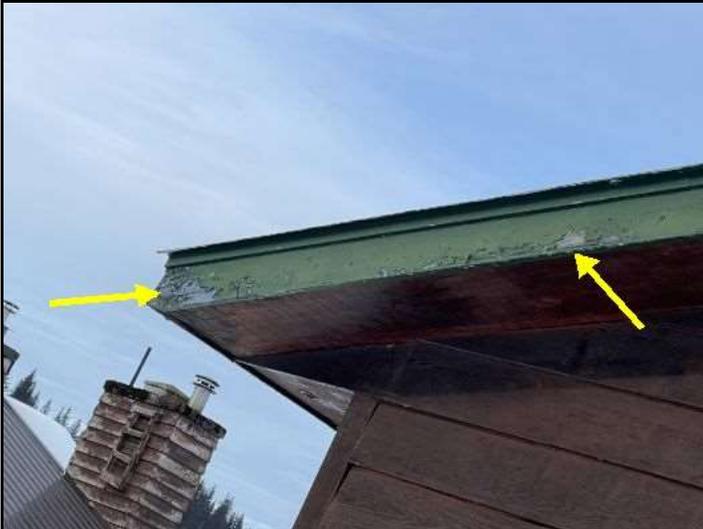
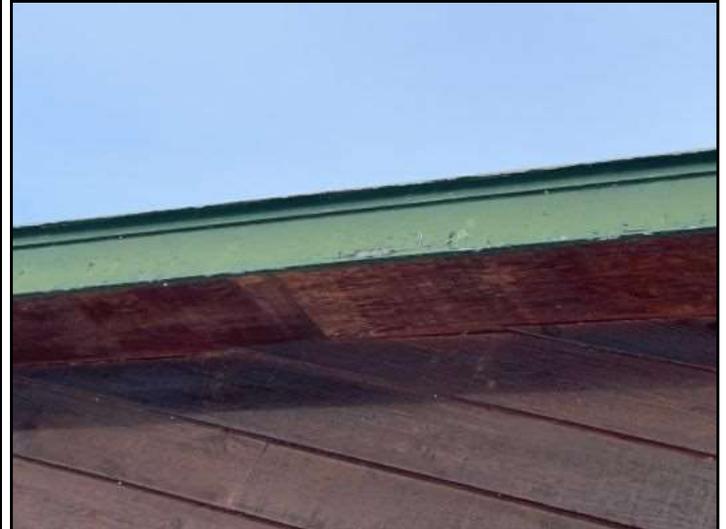
Paint on fascia is worn and weathered.

- Paint on fascia is worn and weathered. Recommend prime and paint to extend life of the fascia.
- Corner of roof of extension storage appears to be damaged from snow and ice. Recommend qualified roofer to evaluate for repair or replacement.

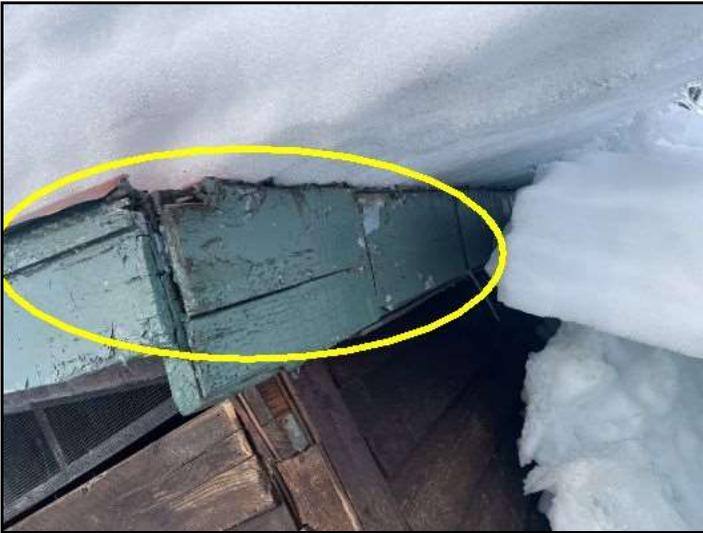
Fascia damaged and leaking in to storage area roof.

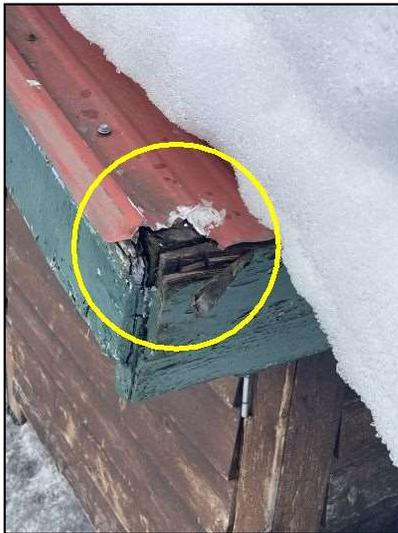
Roofing torn and damaged from the winters snow and ice.

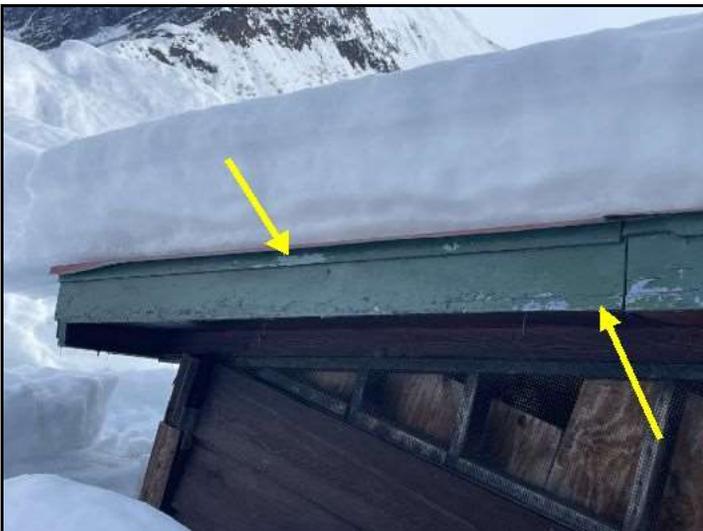
Paint on fascia is worn and weathered.

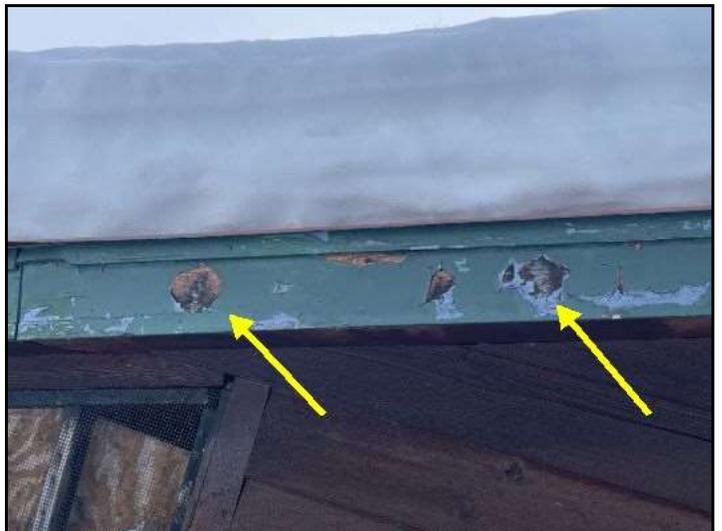
Paint chipping on fascia.

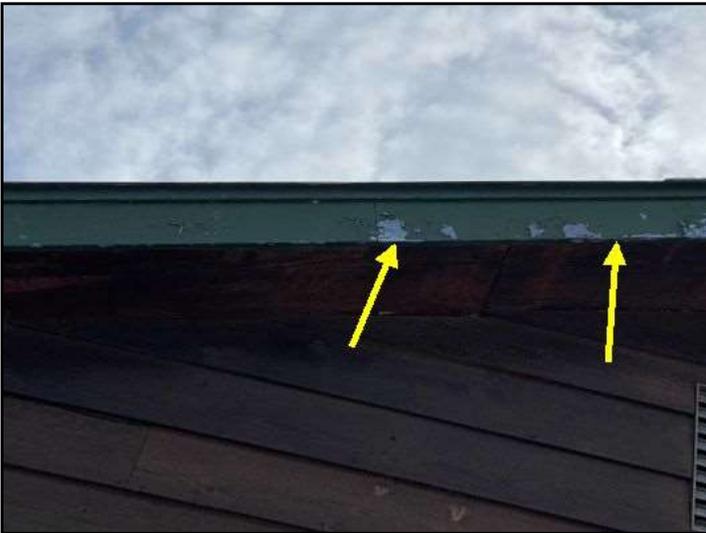
Paint on fasica is worn and weathered.

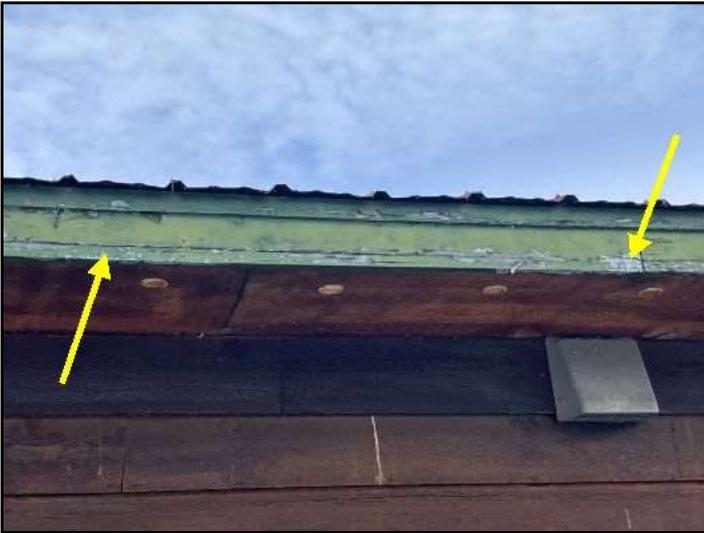
Paint on fascia is worn and weathered.

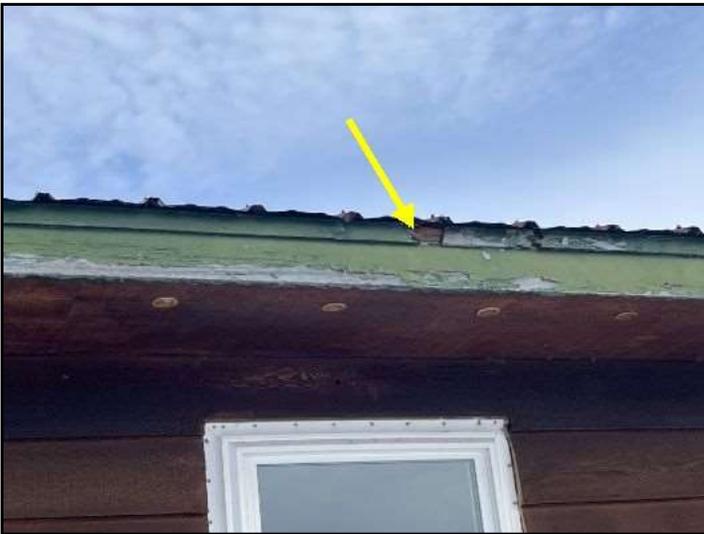
Chip in fascia noted.

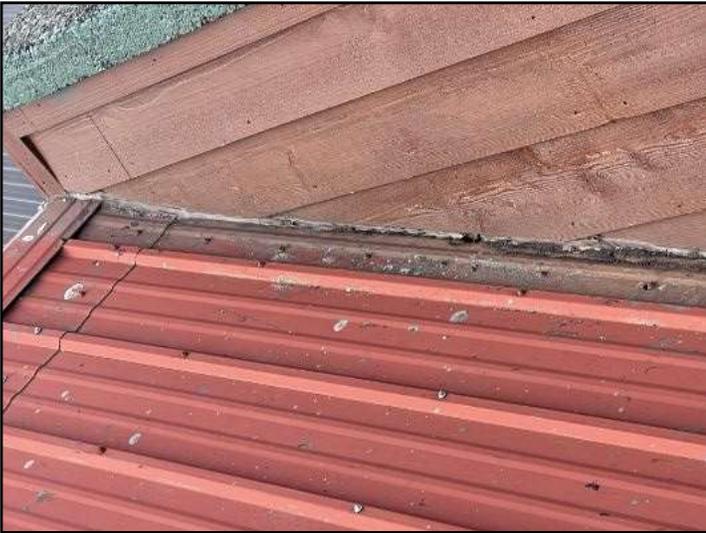
- Typical maintenance necessary, now and on an annual or semi-annual basis. This generally consists of resealing gaps at through-the-roof projections and at the parapet walls as necessary.
- In the inspectors opinion the flashings are near the end of their useful life due to wear.
- Recommend review by a licensed roofer for repair or replacement as necessary.

Organic debris build up on flashing of chimney.

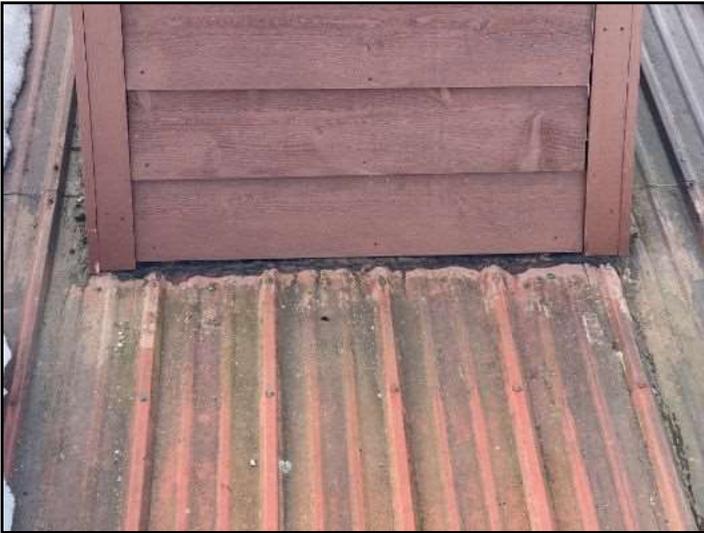
Sealant appears worn and weathered on flashing.

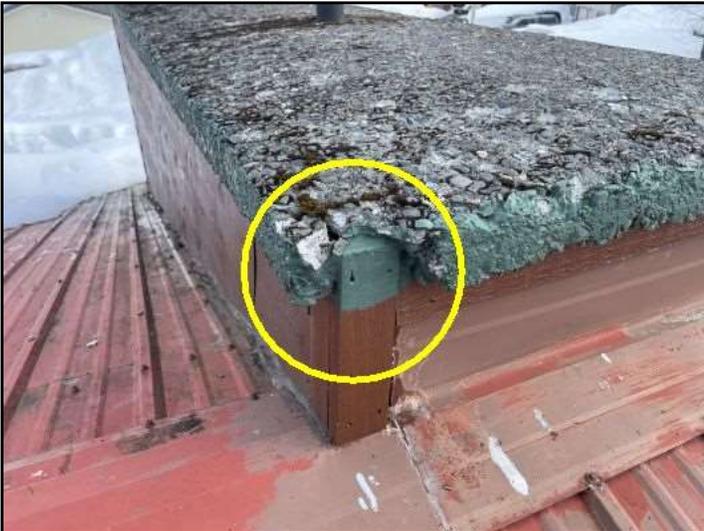
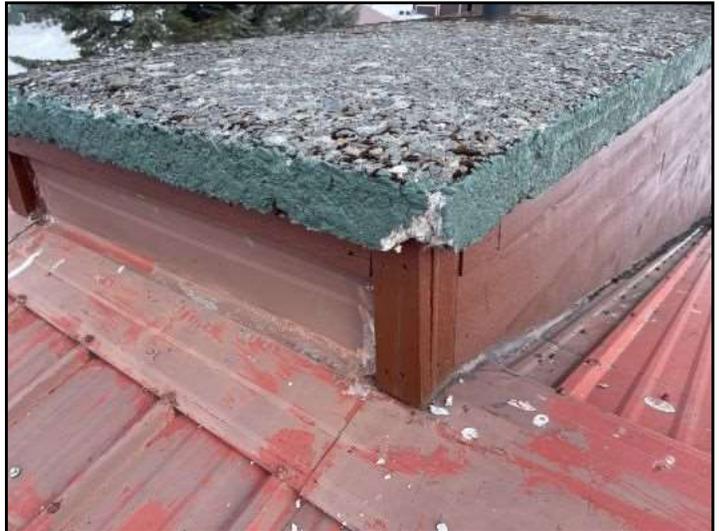
- Chimney Mortar shows sign of deterioration. Recommend having repaired as necessary.
- Minor mortar deterioration at chimney; moss present. Recommend cleaning and maintenance as needed.

Corner piece on concrete for chimney chase broken off.

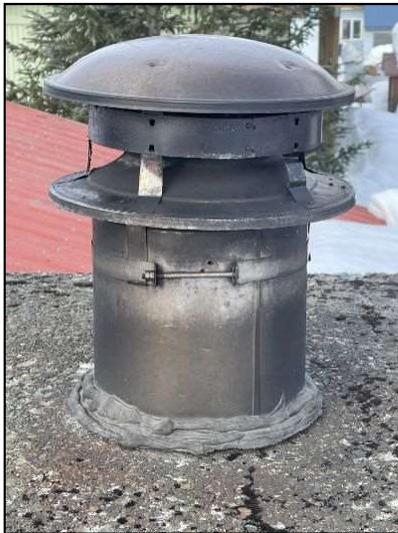
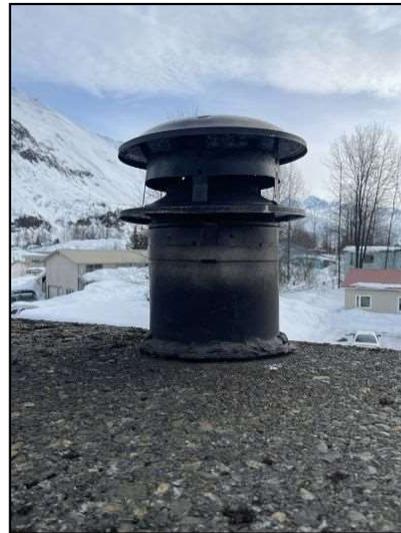
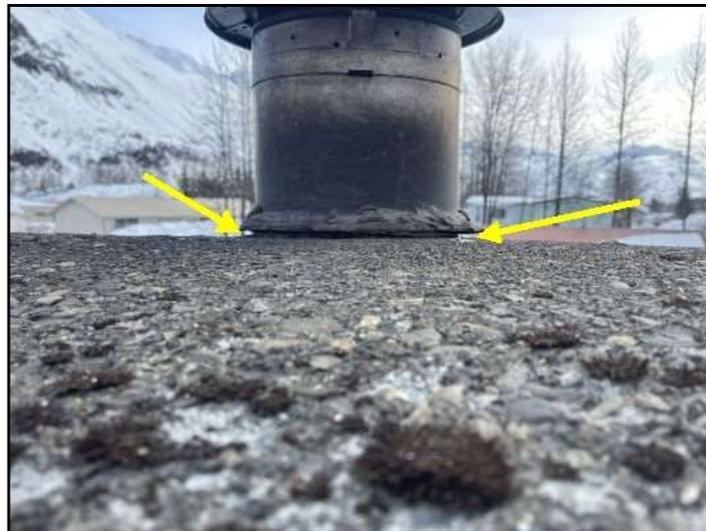
7. Fire Place Chimney

- Sealant is no longer attached to chimney chase. Recommend fresh sealant to prevent moisture intrusion in chase.

Gap between sealant and top of chimney chase.

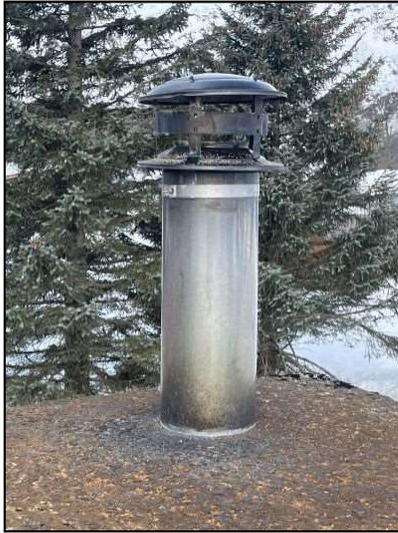
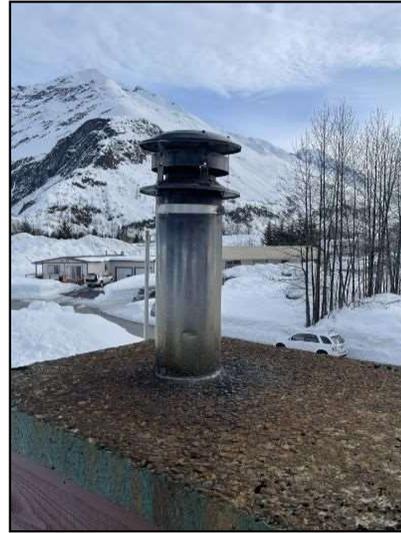
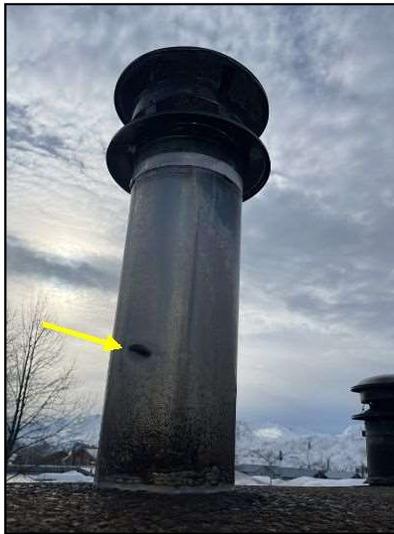
8. Exhaust Stack

- Tear in exhaust stack noted.

Tear in exhaust stack noted.

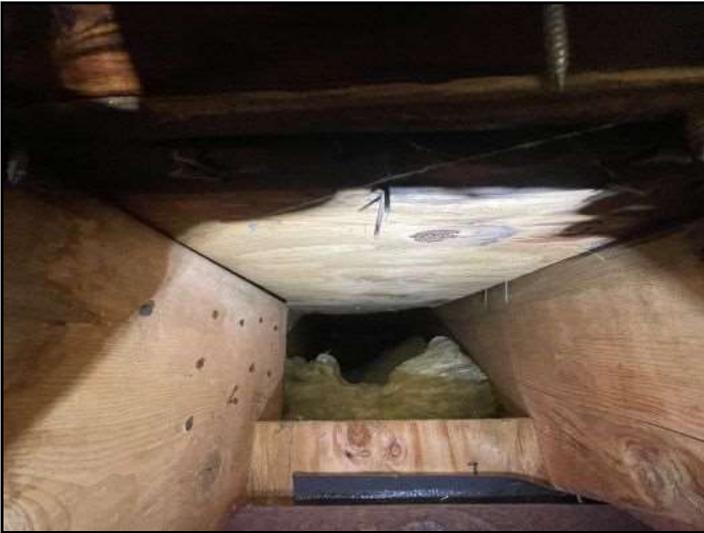
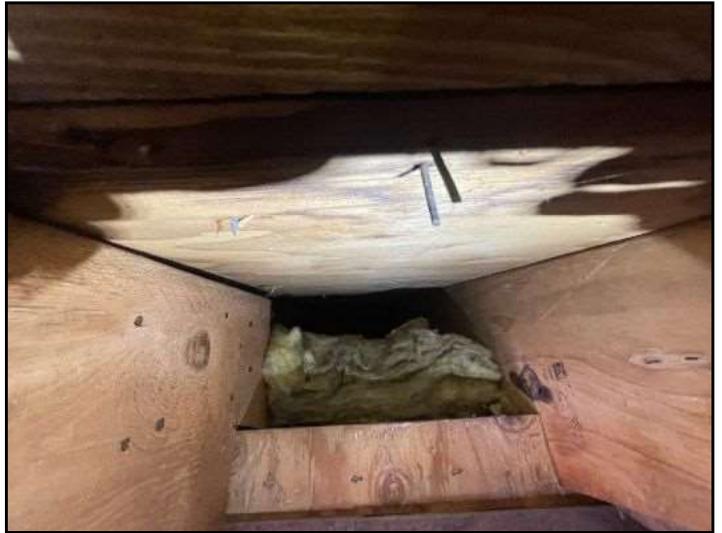
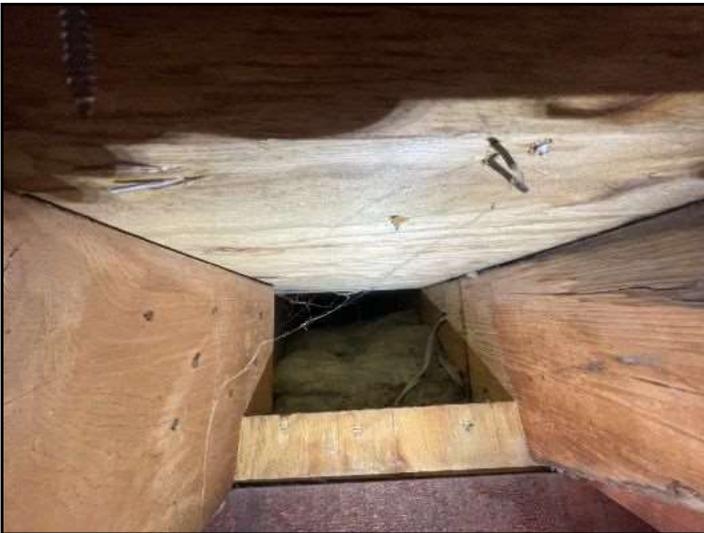
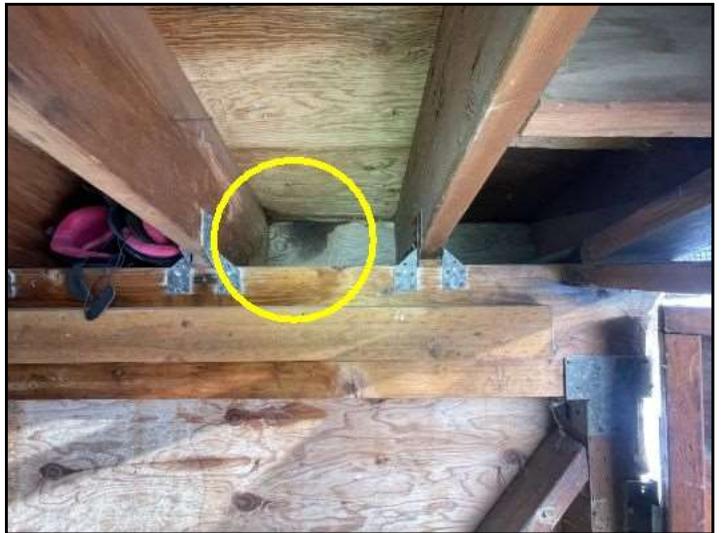
9. Extension Storage Roof

- Extension roof rafters are only nailed and notched to the existing homes roofing system. With the weight of the yearly snow and ice. It's in the inspector's opinion this is the cause of the drywall cracking above the home's doors.

- There are active leaks and moisture intrusion where the homes roofing system and extension roof meets. Recommend a qualified roofing contractor to evaluate roofing for repair or replacement.

Moisture intrusion on edge of roof extension.

Recommend a qualified roofing contractor to evaluate the roofing system for repair or replacement.

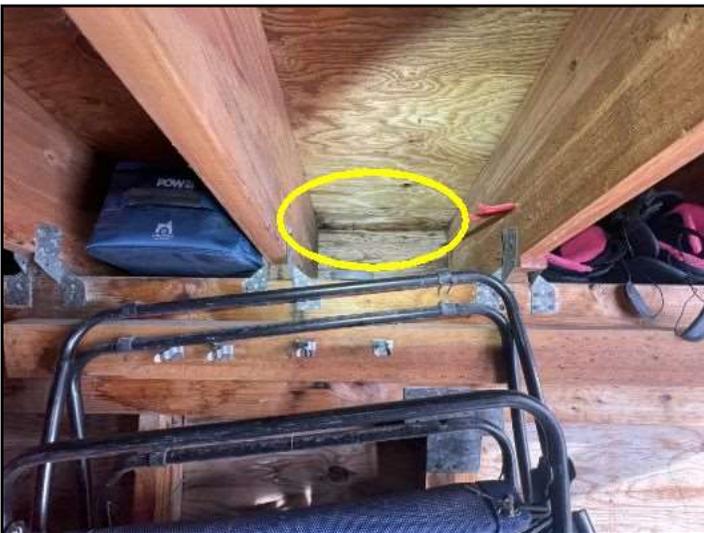
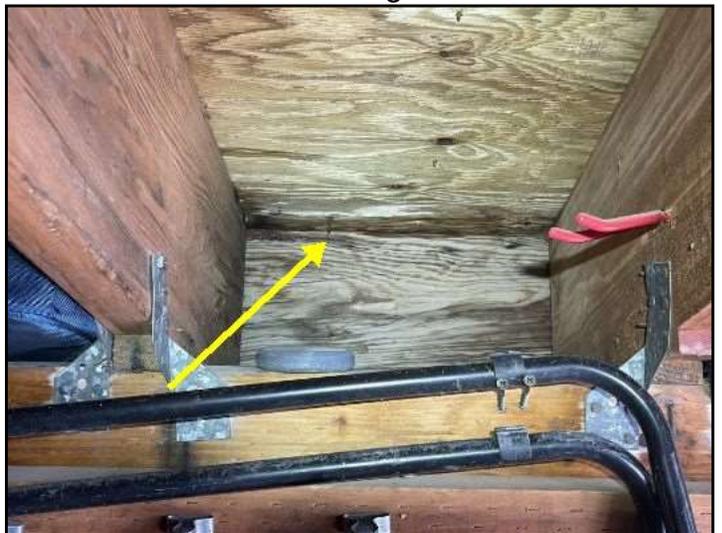
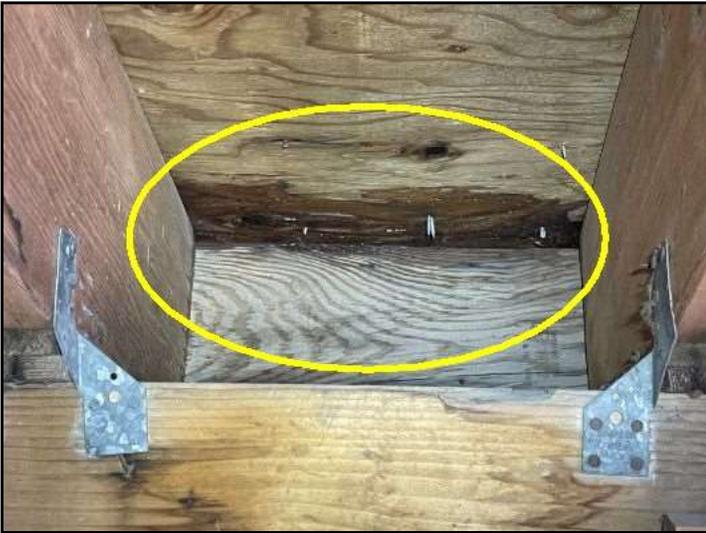
Moisture intrusion on edge of roof extension.

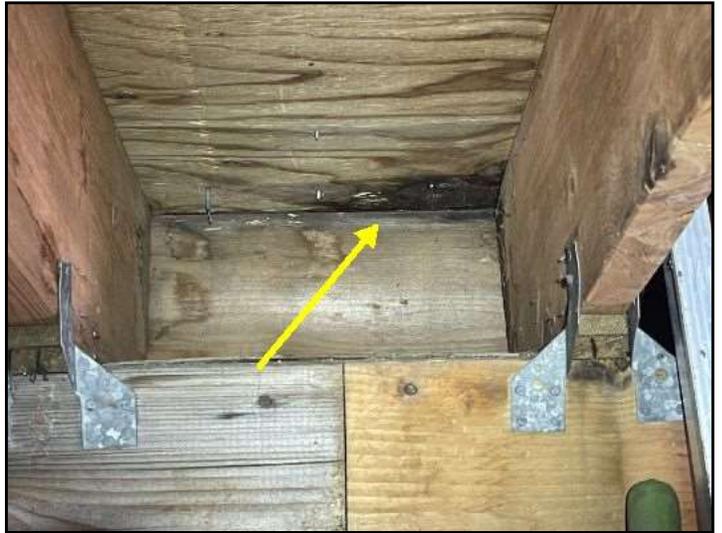
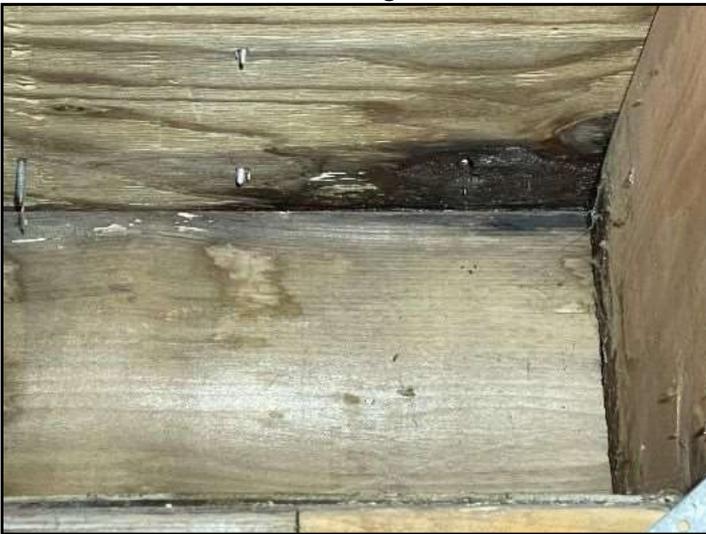
- Extension roofing rafters are only nailed and notched to the homes rafter system. There is no mechanical attachments tying the extension rafters to the homes roofing system. Recommend a qualified roofing contractor to evaluate for repair or replacement.

Rafter only notched and nailed to homes rafter system no mechanical attachment present.

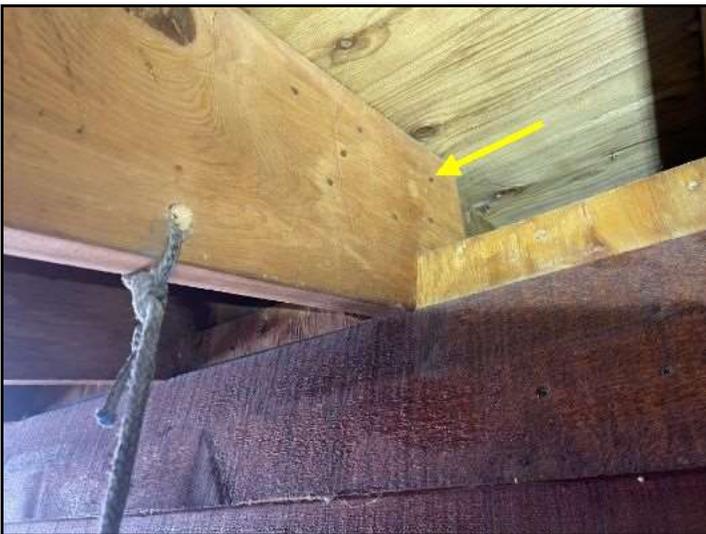
Weight of snow load has caused rafters to spread apart.

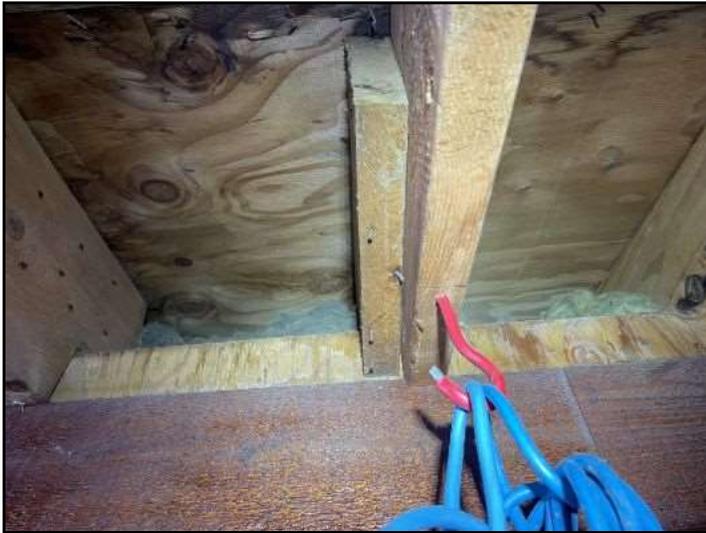
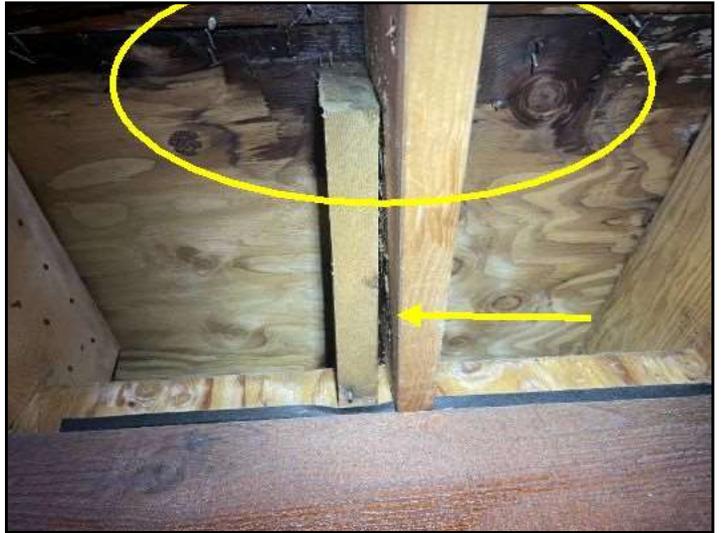
Rafters spread apart. Moisture intrusion where main roof and extension roof meet.

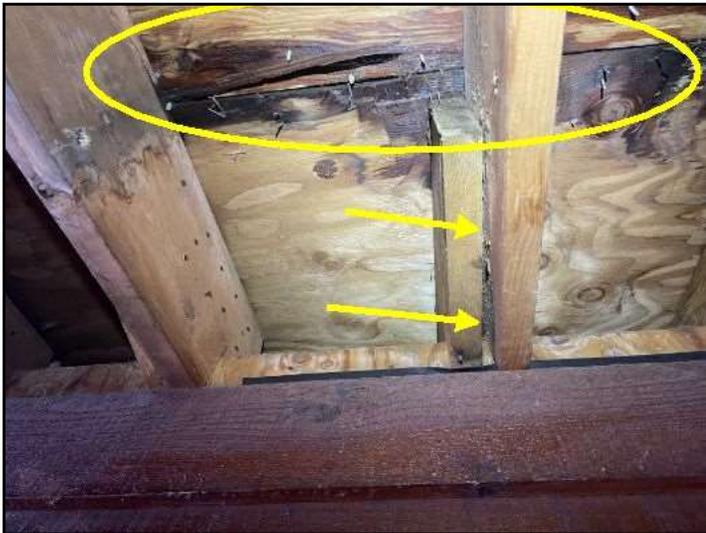
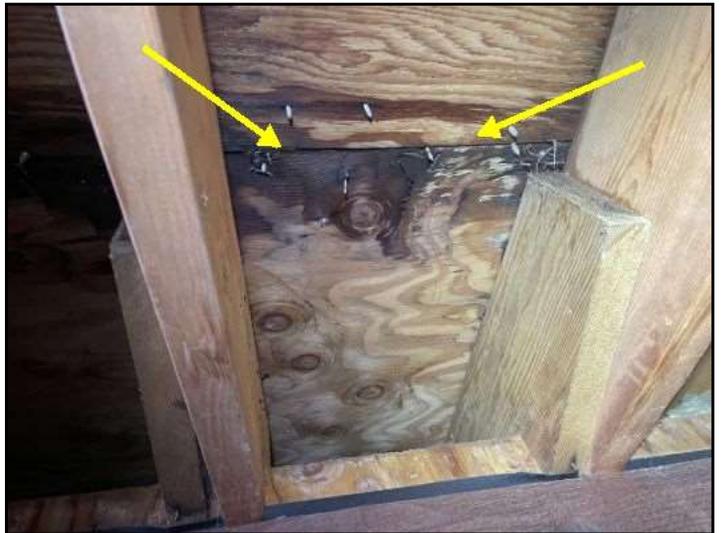
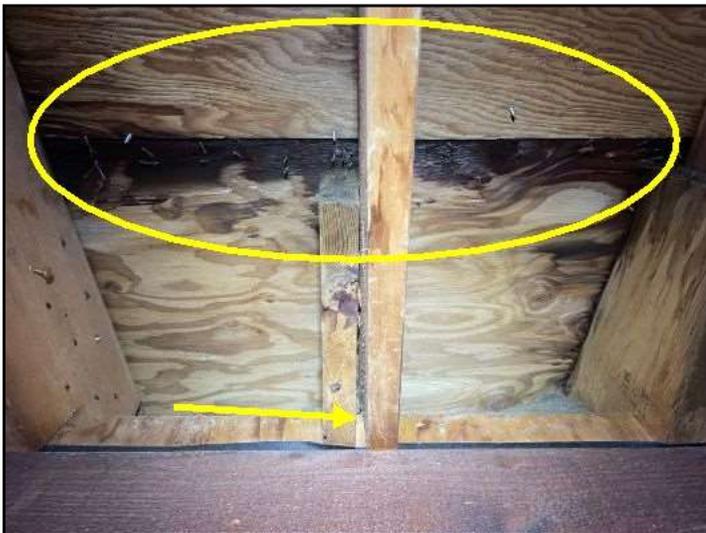
Rafters spread apart. Moisture intrusion where main roof and extension roof meet.

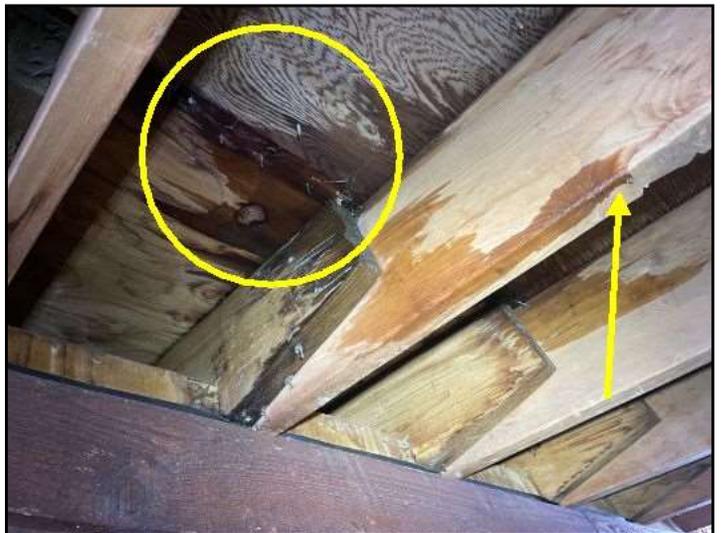
Leak where the main roof and extension roof meet.

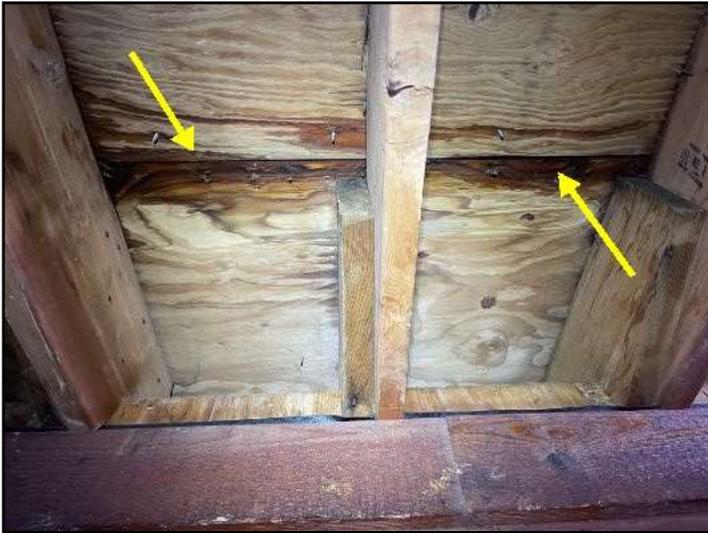
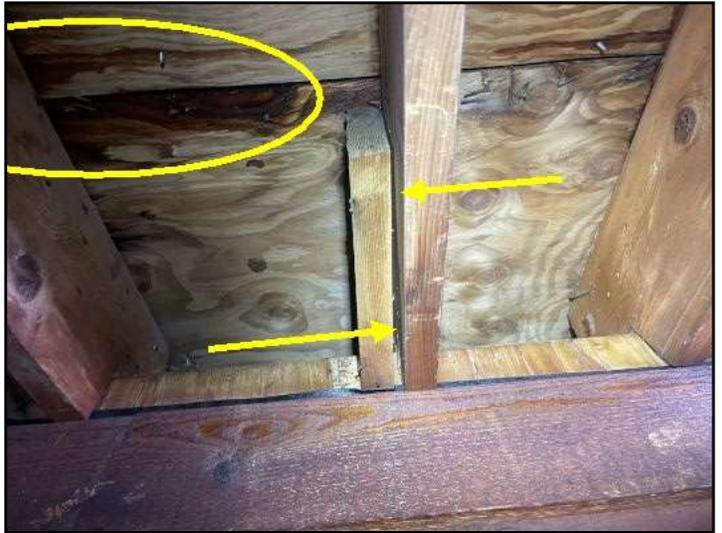
Rafters spread apart. Moisture intrusion where main roof and extension roof meet.

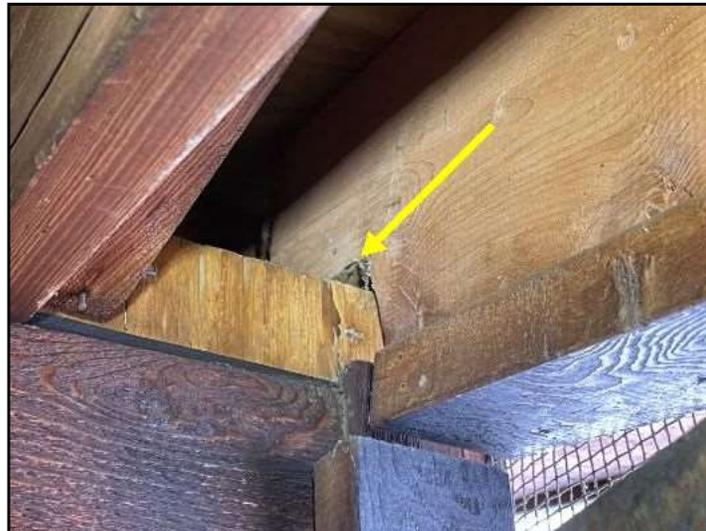
Rafter not resting on support or mechanically attached.
