**Tax Year 2024
Real Property Assessment Appeal
City of Valdez
Office of the City Clerk**

Appeal Number 19

Property ID Number:	7010-005-002-0	NOTE: A SEPARATE FORM IS REQUIRED FOR EACH PARCEL.
Property Owner:	Jaranda and Josh	
Legal Description:	lot 2, block 5, Black Gold #1, lot size 10000 SF	
Physical Address of Property:	616 S. Waterfall

Attached is a full home inspection report for 616 S. waterfall. Highlighted in the 164-page report you will find several repairs on the home that negatively affect the homes value. In my appeal I wrote that the home value should be dropped by \$100,000 based on the repairs outlined in the report. The costliest repairs include.

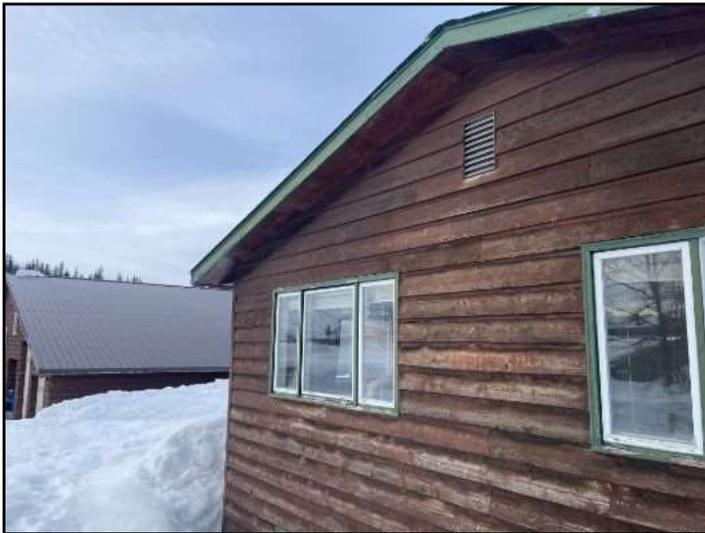
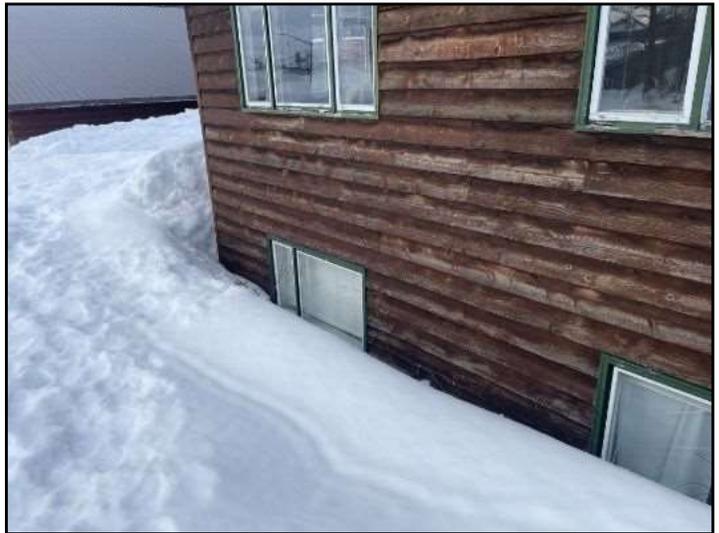
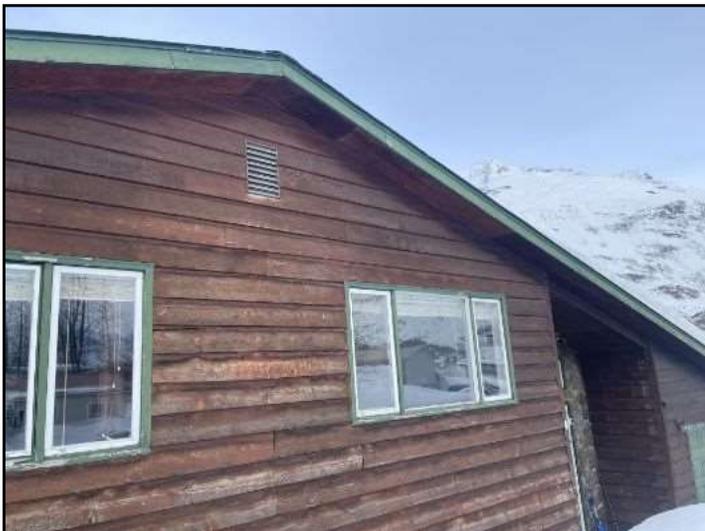
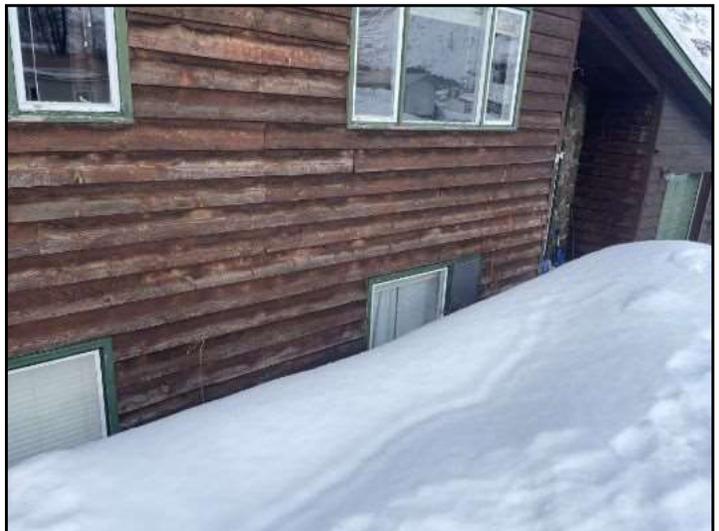
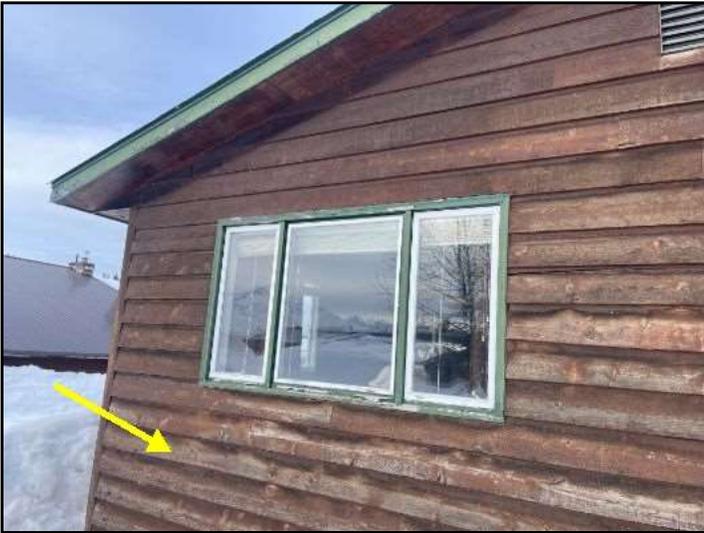
1. Siding Condition

- Exterior siding is worn and weathered in some areas of the home.
Recommend qualified contractor to evaluate for restaining and painting of siding.

Staining on siding is worn and weathered.

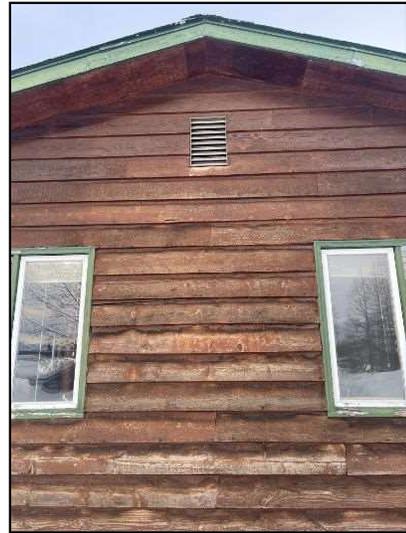
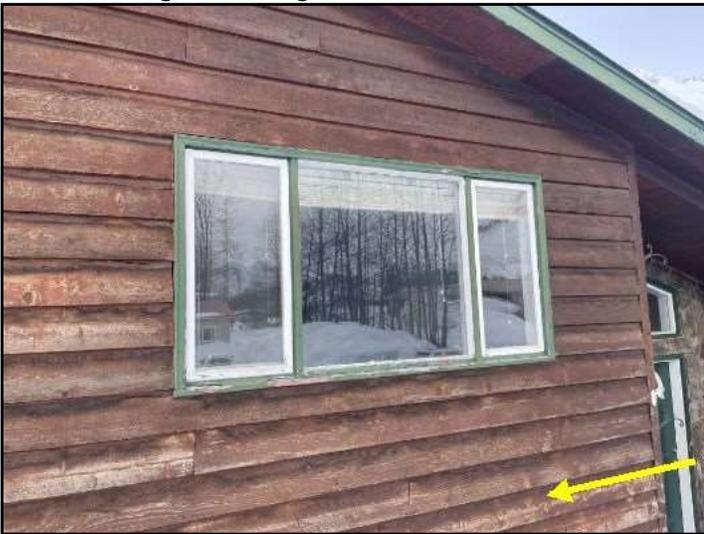
Staining on siding is worn and weathered.

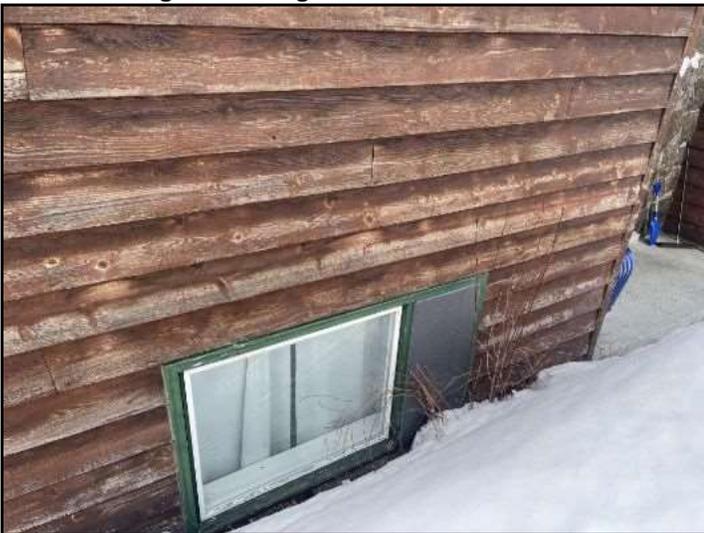
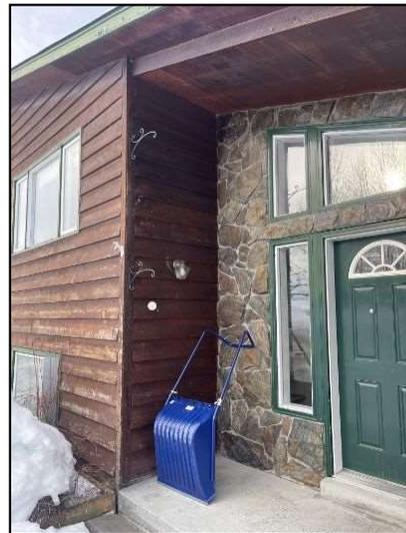
Staining on siding is worn and weathered.

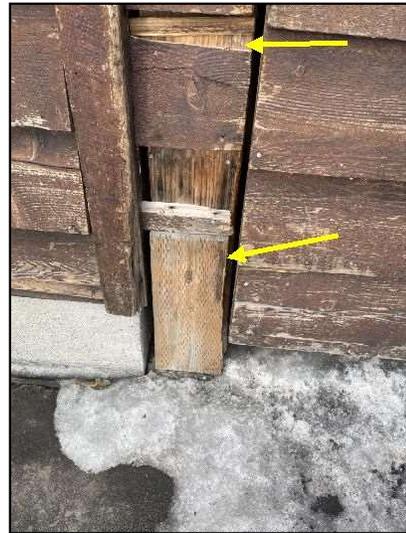
Siding removed and treated wood placed over support post.

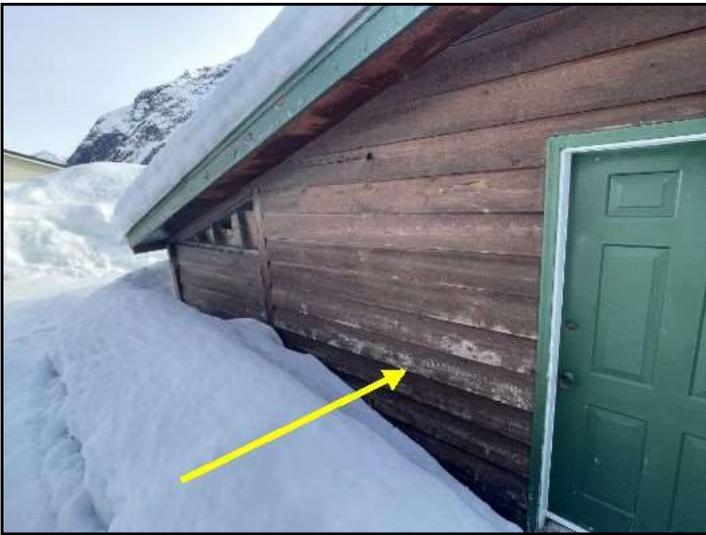
Staining on siding is worn and weathered.

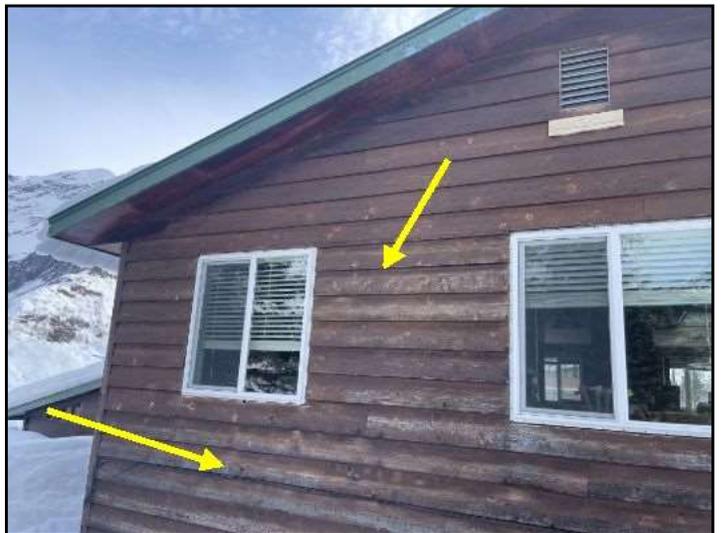
Staining on siding is worn and weathered.

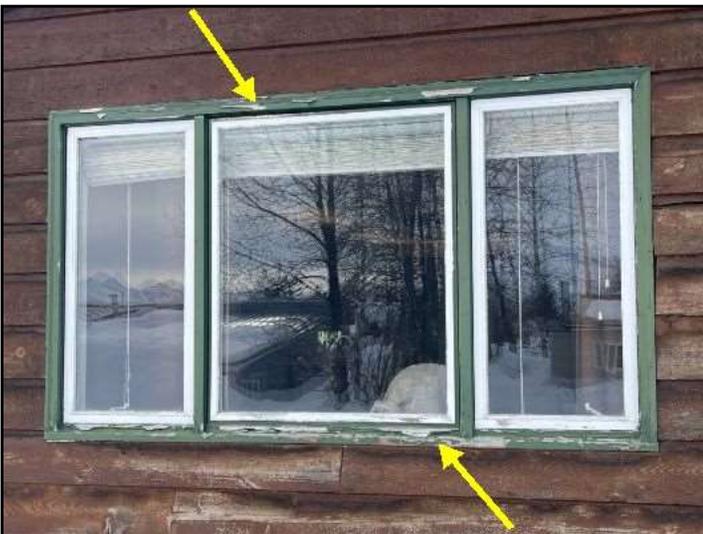
Paint on window trim in chipping and peeling.

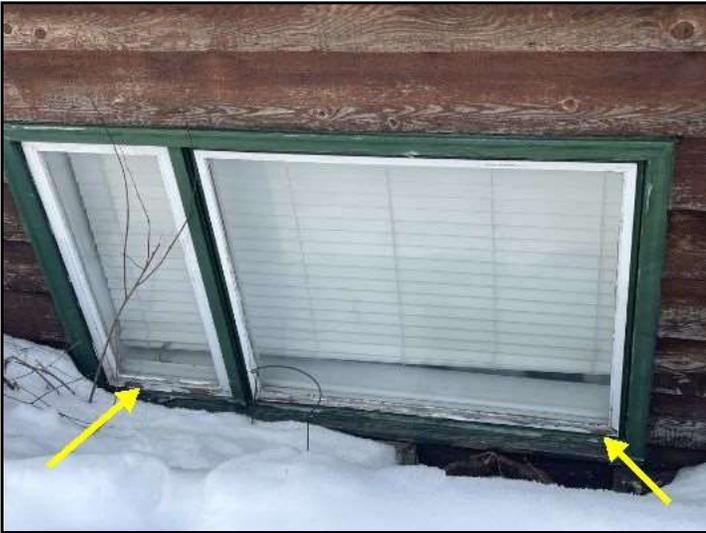
Window trim is worn and weathered from exposure to snow and ice.

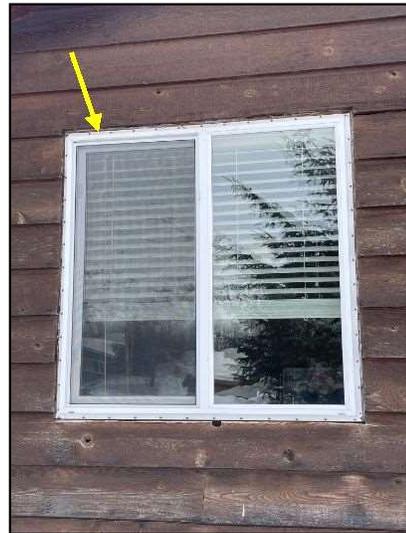
Window missing trim noted.

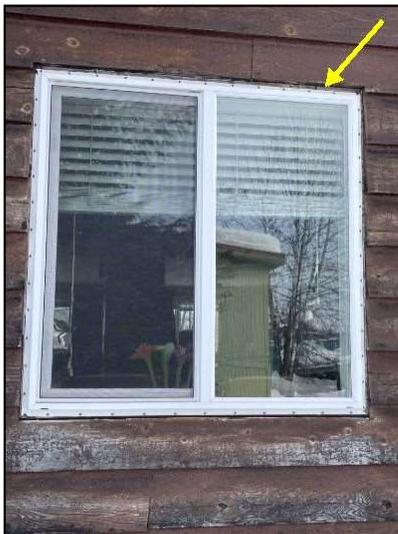
Window missing trim noted.

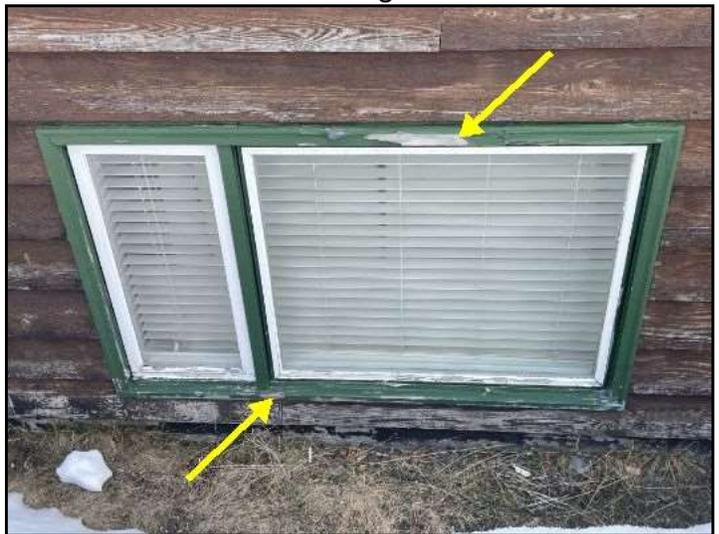
Paint on trim is worn and weathered.

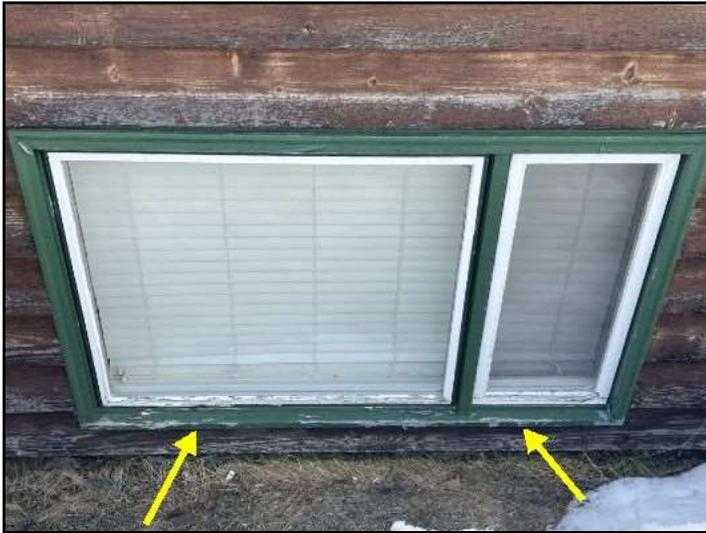
Trim on window is worn and weathered.

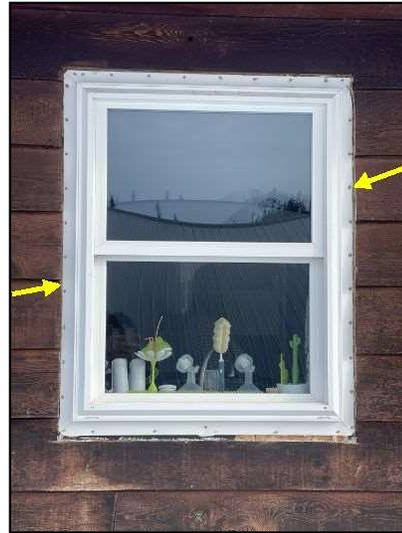
Window missing trim.

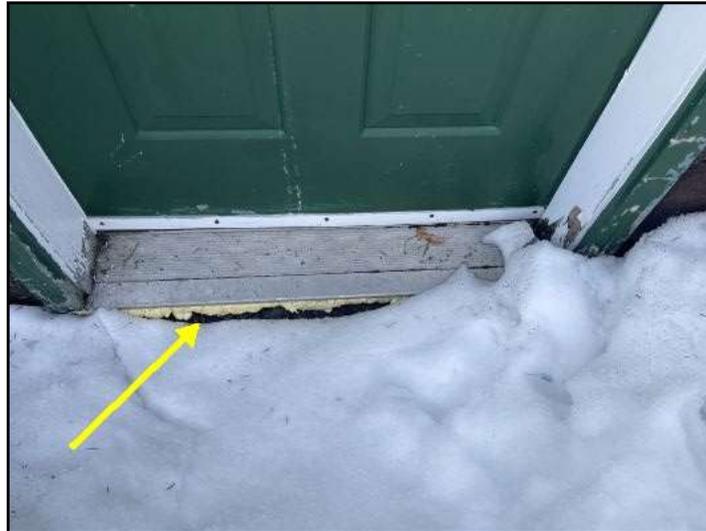
- Spray foam used to seal door sill in rear entrance to garage. Recommend cutting foam so foam is not exposed to the elements.

Spray foam used on underside of door sill.

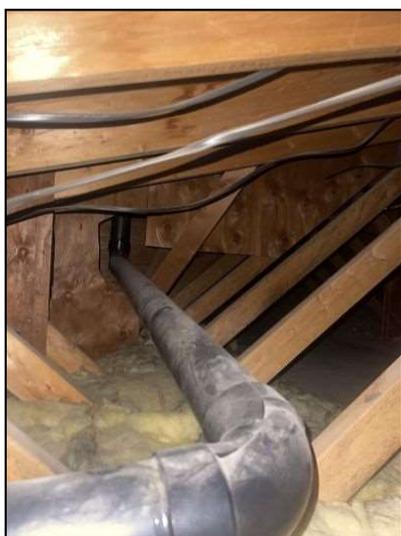
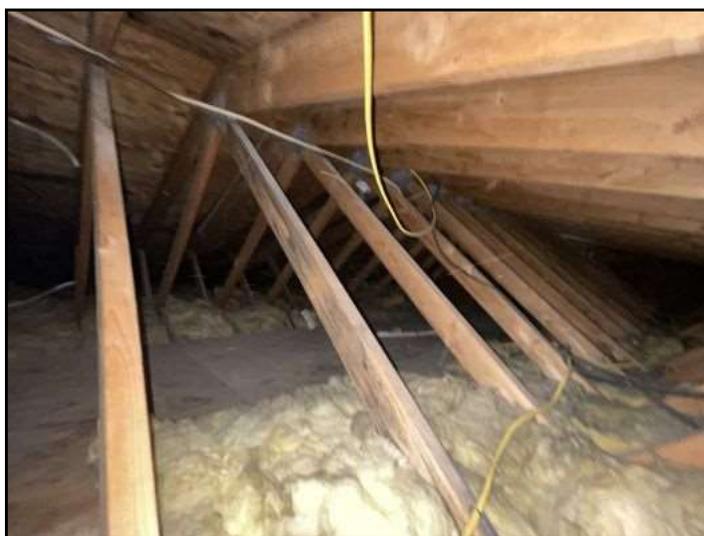
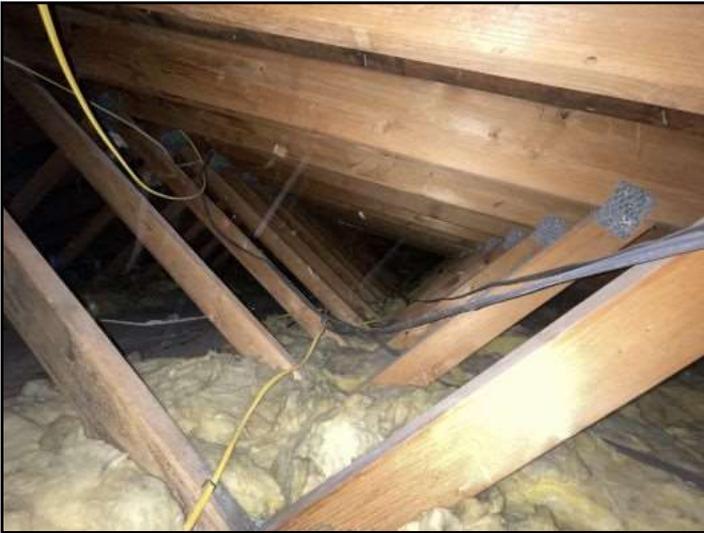
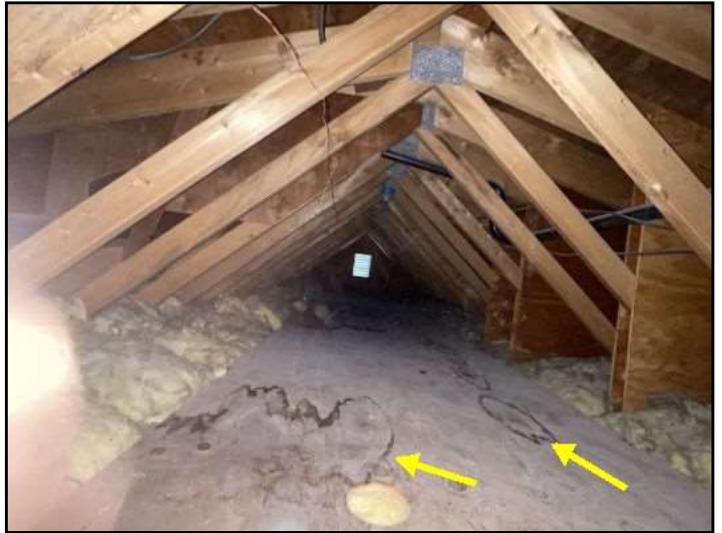
2. Structure

- Evidence of past or present leaks, dry at time of the inspection. Monitor for leaks &/or have roofing contractor evaluate.

Stains on plywood from previous leaks.

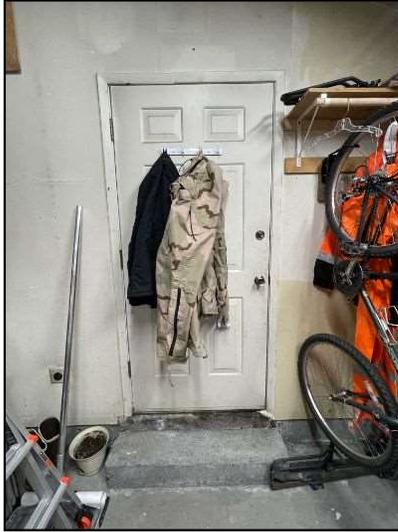
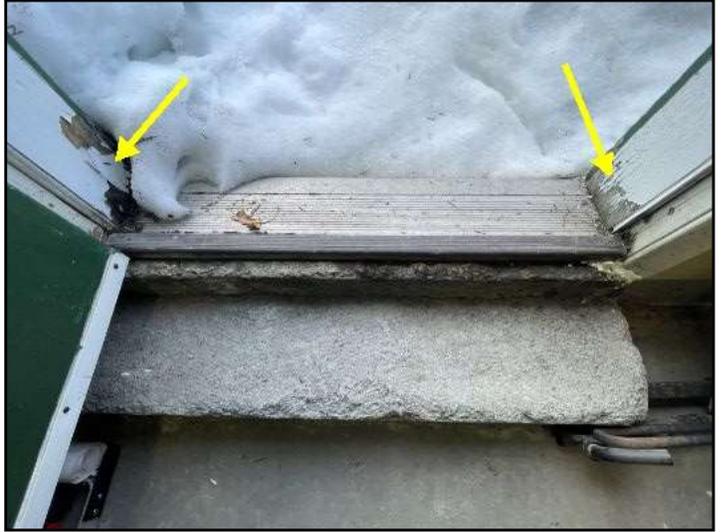
- Door frame is worn and weathered from exposure to snow and ice.
Recommend frame be primed and painted to extend life of door frame.

Paint on door frame is worn and weathered.

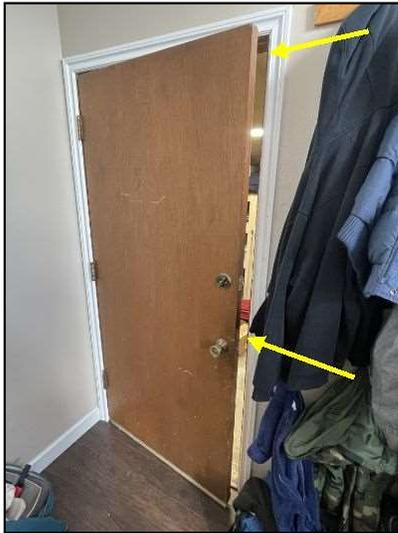
2. Fire Door

- The automatic closure device does not close the door properly. This could allow a fire to enter the home. Recommend adjusting or replacing the hinges to allow for proper closure of the door.
- Drywall crack noted above fire door. Recommend repairing crack and monitoring for any further movement.

Fire door did not fully shut automatically.

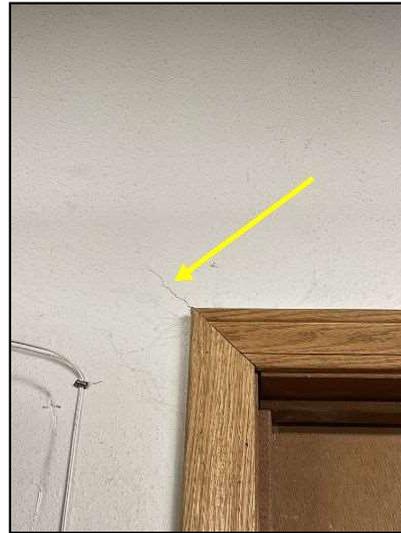
Small crack in drywall above fire door in garage.

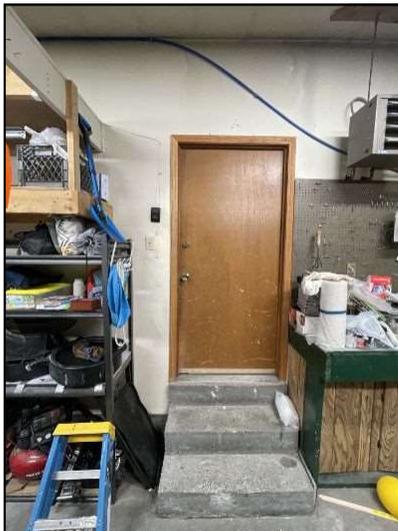
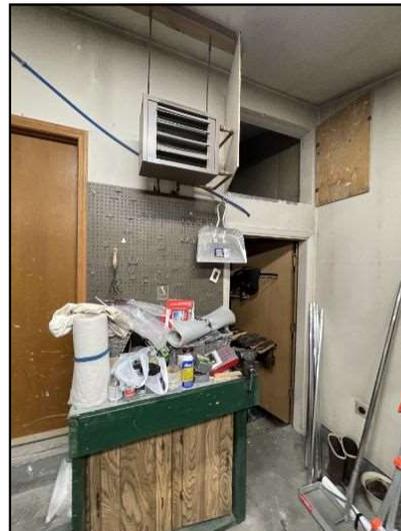
3. Walls

- Large crack above the rear garage exterior door. Recommend repairing crack and monitoring for any further movement.

Crack in drywall above door frame on exterior door in garage.

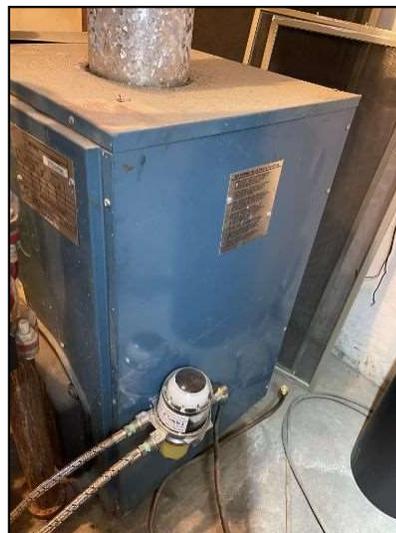
1. Heater Condition

- Fuel Furnace: Last service date is over one year ago, or is unable to be determined. Although this unit appears to be operating properly from controls, there are areas which cannot be seen without specialized equipment and training. One such area is the combustion chamber / heat exchanger where cold air blows across the "fire box", becoming the hot air that circulates throughout your home. During the life span of any furnace, this metal wall may develop a crack or a broken weld, allowing carbon monoxide to circulate throughout the home. This is why furnace specialists recommend a complete inspection annually; consider having unit inspected by certified HVAC technician.
- The heating unit is approaching its designed life expectancy. We make no warranty, guarantee or estimation as to the remaining useful life of this unit.

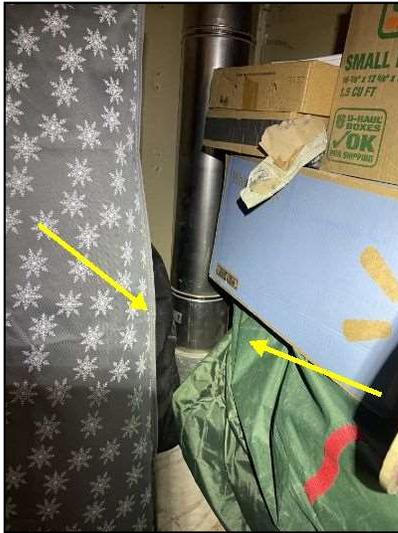
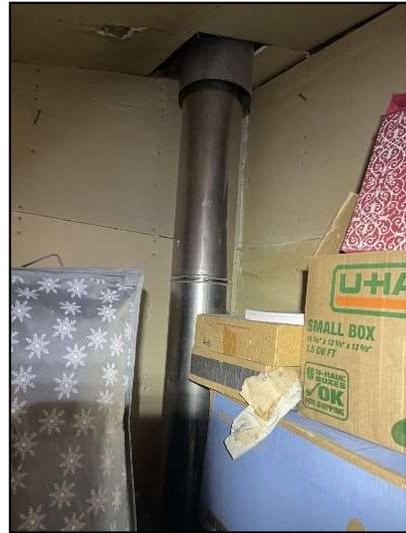
2. Exhaust

- The visible portions of the vent pipes appeared functional.
- **SAFETY CONCERN:** Chimney flue/vent pipe has inadequate clearance to combustible materials. Repair as needed.

It's recommended to keep exhaust stack clear of anything flammable.

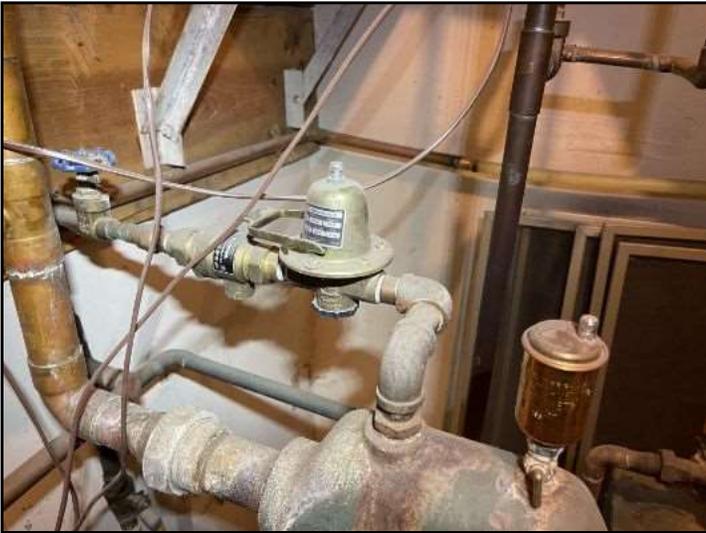
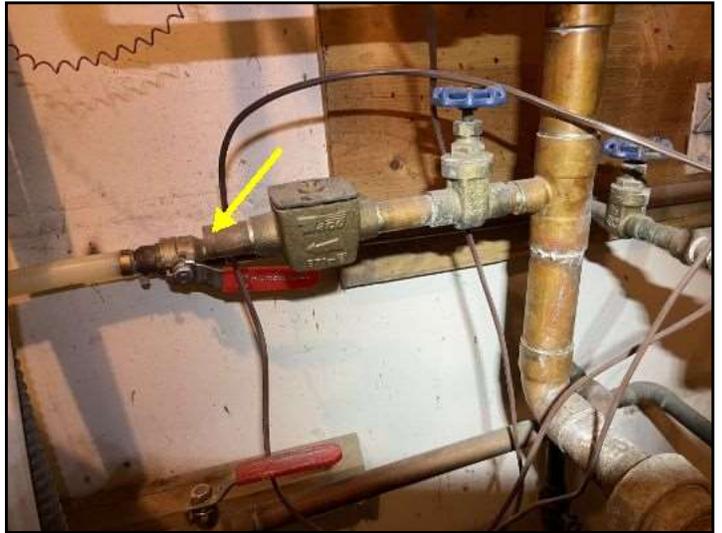
10. Plumbing

- No major system safety or function concerns noted at time of inspection.
- **Cut copper tubing noted. Recommend capping tubing to prevent any leaks or valve being accidentally opened.**
- **Wires are exposed and not capped with wire nuts. Recommend wires be secured and exposed wiring be capped.**

Plumbing line cut and is out of service.

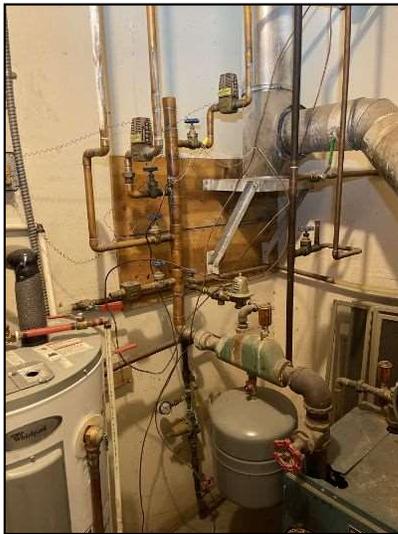
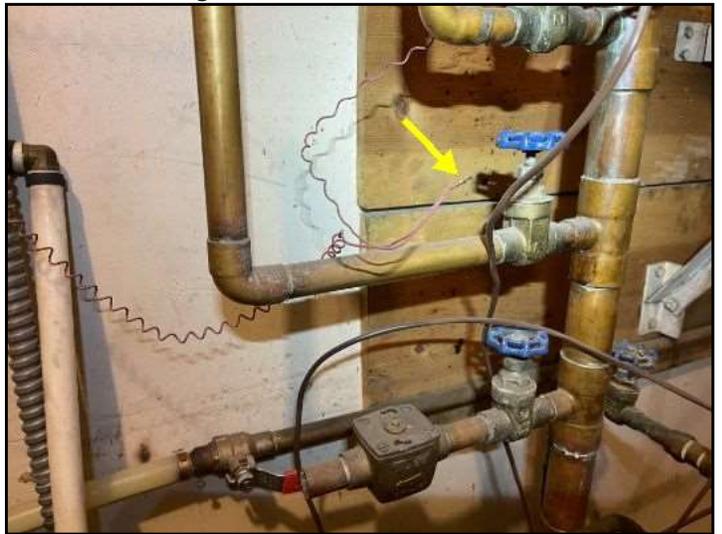
Wiring not capped with wire nut.

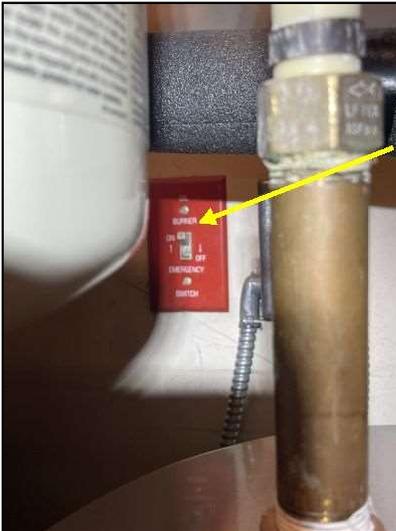
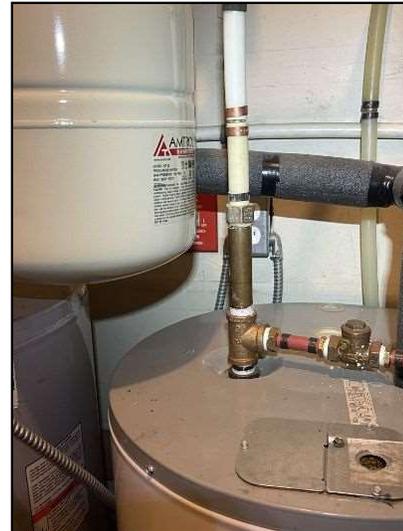
11. Kill Switch

- Kill switch is located behind water heater plumbing and expansion tank. Making it hard to reach switch. Recommend switch be relocated to more accessible area.

Kill switch for boiler is hard to reach behind water heater plumbing.

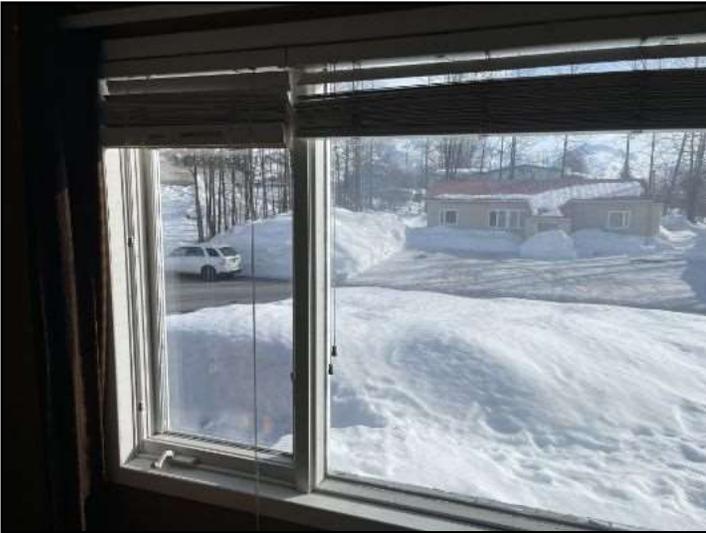
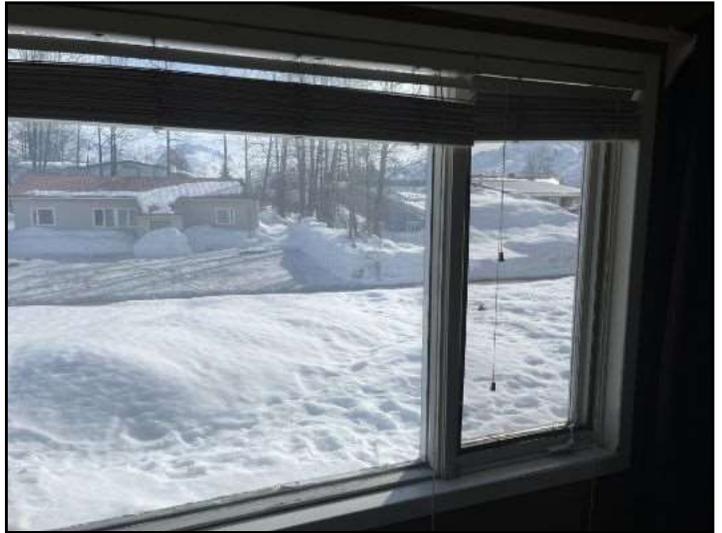
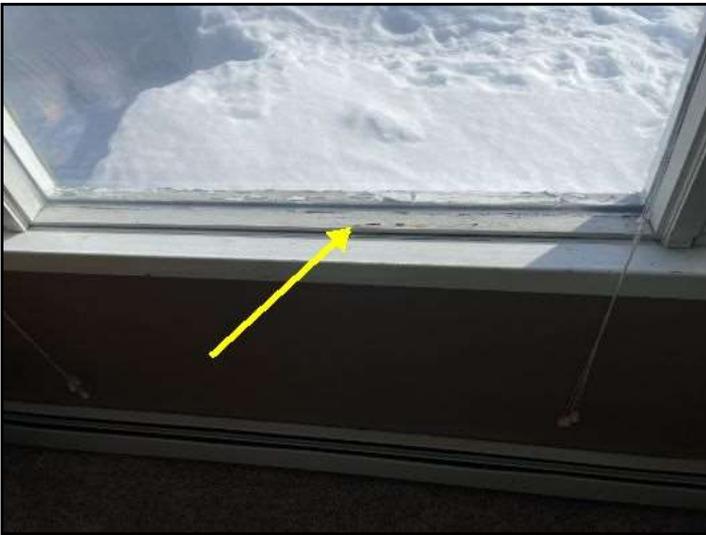
4. Window Condition

- In accordance with ASHI Standards, we do not test every window in the house, and particularly if it is furnished. We do test every unobstructed window in every bedroom to ensure that at least one provides and emergency exit.
- **Deterioration of wooden frames noted. While basic maintenance may prolong the life of these window frames, replacement may be necessary at some point.**
- **DEFERRED COST: Windows are original, older type. Consider upgrading to double pane, thermally insulated, newer efficient type.**

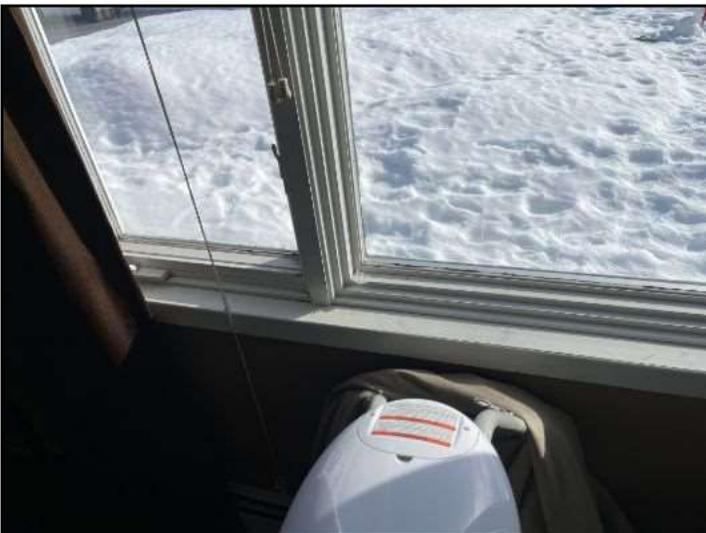
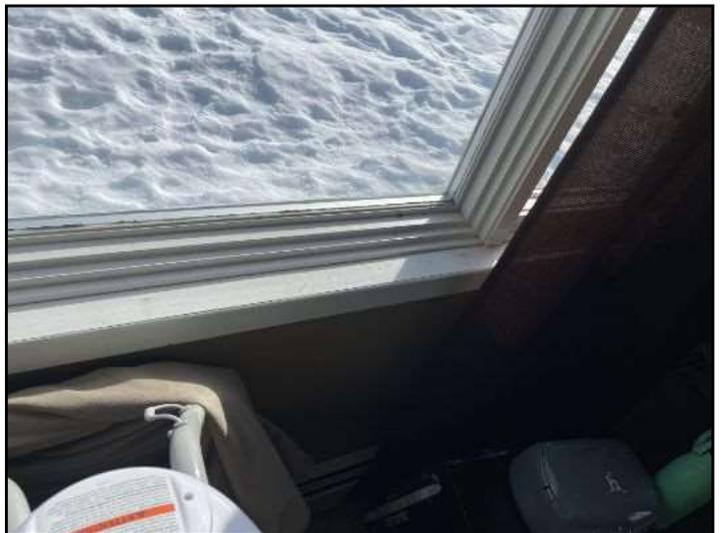
Paint on window sill is worn and weathered.

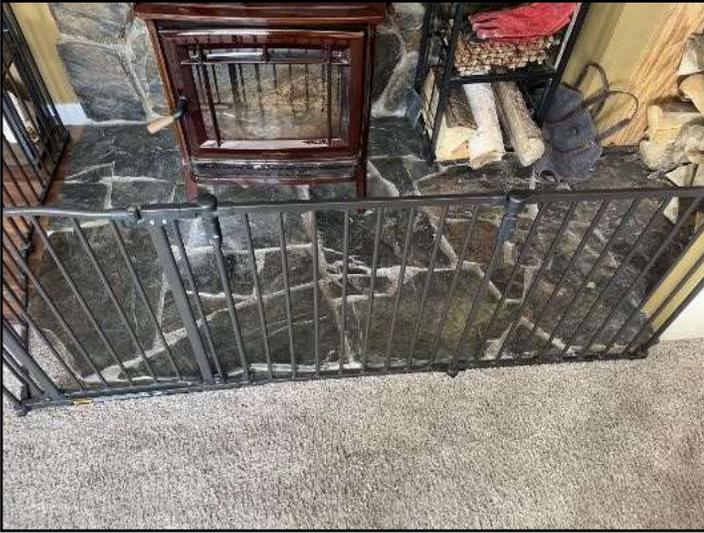
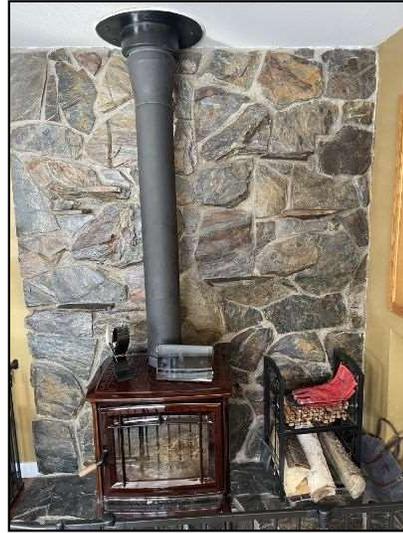
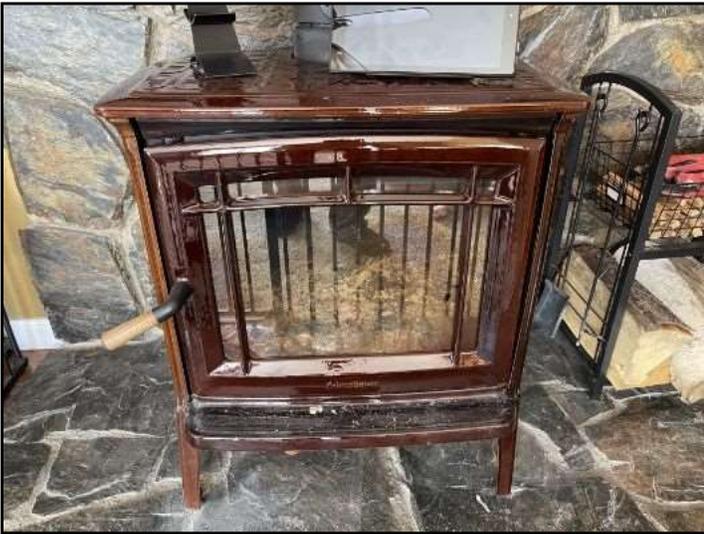
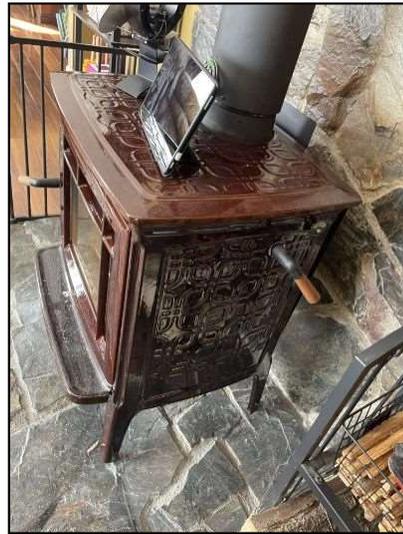
6. Fireplace

- No major system safety or function concerns noted at time of inspection.
- Yearly maintenance: it is recommended chimney be cleaned before every heating season to help prevent chimney fires.

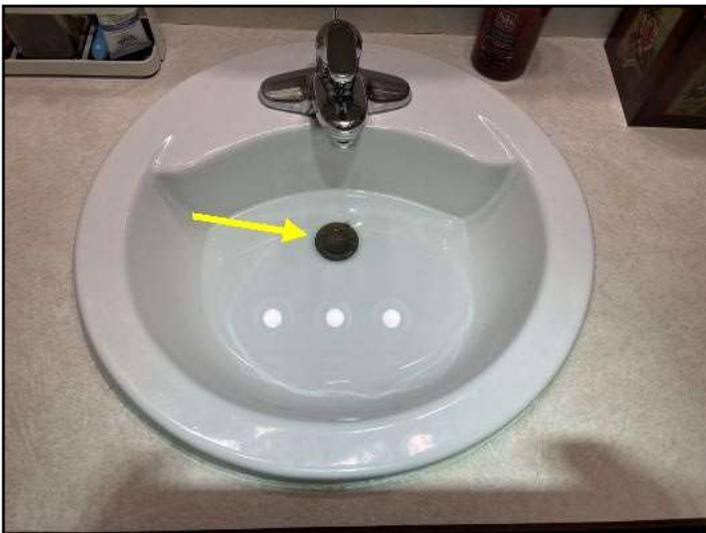
5. Sinks

- Sink in bathroom was slow to drain. Recommend clearing drain line to help sink drain better.

Sink was slow to drain.

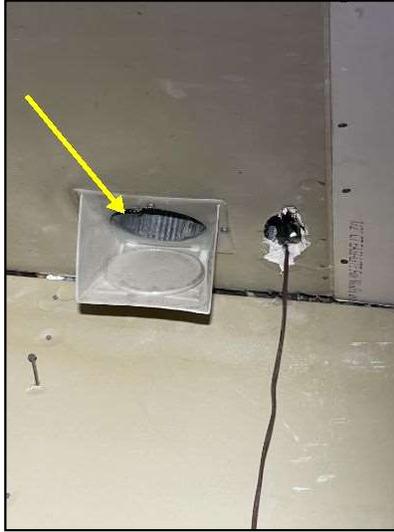
11. Exhaust Fan

- Bathroom exhaust vents to the garage storage area. There are no showers or bath tubs to push moisture in storage area.

Bathroom fan exhaust in to garage storage area.

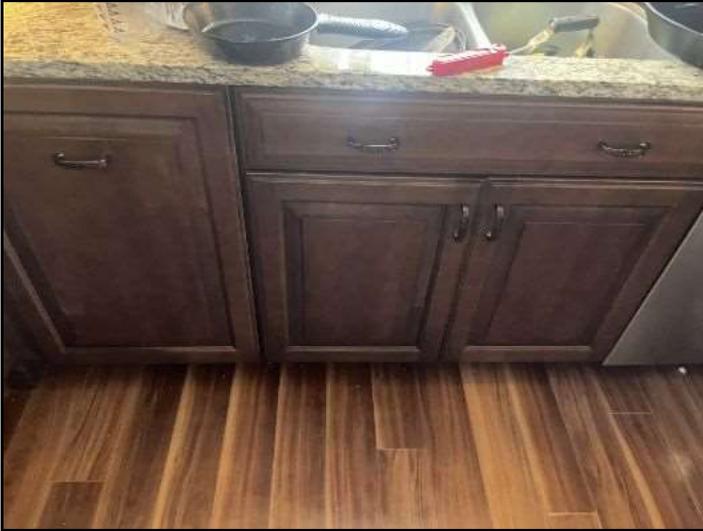
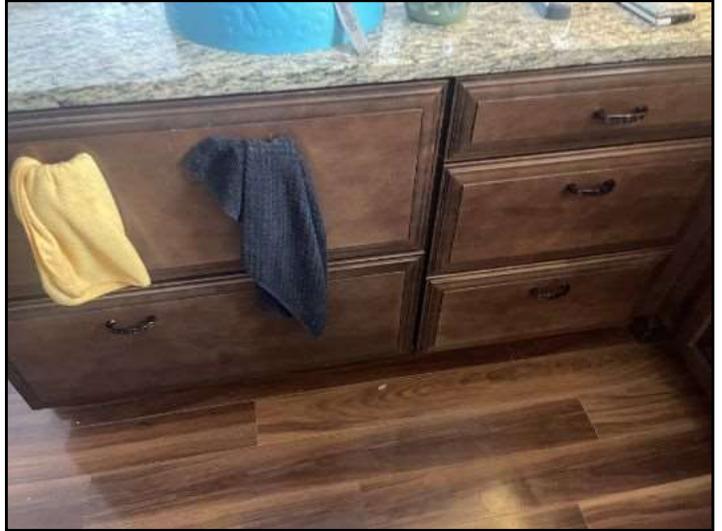
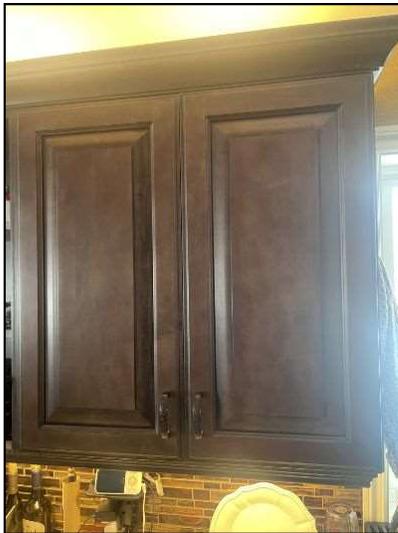
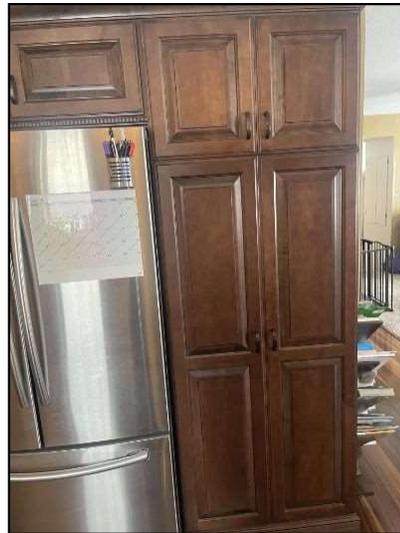
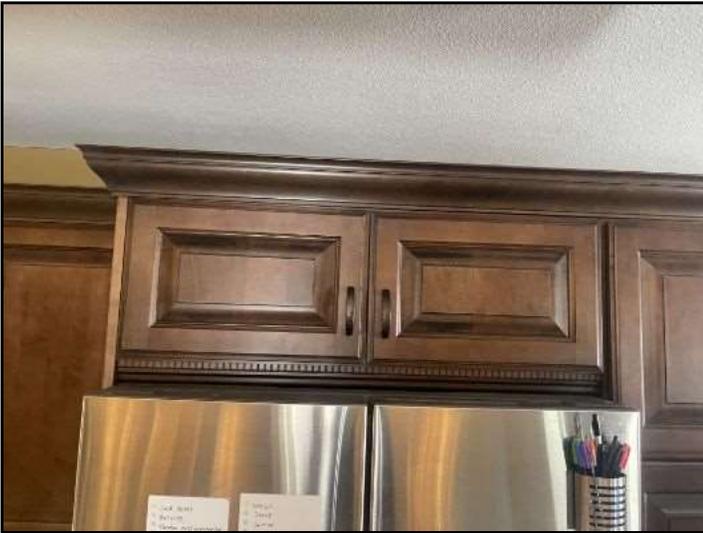
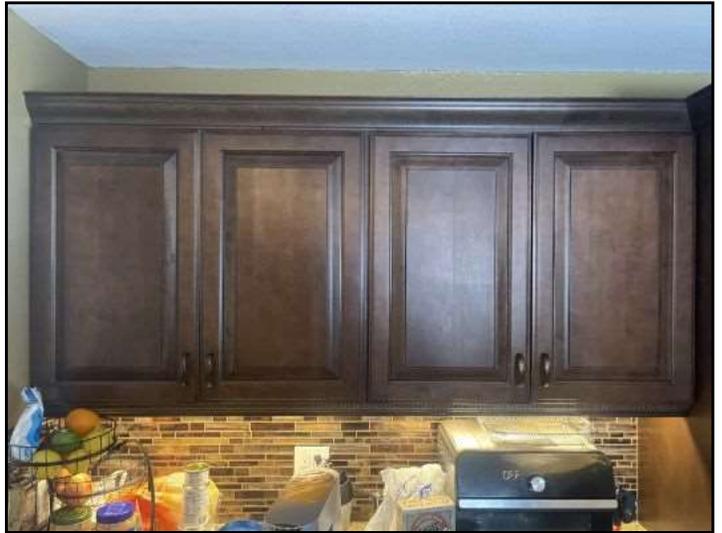
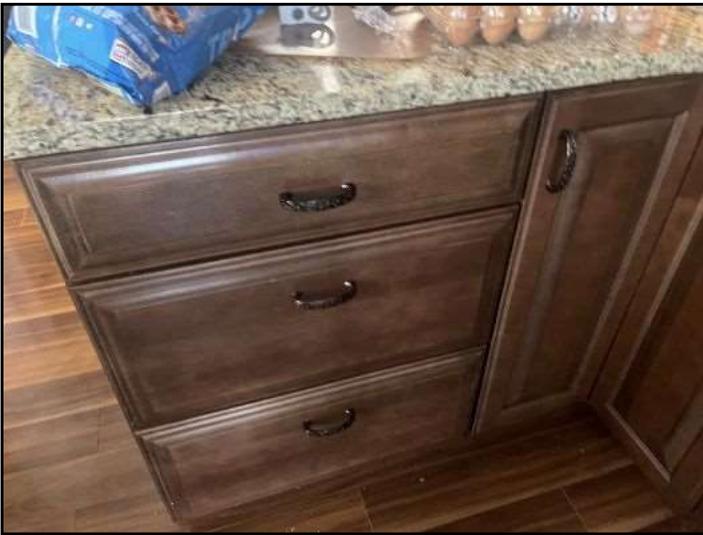
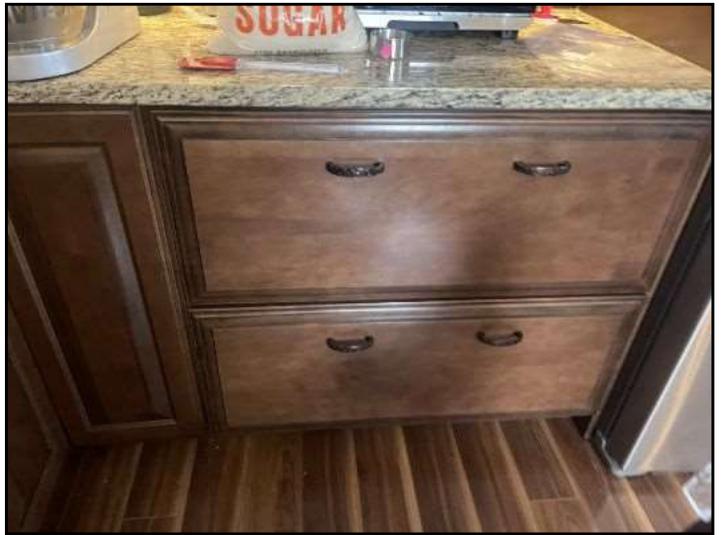
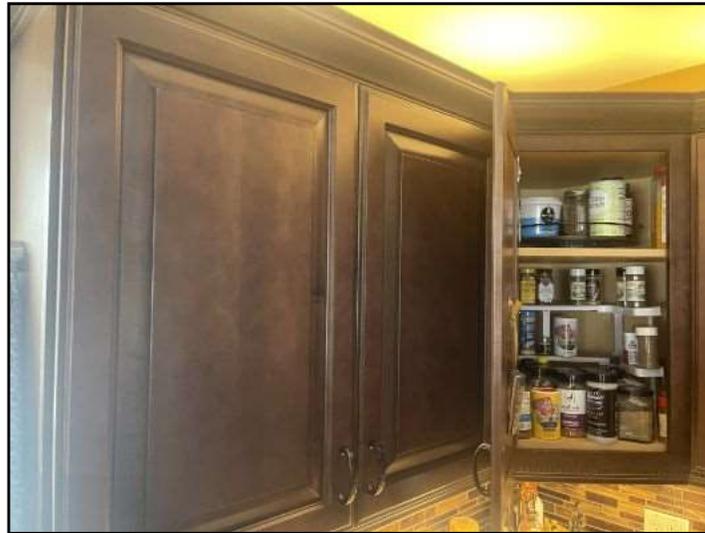
- Appeared functional and in satisfactory condition, at time of inspection.
- No deficiencies observed on all kitchen cabinets.

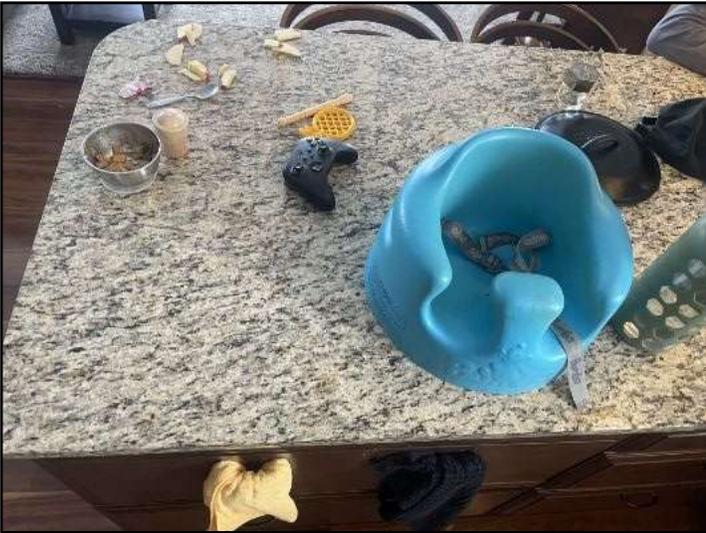
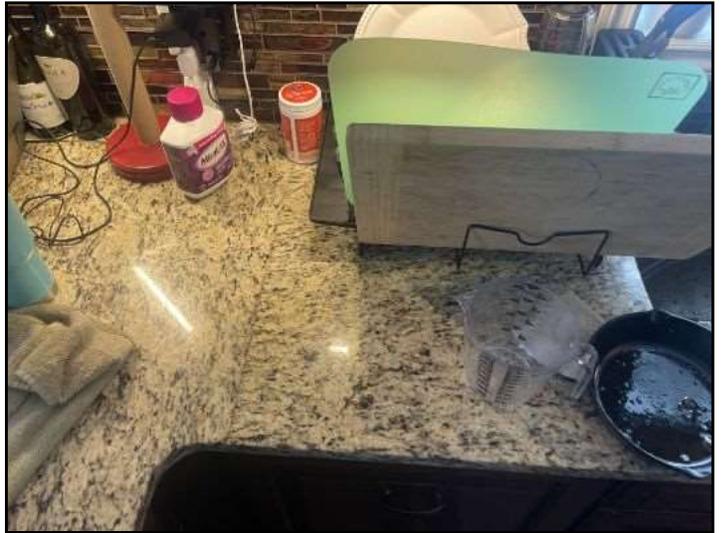
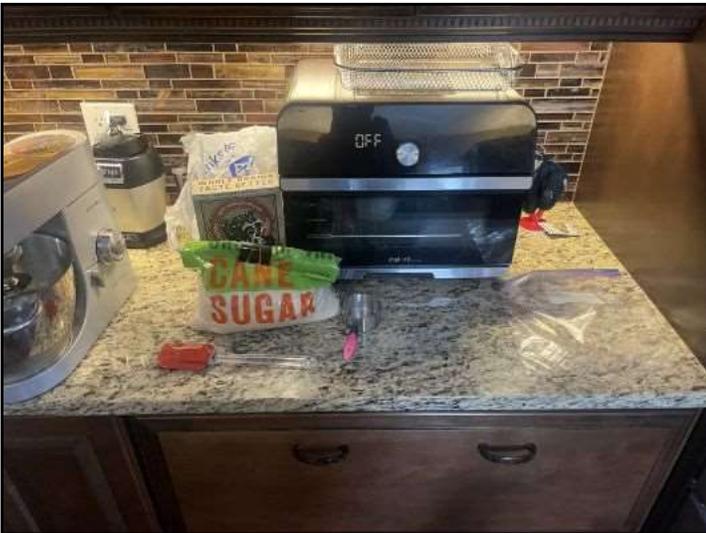
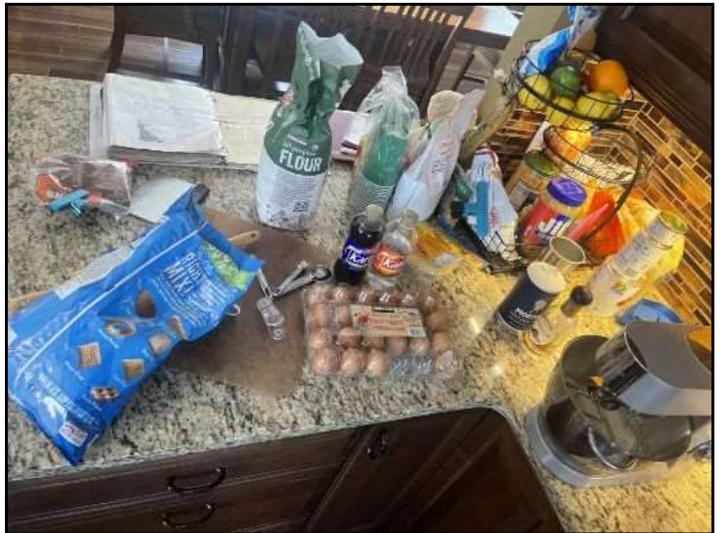
2. Counters

- Solid Surface tops noted.
- No major system safety or function concerns noted at time of inspection.

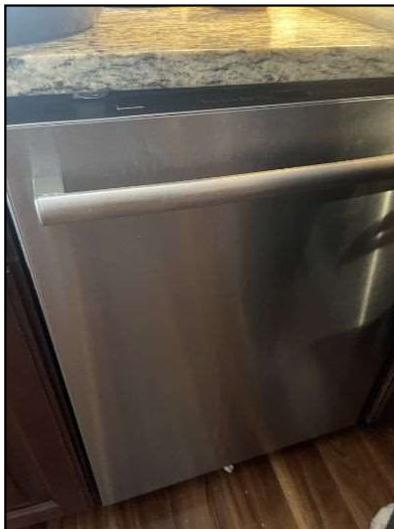
3. Dishwasher

- No major system safety or function concerns noted at time of inspection.

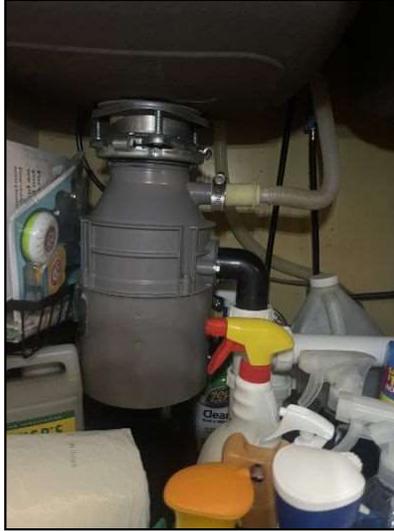
4. Garbage Disposal

- Operated - appeared functional at time of inspection.

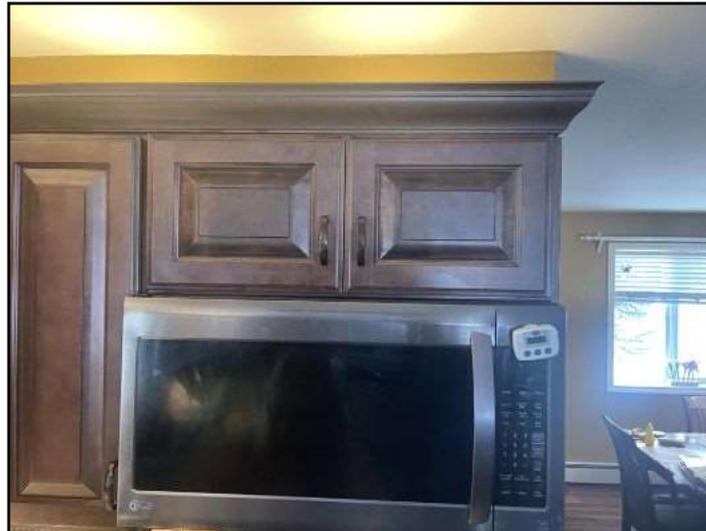
5. Microwave

- No major system safety or function concerns noted at time of inspection.

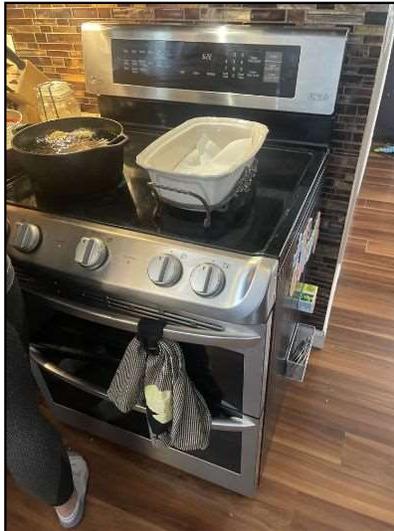
6. Cook top condition

- Electric cook top noted.
- No major system safety or function concerns noted at time of inspection.
