**Tax Year 2024
Real Property Assessment Appeal
City of Valdez
Office of the City Clerk**

Appeal Number 19

Property ID Number:	7010-005-002-0	NOTE: A SEPARATE FORM IS REQUIRED FOR EACH PARCEL.
Property Owner:	Jaranda and Josh	
Legal Description:	lot 2, block 5, Black Gold #1, lot size 10000 SF	
Physical Address of Property:	616 S. Waterfall

Attached is a full home inspection report for 616 S. waterfall. Highlighted in the 164-page report you will find several repairs on the home that negatively affect the homes value. In my appeal I wrote that the home value should be dropped by \$100,000 based on the repairs outlined in the report. The costliest repairs include.

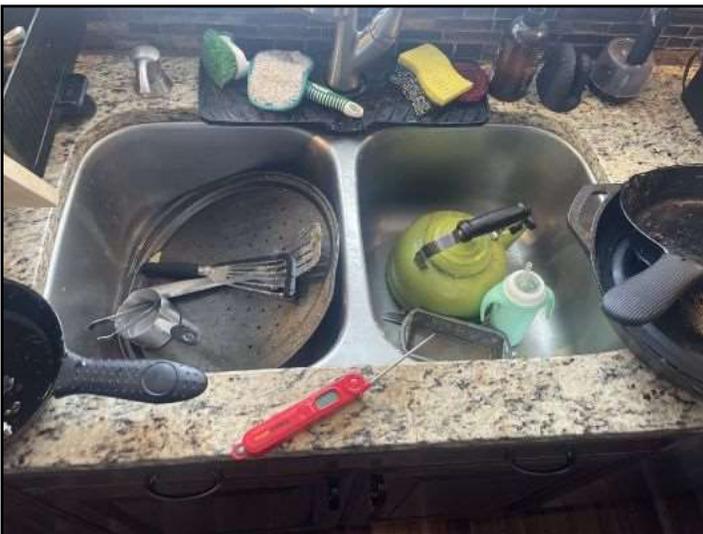
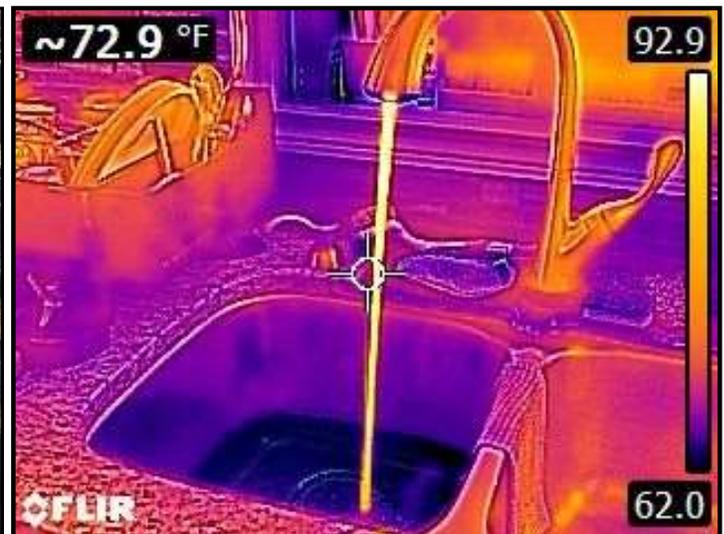
7. Sinks

- No major system safety or function concerns noted at time of inspection.

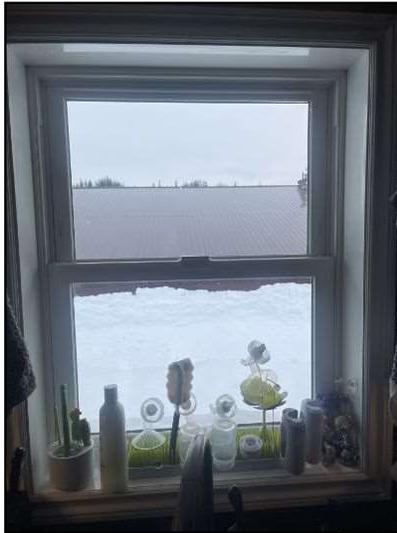
8. Window Condition

- In accordance with ASHI Standards, we do not test every window in the house, and particularly if it is furnished. We do test every unobstructed window in every bedroom to ensure that at least one provides and emergency exit.

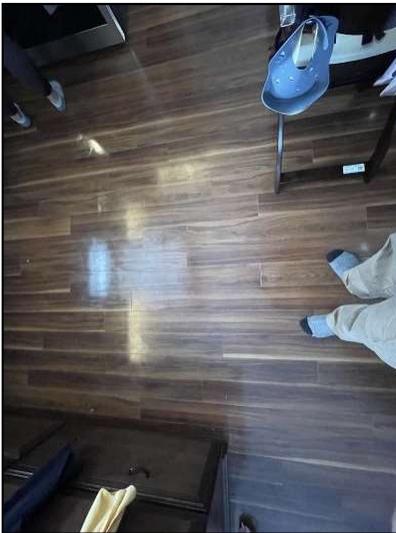
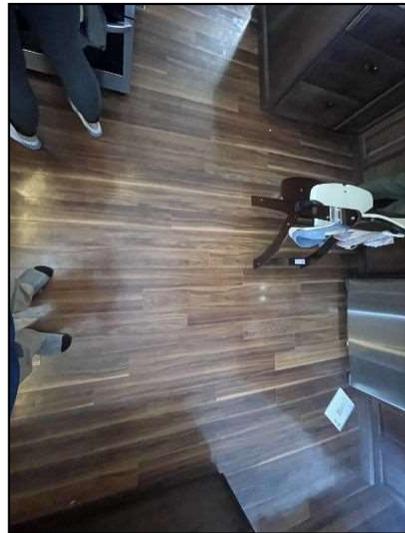
9. Floor Condition

- No major system safety or function concerns noted at time of inspection.

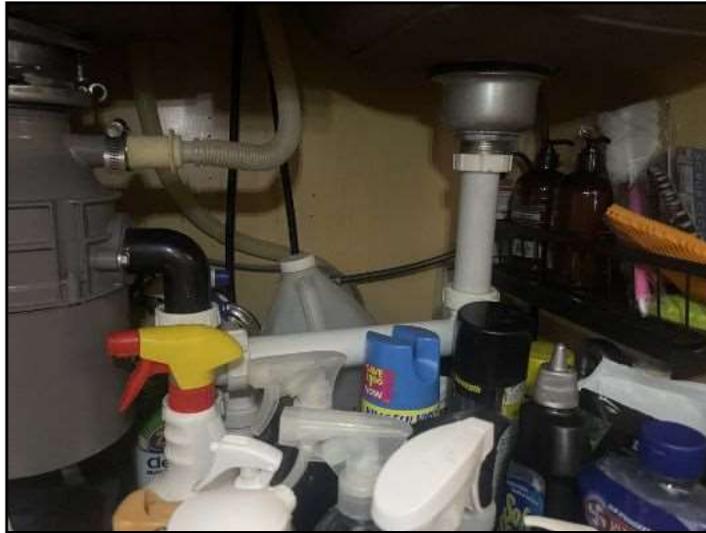
10. Plumbing

- No major system safety or function concerns noted at time of inspection.

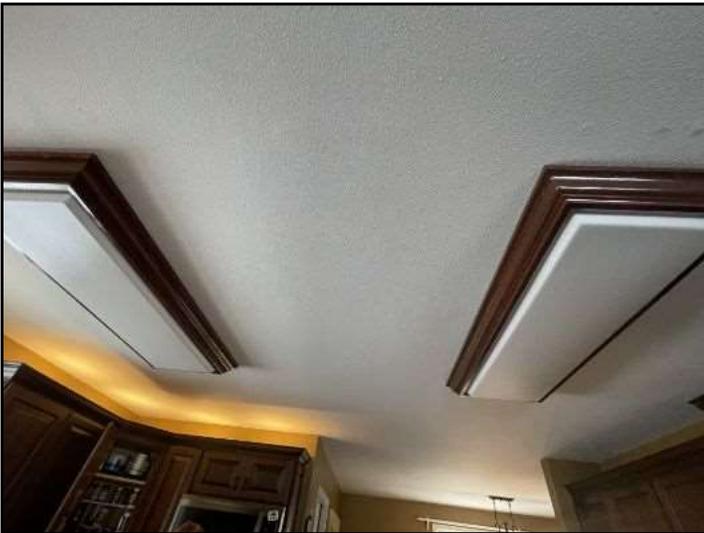
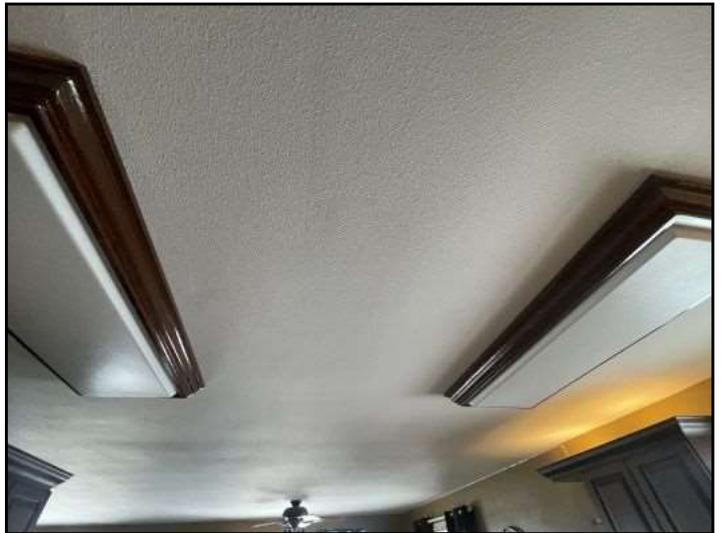
11. Ceiling Condition

- No major system safety or function concerns noted at time of inspection.

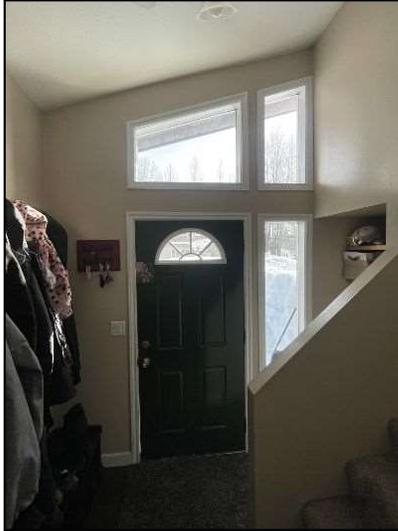
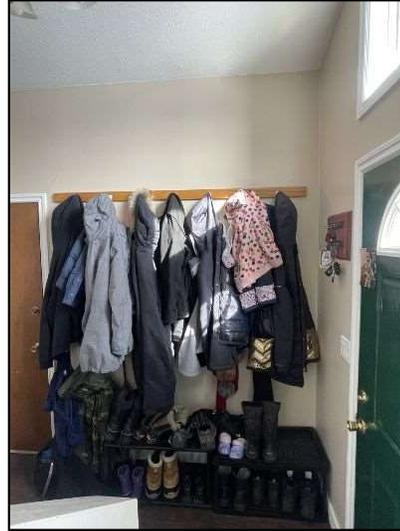
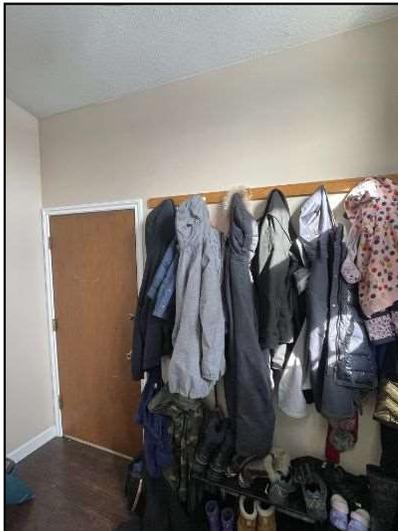
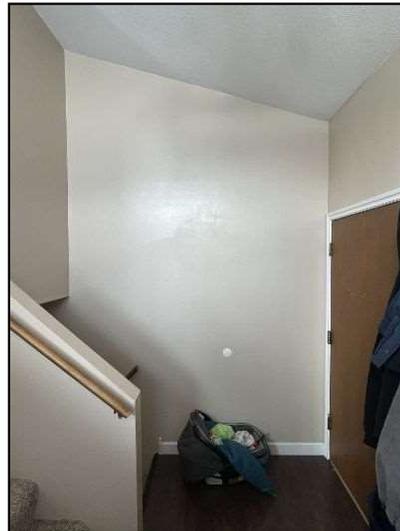
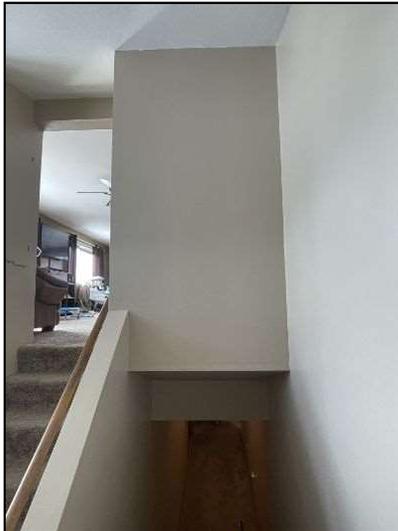
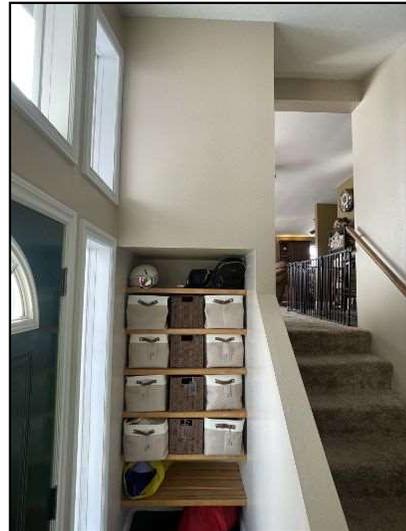
- Crack in drywall above fire door to garage. Recommend repairing crack and monitoring for any further movement.

Cracking in drywall above garage door frame noted.

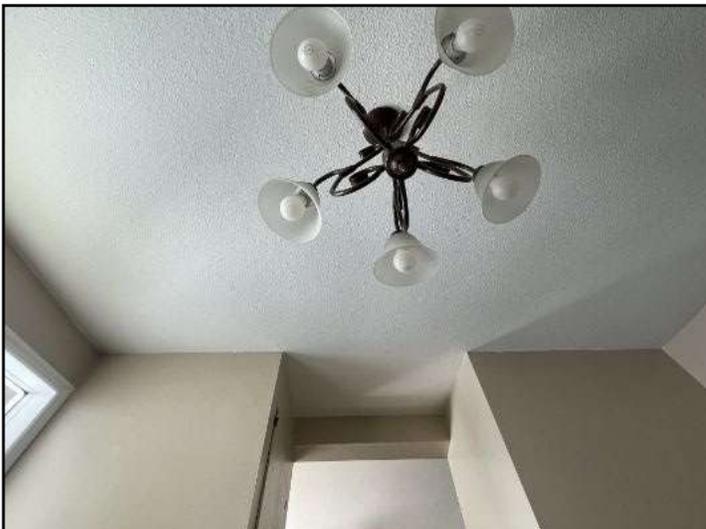
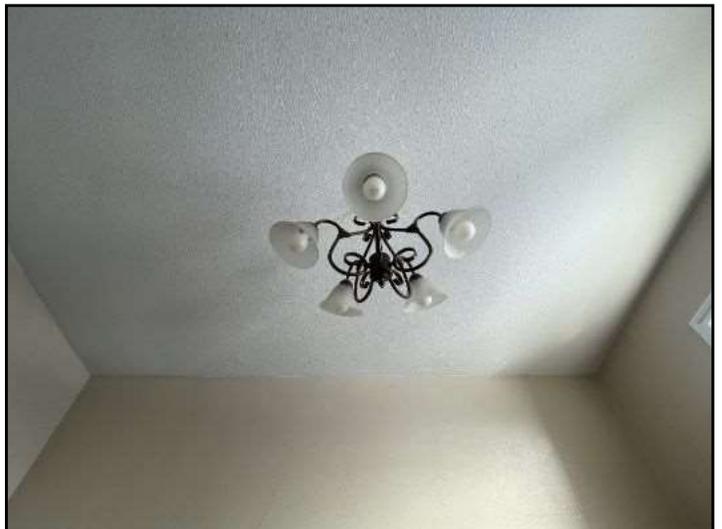
2. Ceiling Condition

- No major system safety or function concerns noted at time of inspection.

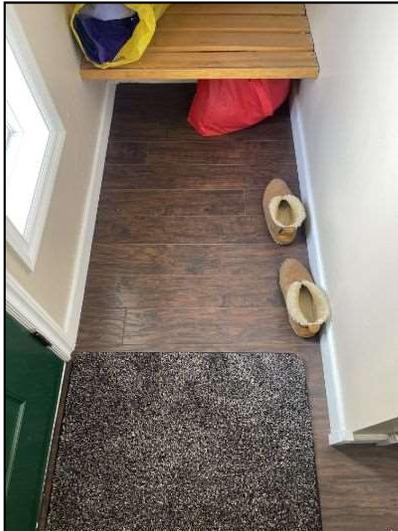
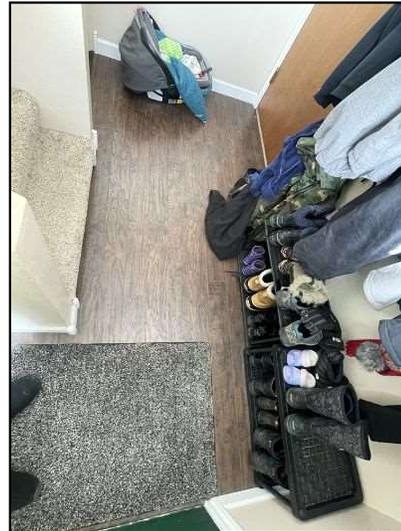
3. Floor Condition

- No major system safety or function concerns noted at time of inspection.

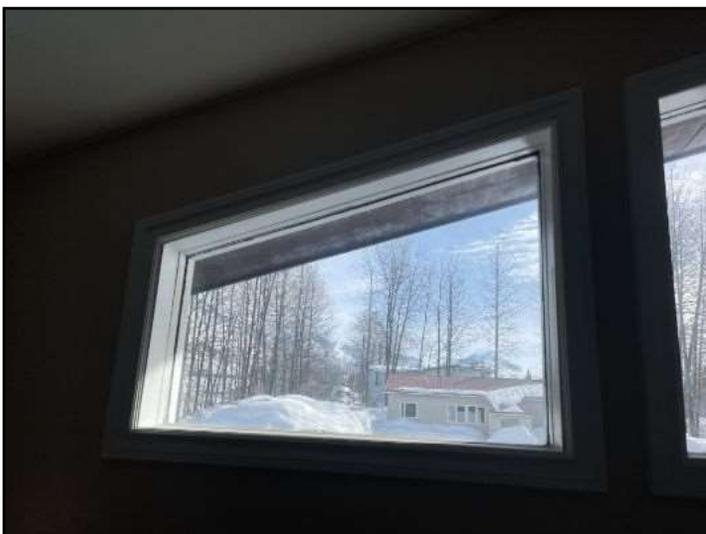
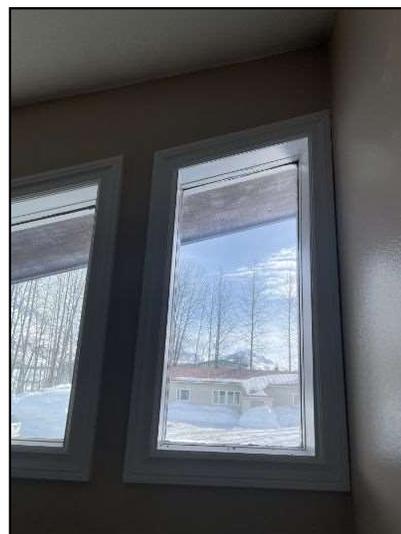
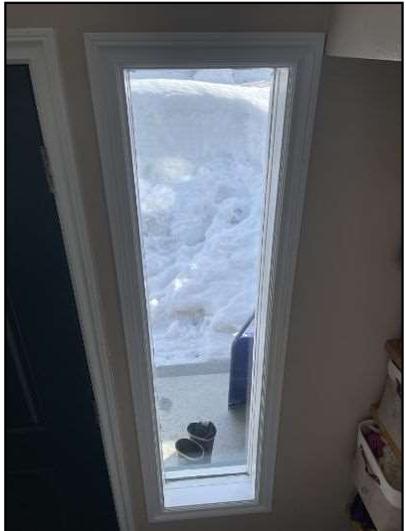
- In accordance with ASHI Standards, we do not test every window in the house, and particularly if it is furnished. We do test every unobstructed window in every bedroom to ensure that at least one provides and emergency exit.

• **DEFERRED COST:** Windows are original, older type. Consider upgrading to double pane, thermally insulated, newer efficient type.

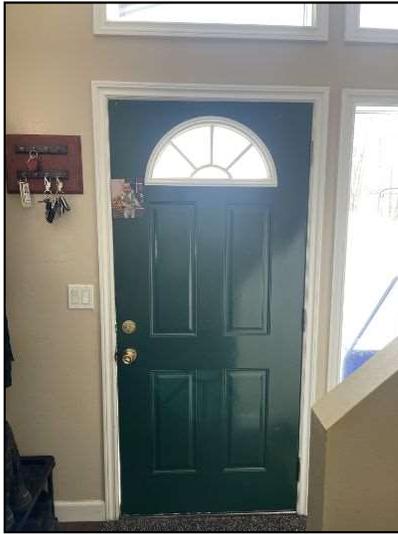
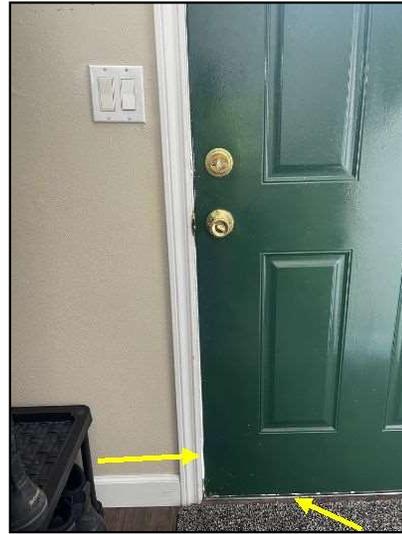
- Sunlight can be seen through front entrance door. Recommend new door seals to help the home be more energy efficient.

Sunlight coming through front door.

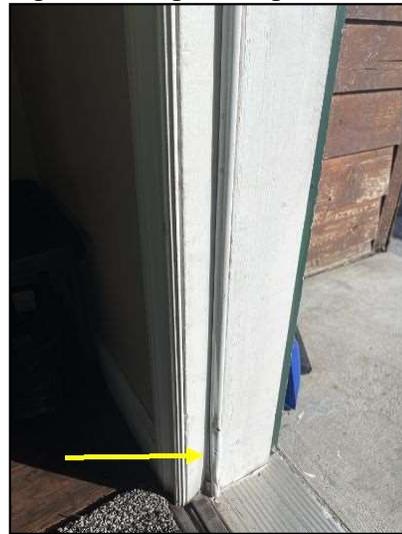
Door seals are worn and weathered.

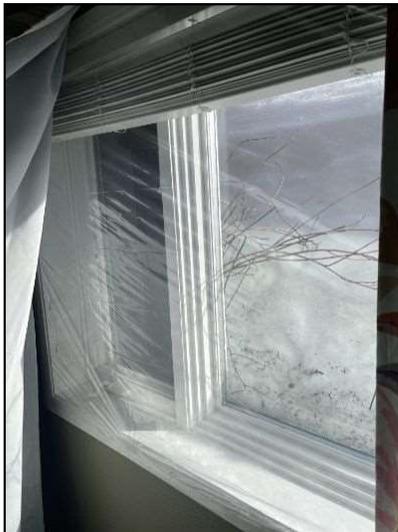
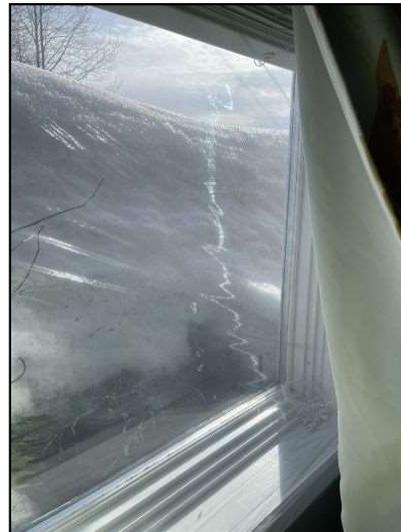
- In accordance with ASHI Standards, we do not test every window in the house, and particularly if it is furnished. We do test every unobstructed window in every bedroom to ensure that at least one provides and emergency exit.
- **DEFERRED COST:** Windows are original, older type. Consider upgrading to double pane, thermally insulated, newer efficient type.

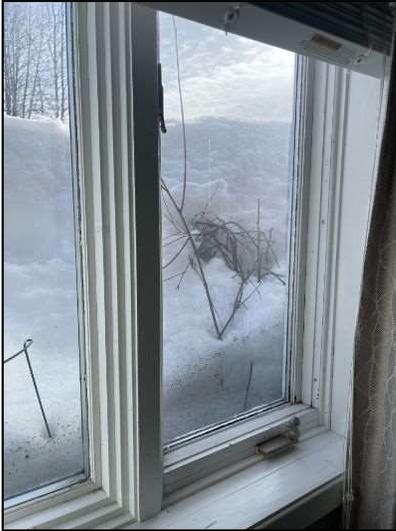
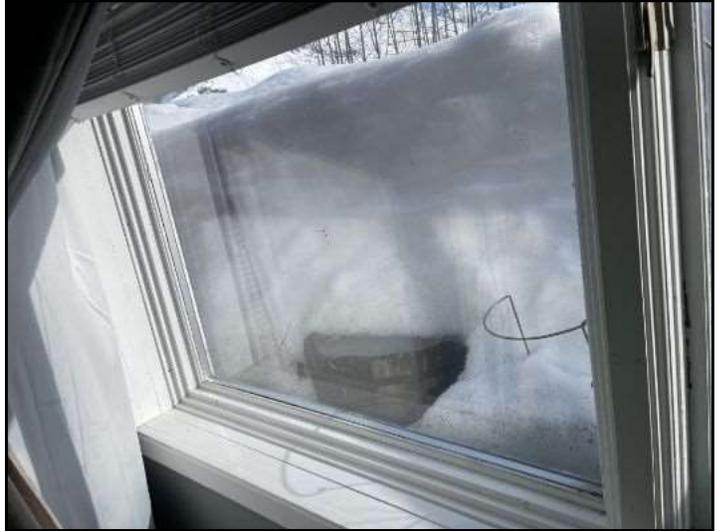
5. Window Condition

- In accordance with ASHI Standards, we do not test every window in the house, and particularly if it is furnished. We do test every unobstructed window in every bedroom to ensure that at least one provides and emergency exit.
- **DEFERRED COST:** Windows are original, older type. Consider upgrading to double pane, thermally insulated, newer efficient type.

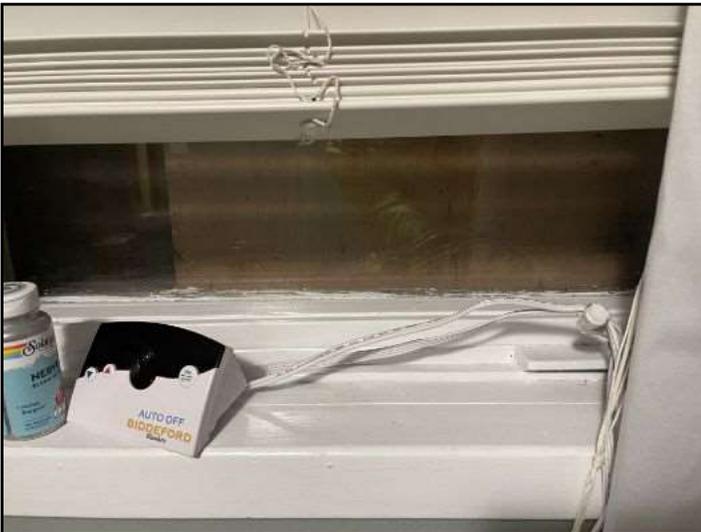
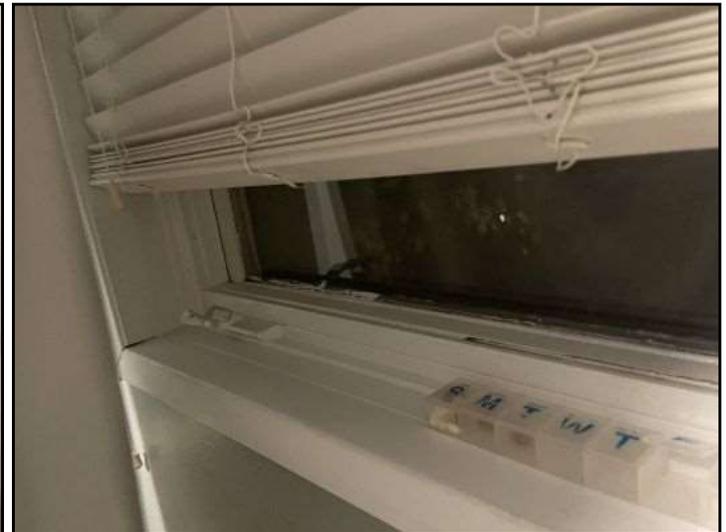
5. Window Condition

- In accordance with ASHI Standards, we do not test every window in the house, and particularly if it is furnished. We do test every unobstructed window in every bedroom to ensure that at least one provides and emergency exit.
- **DEFERRED COST:** Windows are original, older type. Consider upgrading to double pane, thermally insulated, newer efficient type.

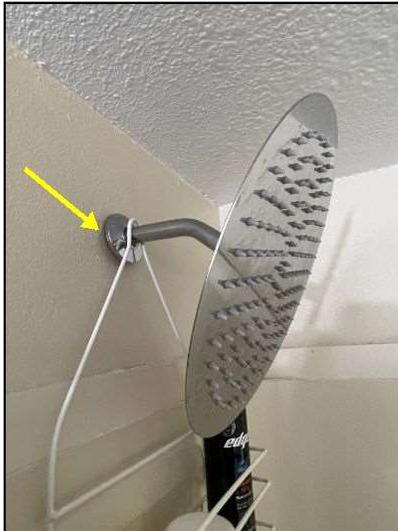
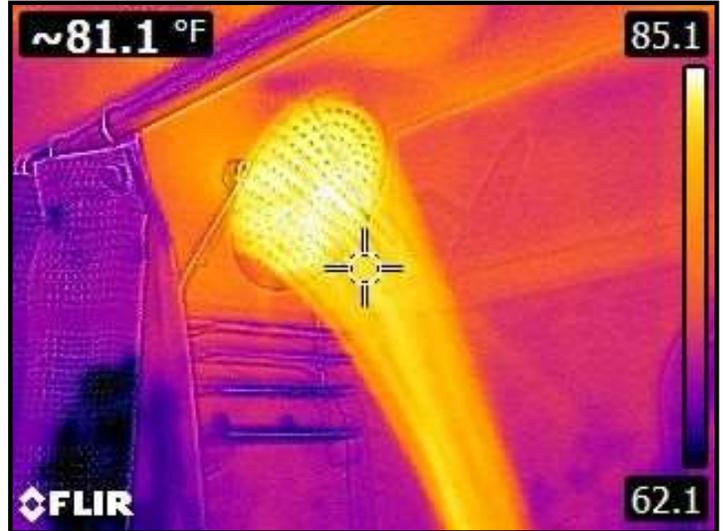
10. Showers

- Shower head not fully secured to wall. Recommend qualified contractor to evaluate for repair.

Shower head not fully secure to wall.

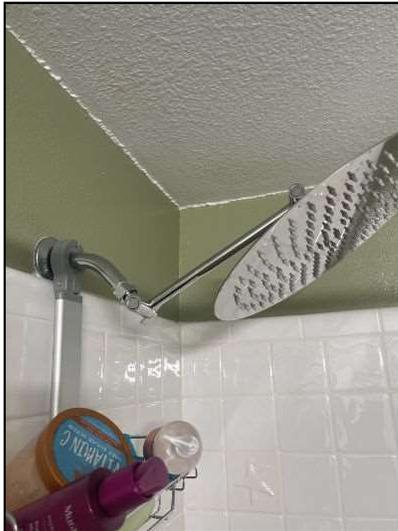
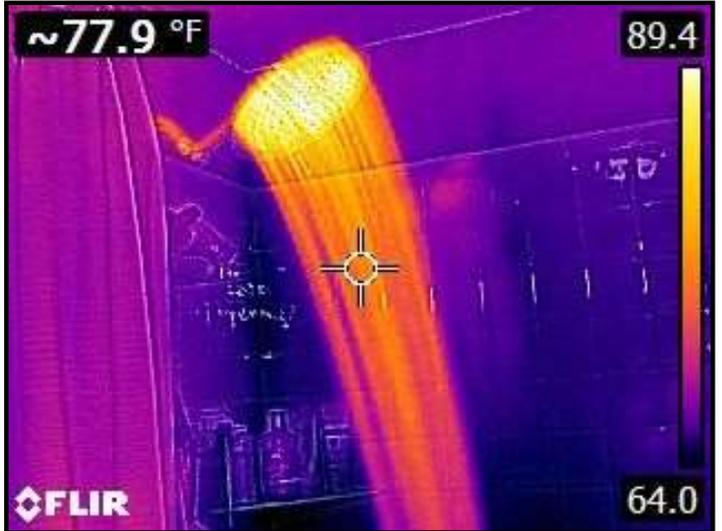
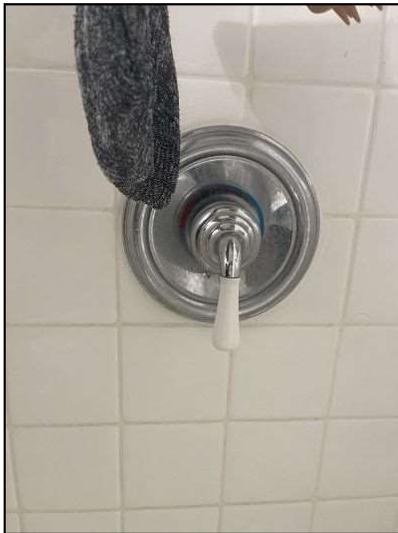
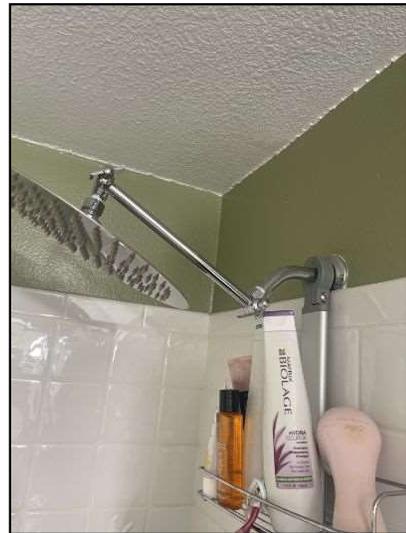
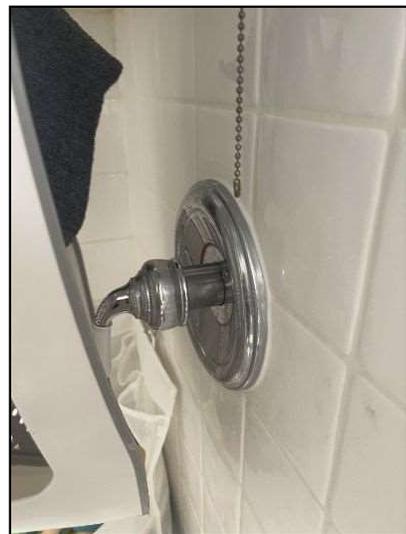
10. Showers

- Right side of shower heads showed no hot water when function tested. Recommend qualified plumber to evaluate for repair.

Right side shower head had no hot water at time of inspection.

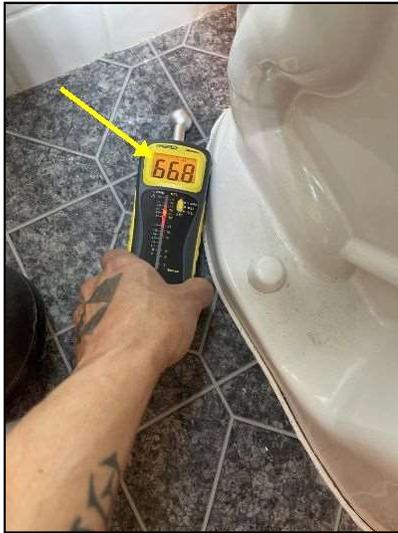
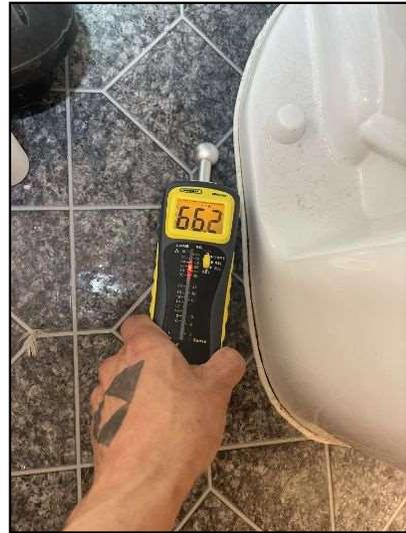
13. Toilets

- Operated when tested. Appeared functional, at time of inspection - except as noted.
- Toilet loose and may need re-anchoring.
- High moisture reading around toilet flooring. Toilet being loose may have caused the seal to come loose. Recommend qualified plumber to evaluate toilet for repair.

High moisture reading by toilet flooring.

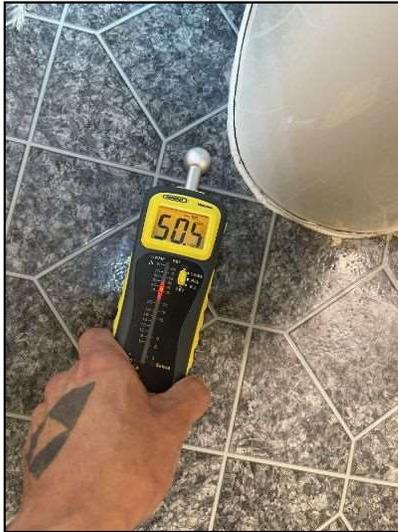
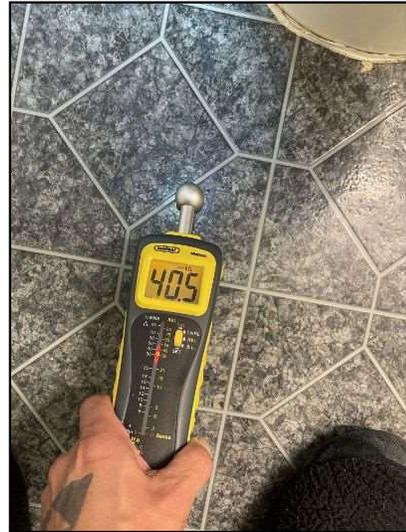
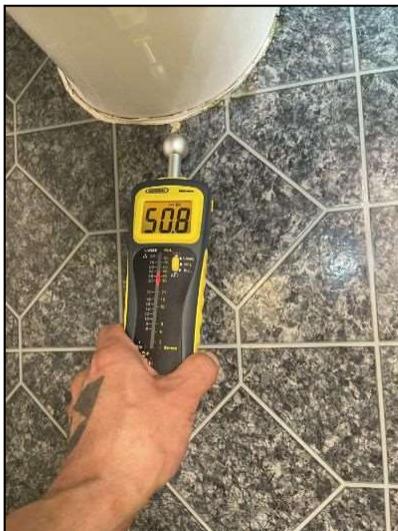
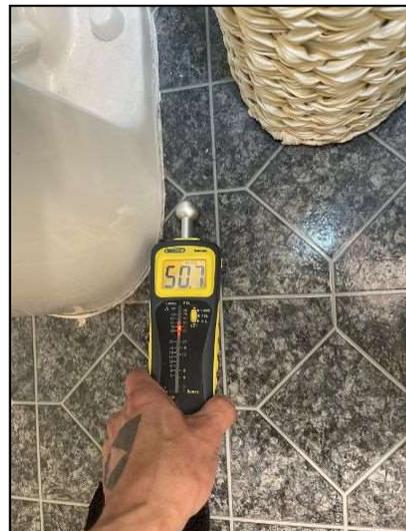
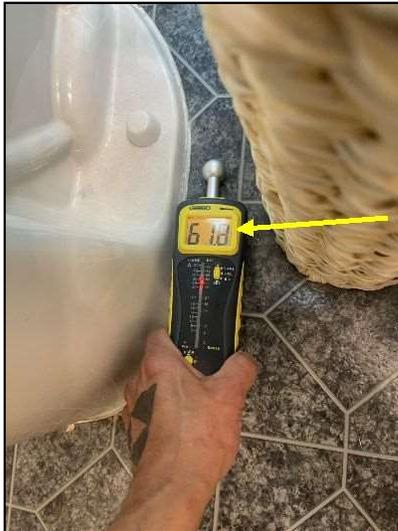
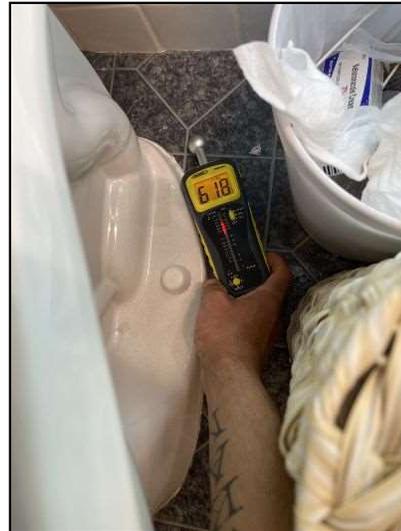
Toilet not fully secured to the bathroom floor.
