**CITY OF VALDEZ ASSESSOR'S REVIEW FORM**Appeal # 234

Property address (or legal description, mile, etc.): 714 N SNOWTREE DR

# *Arctic Home Inspections* Property Inspection Report

714 North Snowtree Drive, Valdez, AK 99686

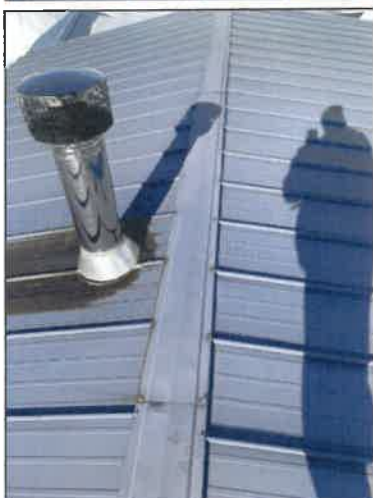
Screw loose on ridge.

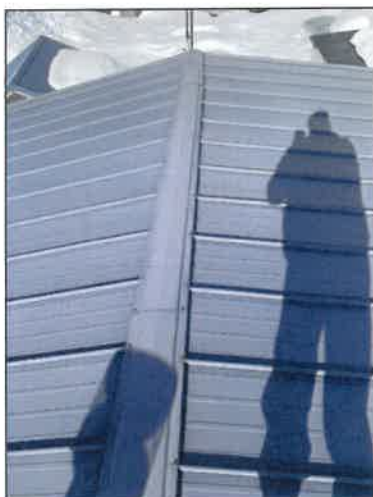
No fasteners on joining of ridge pieces.

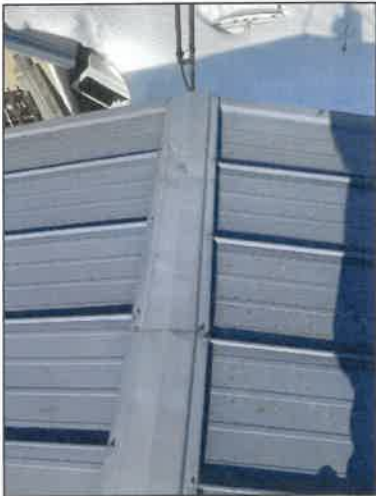
No fasteners on joining of ridge pieces. Loose screw.

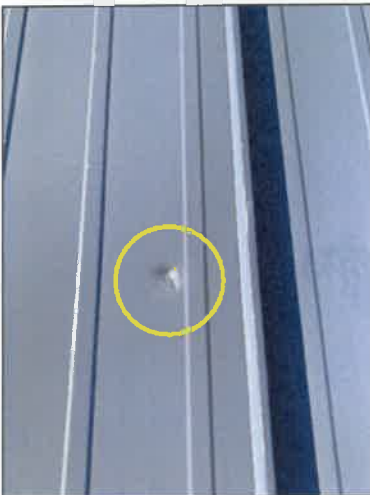
Dent in roof.

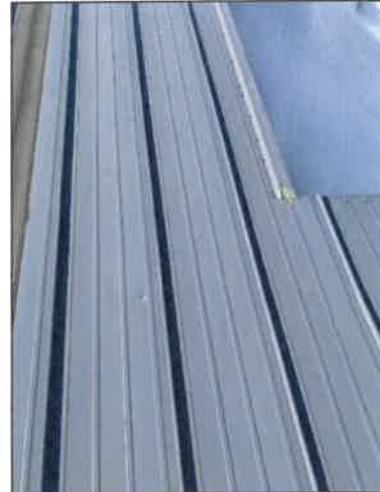
- Multiple screws missing on the ridge of the roof. Recommend having licensed roofer to repair.
- Two dents detected at the time of inspection. One dent has a small crack and may cause a leak in the garage roof. Recommend a licensed roofer to evaluate for repair or replacement.

Dent with a small crack in the roof panel over the garage.

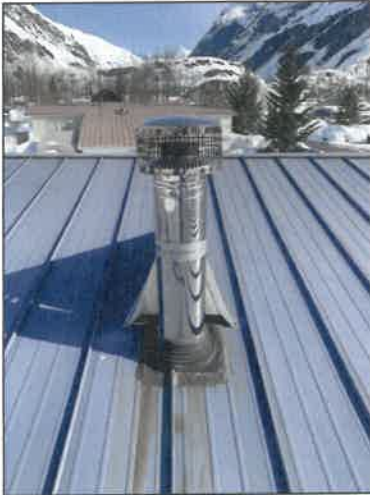
- Recommend better flashing and sealing at the bottom of the boot for exhaust stack.
- Recommend sealing on top of boot to the exhaust stack.
- Recommend sealing gap in cricket to the roof.

Recommend proper sealing of boot.

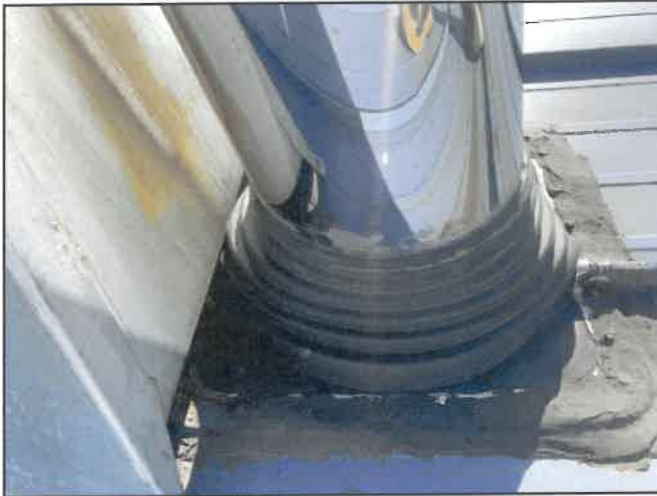
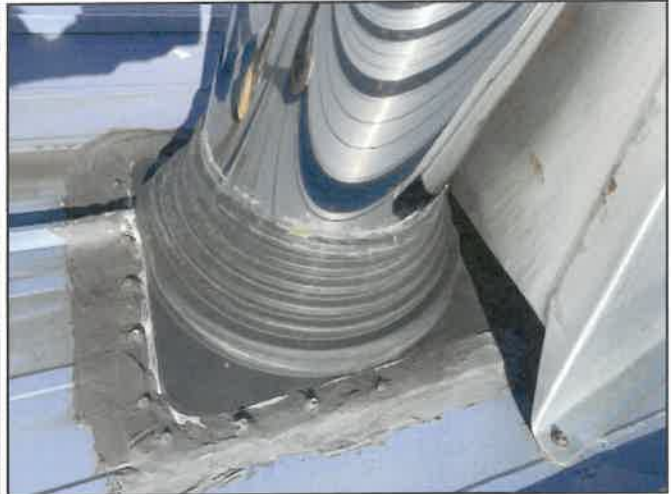
Recommend resealing boot.

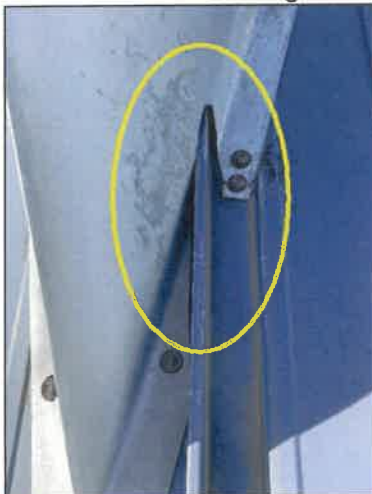
Recommend sealing cricket around seam of roof.

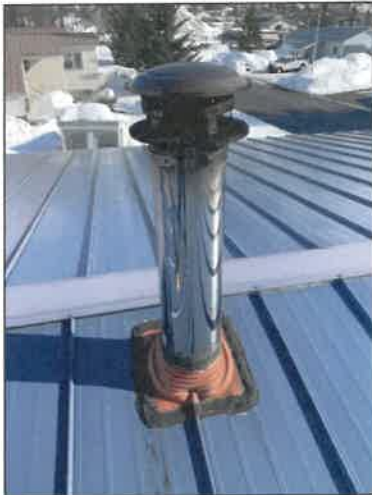
- Recommend better flashing and sealing of the chimney.

Recommend proper sealing of boot.

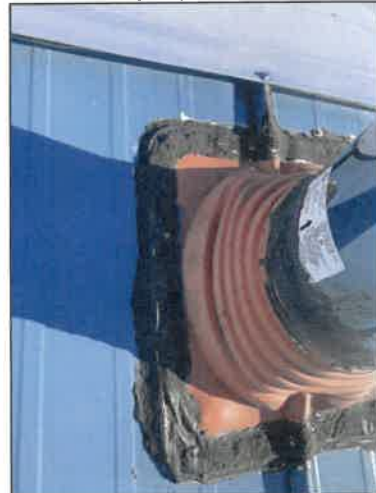
Recommend proper sealing of boot.

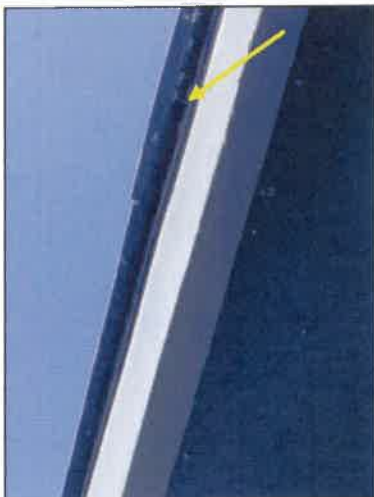
Screw causing drip edge to protrude.

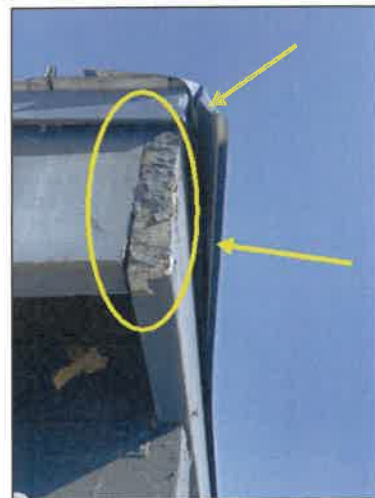
Drip edge is bent out. Fascia is weathered.

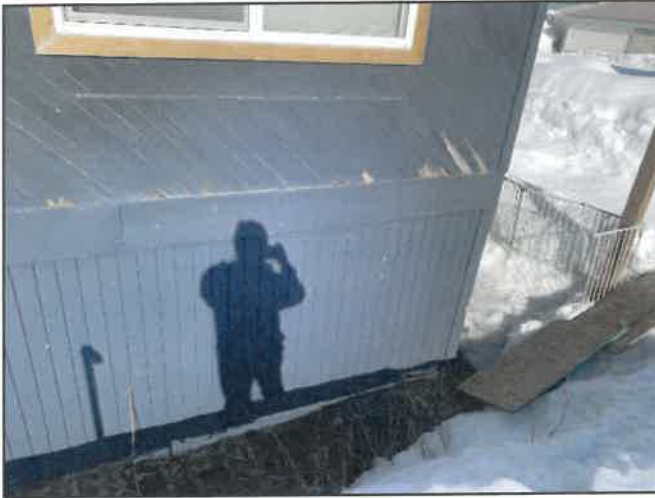
- Some areas need priming and repainting.
- Caulk and seal all gaps, cracks and openings.
- Garage wall have spray foam insulation on the underside of the wall to prevent a gap in to the garage. This appears to be a way for moisture intrusion. Recommend having a licensed contractor to evaluate for repair or replacement.
- Siding damage on northeast corner of home. Siding has some holes and moisture damage on the trim. Recommend a licensed contractor to evaluate for repair or replacement.

Paint chipping on homes siding.

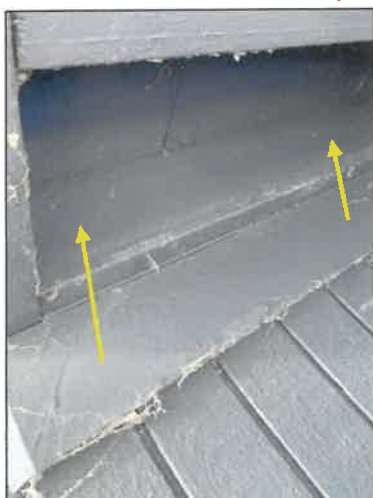
- Lag bolts not present.
- Stairs and handrails are worn and weathered. Recommend a licensed contractor to evaluate for repair or replacement.
- Stairs are not properly attached to the patio. It is only secured with nails. Recommend joist hangers to better support the stairs to the patio.

No lag bolts attaching porch to the home.

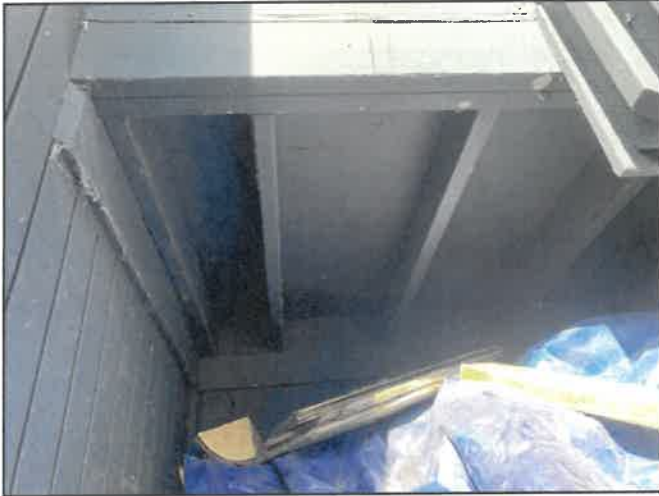
Stairs are worn and weathered. Some steps are damaged.

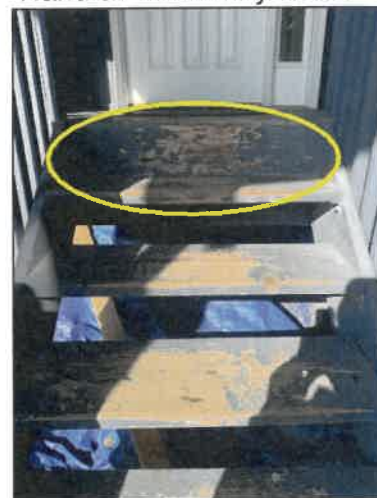
Stairs are not fastened properly to the porch.
